Embankment Criteria,
Performance, and
Foundation Report

Waco Lake
Bosque River, Texas
Brazos River and Tributaries, Texas

SUBJECT: Waco Lake, Texas, Embankment Criteria and Performance Report

EMBANKMENT CRITERIA, PERFORMANCE
AND
FOUNDATION REPORT

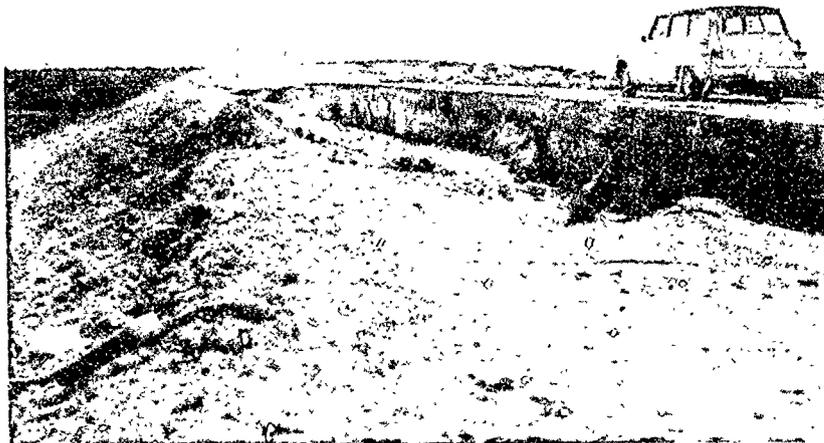
1-05. Foundation Slide. A major slide involving part of the embankment and its foundation occurred in October 1961, during construction of the first major portion of embankment under Contract No. 60-82 (See Plate 47 and Photos 6 and 7). The portion of embankment affected was between Stations 50 and 65. According to the classification system of the U.S. Committee on Large Dams, (ASCE/USCOLD, 1975), the slide was a "Type 3 Accident"; a slump that took place before any water was impounded. A detailed description of the slide is given in paragraph 5.02.

PHOTO 6. Crest of dam, slide area about sta 55+00, Oct 61.

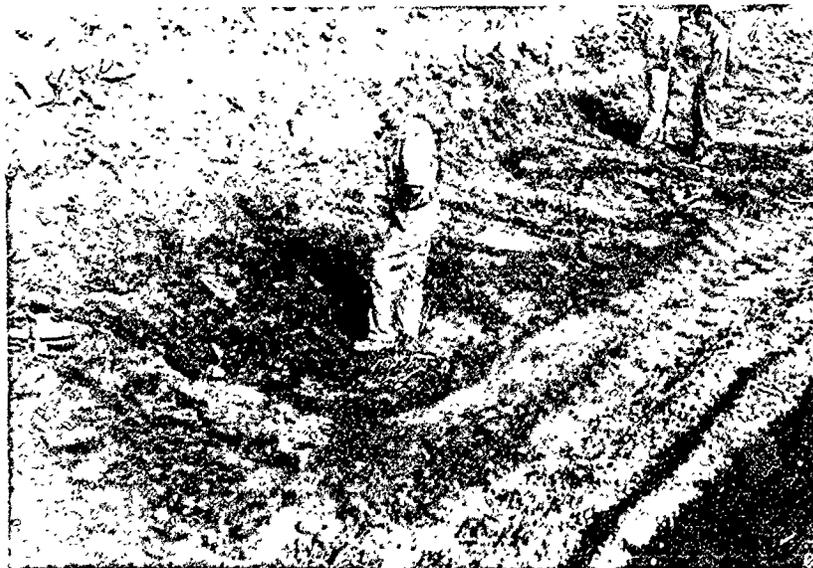
PHOTO 11. Upturned Eagle Ford shale on the down-thrown side of the South Fault in the upstream fault excavation.

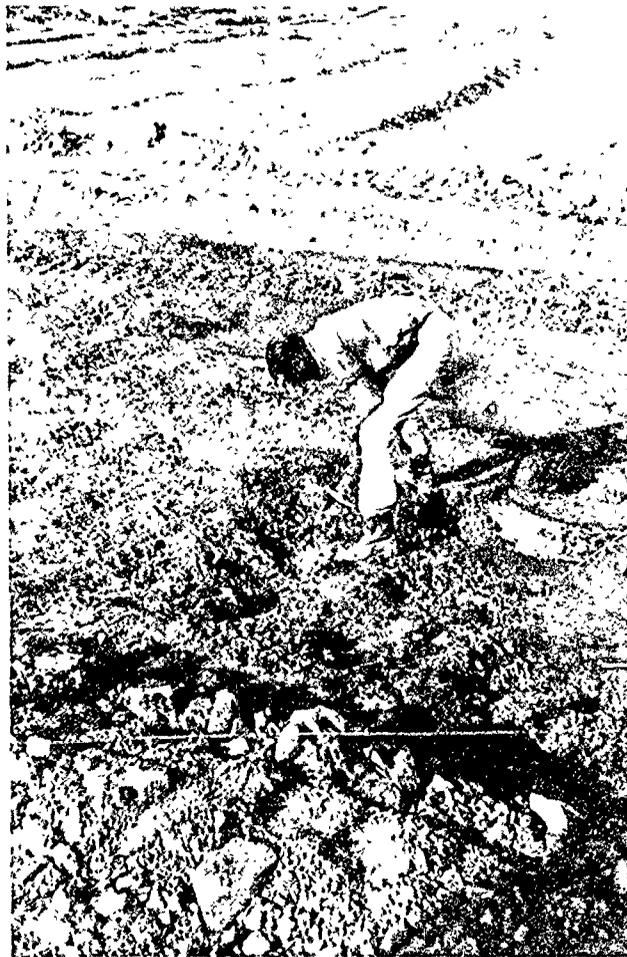
PHOTO 14. Eagle Ford shale (left)/overburden contact in the embankment foundation; vicinity of station 20+00 on centerline.

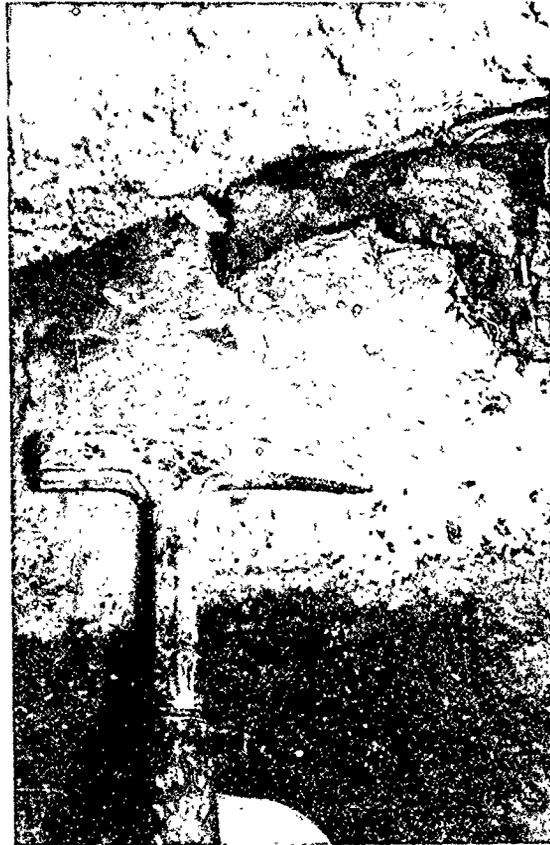
PHOTO 16. Slickenside in the Pepper shale below and nearly normal to the failure plane in inspection hole sta 58+20.

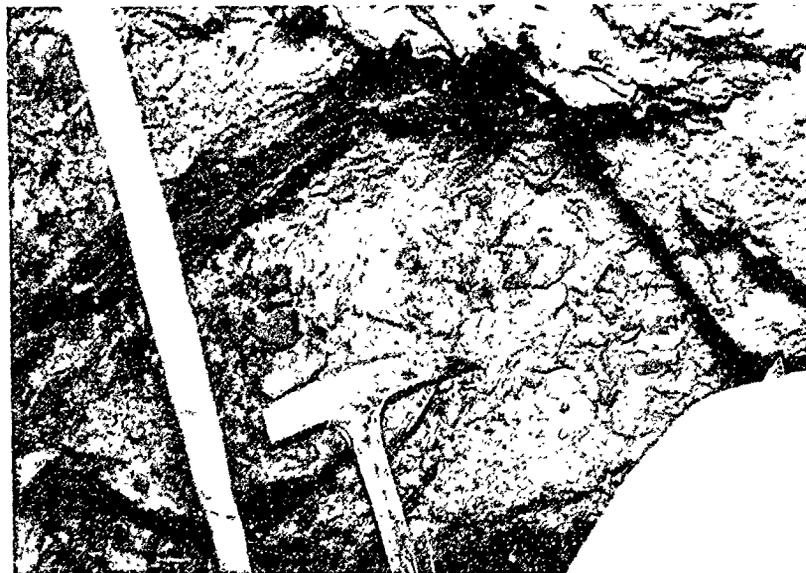
PHOTO 17. Slickenside 2-1/2 feet below and nearly paralleling the failure plane in inspection hole sta 58+20.

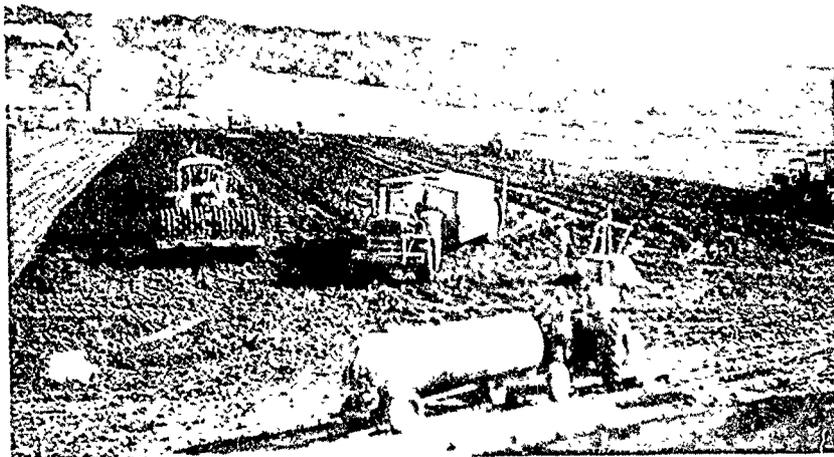
PHOTO 18. Fill placement in the area between the outlet works and river, Nov 63.
