Task Order 2 Enhanced Preliminary Assessment

HAMILTON ARMY AIRFIELD
NOVATO, CALIFORNIA

January 1990

USATHAMA Task Order 2
ENHANCED PRELIMINARY ASSESSMENT REPORT
HAMILTON ARMY AIRFIELD
NOVATO, CALIFORNIA
Contract No. DAAA15-88-D-0007

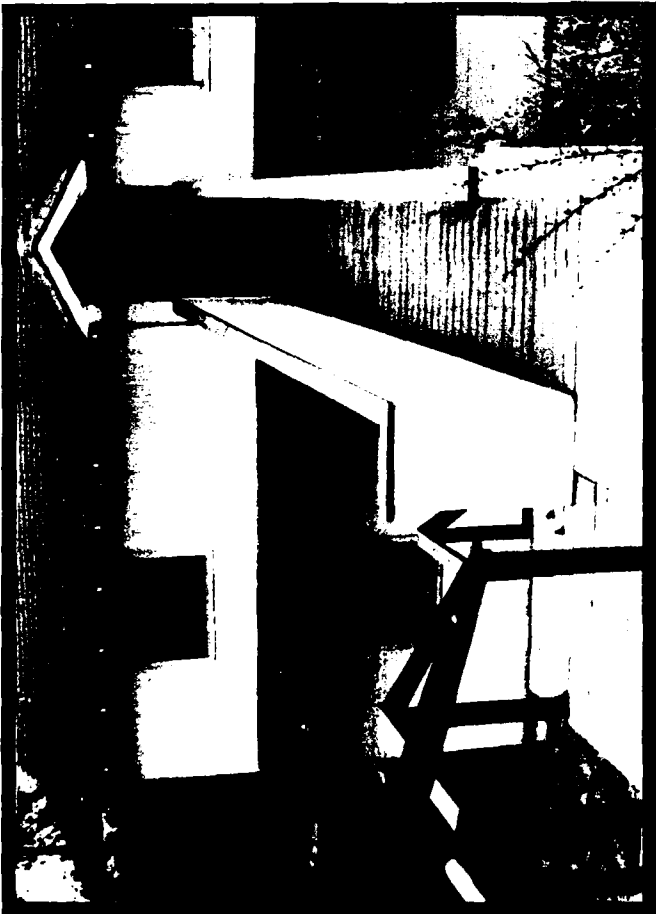
It was noted that several of the buildings may have materials that contain asbestos on or within the structures. The exterior of Buildings 511, 512 (photo 1), 520 (photo 2), and 521 were sided with what appeared to be asbestos-cement Transite siding. The condition of the siding was generally poor, with chips of fallen materials scattered on the ground. A sample tag indicating the location of asbestos sampling points was noted on the siding of Building 520. Hot water pipes located below and in Buildings 511, 512, 515, 520, 521, and on pipes at pump stations (photos 3 and 4) appeared to be wrapped in asbestos material that was left exposed. Sample tags were seen in Building 515 on exposed piping as well as on the boiler in the basement. It was mentioned by Army personnel that asbestos may also be in the boiler rooms of Buildings 442 and 138 [I-1, I-2]. Nine-inch floor tiles similar to others known to contain asbestos were noted in Buildings 511 and 515, and sample tags were seen in Building 515. Appendix A contains asbestos testing information.

1. TRANSITE SIDING ON BUILDING 512

It is recommended that the OCCUSAFE recommendations as well as ambient air sampling be implemented where friable asbestos has been removed or encapsulated.

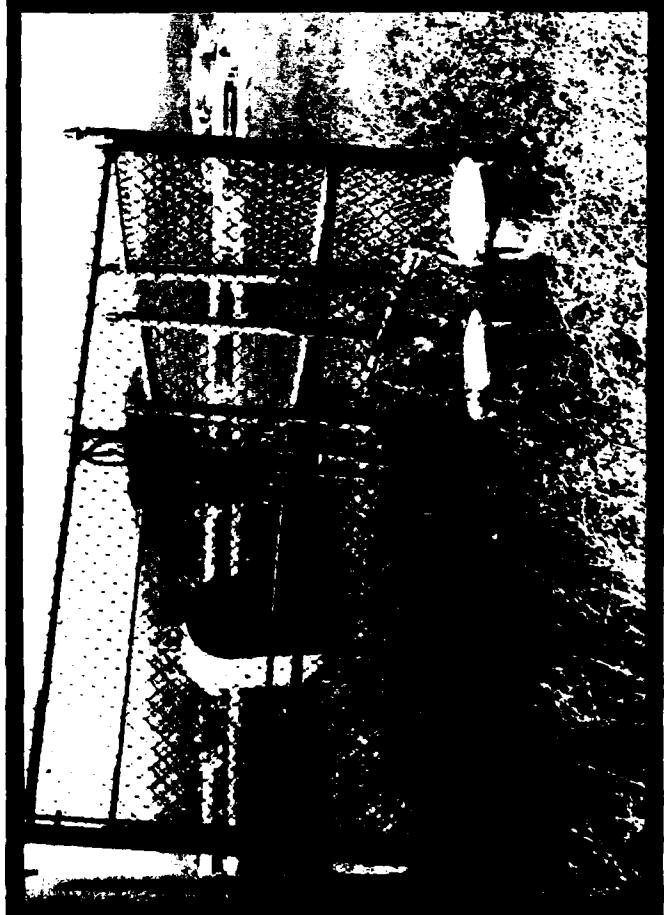
8. ABOVEGROUND STORAGE TANK
AT BUILDING 15

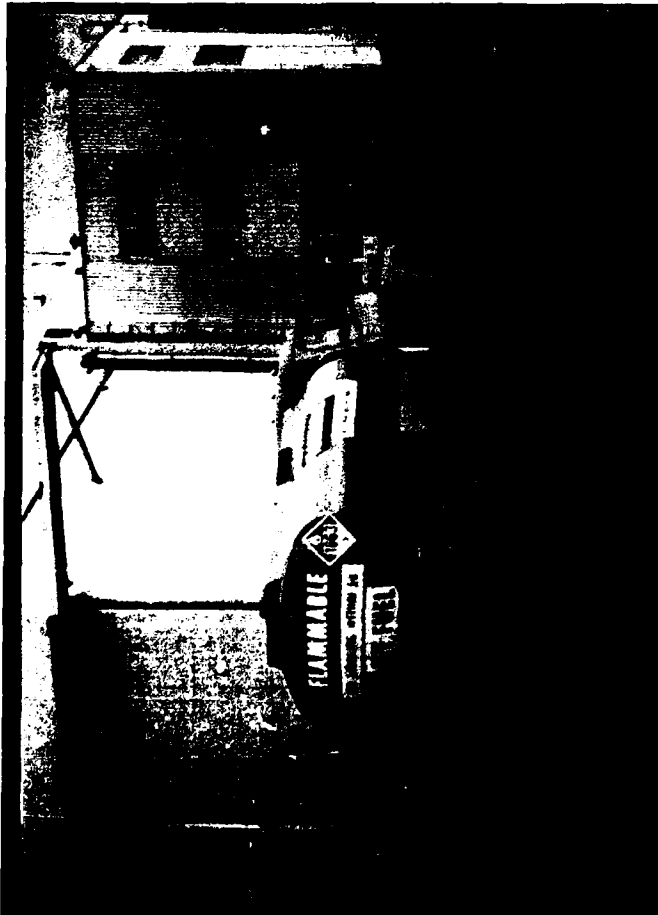
9. MOBILE FUEL TRUCK AND STORAGE
AREA 2 AT BUILDING 86
