Report No. CETHA-BC-CR-89049

**Task Order 2  
Enhanced Preliminary Assessment**

**DEFENSE MAPPING AGENCY (DMA)  
HERNDON, VIRGINIA**

December 1989

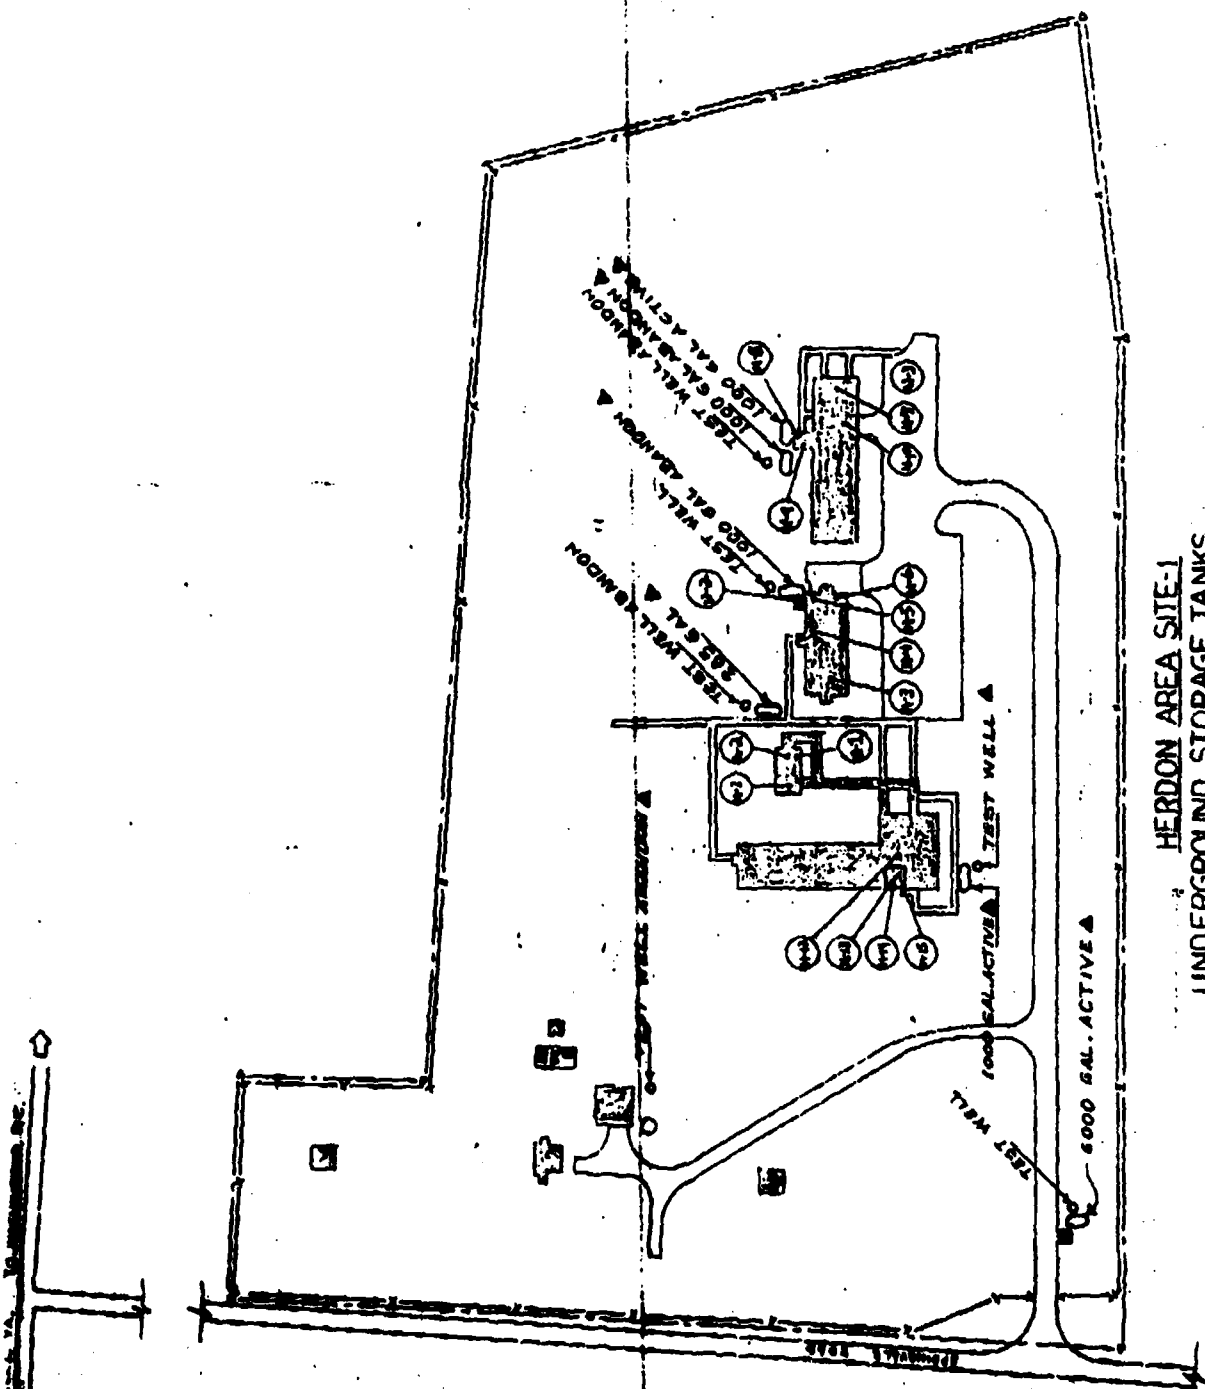
HERDON AREA SITE-1  
UNDERGROUND STORAGE TANKS  
NOT TO SCALE

The two tanks at Buildings 3 and 4 could not be effectively leak tested and there was some breakage or corrosion associated with the fill pipes. Accordingly, there is a possibility that underground storage tanks on the facility may have released some of their contents to soils.

Seven underground storage tanks remain on the property. Three are active; four have been abandoned in place and filled with concrete. The tanks were leak tested and found to be tight in 1986, except for one tank near Building 3 and one tank near Building 4 which could not be tested due to the poor condition of fill pipes in each tank, and water in the tank by Building 3. Monitor wells have been installed near the tanks for future use; no sampling has been conducted to date.
