REPAIR, EVALUATION, MAINTENANCE, AND  
REHABILITATION RESEARCH PROGRAM

TECHNICAL REPORT REMR-CS-30

IN SITU REPAIR OF DETERIORATED CONCRETE  
IN HYDRAULIC STRUCTURES: EPOXY INJECTION  
REPAIR OF A BRIDGE PIER

Prepared for DEPARTMENT OF THE ARMY  
US Army Corps of Engineers  
Washington, DC 20314-1000

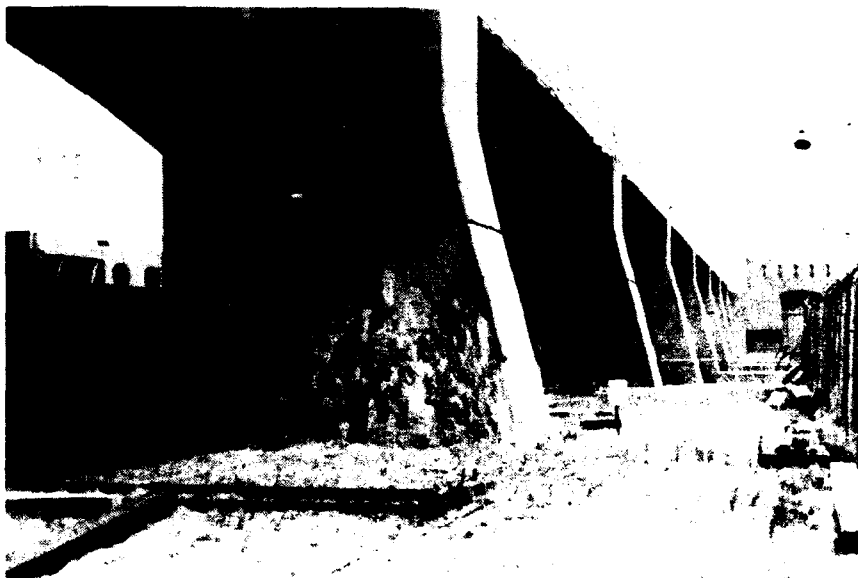
Figure 8. Iowa face of Pier No. 13

46. Periodic inspection of Pier No. 13 indicated extensive deterioration in the lower 12-ft of the pier, i.e., between El. 590.5 and 602.55 (Figure 7). The deterioration was characterized by an extensive crack network running throughout the base of the pier, large sections of drummy concrete in the corners, and excessive amounts of efflorescence on the exterior surfaces (Figures 8-10). The inspection reports are presented in Appendix A.

- e. Iowa face - the face was highly cracked around its perimeter, below the level of the construction joint. The interior portion of the face did not appear to be highly cracked; however, it sounded very delaminated. The corner shared with the downstream face, as previously noted, was partially broken away as a result of the cracking and delaminations. The upstream portion of the bearing seat curtain wall was cracked but relatively sound. The downstream half, however, was badly deteriorated and needed to be patched before the cracks could be repaired.

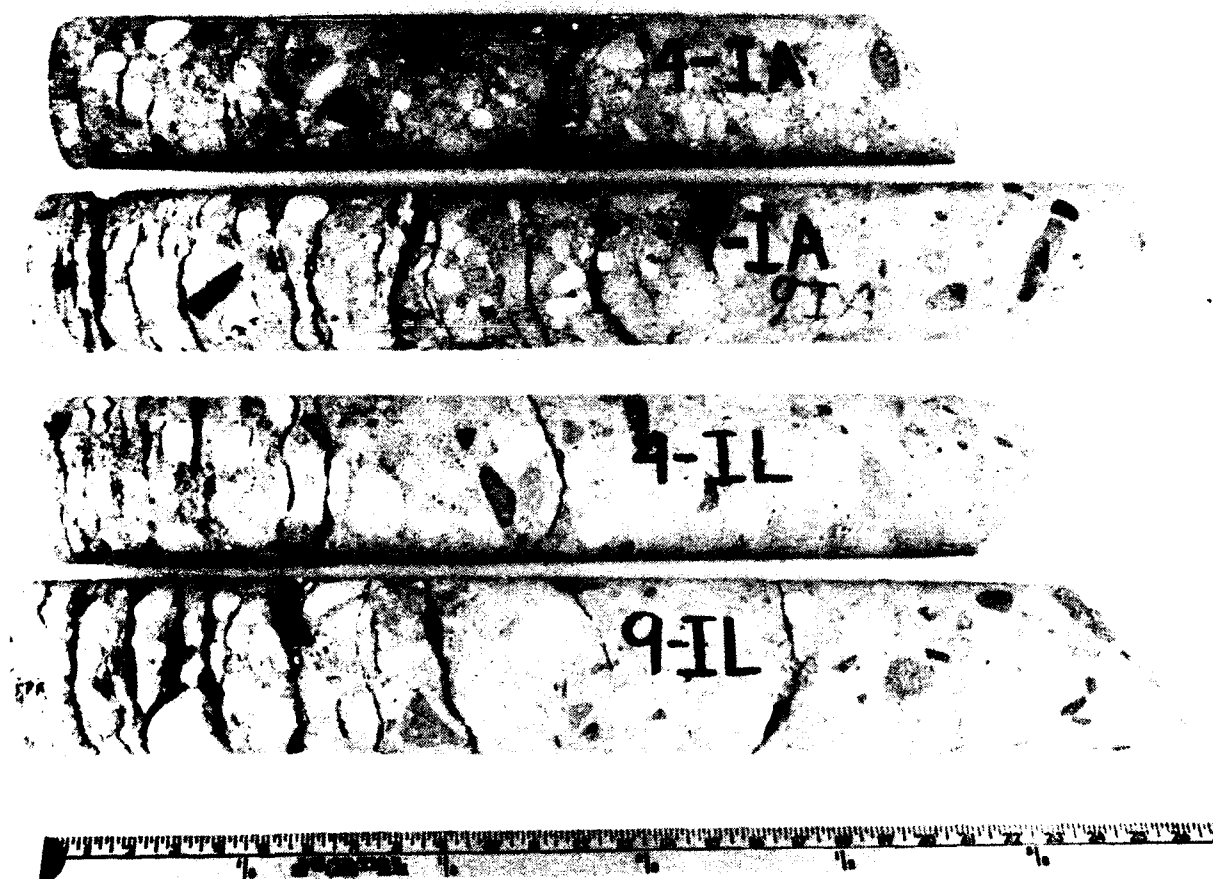
Figure 11. Cores removed from the Iowa (4-IA and 9-IA) and Illinois (4-IL and 9-IL) faces of Pier No. 13 before repair

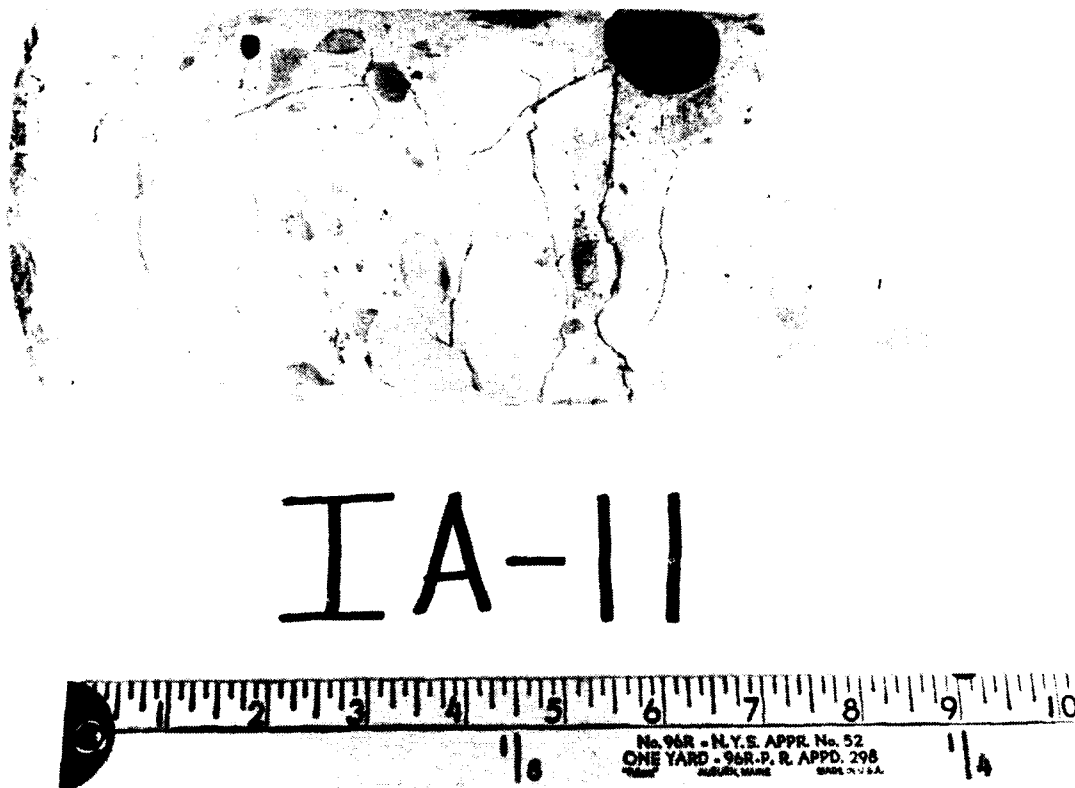
84. The results of the ultrasonic pulse velocity tests and the visual examination of the postinjection cores indicates that the crack network within the top 6 to 10 in. was repaired by the epoxy injection, which appeared to have

Figure 31. Closeup of core IA-11 showing epoxy-filled crack network
