# NATIONAL COMMUNICATIONS SYSTEM

## TECHNICAL INFORMATION BULLETIN 89-11

### 4 ESS™ SWITCH ELECTROMAGNETIC PULSE ASSESSMENT

### VOLUME 2: TASK 3 LABORATORY TESTING OF THE 4 ESS SWITCH

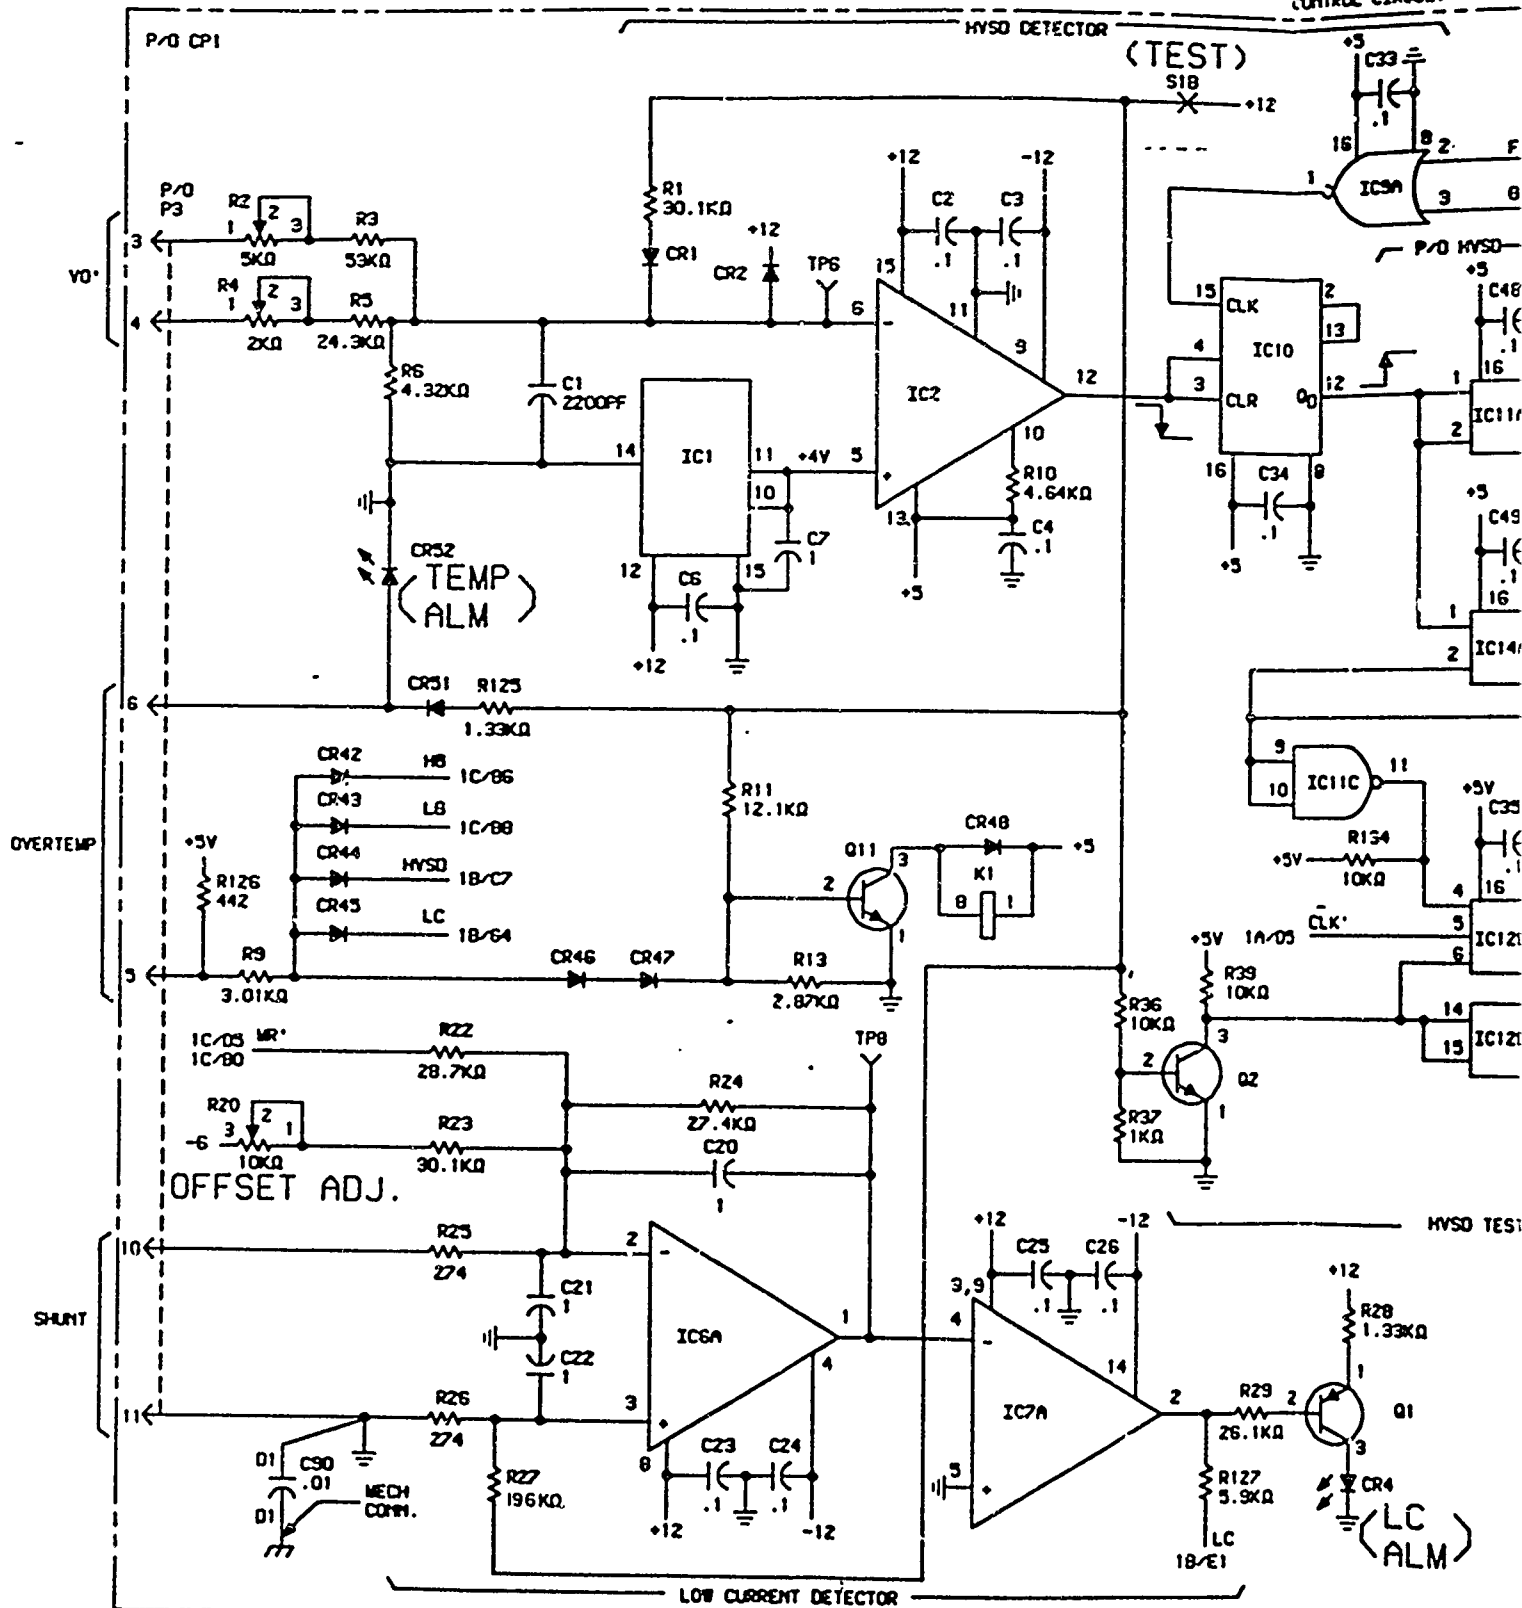
Figure 7. Schematic of circuit pack in 620C and 625C power plants, with modification circled.

Power converters in almost every frame showed susceptibility to direct coupling from the field to the circuit board controlling the power converter, which generally resulted in the converters powering down. Susceptibility to shutdown was noticed in the following converters or controllers:

The sensitivities arose from coupling transients into the High-Voltage Shutdown (HVSD) circuitry, either onto voltage sense leads or onto leads carrying a shutdown signal. No hardware damage was found after these shutdowns.

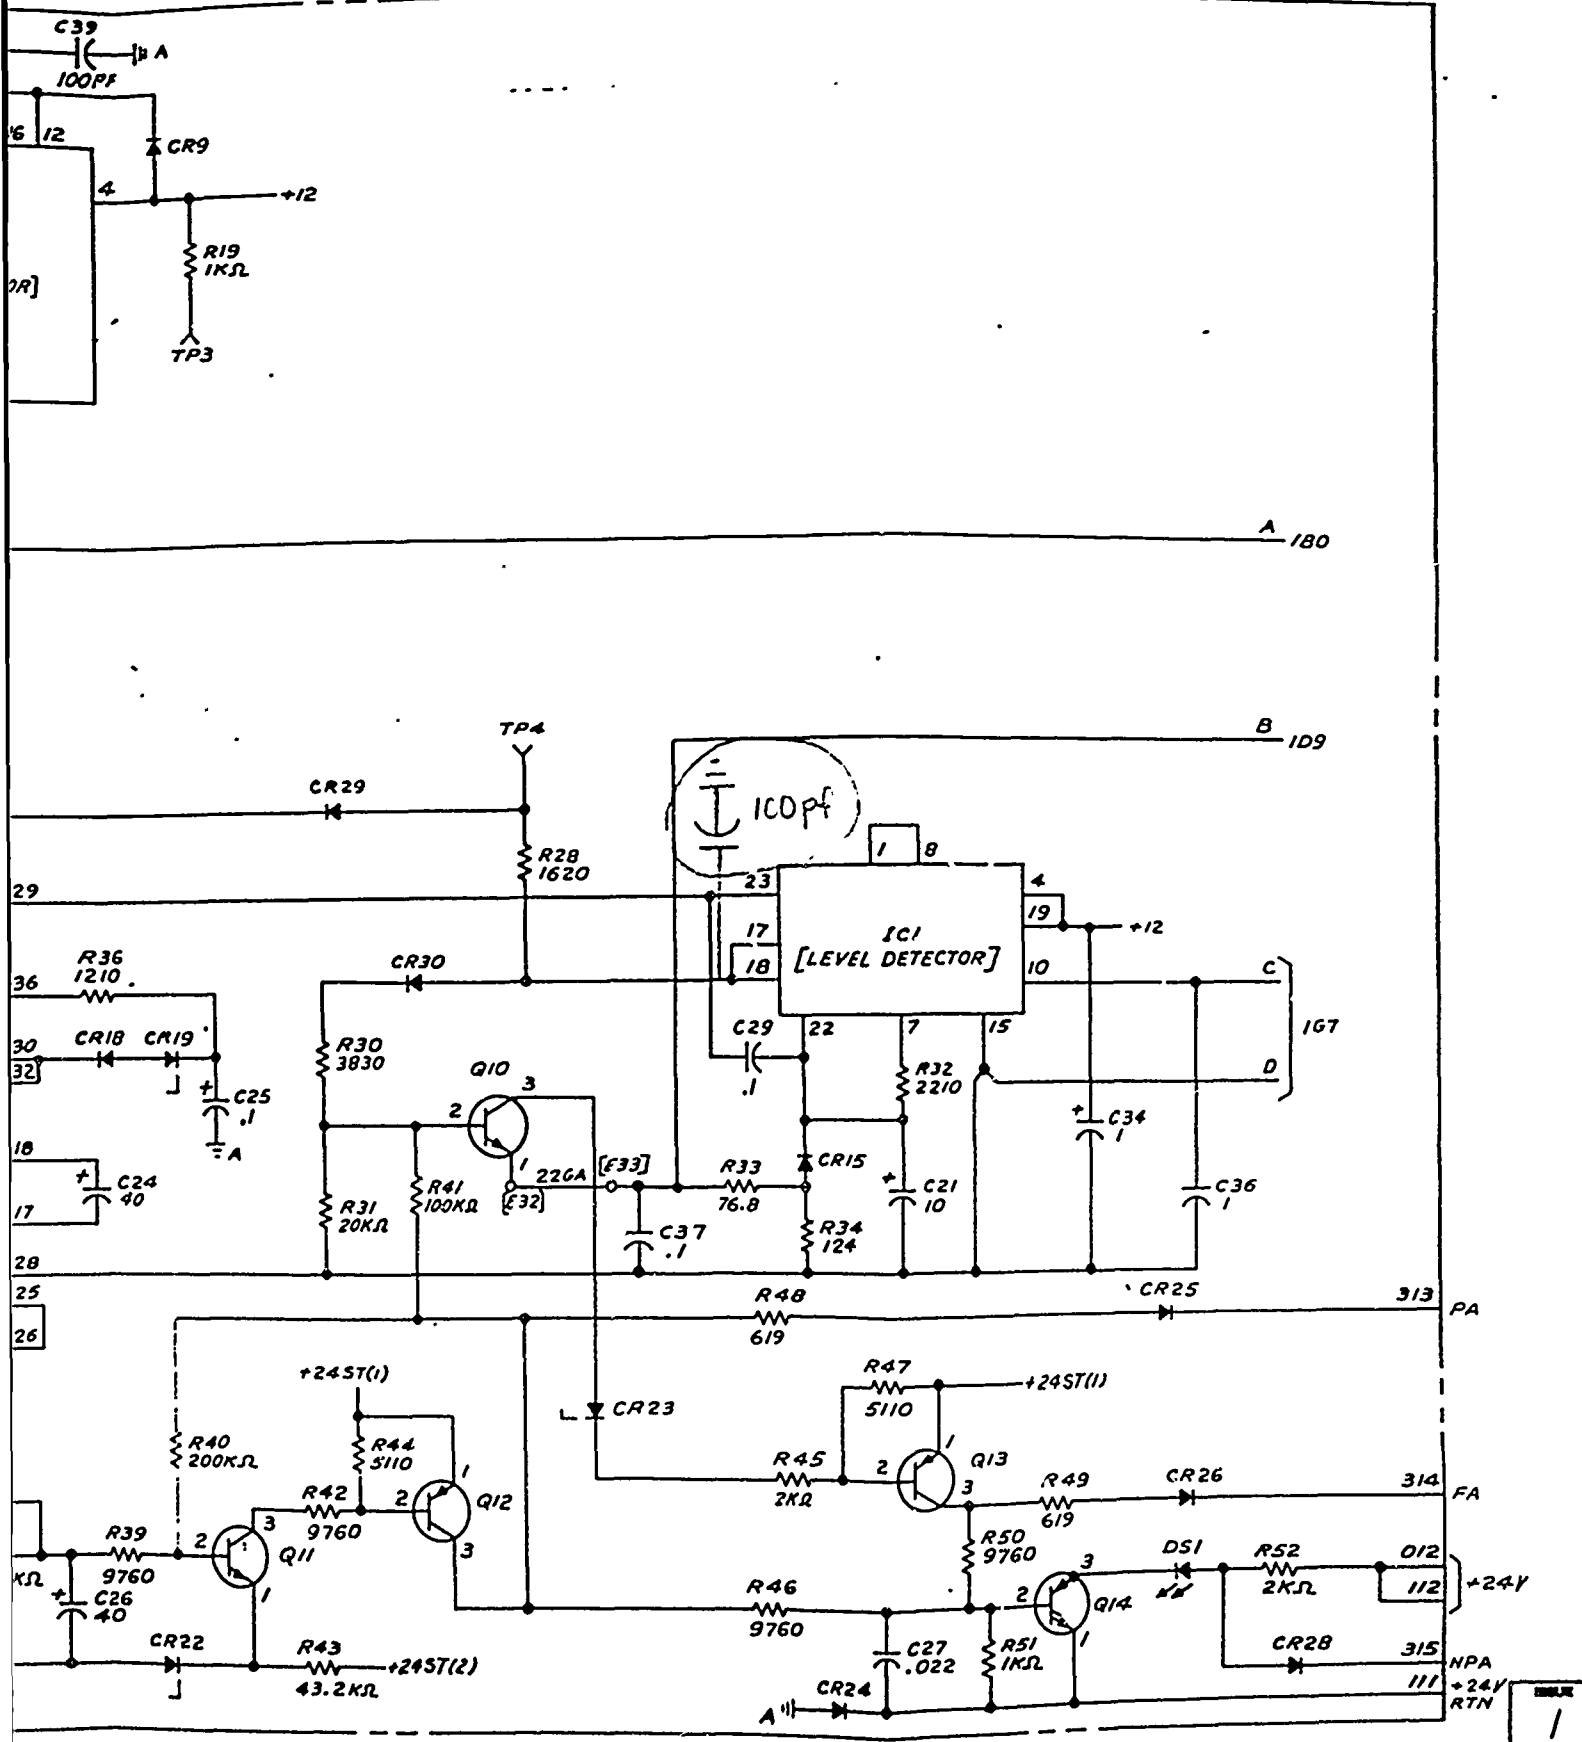
**Figure 9. Schematic of circuit pack for 87389-E, -F, -J, -M, -S power converters, with modification circled.**

Hardware damage was observed in two power supplies in the SPs (J-87389-E and J-89389-S) during the high-level cable current injections over the SP lineup. The damage, which was probably caused by transients on the 24V input bus, was sustained on a reference voltage chip in each of the power supplies. This damage occurred on only one of the bays of the SPs; the SPs were still functional. This result may have been an artifact of the testing arrangement, due to arcing from the primary driver cable, and not characteristic of the types of transients expected from an EMP.

| Circuit Pack | Modification |
|---|---|
| 87389-E, -F, -J, -M, -S | 100 pF from IC1, pins 17 and 18 (shutdown signal) to ground |
