NASA  
Technical Memorandum 4195

# Evaluation of Composite Components on the Bell 206L and Sikorsky S-76 Helicopters

Donald J. Baker

AUGUST 1990

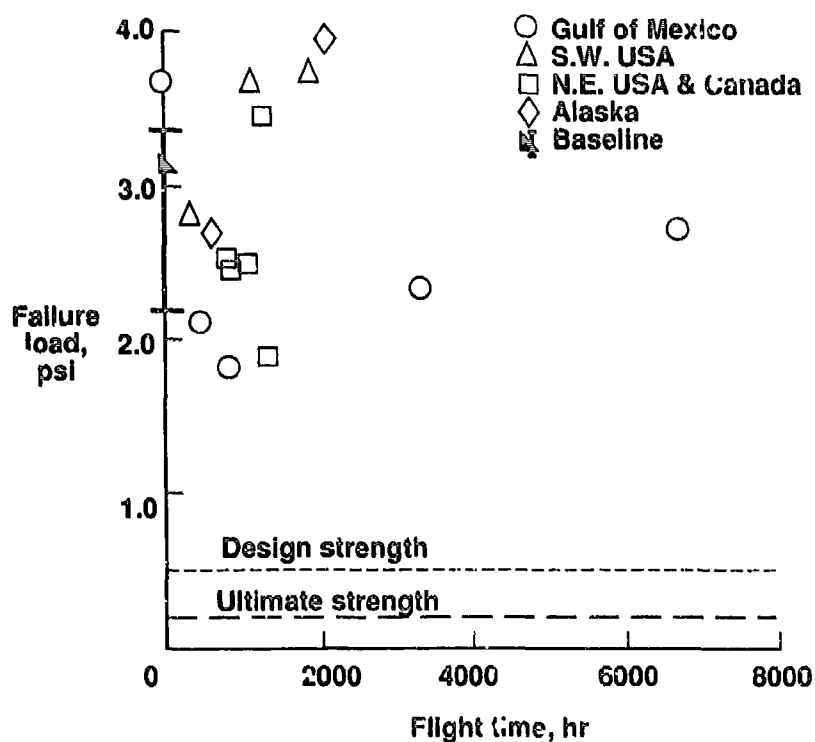
Failure loads (table 3) for 15 forward fairings vary from 1.80 to 3.93 psi, and service times for these components vary from 386 to 6750 hr. Failure loads as a function of flight hours are shown in figure 13. Each open symbol represents the failure load for

a different exposure area. Failure loads vary from 1.80 to 3.93 psi and exceed the design strength of 0.49 psi (ref. 2) by more than a factor of 3. Failure loads for forward fairings tested to determine the baseline strength (ref. 2) varied from 2.2 to 3.4 psi. Failure loads for 8 of the 15 forward fairings tested are between 2.2 and 3.4 psi. The large scatter in the failure load could be the result of variations in the fabrication process. Considerable variation could result from putting down the single ply of Kevlar fabric (style 281) on a compound contoured surface. The lay-up requires cutting and overlapping the fabric at many places to prevent wrinkling on the surface. The stiffness of the forward fairing as a function of the flight hours is shown in figure 14. The stiffness was calculated using measurements for the deflection of the upper surface at a point 14.5 in. from the aft end as the load was applied. The stiffness of all fairings, except one, exceeded the stiffness of the certification fairings. The fairings that have been tested accumulated a total of 23 730 hr of flight time.

Figure 13. Failure load of forward fairings after exposure.
