Naval Research Laboratory

NRL Memorandum Report 6861

High Pressure Turbine Blade Life Extension

August 28, 1991

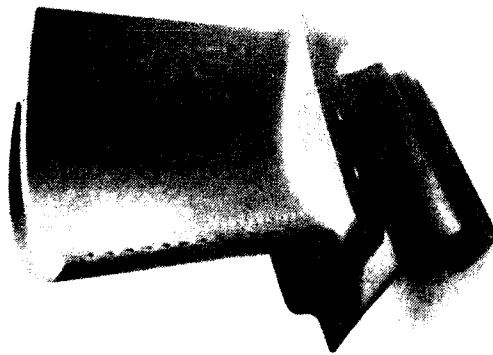
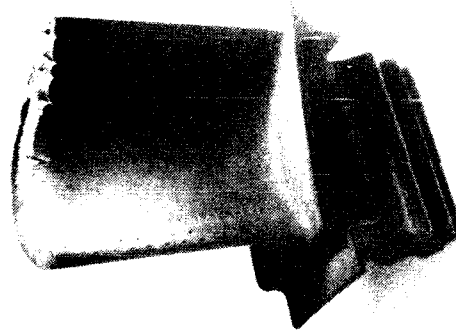
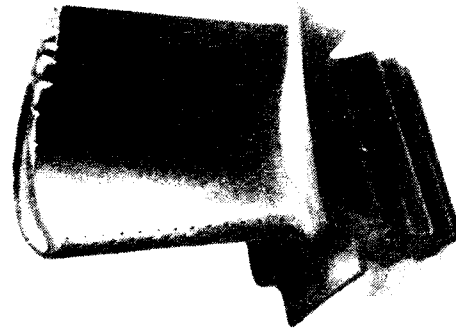
F404 HPT BLADES

DS-R80H HPT blades, both new and those removed from F404 engines after 14,030 EFTC (low EFTC) and 27,449 EFTC (high EFTC), were received from the NADEP NORIS for evaluation in this study. All blades received a CODEP coating and the precipitation heat treatment as shown in Table 1. Additional blades in all three conditions were received from NADEP NORIS, via Chromalloy Division Oklahoma, following removal of the CODEP coating. Figure 1 illustrates the appearance of the HPT blades without the CODEP coating. The severe erosion of tip region of both the low and high EFTC blades is readily apparent in Figure 1.

The blade tip erosion visible in Figure 1 and the microstructural examination of the engine run blades suggested that a blade tip repair procedure could be considered to extend the blade life since the structure of all blades below the tip regions exhibited no apparent degradation from F404 engine operation. Chromalloy Division Oklahoma suggested the use of MERL 72, a cobalt-base alloy, as a possible tip repair material on the basis of previous blade tip repair experience. Subsequently, Chromalloy Division Oklahoma produced trial blade tip weld repairs using MERL 72 on both low and high EFTC blades for NRL evaluation.

Figure 1. HPT blades in the new and engine-run conditions.

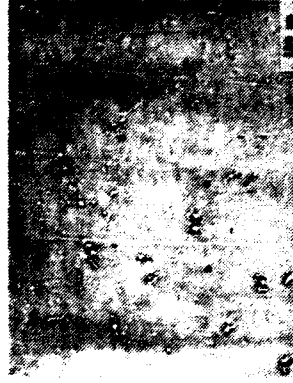
The microstructure of the engine run and new blades is illustrated in Figure 4. This figure compares the microstructure of the blades at two locations along the blade axis. In the mid region of the blades, approximately the mid-point of the length of the blade, the microstructure of all three blades is seen to be similar.

Figure 4. Optical micrographs of new and engine run (not HIP) DS-R80H blades at two locations along the blade axis.

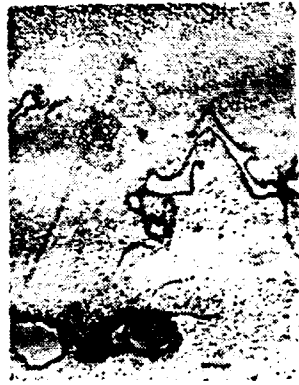
The effect of hot isostatic press (HIP) processing on the microstructure of the new and engine-run blades was investigated. Figure 6 illustrates that the microstructures of the mid region of the HIP processed and not-HIP processed blades was similar for all three blade life conditions examined. However, as shown in Figure 7, the microstructure of the tip region of the not-HIPped low and high EFTC blades have experienced considerable coarsening of the gamma prime precipitate when compared with the microstructure of the new blade in this location. Following HIP processing, all three blades have been restored to a similar microstructural condition.

Figure 6. Optical micrographs of the mid region of HPT blades in new, low hours and high hours engine run conditions for the HIP processed and non-HIP processed conditions.

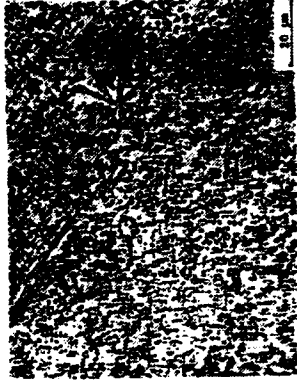
Figure 7. Optical micrographs of the tip region of HPT blades in new, low hours and high hours engine run conditions for the HIP processed and non-HIP processed conditions.

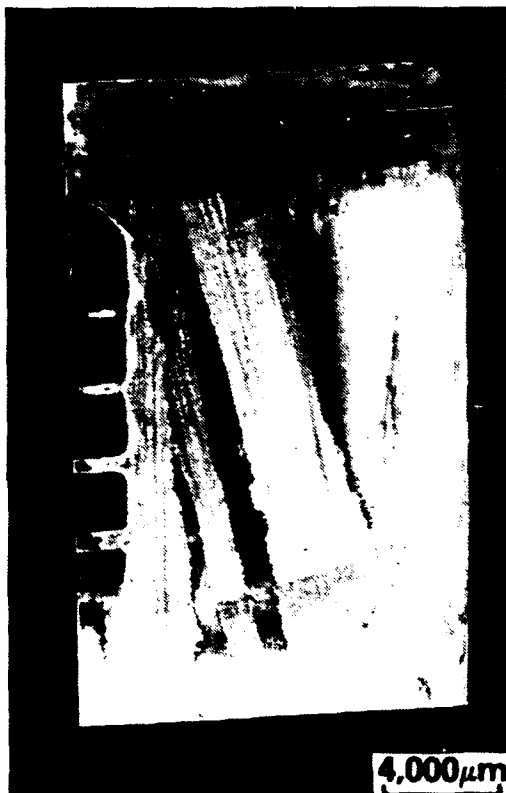
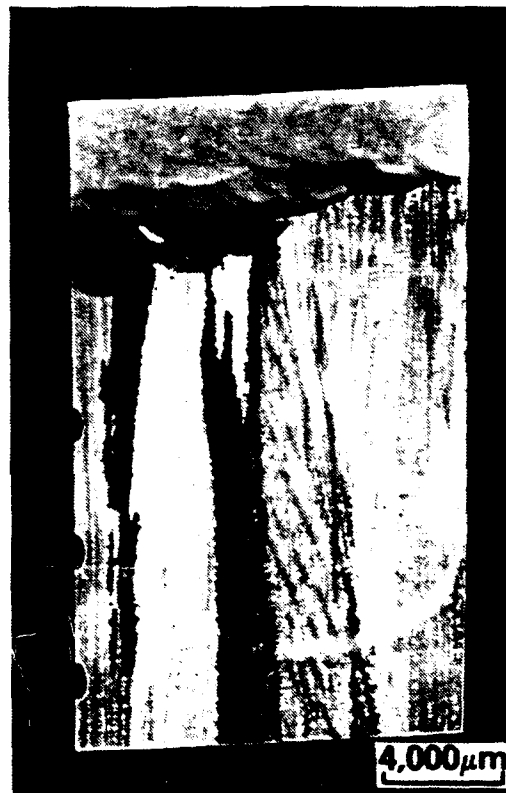
Figure 9 shows the optical microstructure of the interior and exterior surfaces of a DS-R80H blade which has undergone the MERL 72 blade tip repair. Note the appearance of the interface between the directionally solidified grains and the weld deposited material. Figure 10 shows section views of the blade illustrating the well-defined blade-weld interface at several locations. Note the clearly defined interface between the weld and the blade alloy at all sections. However, in sections 2 and 8, small discontinuities originating from the blade interior are clearly visible. These are thought to be associated with oxidation products remaining from the prior engine operation.

Figure 9. Optical micrographs of the interior and exterior surfaces of DS-R80H blades which have received a MERL 72 tip repair.

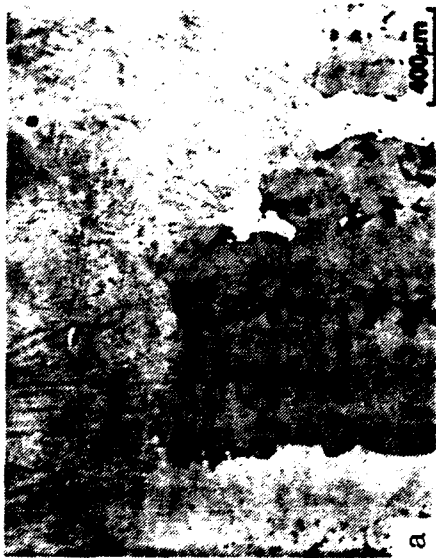
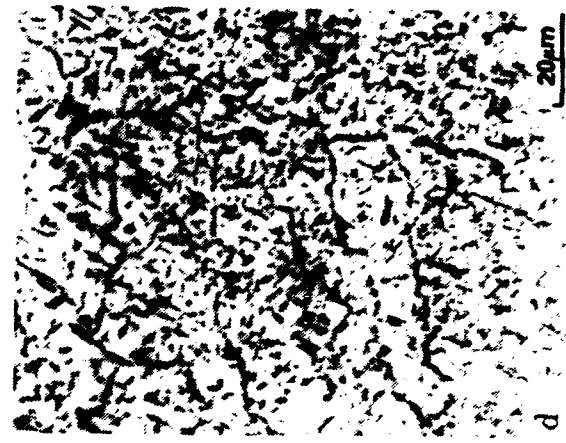
The microstructure of the blade-weld interface is illustrated in the optical micrographs in Figure 11. Figure 11a shows that the weld deposit has formed a porosity-free metallurgical bond with the blade alloy, with minimal dissolution of the blade alloy microstructure. Figures 11(b) through (d) illustrate the microstructures of the blade, weld fusion zone and weld, respectively. In particular, the microstructure of the weld fusion zone shows that minimal dissolution of the blade alloy has occurred during the welding process and that the heat-affected zone was confined to the narrow region near the blade/weld interface.

Figure 11. Optical micrographs of the blade-weld interface.

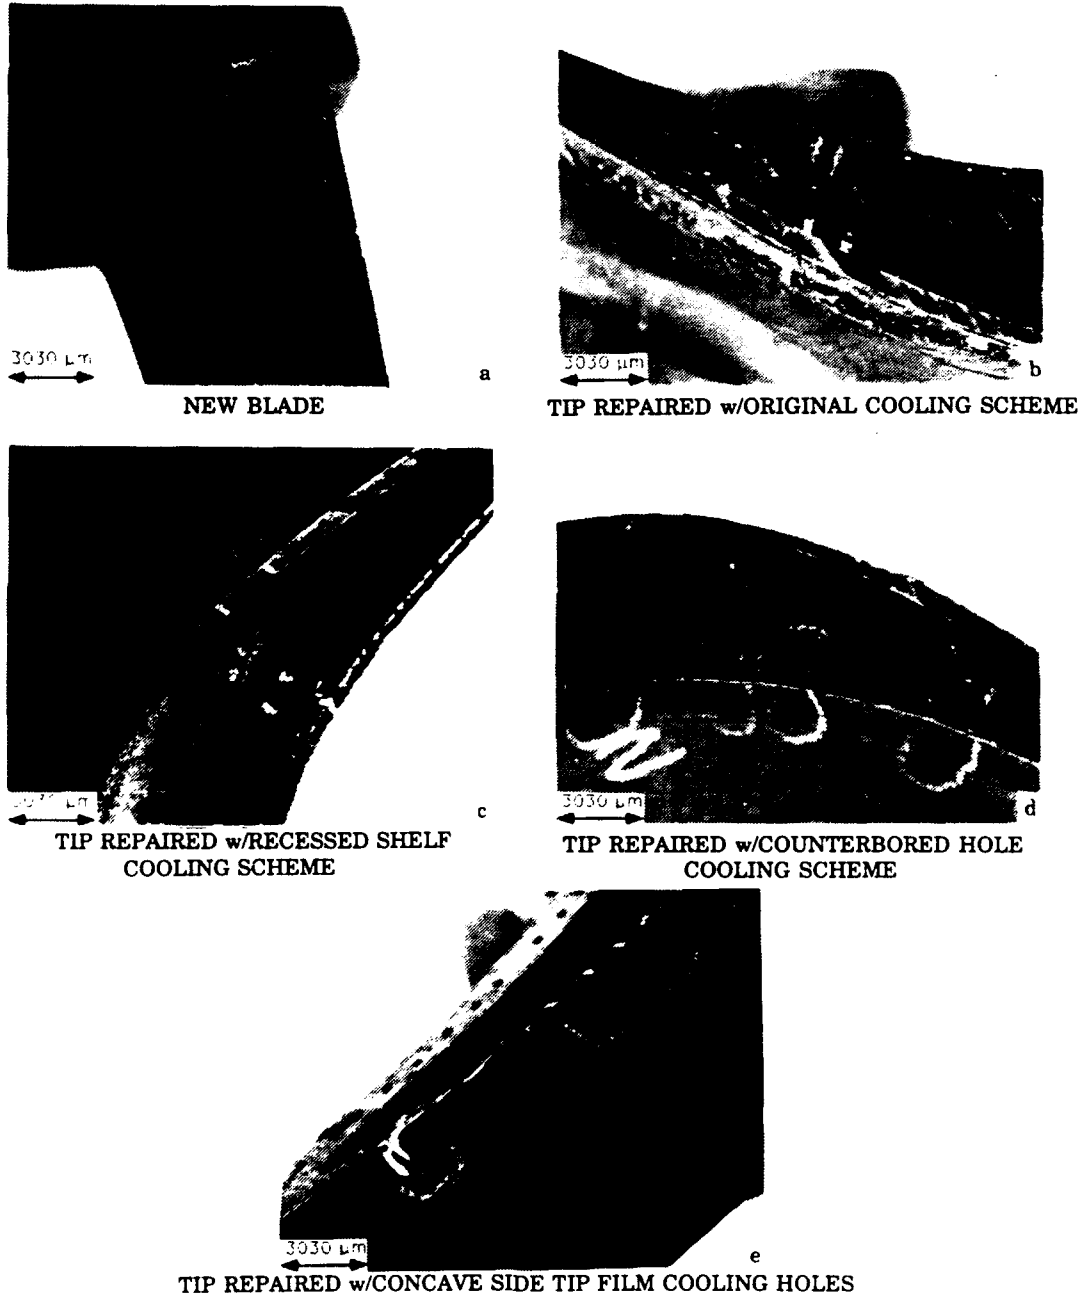
The blade tip regions of the HPT blades which were ASMET engine tested are illustrated in Figure 14. Note the physical condition, especially the trailing edge tip of each blade, which

shows the erosion and/or cracking produced by the ASMET engine test exposure. In particular, note the severe erosion of the blade which was new prior to the engine test and the general lack of erosion of the tip repaired blade with a similar cooling hole configuration.

Figure 14. Trailing edge tip regions of ASMET engine tested, MERL 72 tip repaired, DS-R80H HPT blades.

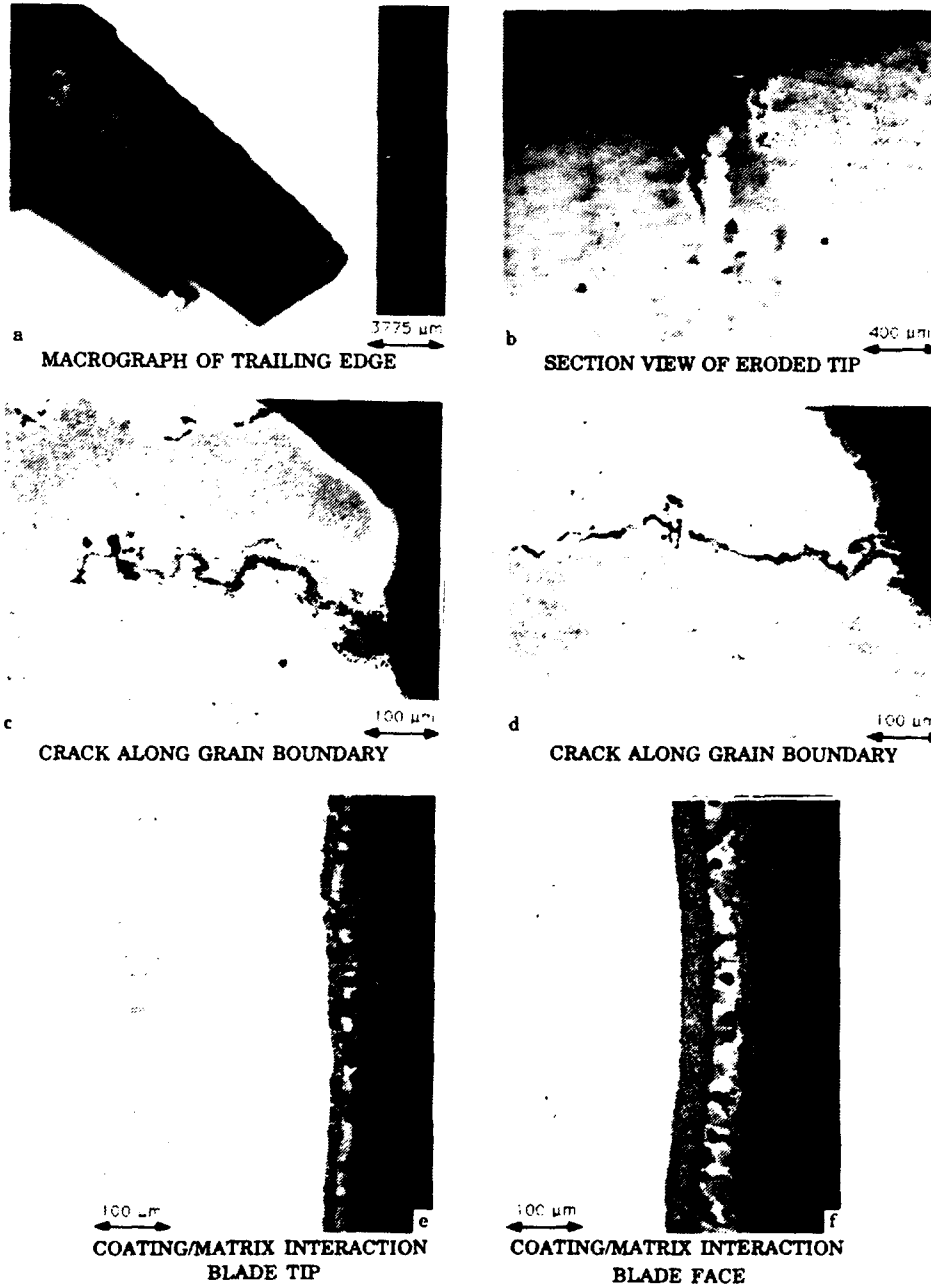
Figure 15 shows the microstructure of a new HPT blade after ASMET engine testing. The severe trailing edge tip erosion is shown in Figures 15(a) and (b). Figures 15(c) and (d) show the development of cracking along grain boundaries. The coating/matrix interaction is shown for both the blade tip and the blade face in Figures 15(e) and (f).

Figure 15. DS-R80H HPT blade, ASMET engine tested, new before test.

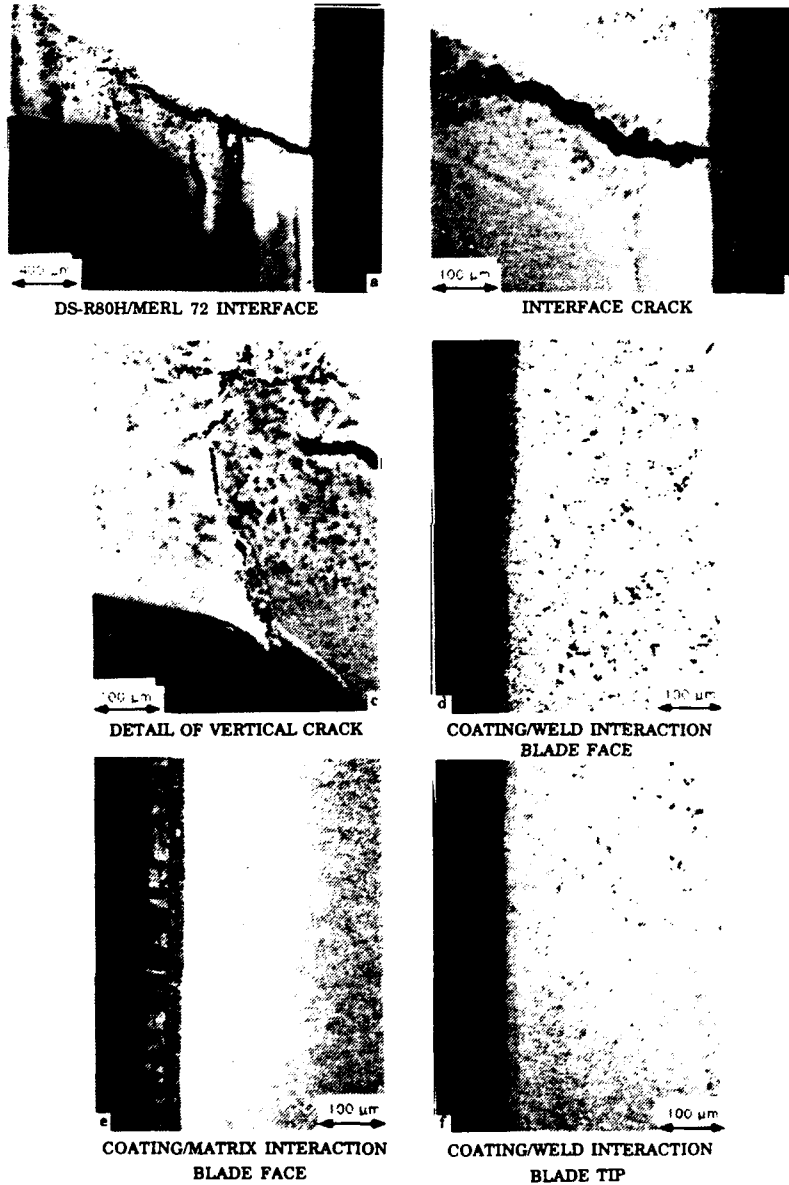
The microstructure of an engine run HPT blade (total EFTC unknown) which was MERL 72 weld tip repaired by Chromalloy Division Oklahoma, configured with the original cooling hole scheme and ASMET engine tested is shown in Figure 16. Figures 16(a) and (b) illustrate a crack which developed at the blade surface which followed the DS-R80H/MERL 72 interface. Figure 16(c) shows the crack tip region and the oxide formed along the entire crack path. Figures 16(d), (e) and (f) illustrate the microstructure of the coating/weld and coating/matrix interactions at various locations on the HPT blade.

Figure 16. DS-R80H HPT Blade, ASMET engine tested, MERL 72 tip repaired by Chromalloy to original tip cooling scheme before engine test.

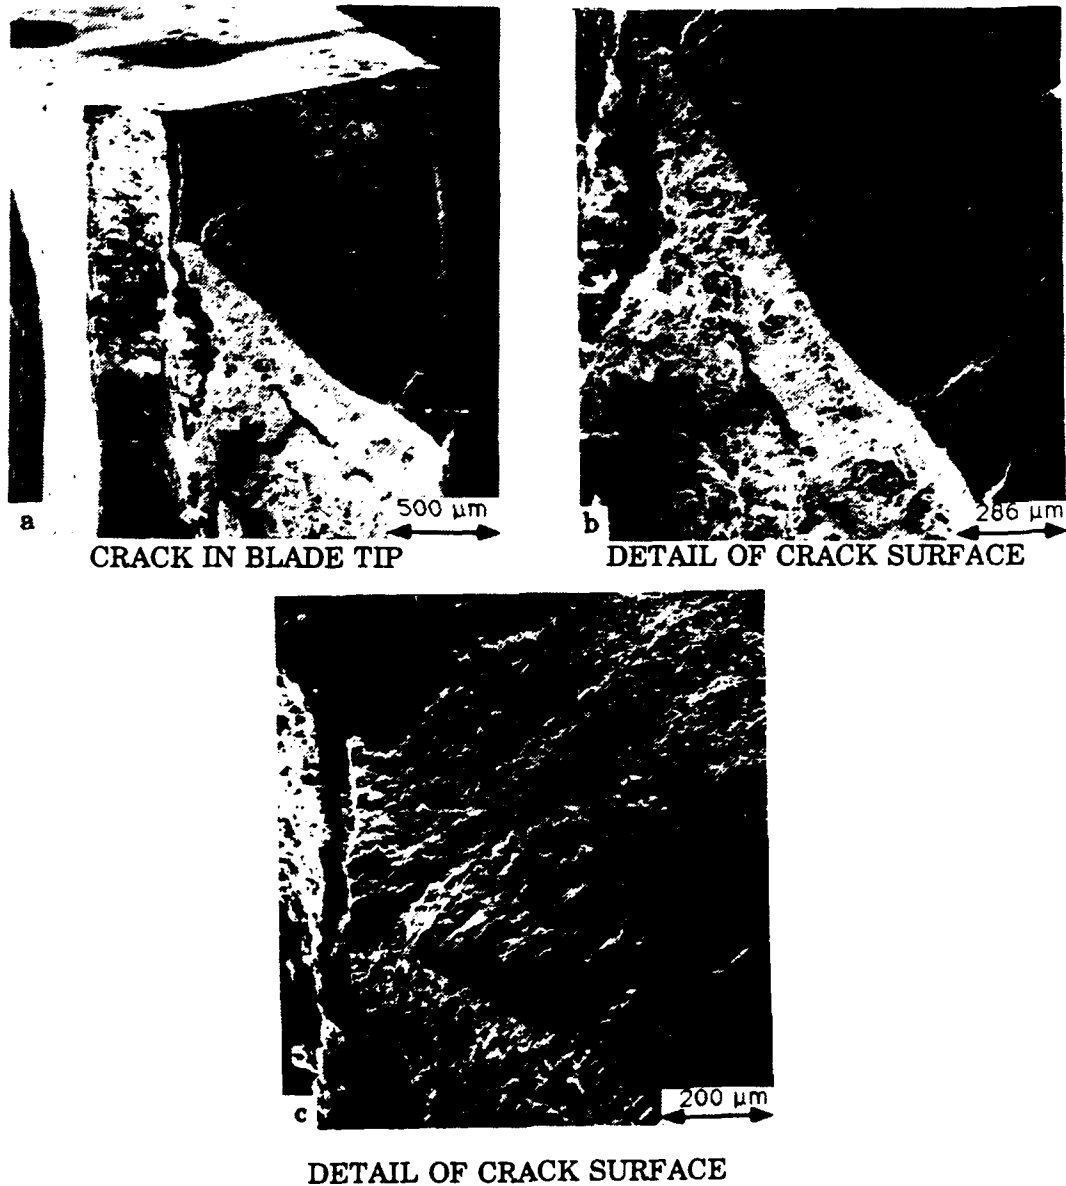
A portion of an ASMET engine tested blade which contained a crack in the repaired blade tip was fractured at liquid nitrogen temperatures to separate the crack and to reveal the details of the crack surfaces. The fractographs in Figure 17 relate to a tip repaired to the original tip cooling scheme. The darker, oxidized crack surfaces were generated by processes during the ASMET engine run and the lighter surfaces were formed when the crack was fractured open. Cracking appears to have initiated at the cooling hole, Figure 17(c), and outside blade surfaces. The crack eventually assumed a growth direction perpendicular to the crack front shown in Figures 17(a) and 17(b).

Figure 17. Fractographs of tip cracks formed during the ASMET engine test of a repaired blade with the original tip cooling scheme before test.

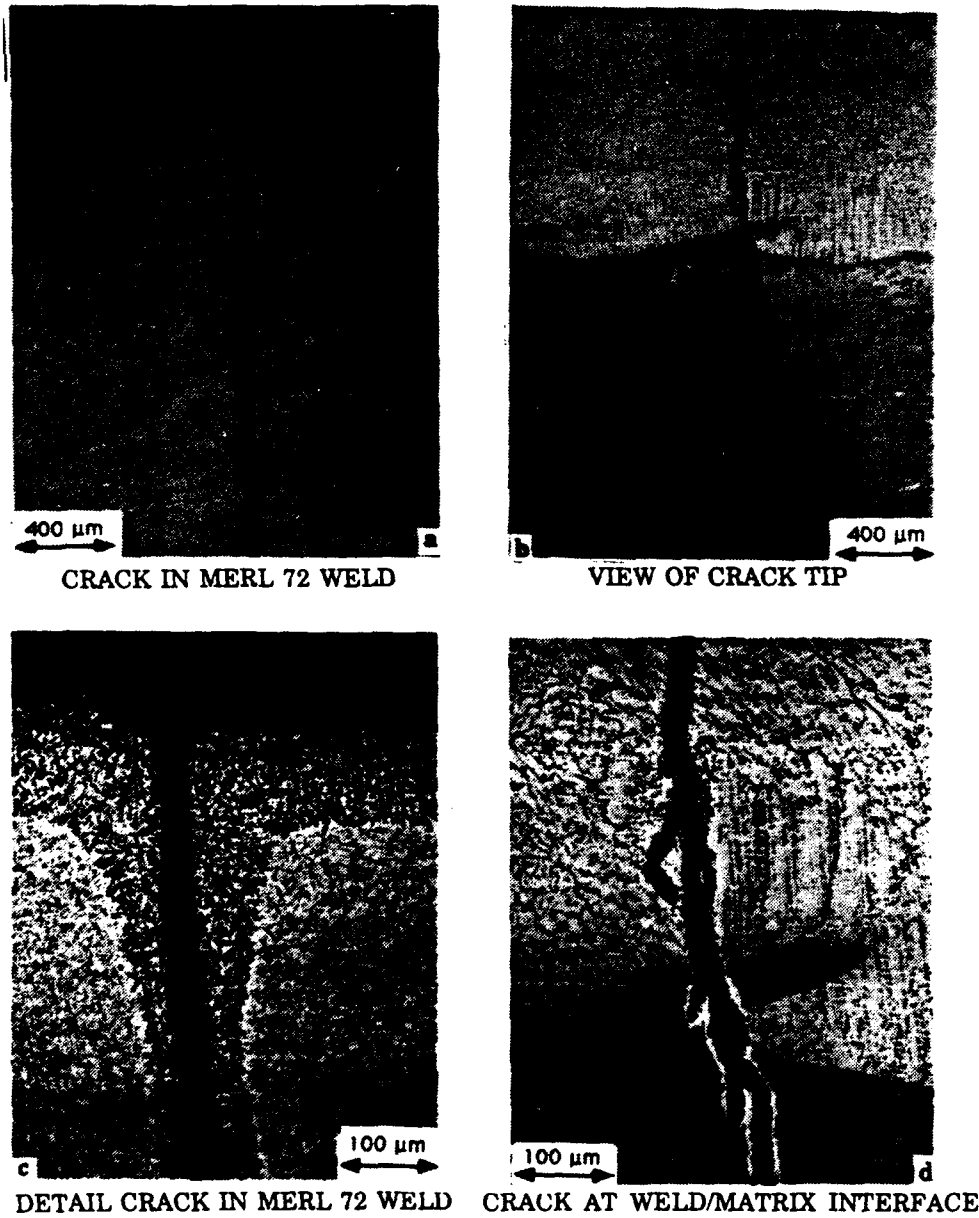
The microstructure of an engine run HPT blade (total EFTC unknown) which was MERL 72 weld tip repaired by Chromalloy Division Oklahoma, configured with a recessed shelf tip cooling scheme and ASMET engine tested is shown in Figure 18. Figure 18(a) illustrates a crack observed in the MERL 72 weld in the vicinity of a cooling hole. Figure 18(b) shows the crack tip region at the DS-R80H/MERL 72 interface. These regions are shown in greater detail in Figures 18(c) and (d). Note the reaction zone formed within the weld along the crack surface and at the top surface of the blade tip, Figure 18(c). Of the four tip configurations examined microstructurally, only the recessed shelf tip cooling hole configuration exhibited this behavior. No differences in microstructure, weld alloy chemistry or coating integrity could be determined which would explain the formation of the reaction zone observed for this blade.

Figure 18. DS-R80H HPT blade, ASMET engine tested, MERL 72 tip repaired by Chromalloy with recessed shelf tip cooling scheme before engine test.

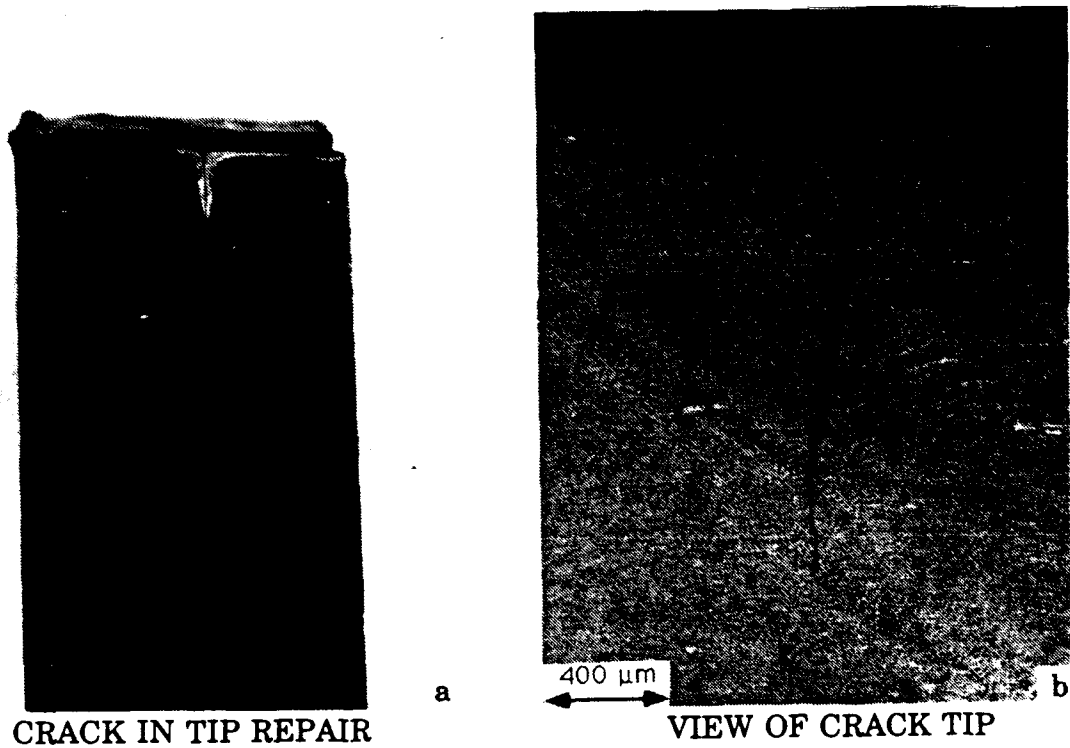
The microstructure of an engine run HPT blade (total EFTC unknown) which was MERL 72 tip repaired by Chromalloy Division Oklahoma, configured with concave side tip film cooling holes and ASMET engine tested is shown in Figure 20. Figure 20(a) illustrates the overall view of a crack associated with a cooling hole. Figure 20(b) illustrates the detail of the crack in the weld built-up blade tip. Fractographs of a crack similar to that shown in Figure 20 are shown in Figure 21. Similar to most blade tip cracks examined, the crack in Figure 21 appeared to initially propagate from the top and outside portions of the blade. The crack then grew as a through-thickness crack, with the crack tip boundary larger on the outside face of the blade.

Figure 20. Photomicrographs of tip cracks formed during the ASMET engine test of a blade repaired with concave side tip film cooling hole scheme.

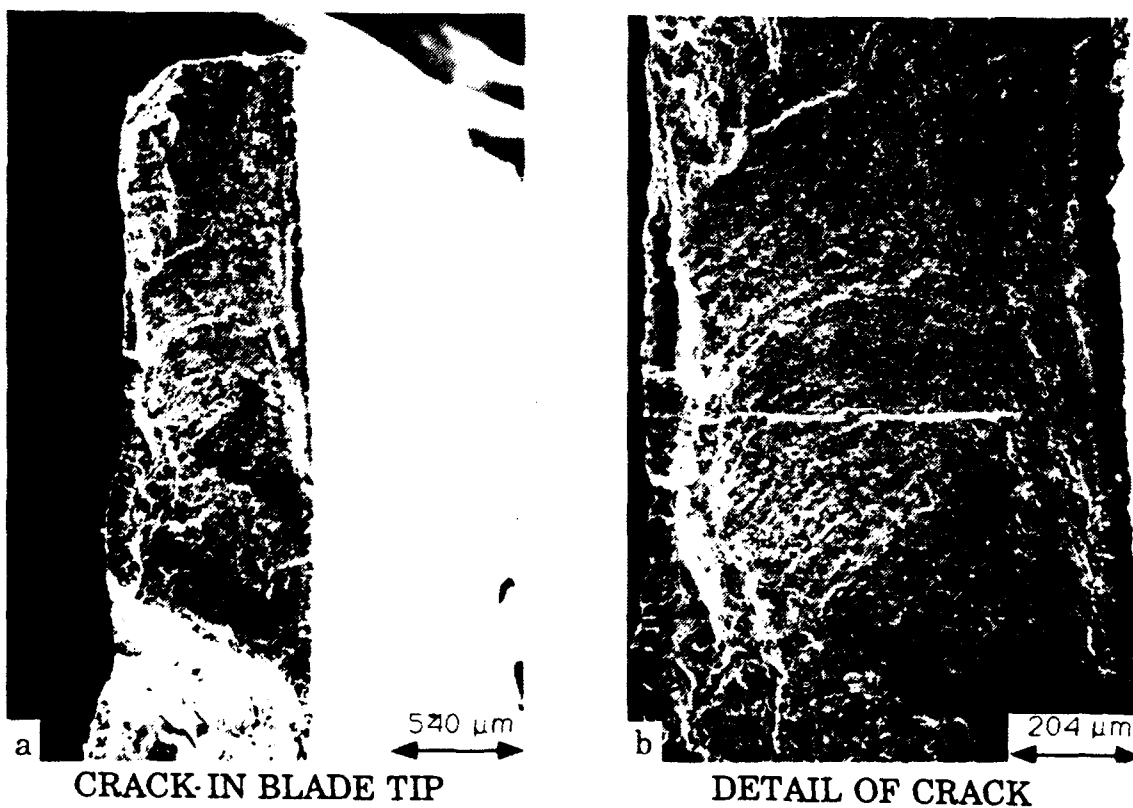
Figure 21. Fractographs of a crack in a DS-R80H HPT blade, ASMET engine tested, MERL 72 tip repaired by Chromalloy with concave side tip film cooling holes before engine test.

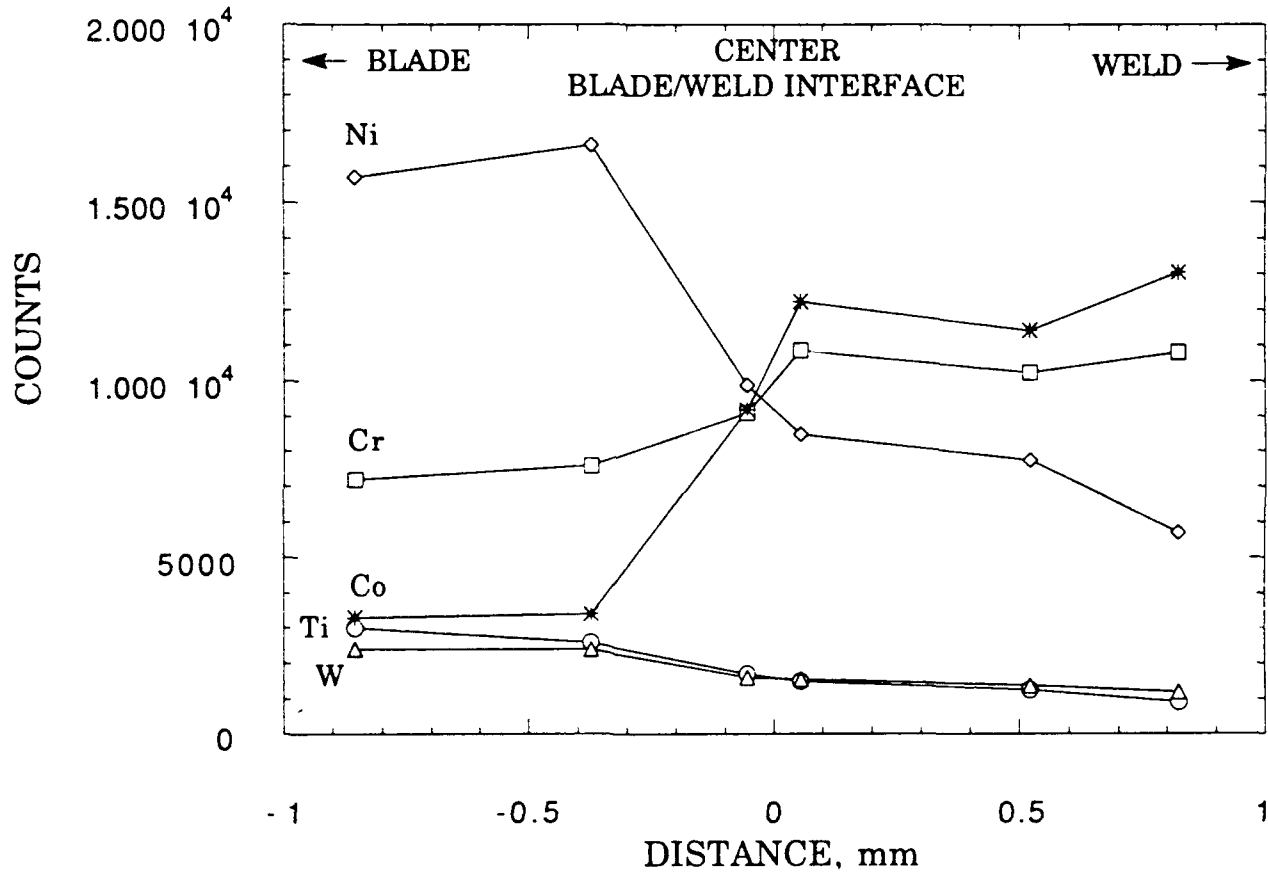
The ASMET engine tested blades showed no metallurgical weld defects, such as cracking or porosity. Weld metal dilution effects were examined using the SEM to conduct semi-quantitative energy dispersive x-ray analyses of the blade-weld interface region. Alloy composition profiles are shown in Figure 22 for the elements Ni, Cr, Co, Ti and W. The data indicate that elemental mixing at the interface of the repair was confined to a region approximately 1 mm or less in overall extent. These results are in agreement with those found for previously repaired blades, Figure 12, and suggest that the weld repair process can be expected to be repeated with considerable consistency.

Figure 22. Semi-quantitative compositional analysis of the DS-R80H blade/MERL 72 weld interface region of an ASMET engine tested blade.

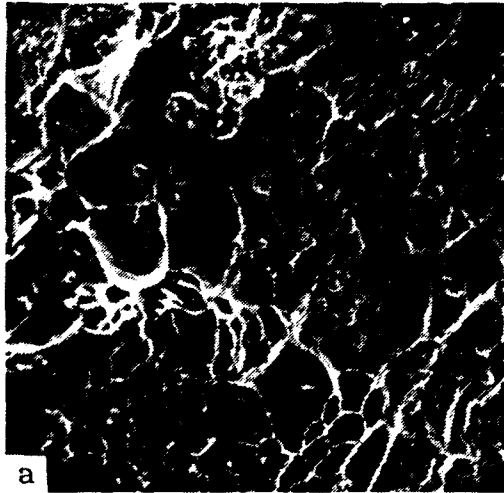
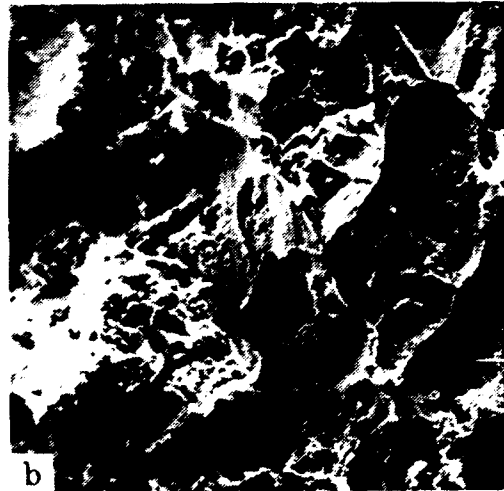
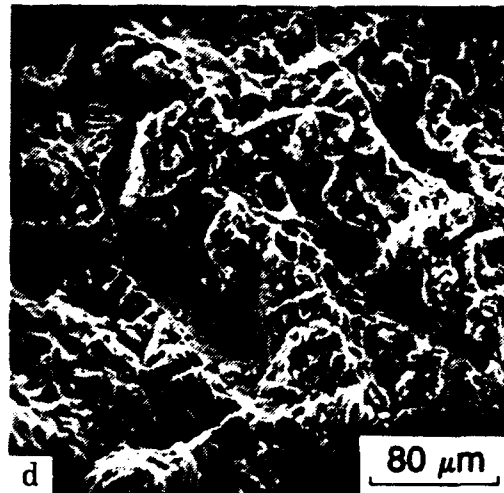
Scanning electron microscopy (SEM) was used to examine the rupture surfaces of the creep/rupture specimens tested in this investigation. SEM micrographs from a specimen tested at 871°C (1600°F), Figures 26(a) and (c), show that both the HIP processed and non-HIP processed specimens failed in a ductile manner by microvoid coalescence. However, for the specimens tested at 982°C (1800°F), the SEM micrographs indicate evidence of surface cracking which linked up to reduce the creep life of the HIP and, to a lesser extent, the not-HIP processed specimens, Figures 26(b) and (d).

Figure 26. Scanning electron micrographs of the DS-R80H creep-rupture specimens tested at 871 and 982°C.
