**ENVIRONMENTAL TEST  
SONY DIR-1000, ID-1 DIGITAL TAPE RECORDER  
(VIBRATION, TEMPERATURE AND HUMIDITY)**

John Morgan and Paul Beer  
Mission and Avionics Technology Department (Code 5053)  
NAVAL AIR WARFARE CENTER — AIRCRAFT DIVISION  
Warminster, PA 18974-5000

**13 MARCH 1992**

**FINAL REPORT**  
**Period Covering 20 January 1992 to 24 January 1992**

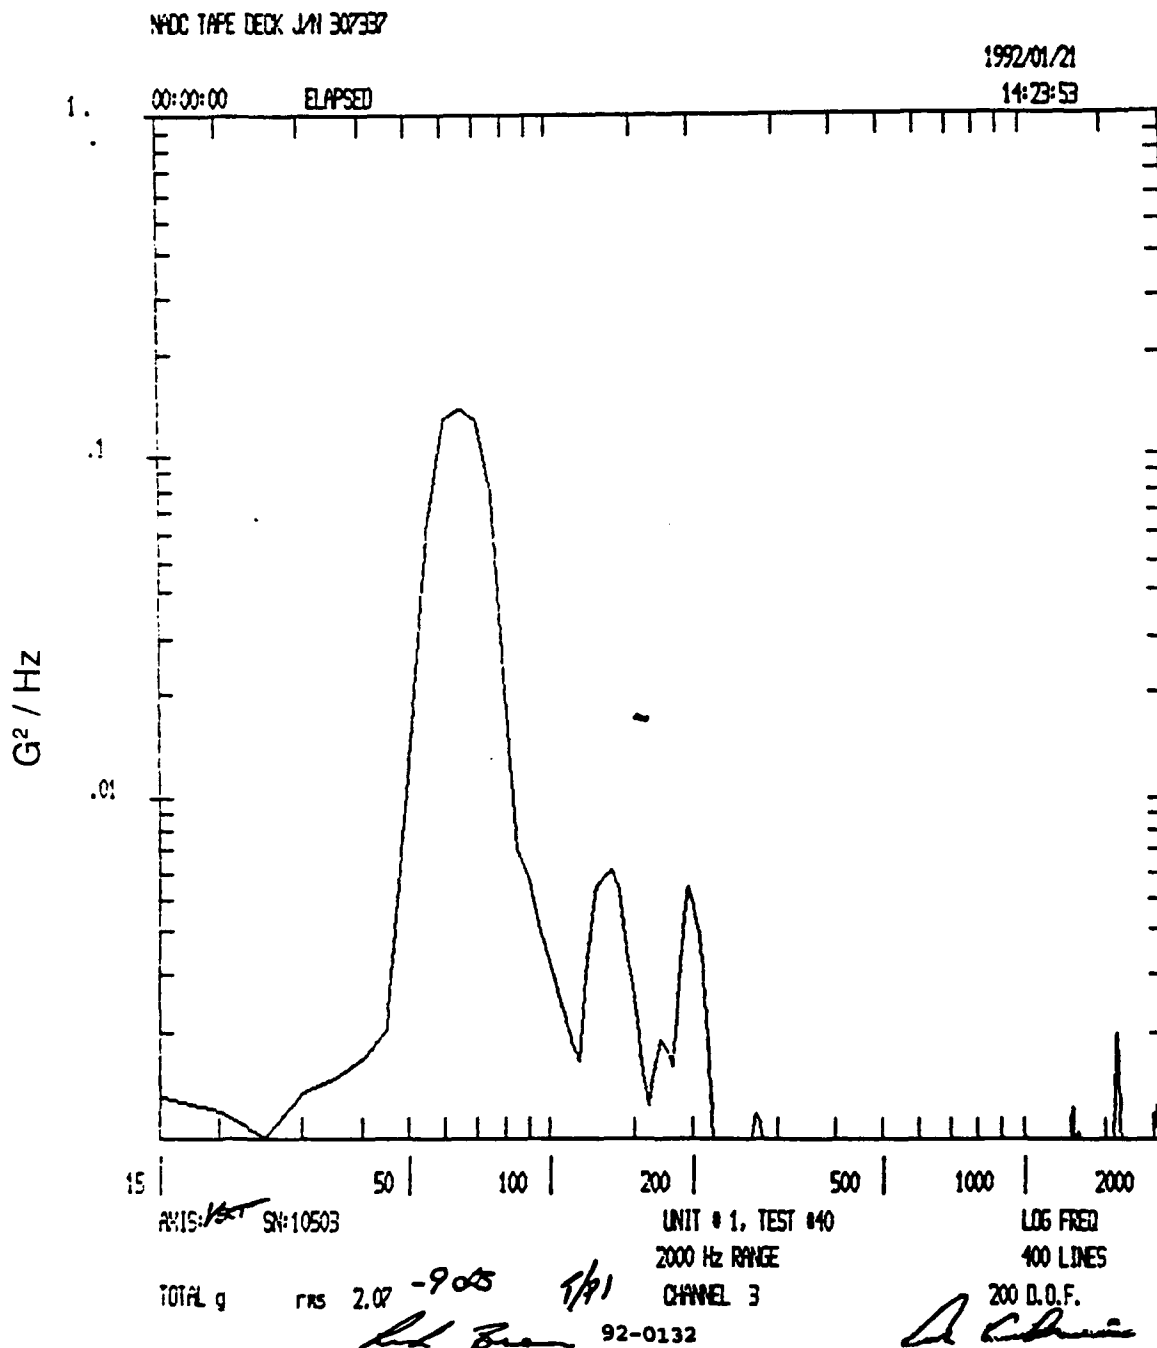
Referencing Table I, it is seen that the Sony DIR-1000 **successfully** Recorded/Reproduced data over the complete "Boeing" vibration profiles (Tests #1 through #12). Figure B-28 (Test #4) shows large errors occurring at the end of the "-9dB" Mil-Std-810E 10 minute test. It was difficult to determine the cause of these errors (test equipment or "real" failure due to vibration); therefore Test #15, a repeat of Test #14, was run. BER performance during Test #15 (figure B-30) was much better than that of Test #14, although a small amount of errors did occur (160 errors total, for a CBER =  $8.0 \times 10^{-9}$ ). It was decided to continue on to the "- 6 dB" Mil-Std shake.

| VIBRATION<br>TEST# | TAPE # | VIBRATION<br>PROFILE<br>APPLIED<br>[FIGURE#] | AXIS | MODE<br>REC/PLAY | ECC<br>ON/OFF | BER TEST<br>FIGURE # | EVALUATION<br>(PASS/FAIL) |
|---|---|---|---|---|---|---|---|
| 14 | 42 | B-26, B-27 | [Z] VERT | PLAYBACK | ON | B-28 | — |

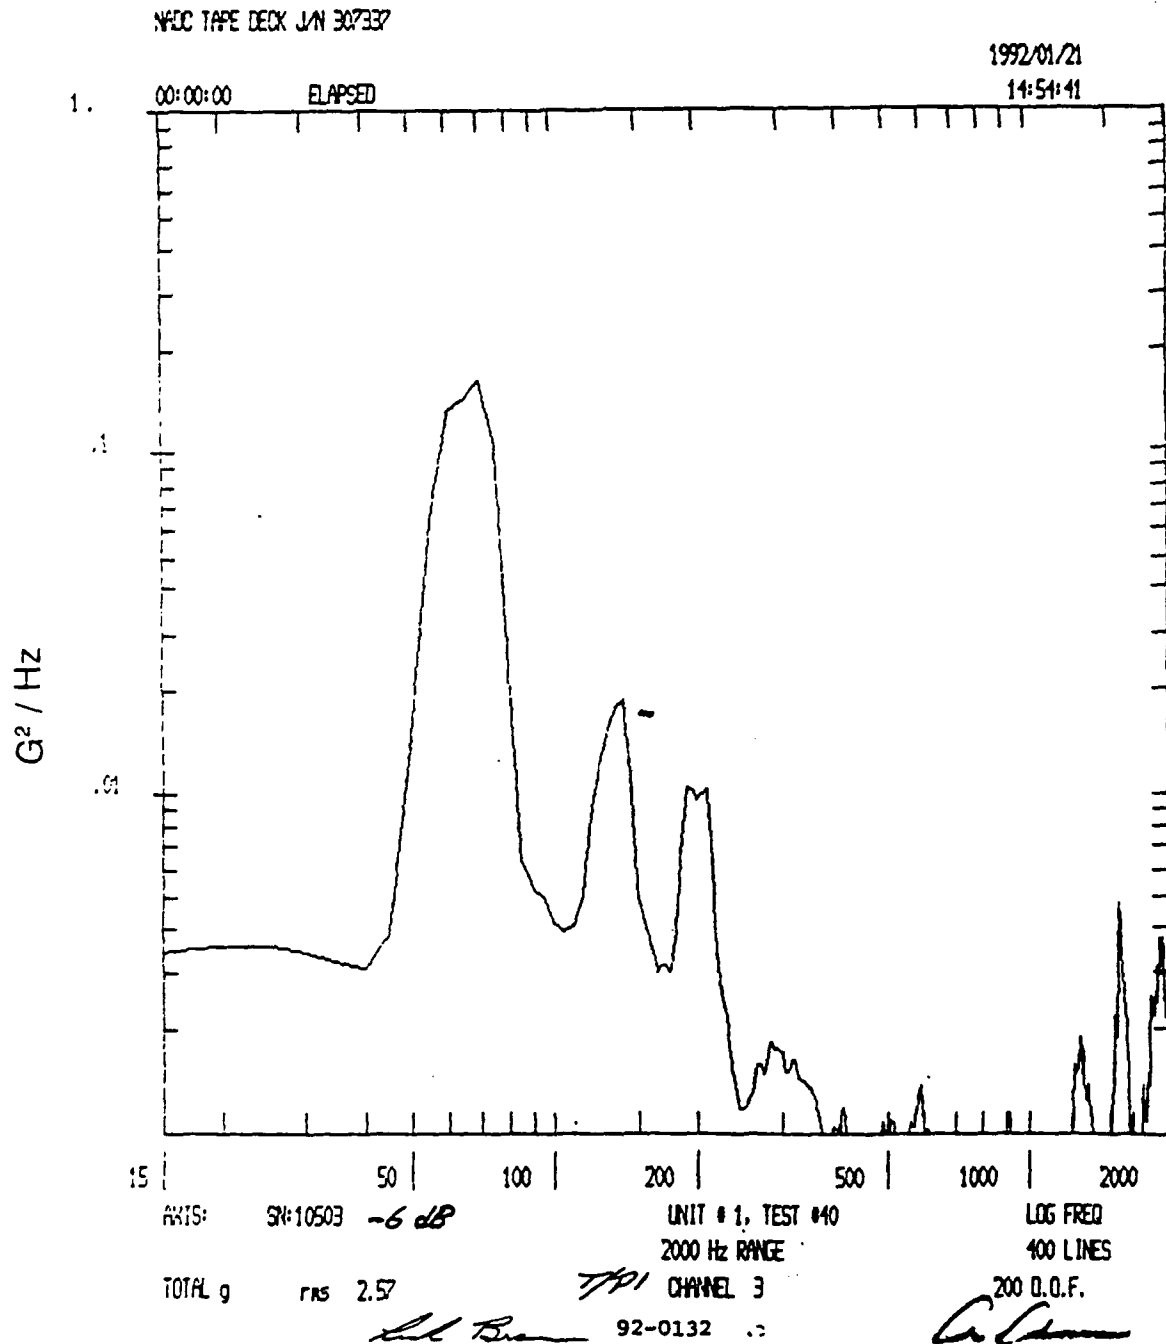
In Figure B-33, the BER plot for Test #16, *all* the BER samples were "Tau-Tron Overflows", or large amounts of errors. However, during Test #16, the Recorder shook itself loose from the mounting spacers (spacers part of Dayton T. Brown's fixture), and therefore the vibration test was not valid. The recorder was remounted, and Test #17, a repeat of #16, was run. **This test showed that the Sony DIR-1000 Failed the- "-6 dB" Mil-Std-810E profile, in the Z (vertical) axis.** The BER data (figure B-36) showed all "Tau-Tron Overflows", and the Recorder's Self-Diagnostics reported "Uncorrected Errors", "Servo Lock Loss", and "Motor FG Defective".

| VIBRATION<br>TEST# | TAPE # | VIBRATION<br>PROFILE<br>APPLIED<br>[FIGURE#] | AXIS | MODE<br>REC/PLAY | ECC<br>ON/OFF | BER TEST<br>FIGURE # | EVALUATION<br>(PASS/FAIL) |
|---|---|---|---|---|---|---|---|
| 16 | 42 | B-31, B-32 | [Z] VERT | PLAYBACK | ON | B-33 | FAIL |

The Sony DIR-1000 Recorder operated satisfactorily throughout the in-flight vibration test spectra provided by Boeing. It failed Playback Performance testing under vibration, to a Mil-Std-810E spectra derated 6 dB, but passed the derated 9 dB test. Vibration isolators are recommended for any installation aboard P-3C aircraft to reduce risk of failure and facilitate installation/removal of this unit.

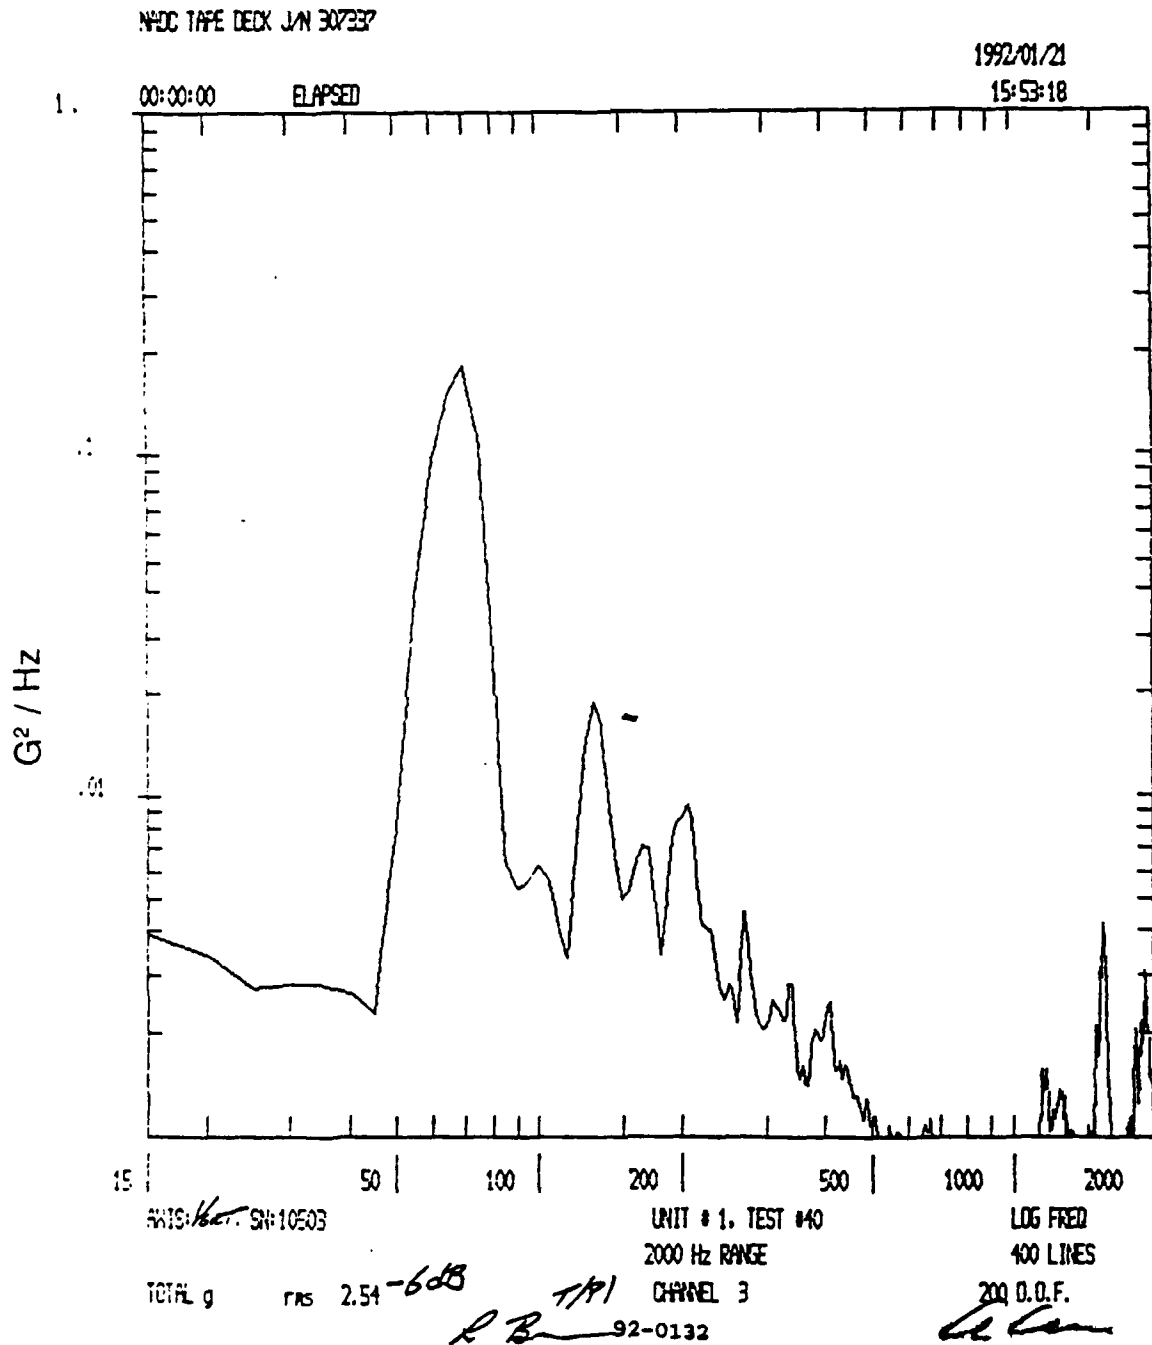
After Test #17, the recorder power was cycled, and all warning messages were extinguished. When powered up, the BET immediately showed no errors, indicating that the test equipment was functional. Then, with no vibration applied, the Sony was briefly put in Record Mode, and performed successfully with no errors/warnings. It is therefore concluded that the errors in Test #17 *were* vibration induced.

| VIBRATION<br>TEST# | TAPE # | VIBRATION<br>PROFILE<br>APPLIED<br>[FIGURE#] | AXIS | MODE<br>REC/PLAY | ECC<br>ON/OFF | BER TEST<br>FIGURE # | EVALUATION<br>(PASS/FAIL) |
|---|---|---|---|---|---|---|---|
| 17 | 42 | B-34, B-35 | [Z] VERT | PLAYBACK | ON | B-36 | FAIL |
