General Document 37

**AIRCRAFT ACCIDENT INVESTIGATION AT ARL  
THE FIRST 50 YEARS**

**J.L. KEPERT**

MARCH 1993

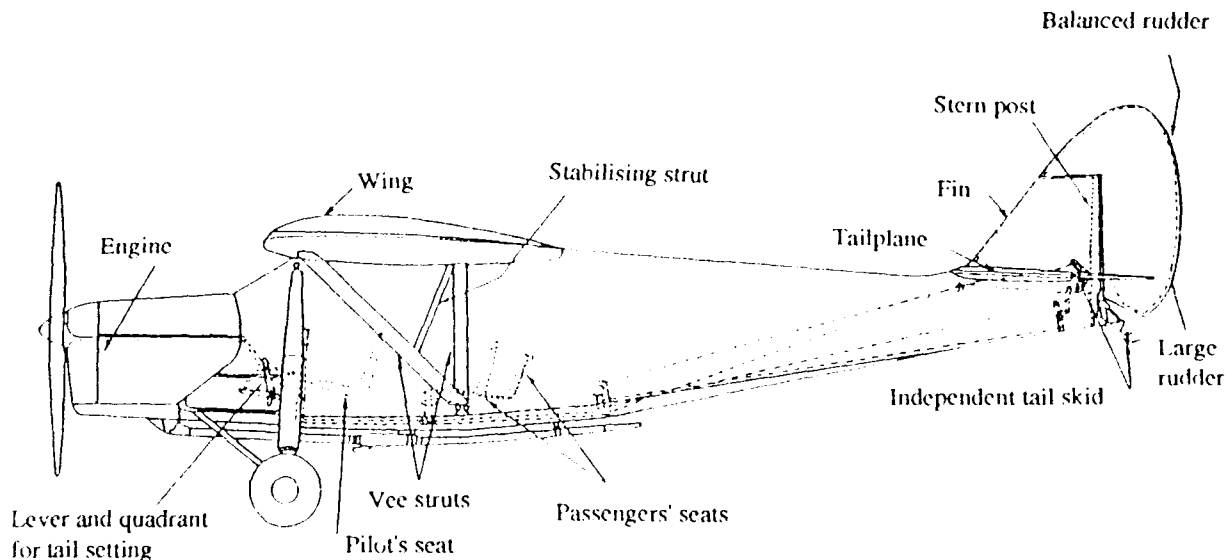
it easily met the load factor requirements of +5.5g and -2.75g specified for the normal category when the type certificate was issued in May 1930. Additional tests carried out by the RAE Farnborough supported this conclusion but indicated the desirability of fitting a stabilising bar to the forward leg of the vee strut; see Fig. 1. This mod was incorporated on 21 March 1932.

**Fig. 1** DH Puss Moth showing location of stabilising strut

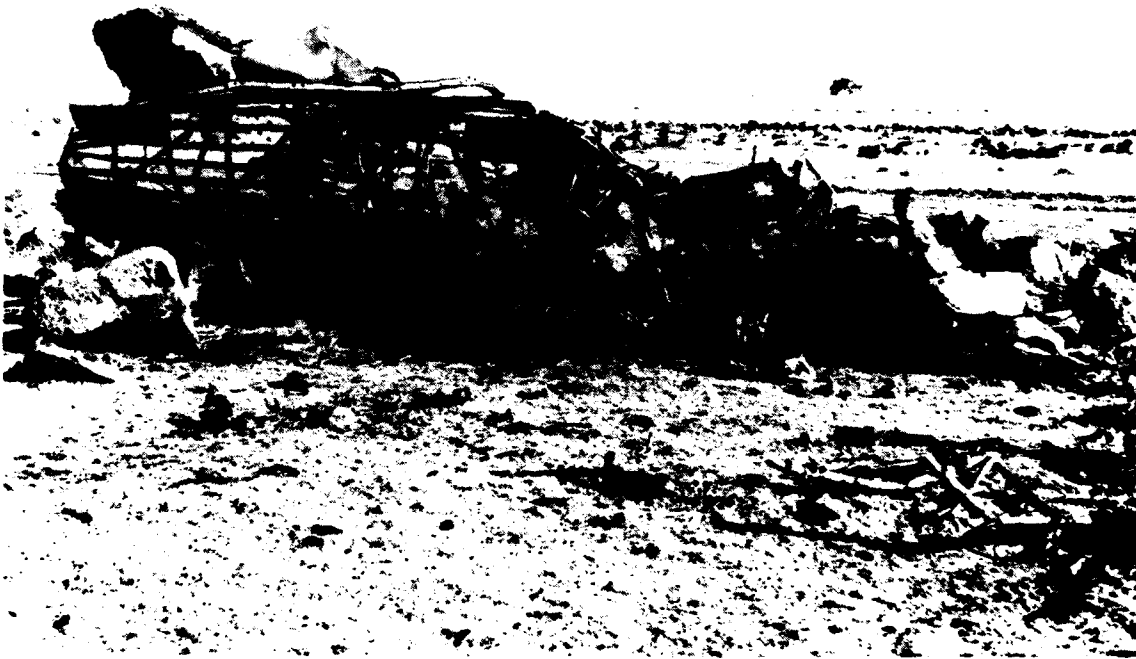
**Fig. 5**            **The burnt out fuselage of A20-679 marked the end of the wreckage trail**

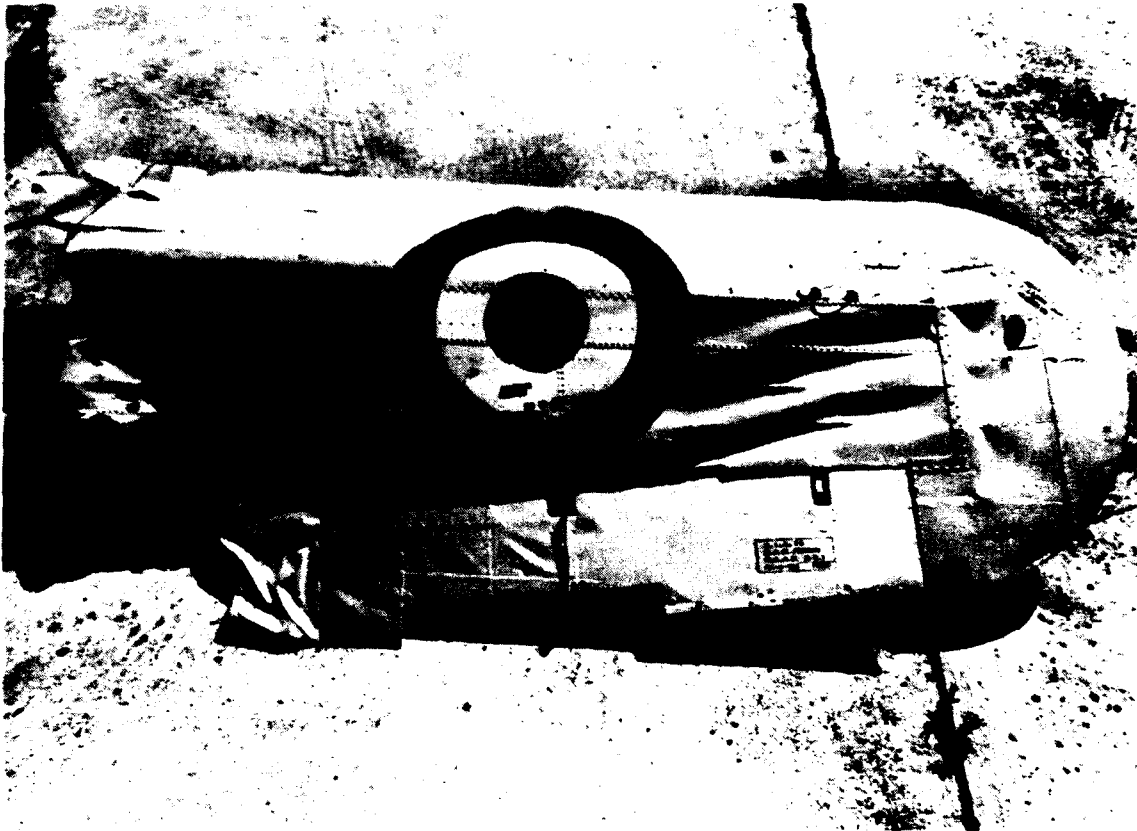
Examination of the wreckage revealed that the mode of wing failure was virtually identical with that exhibited by A20-201, Fig. 6. In the later accident, ARL had the benefit of being able to inspect all of the wreckage, not just the detached wing section, Applied Report 6. This confirmed that the starboard wing had incurred no in-flight damage and that the port aileron was up at the moment of wing failure; two features which could only be inferred during the investigation into A20-201.

**Fig. 6** Lower surface of the detached port wing from A20-679 showing the upward collapse of the leading edge. The downwards bending failure of the tip occurred under inertia and aerodynamic loading when the wing failed

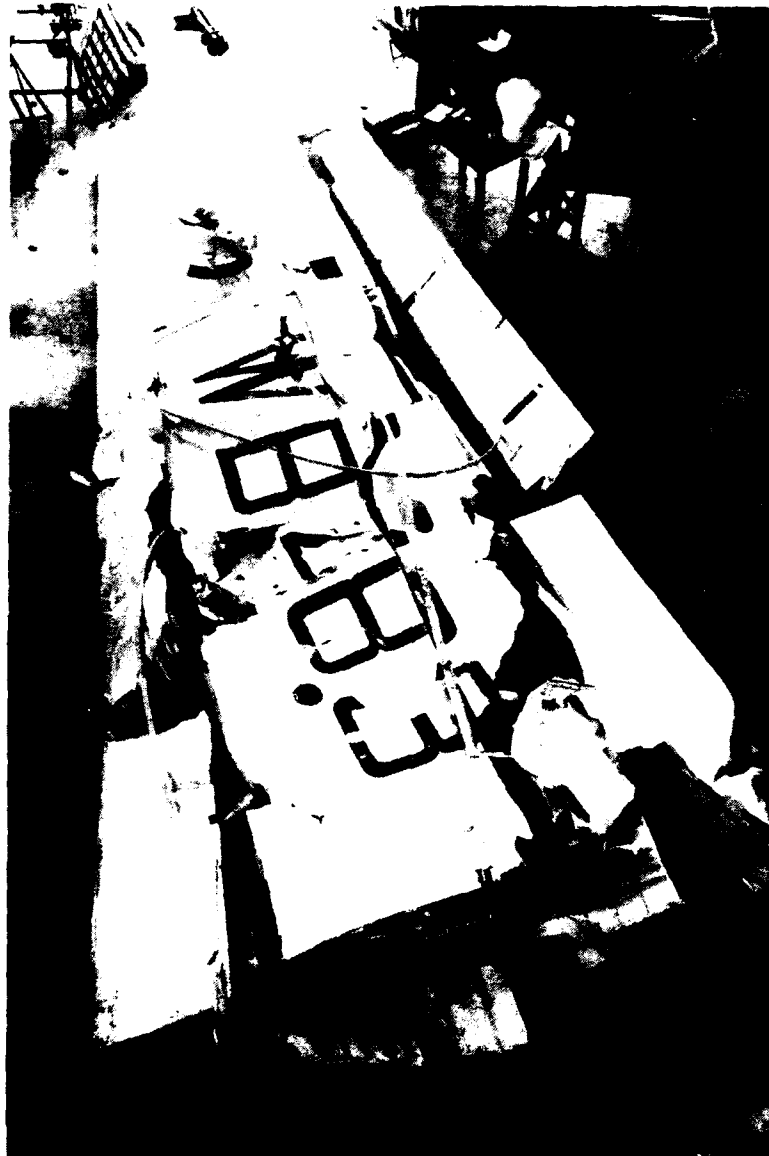
On 25 November 1953 near Mallala, SA, A81-2 was observed to be diving at a speed approaching the placard limit speed ( $V_{NE}$ ). As it pulled out of the dive at an altitude of 4,000 ft, the port wing failed and the aircraft crashed killing the crew of two. An examination of the separated port wing, Fig. 7, showed that the wing had failed in overload bending without the prior leading edge collapse which characterised the Wirraway wing failures. The examination also showed that the port aileron was deflected 10° down when wing failure occurred, S & M Report 224.

**Fig. 7** Port wing of A81-2 re-assembled to show the mode of failure. The lower surface retained the aircraft's original RAF serial

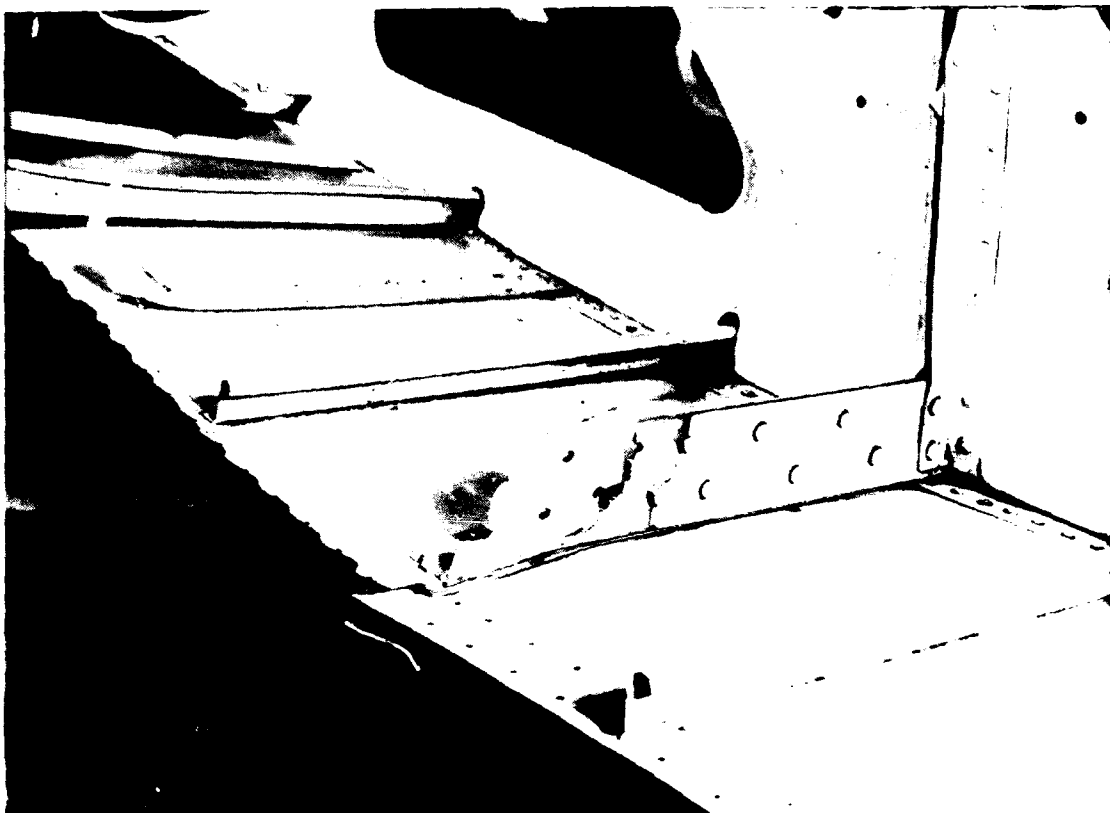
When the starboard wing sections arrived at ARL, it was immediately obvious that the wing failure initiated at the inboard end of a repair which had been carried out on the lower surface leading edge skin between wing stations 168-180. This area is located in the outer wing panel outboard of the wing joint at station 119. The repair was poorly designed in that it terminated in a double staggered row riveted joint using 3/32 in. rivets at one inch pitch. This joint had failed through shearing of the rivets without any associated tearing of the skin edge, Fig. 9. It is most unusual for riveted joints to fail in this way and indicates a gross mismatching between skin tensile strength and rivet shear strength.

**Fig. 9** Starboard wing of A16-38 showing failure details. Forward of the spar, the joint has failed by shearing of the rivets (lower centre) in contrast with the skin tearing evident aft of the spar (upper left)

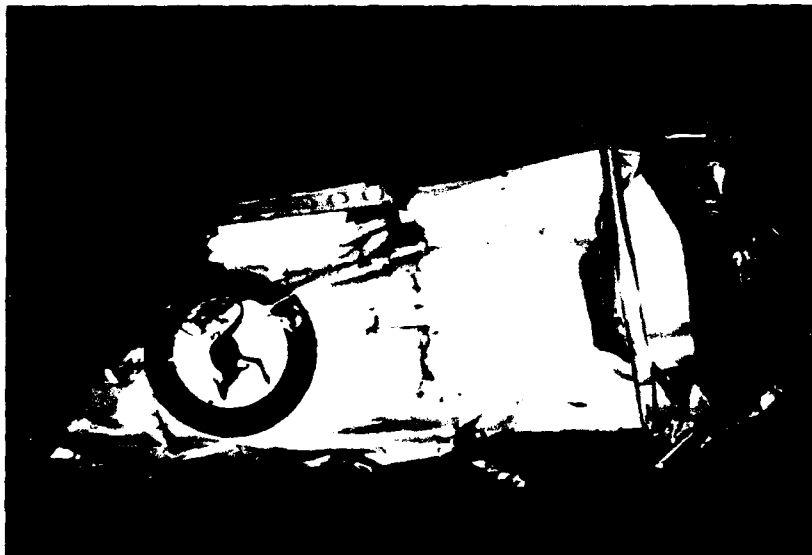
rotate upwards about station 62, a second failure occurred further outboard at station 180 in downwards bending and torsion under the combined action of the high inertia and aerodynamic loads induced by the primary failure. This second failure is analogous to that experienced by the Wirraways; see Fig. 6. The section outboard of station 180 then separated and struck the starboard tailplane which failed in turn.

**Fig. 10** A85-416 starboard wing upper surface. Note the deep compression buckle immediately outboard of the wing joint and the missing wing tip. The leading edge damage resulted from impact with the tailplane

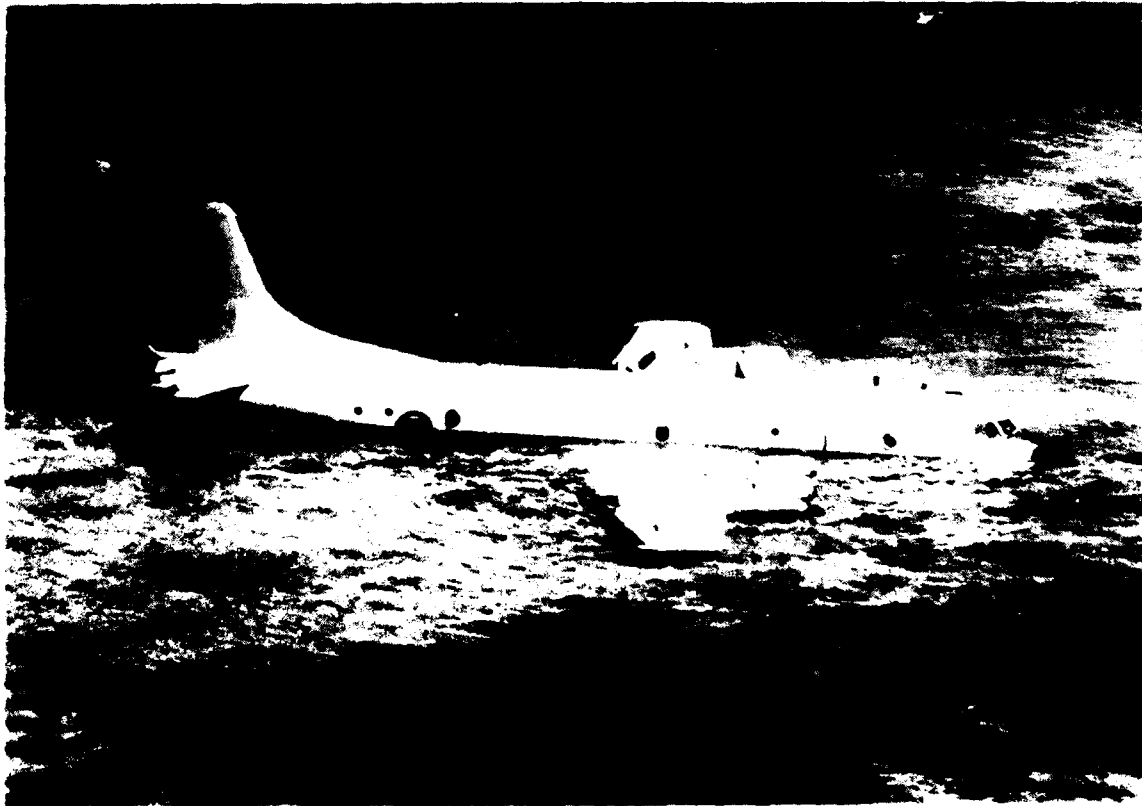
Water impact occurred with the aircraft in a nose high, slightly left wing low attitude. Because all engines were at full power, torque reaction caused all four propellers to separate from their respective engines when the blade tips touched the water. Since their direction of rotation was clockwise when viewed from the rear, the propellers separated by moving to starboard and the port inboard propeller (No. 2) penetrated the port side of the forward fuselage killing one of the occupants. Similarly, the detached starboard propellers inflicted some damage on the outer section of the starboard wing leading edge, the starboard aileron and the starboard flap. As its speed diminished, the aircraft finally slewed to port and came to rest on the sea bed, Fig. 16.

**Fig. 16** Orion A9-754 in the lagoon at Cocos Island. Note the missing propellers

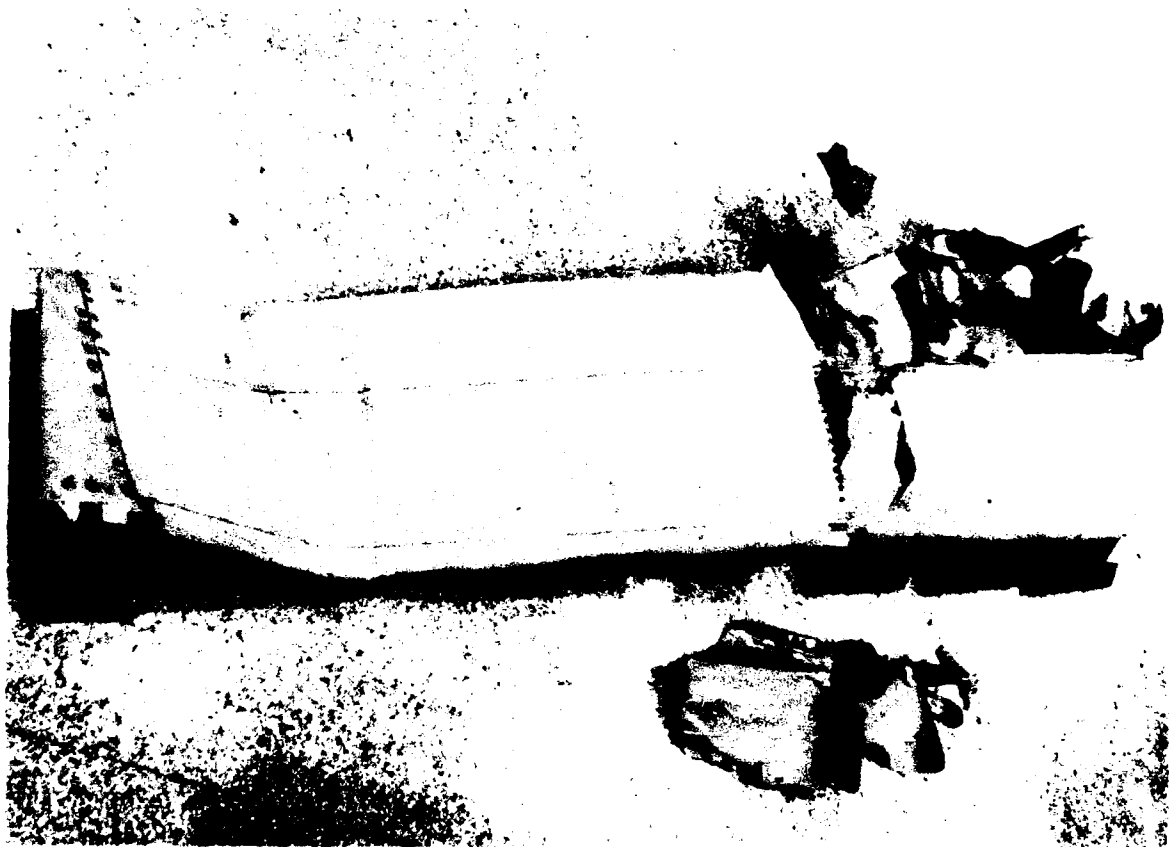
**Fig. 17** Outboard section of the starboard elevator showing failure on both sides of the mass balance weights

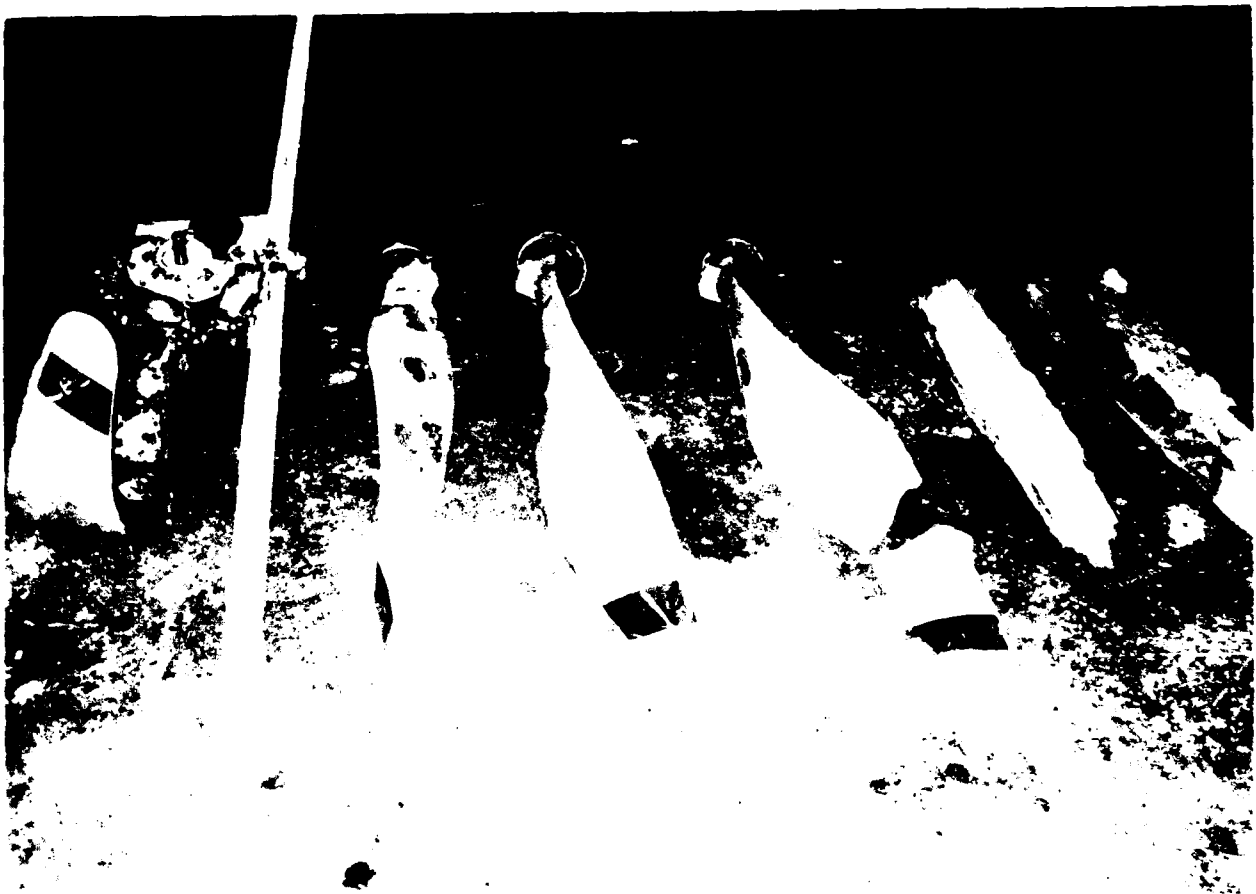
A more complex example is provided by Pilatus PC-9 A23-035 which crashed at East Sale, Vic. on 5 August 1991. In this accident, the propeller contacted a wire fence before striking the ground. The variation in blade damage is shown in Fig. 21 where the blades are numbered 1 - 4 in sequence from right to left. As may be seen, blade 4 picked up fence wires and was pulled into a smooth rearwards bend as the wires stretched. Blade 1 cut through the fence post shown at far right losing its tip in the process. Blades 2 and 3 missed the fence and were slightly twisted, but not bent, on ground impact. At first sight, the small damage to blades 2, 3 and 4 would seem to suggest that the engine had failed and was not delivering any power. However, for blade 1 to cut completely through a thick post of dry hardwood means that some power must have been developed and Structures Technical Memorandum 582 estimated this as 15% of full power.

**Fig. 21** Propeller blades from A23-035 with the fence post cut through by blade 1 at right

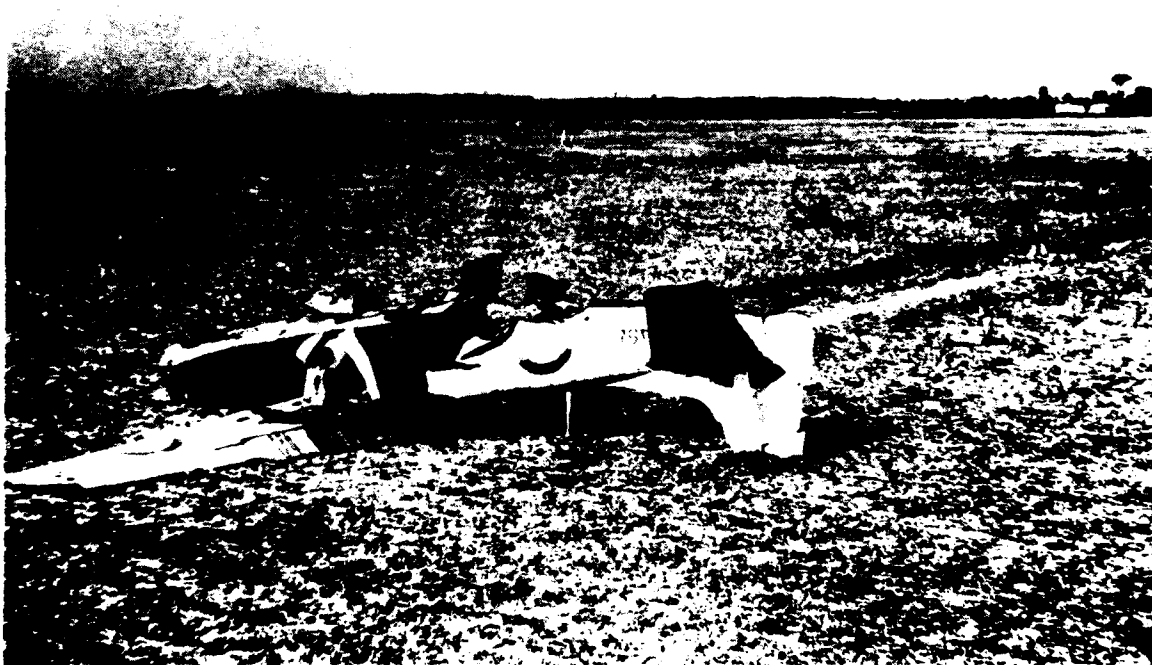
propeller blades showed these to have the classical smooth rearwards bend normally associated with low power output. A strip-down examination of the Rolls-Royce Merlin revealed that the flame traps were severely damaged. These flame traps were built up from sheets of copper alloy to form a fine mesh honeycomb within the intake manifold. A considerable amount of this material was found in the cylinders with pieces lodged under inlet and exhaust valves thus preventing them from closing. Further examination revealed a broken inlet valve seat and this probably induced the backfire which initiated failure of the flame traps.

**Fig. 22      The wreckage of A68-123 with its detached propeller in the distance**

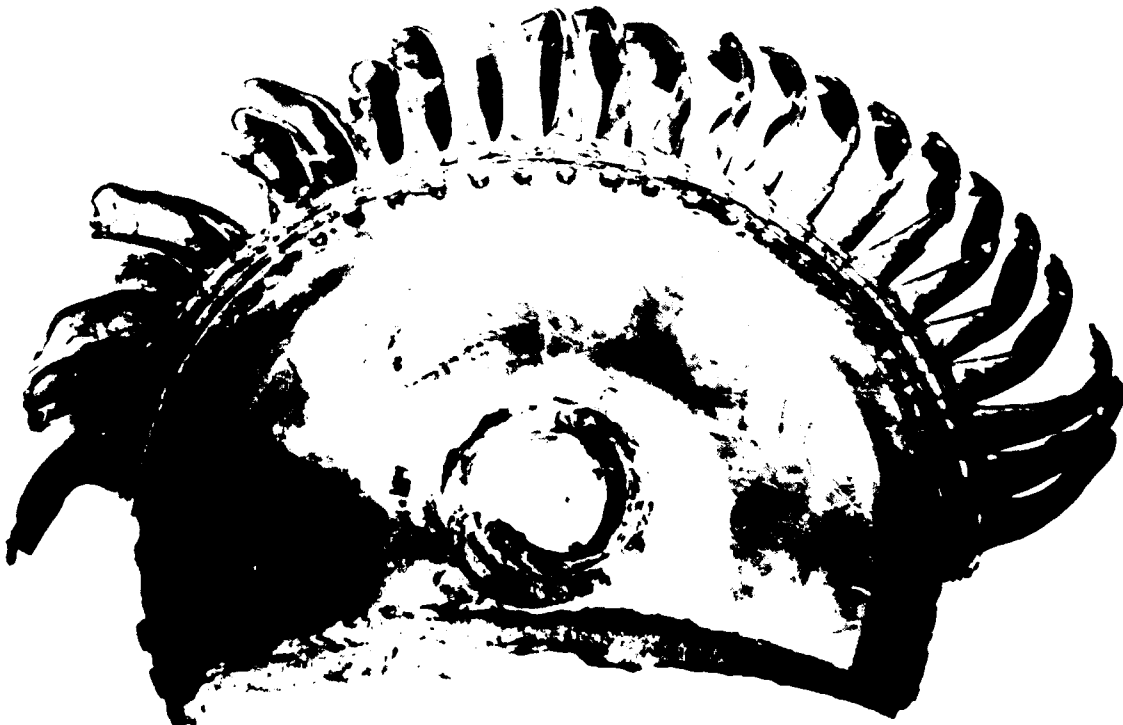
**Fig. 23**      **Fractured turbine disc recovered from the wreckage of WM374**

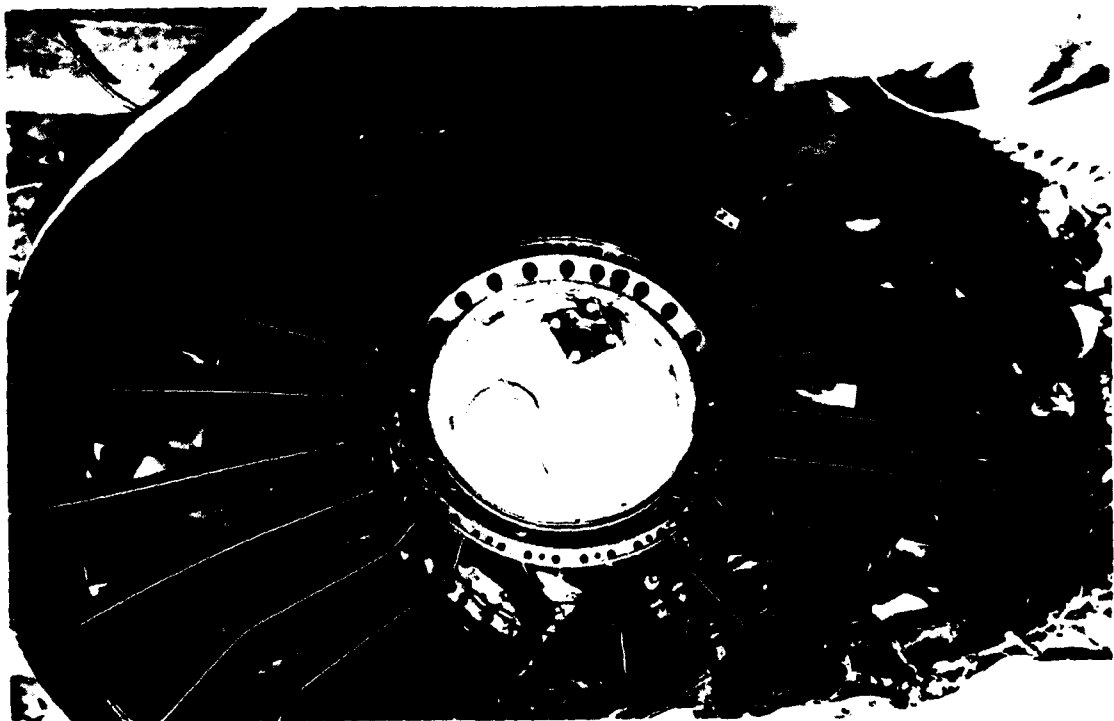
**Fig. 27** Fan stage of engine No. 2 as recovered. The blade damage is still small although greater than that for engine No. 1

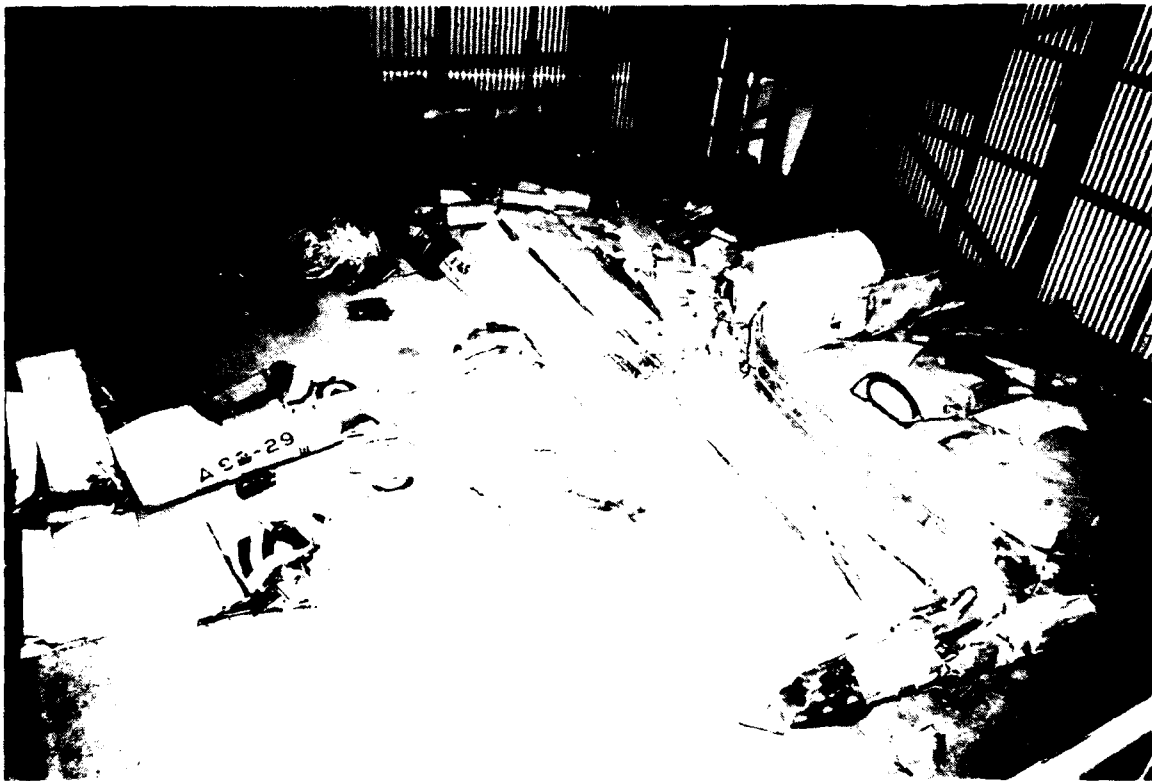
**Fig. 30**      **Wreckage of A92-29 re-assembled to show the multiplicity of structural failures**

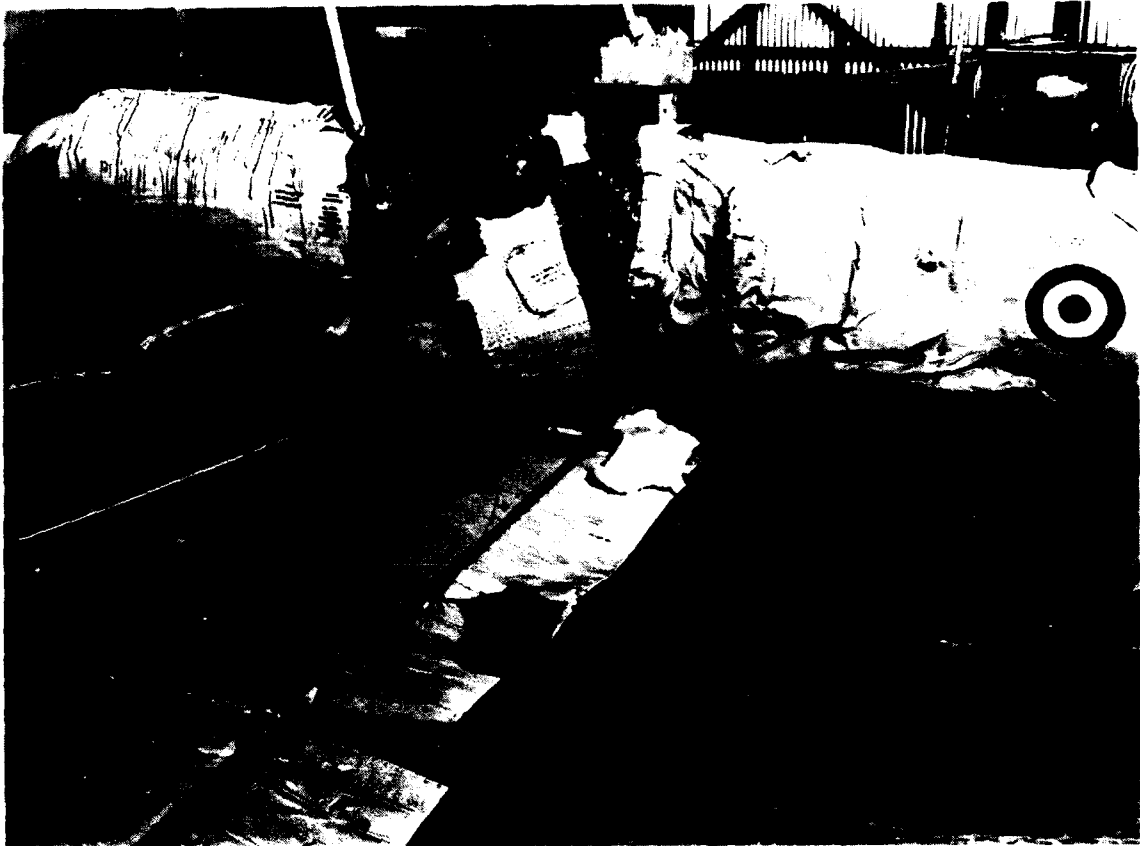
**Fig. 31**      **Upwards bending failure of the port wing of A92-45. Note the fuselage failures at stations 130 and 162 and the break-up of the centre fuselage. The underwing fairing was not recovered**

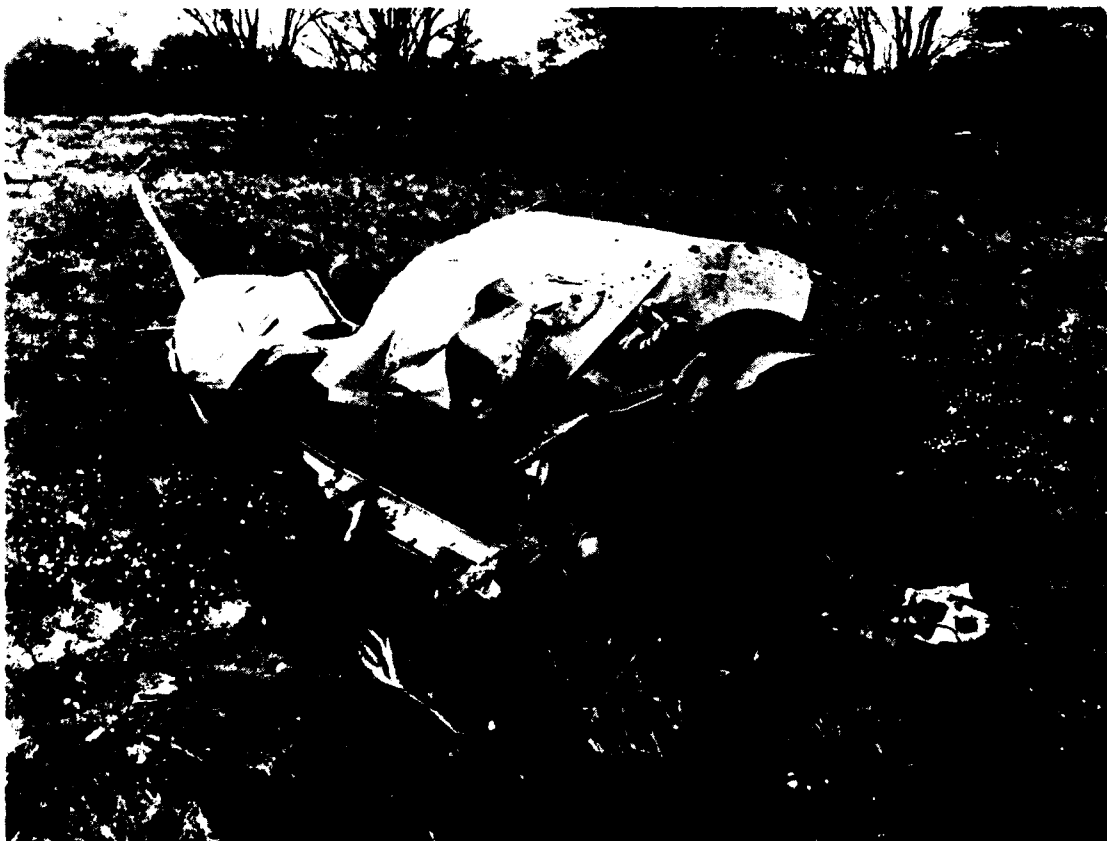
**Fig. 32**      A familiar pattern of fuselage failure. The forward fuselage of A92-90 after failure at station 130

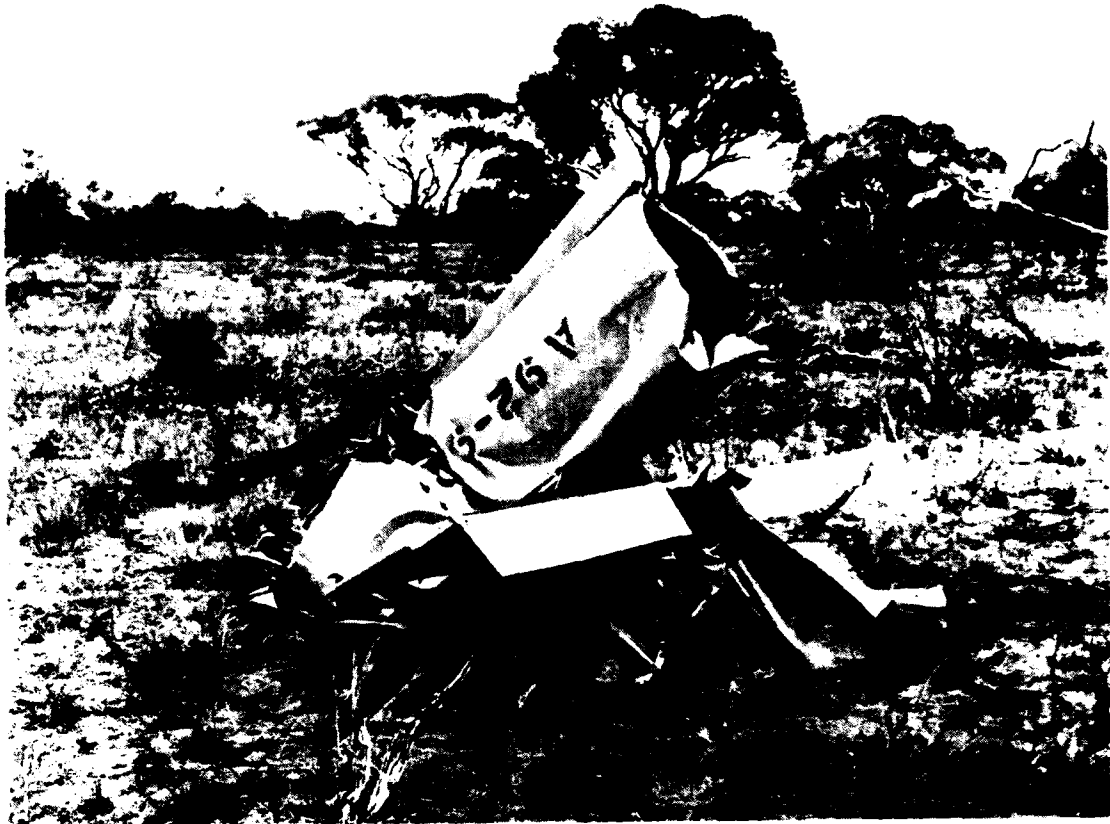
**Fig. 33**      **Tail unit of A92-90 showing damaged elevators with mass balances still attached**

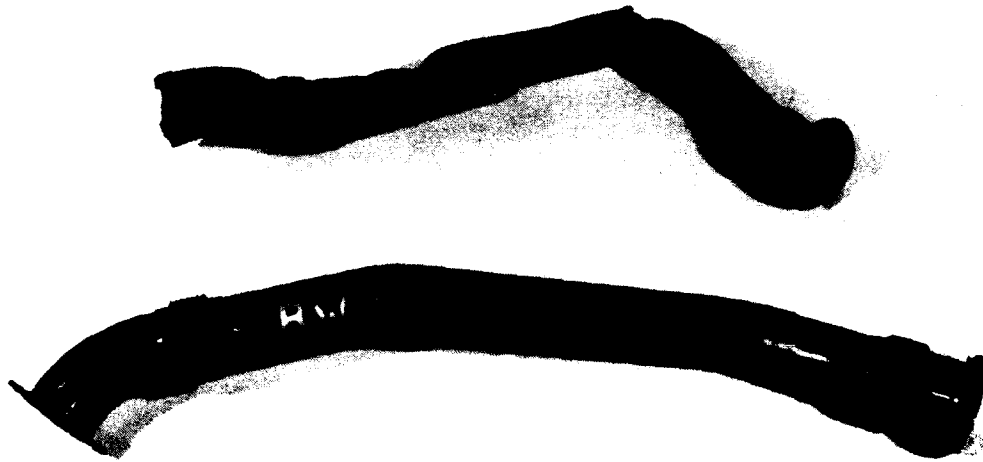
**Fig. 38** Hot air duct from A8-136 as recovered compared with a new duct

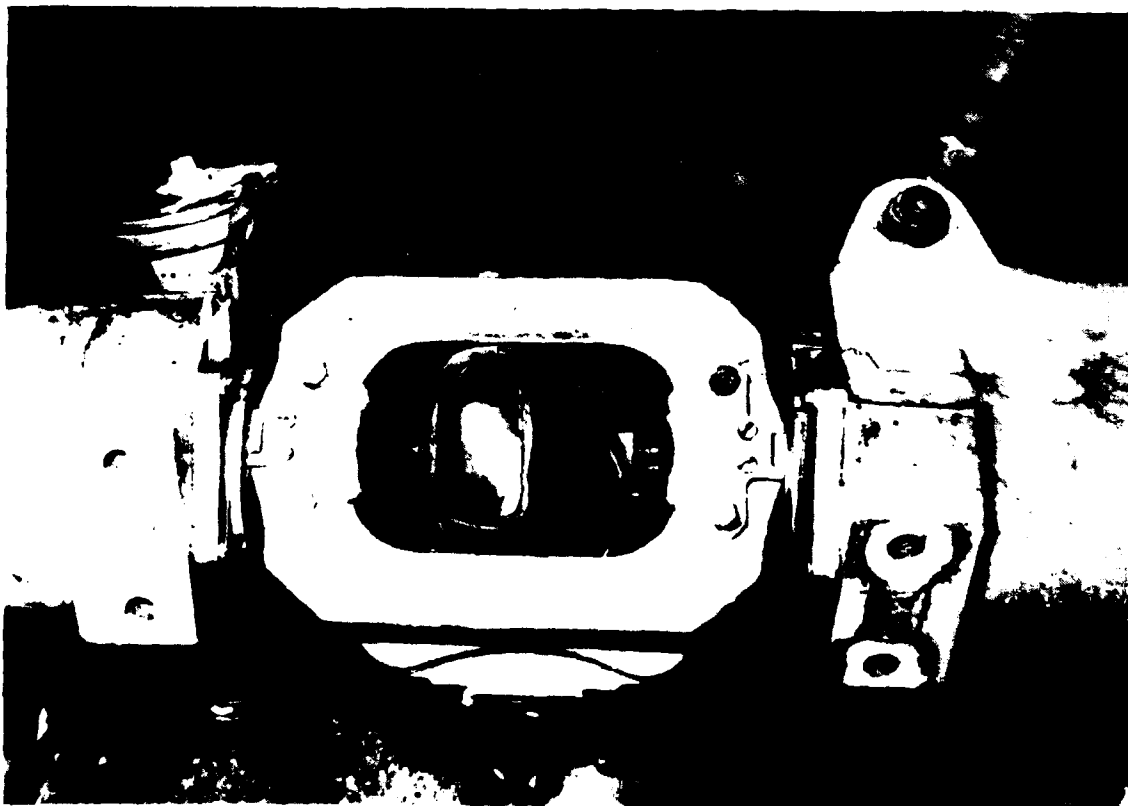
Fig. 41 Main rotor yoke of A2-719 showing the deformed and broken mast

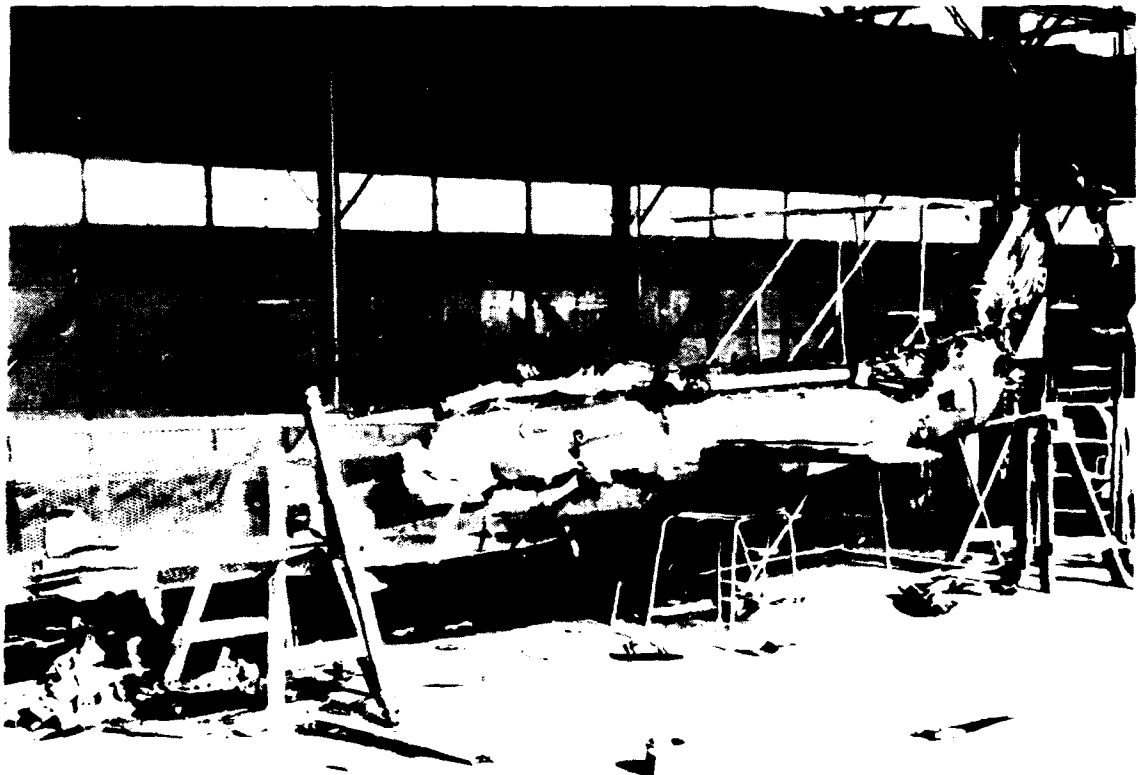
**Fig. 42**      **A2-719 at an early stage of re-assembly. The tail boom was severed forward of the elevator by a single main blade strike as indicated by the single impact damage to the tail rotor drive shaft**

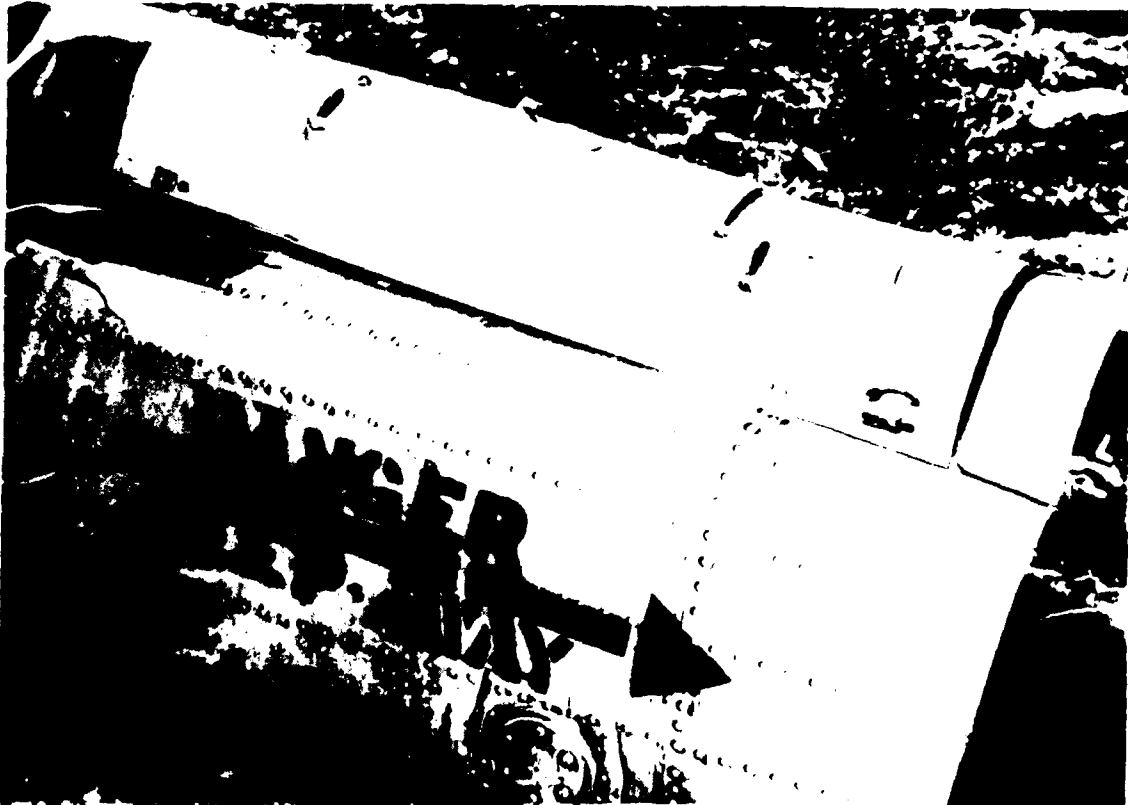
**Fig. 43** Transverse holes in the drive shaft tunnel cover of A2-386 made by a flailing pitch control cable

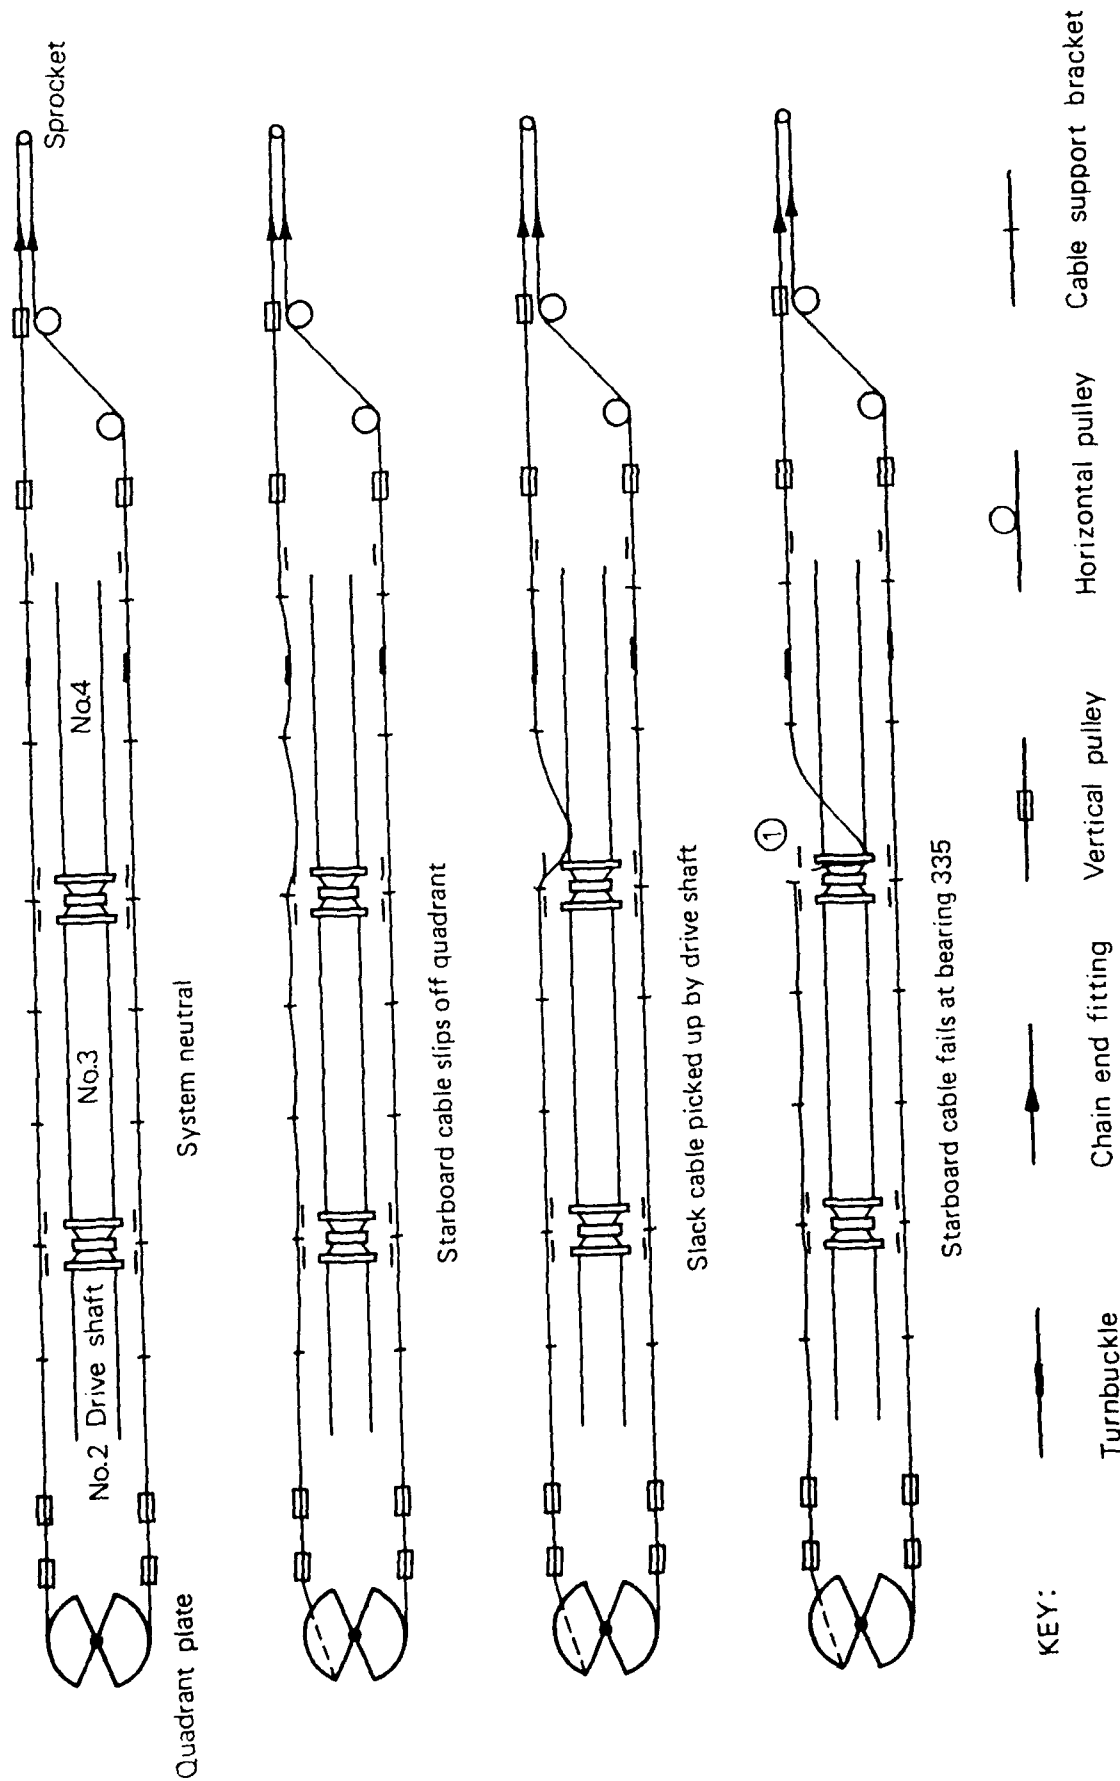
Fig. 45 Postulated accident sequence - tail rotor cable system

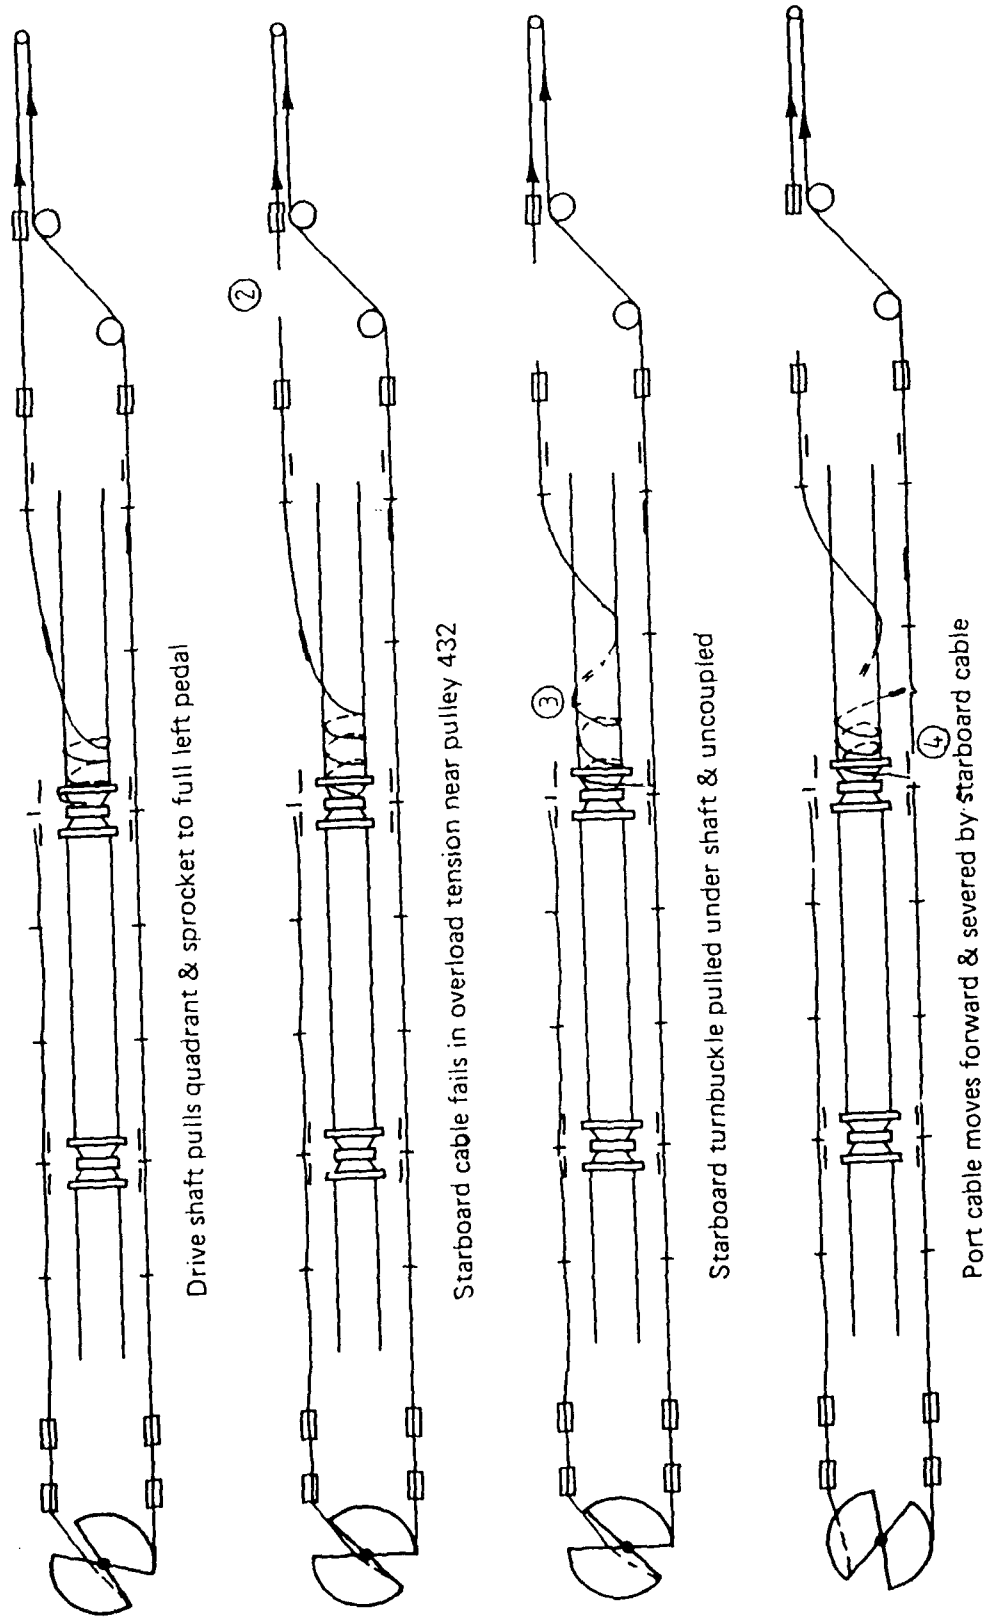
**Fig. 46 Further stages in the failure of the tail rotor cable system**
