General Document 37

**AIRCRAFT ACCIDENT INVESTIGATION AT ARL  
THE FIRST 50 YEARS**

**J.L. KEPERT**

MARCH 1993

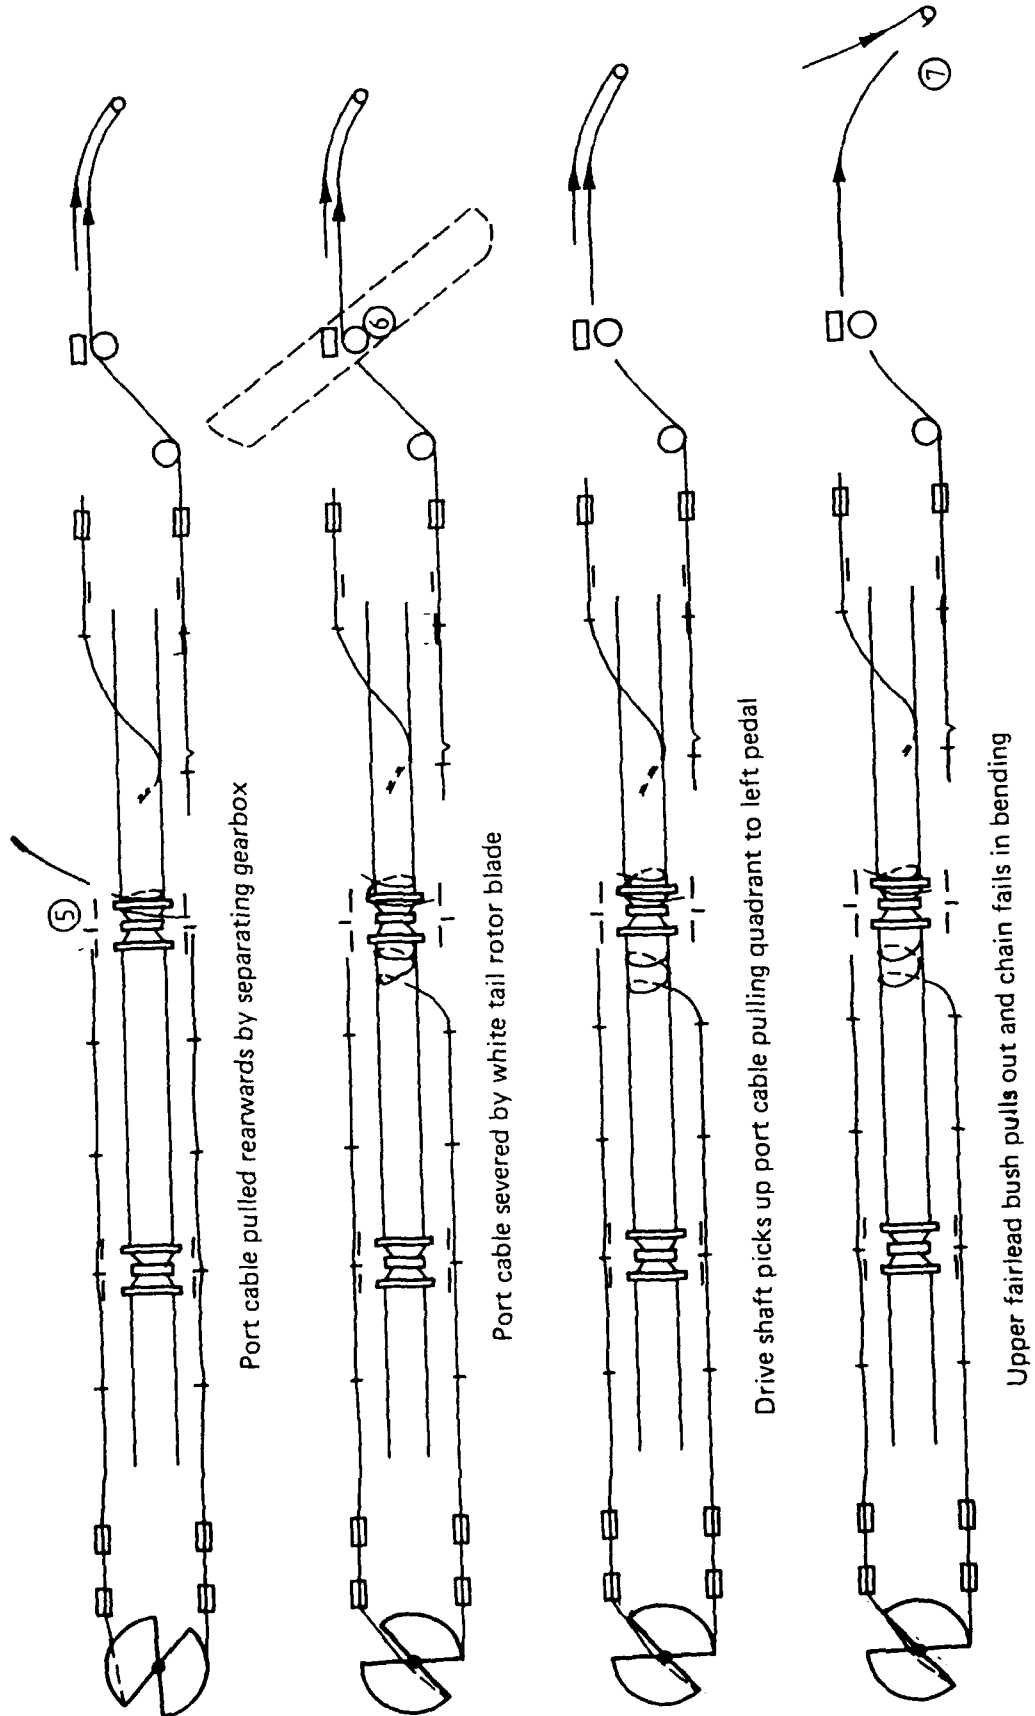
Fig. 47 Final stages in the cable system failure

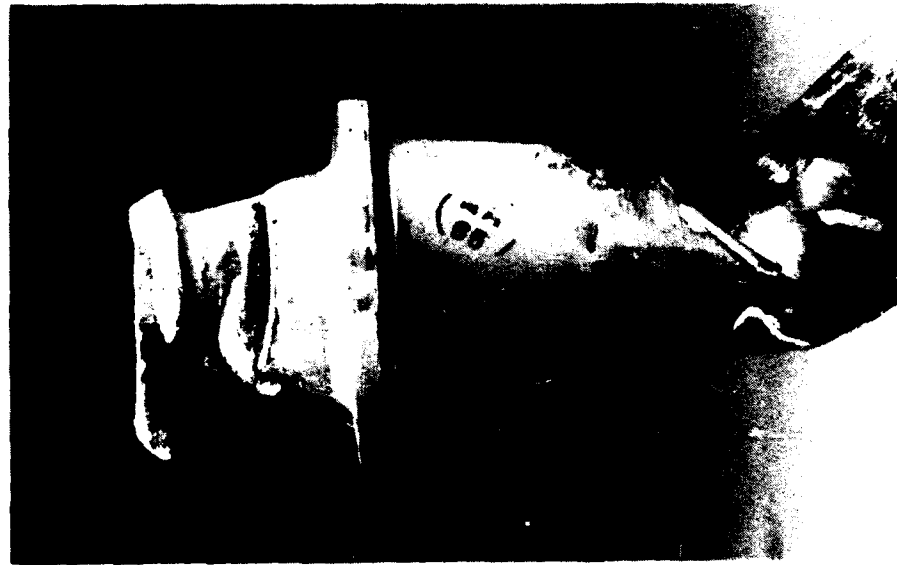
**Fig. 52**      **The failed drive shaft coupling from M38-02. Note the broken lugs at right caused by contact with the compressor drive drum, the cut in the end fitting made by the firewall, and the ground impact buckling of the shaft at left**

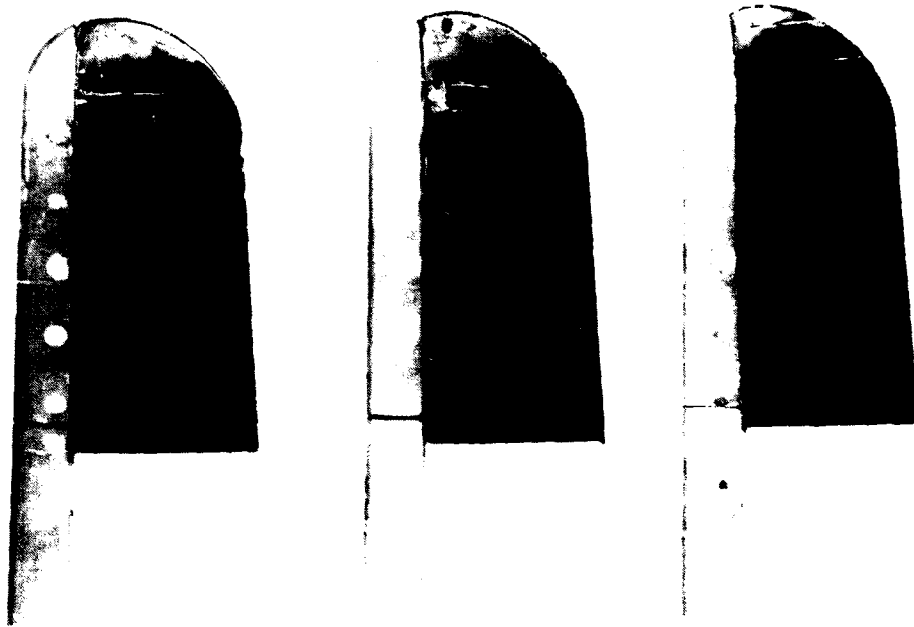
**Fig. 54**      **The three tail rotor blades from XN449 showing chordwise scratches on their outboard faces**

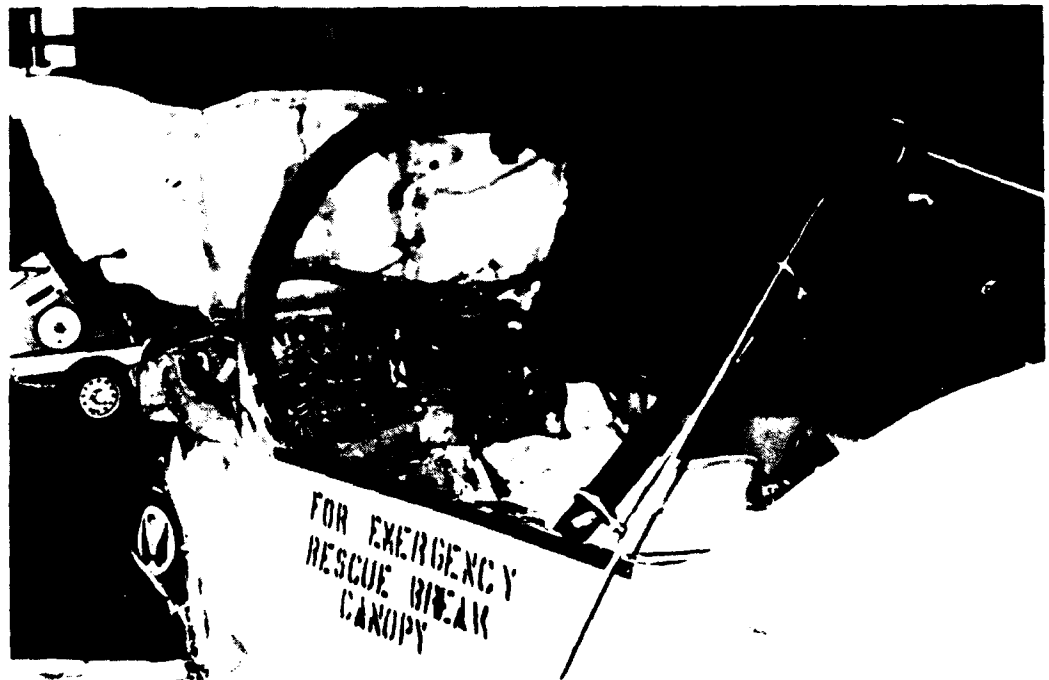
**Fig. 58** Cockpit structure of A19-028 after the accident. Note the impact damage to the instrument panel and the missing windscreen
