LIVE FIRE TEST AND EVALUATION OF M113A3
ARMORED PERSONNEL CARRIER SPALL LINERS (U)

OUSD(A) Log No. S-2/LFT01
1 May 1993

LIVE FIRE TEST AND EVALUATION OF M113A3 ARMORED
PERSONNEL CARRIER SPALL LINERS

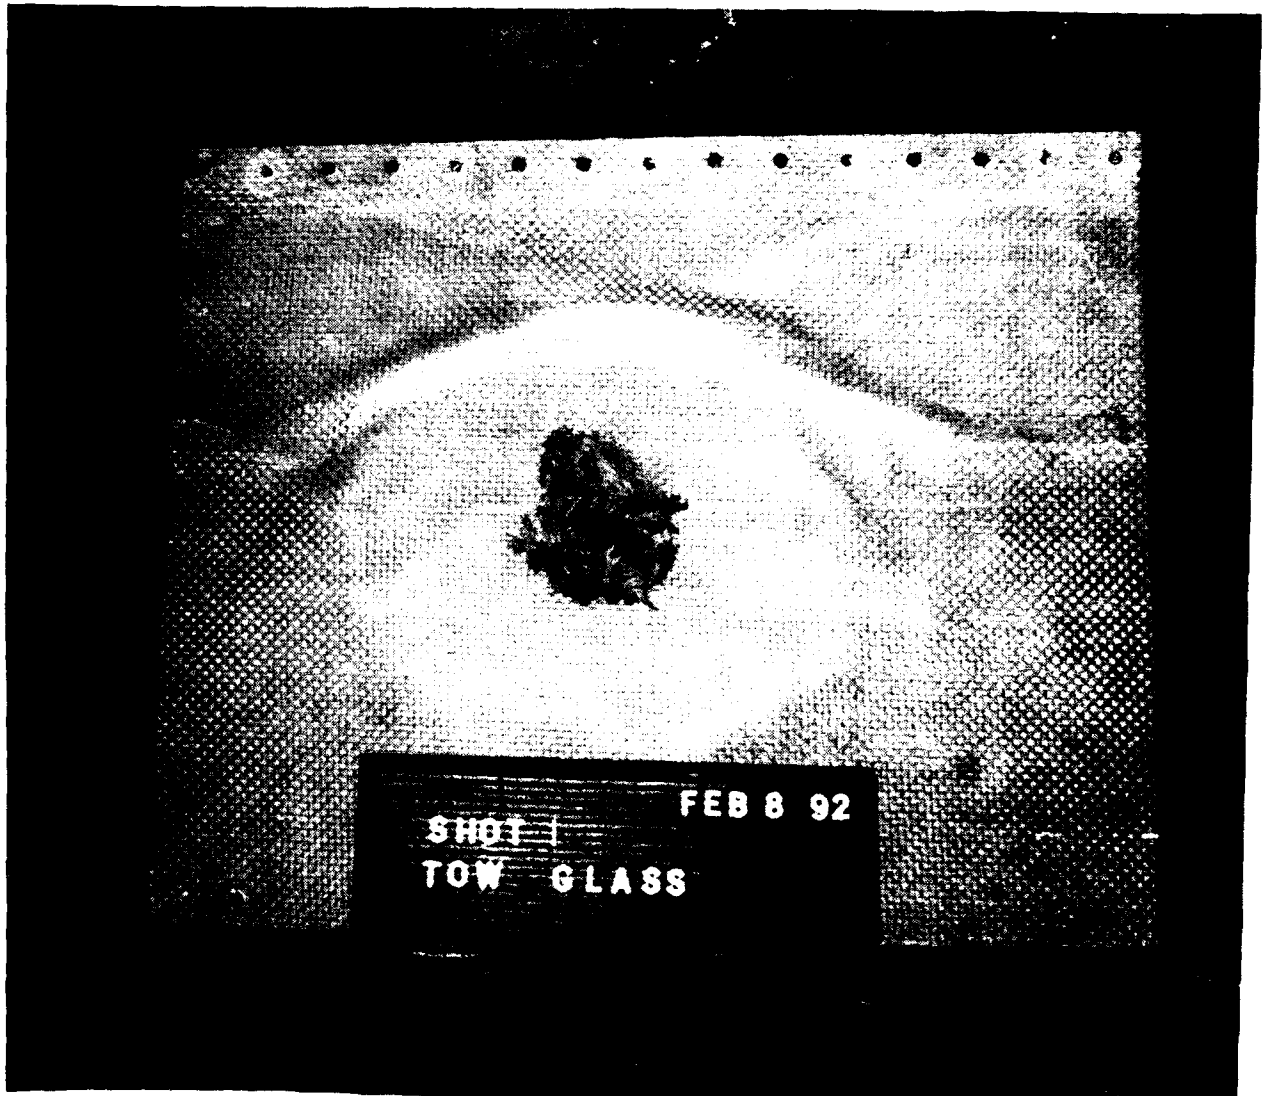
Damage photographs (Figures 8 through 15) indicate that the damage is considerably reduced behind both the S-2 Glass and the Kevlar liners. Thus, S-2 Glass and Kevlar spall liners are equally effective in stopping the spall. Figures 8 through 11 show the damage from TOW shaped charge shots with S-2 Glass liner. Figures 8 and 9, respectively, show the damages on front and back of the S-2 Glass panel. Figures 10

Figure 9. Damage, Rear of S-2 Glass Liner, TOW Shaped Charge Versus S-2

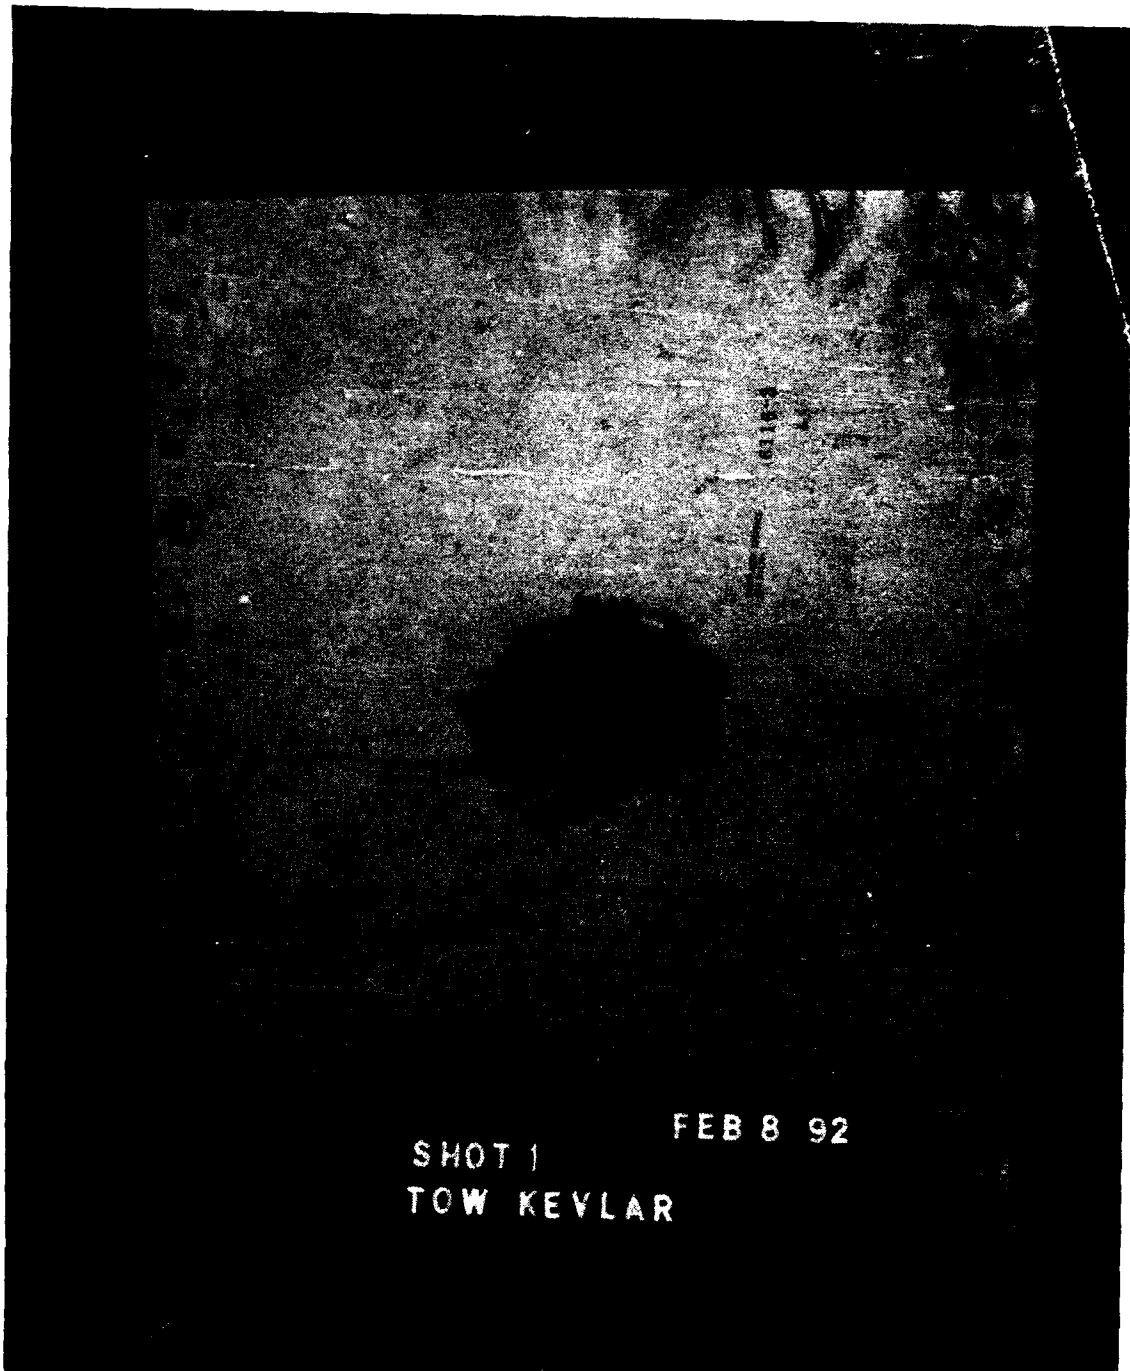
Figure 13. Damage, Rear of Kevlar Liner, TOW Shaped Charge Versus Kevlar

and 11, respectively, show the damages on front and back plates of the BAD pack. Similarly, Figures 11 through 14 show the damage from the TOW shaped charge shots with the Kevlar liner. Appendix A presents similar results for the VIPER shaped charge shots and the 30mm APDS shots. These figures show that the ballistic damage and damage from fragments and spall are comparable for the S-2 Glass and the Kevlar liners.

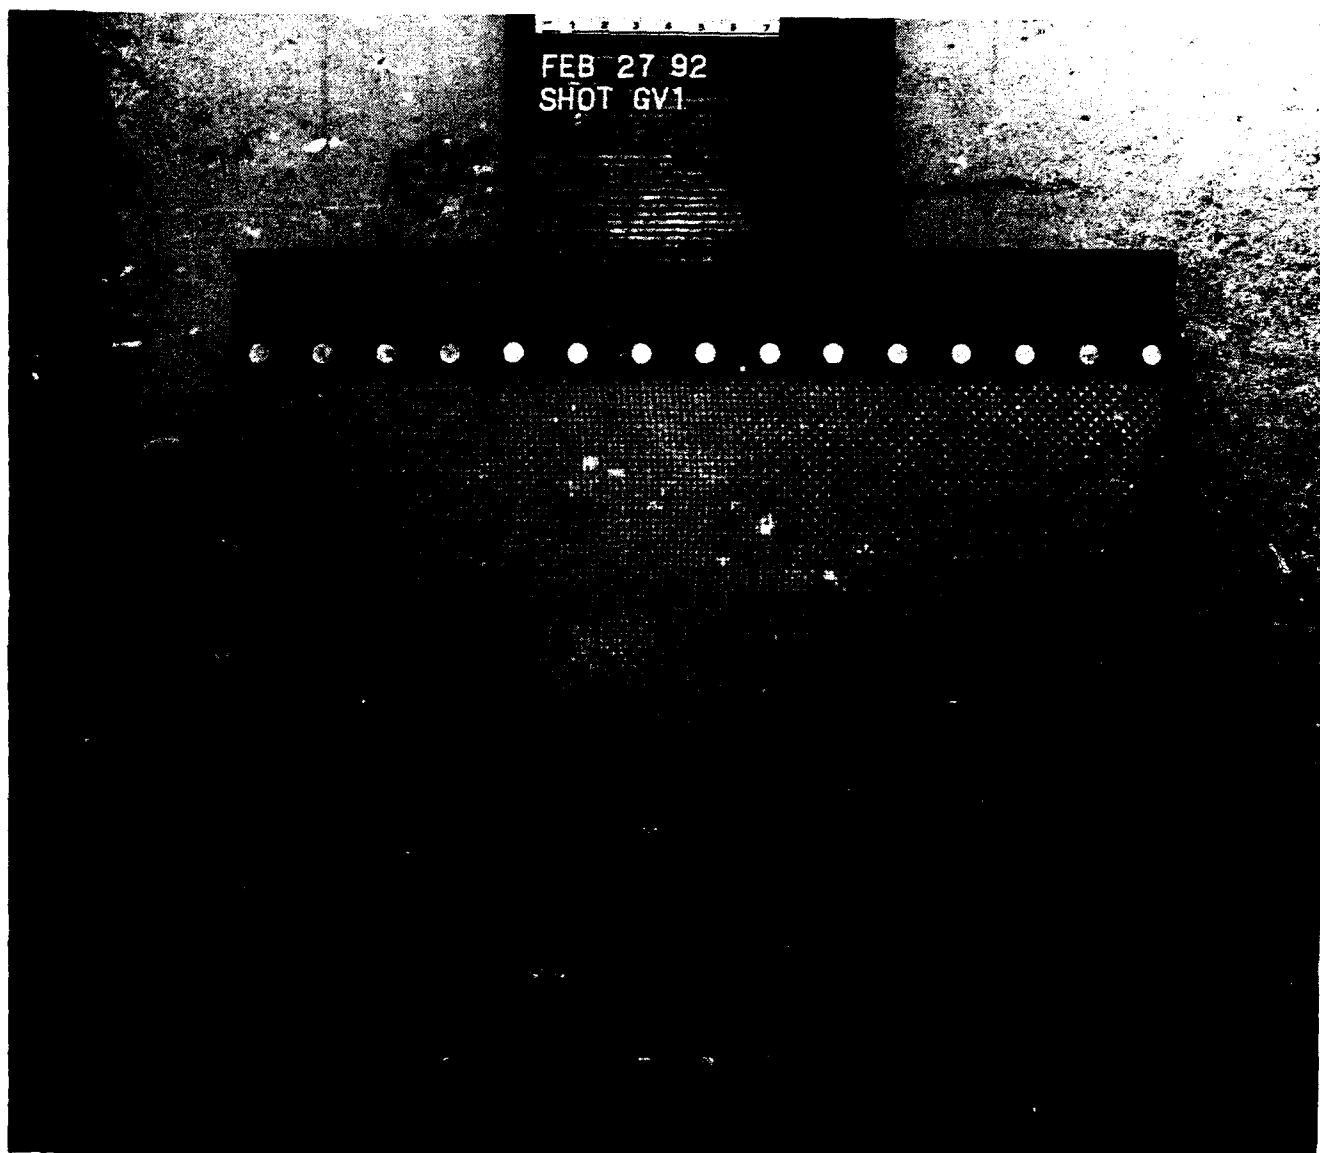
Figure A-2. Damage, Rear of S-2 Glass Panel, VIPER Shaped Charge Versus
S-2

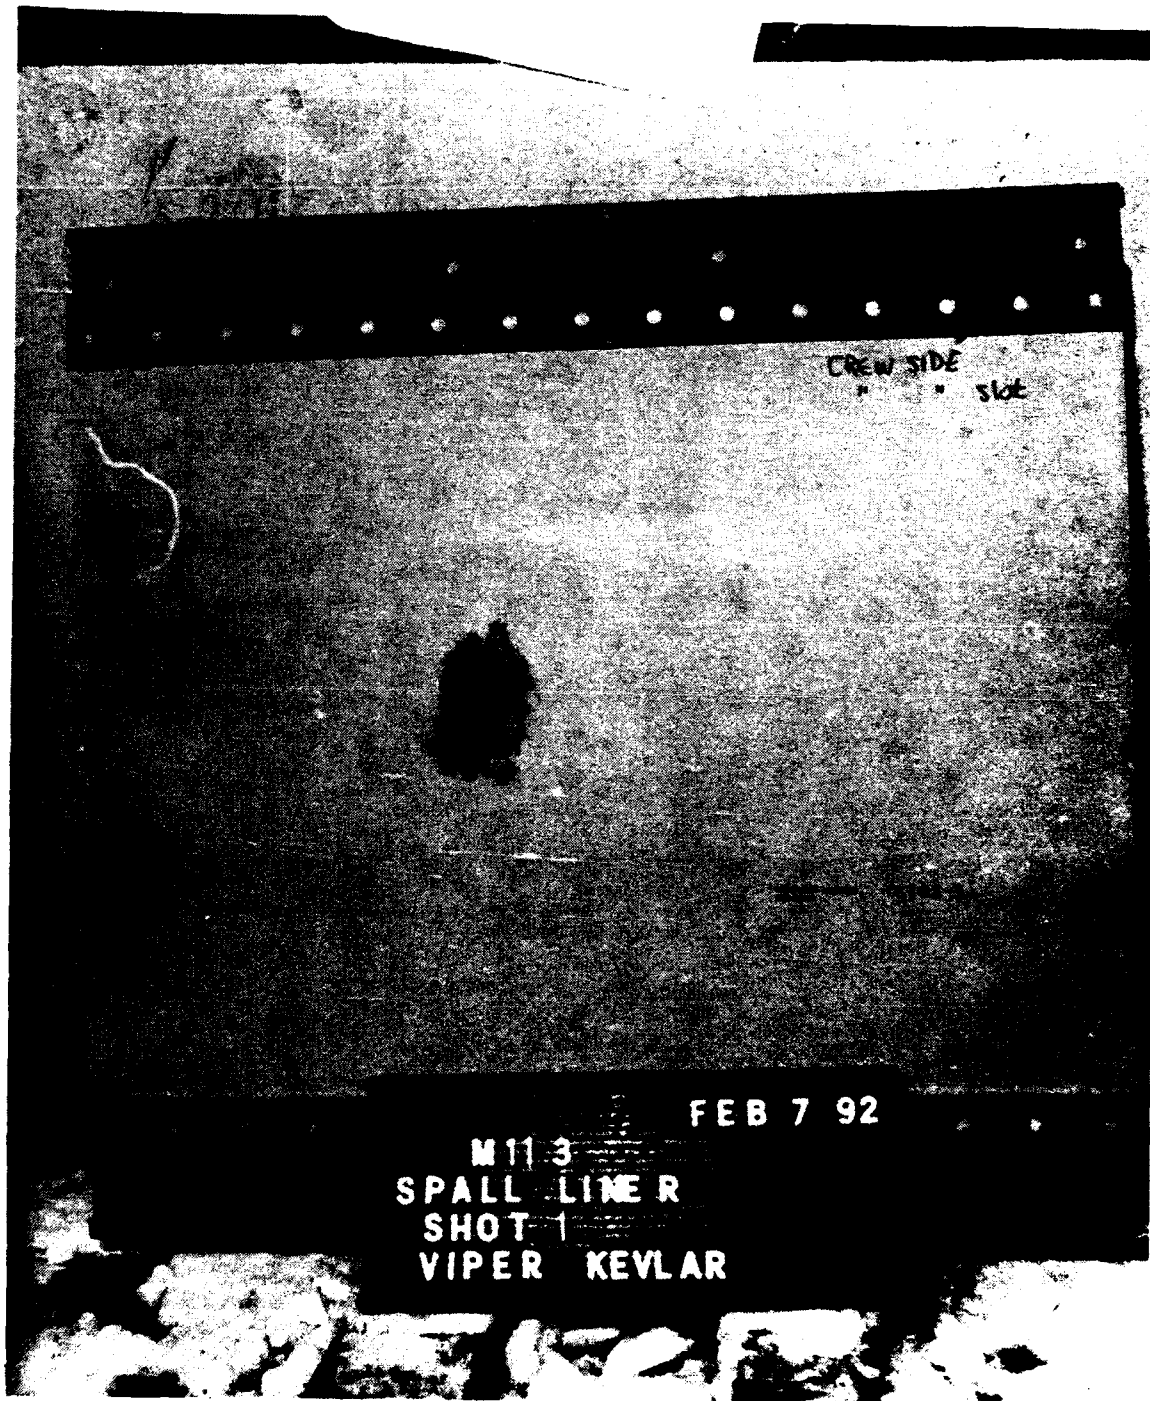
Figure A-6. Damage, Rear of Kevlar Liner, VIPER Shaped Charge Versus Kevlar

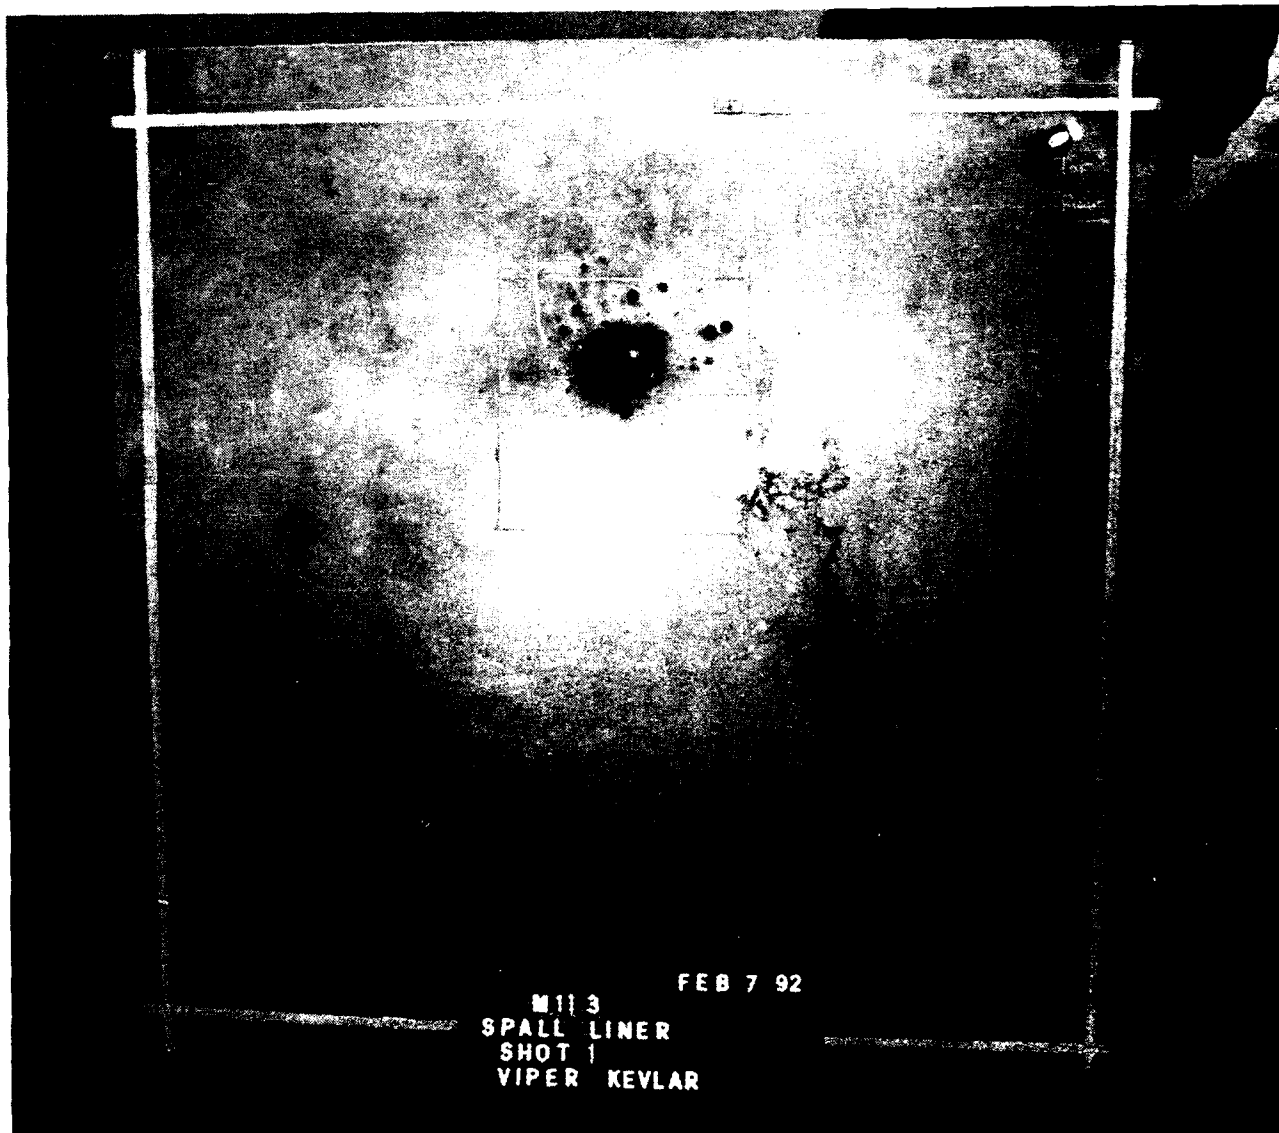
Figure A-7. Damage, Front of BAD Pack, VIPER Shaped Charge Versus Kevlar

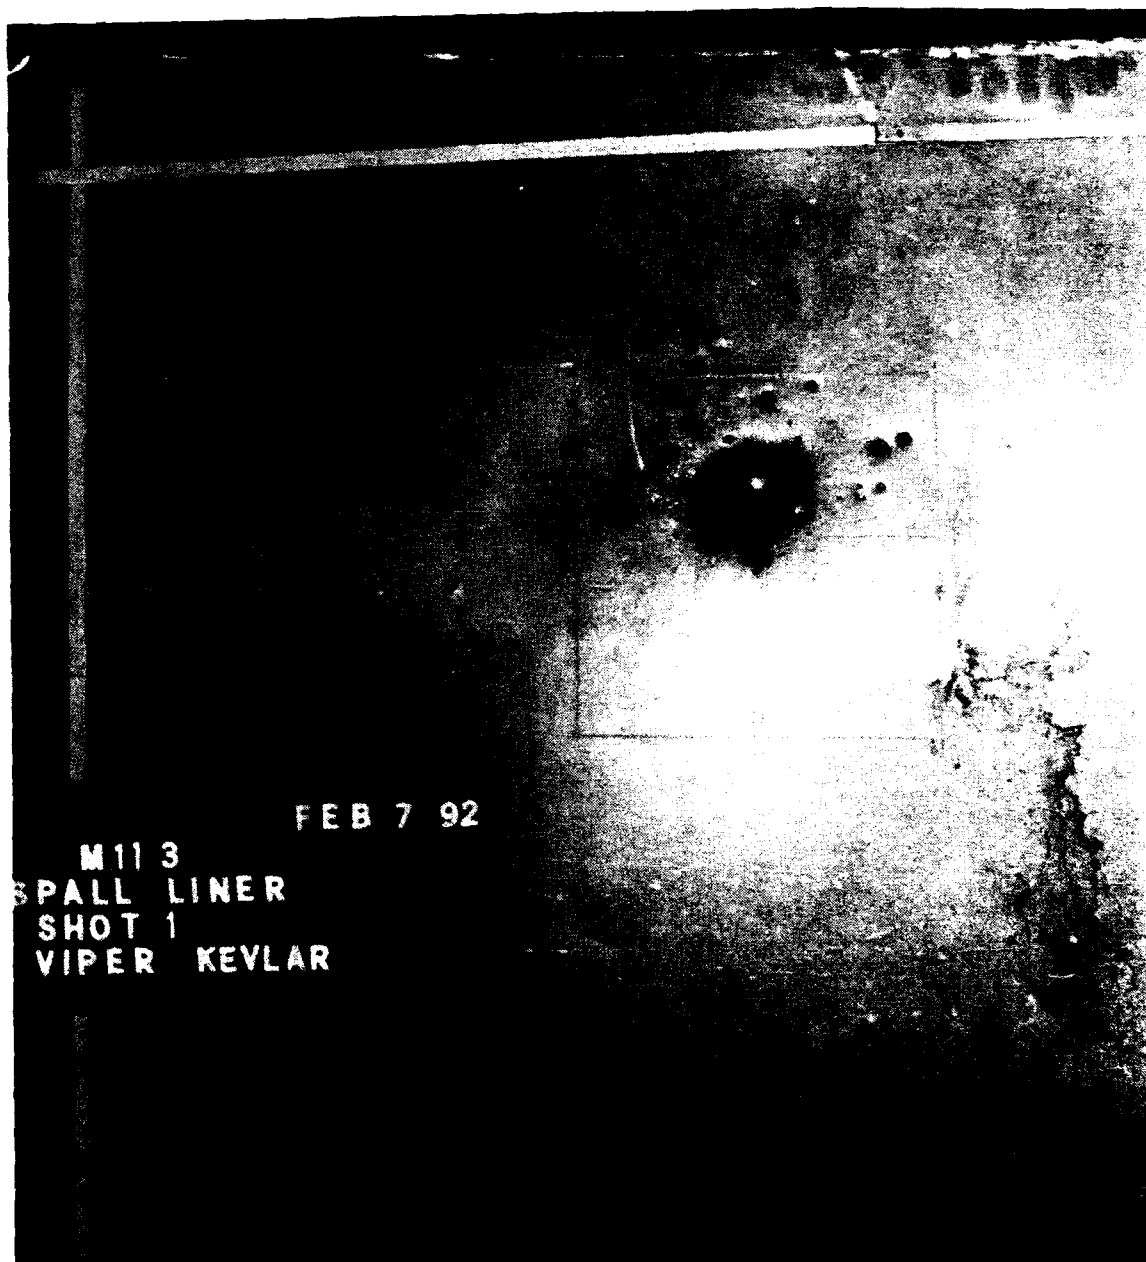
Figure A-8. Damage, Rear of BAD Pack, VIPER Shaped Charge Versus Kevlar

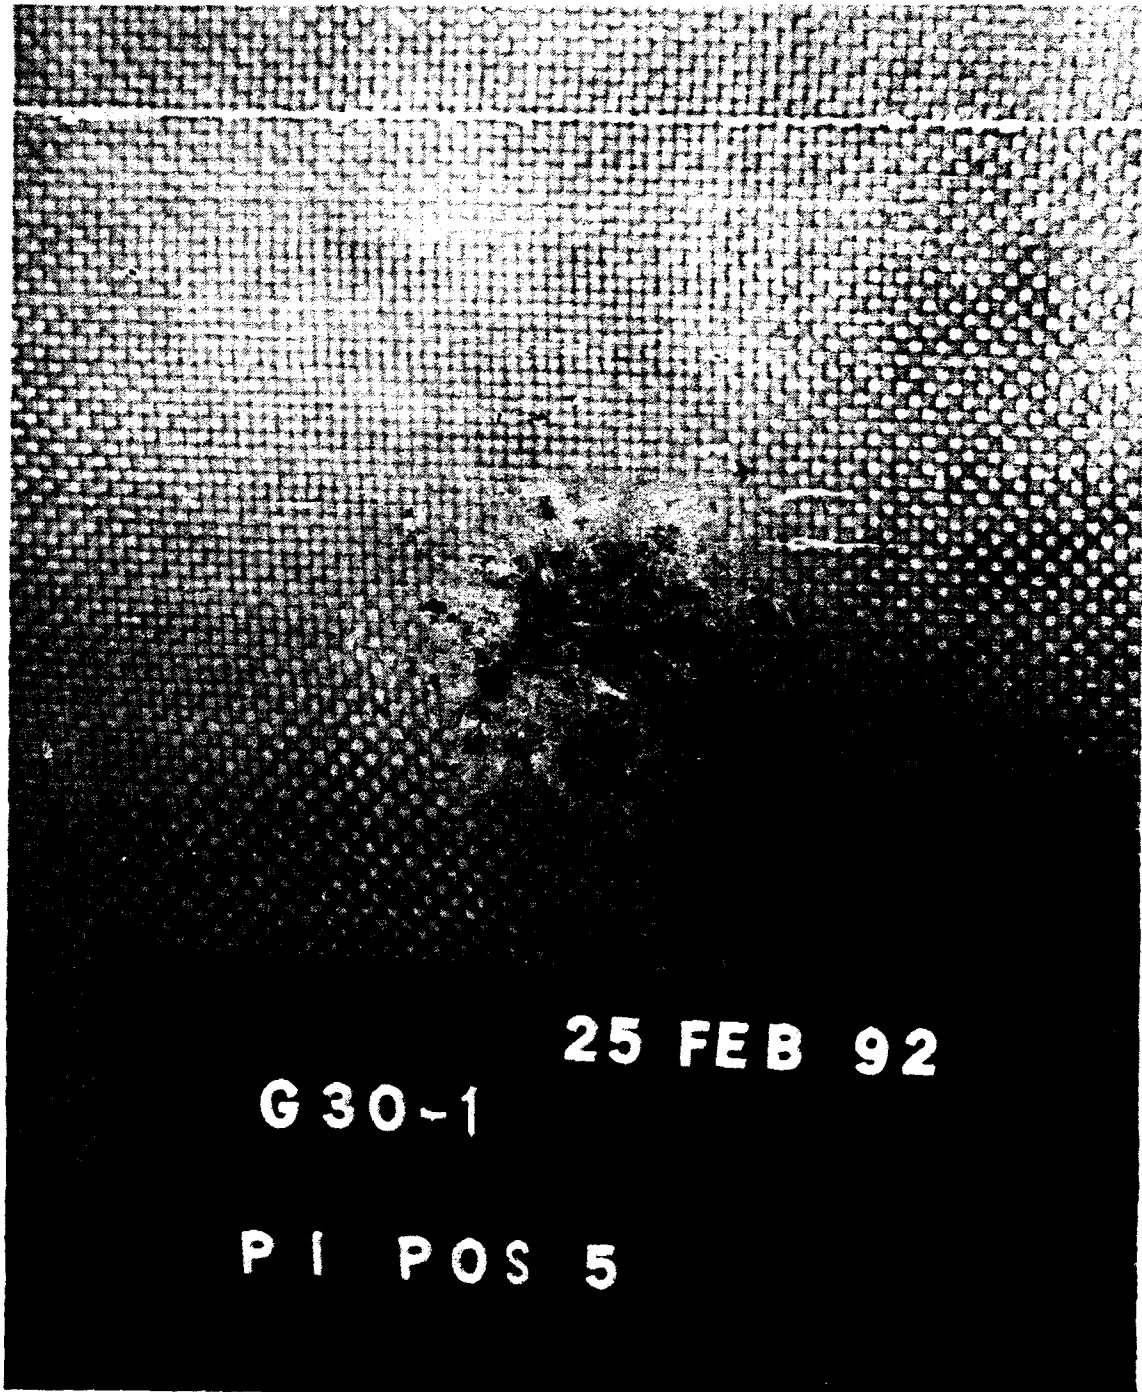
Figure A-9. Damage, Front of S-2 Glass Liner, 30mm APDS Versus S-2

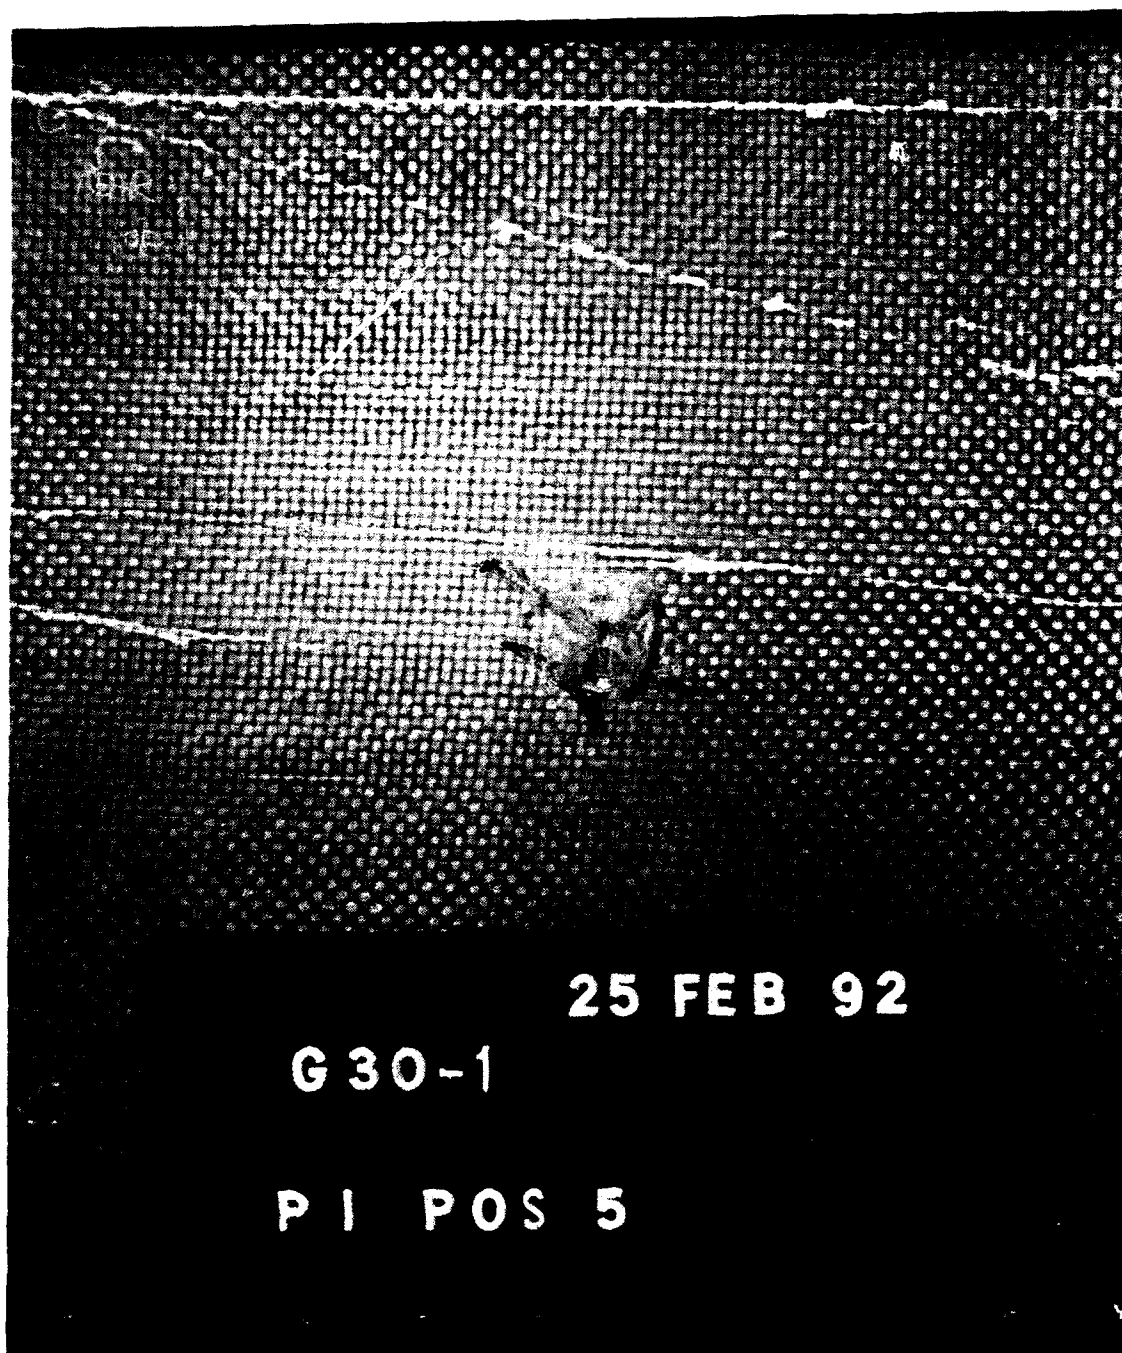
Figure A-10. Damage, Rear of S-2 Glass Liner, 30mm APDS Versus S-2

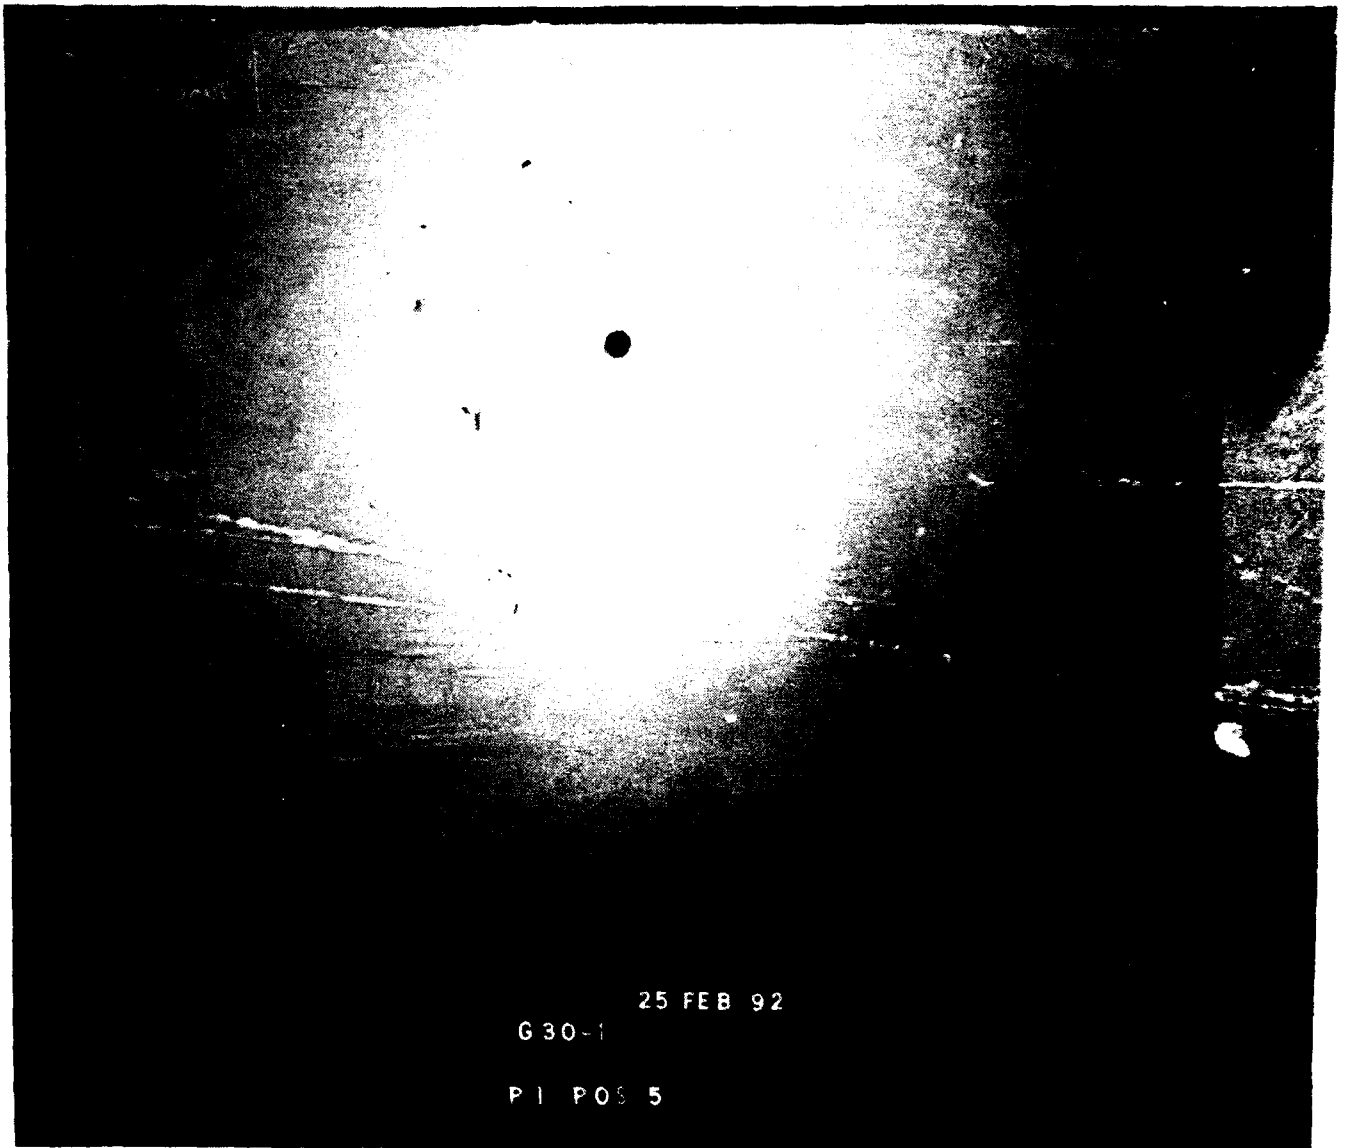
Figure A-11. Damage, Front of BAD Pack, 30mm APDS Versus S-2

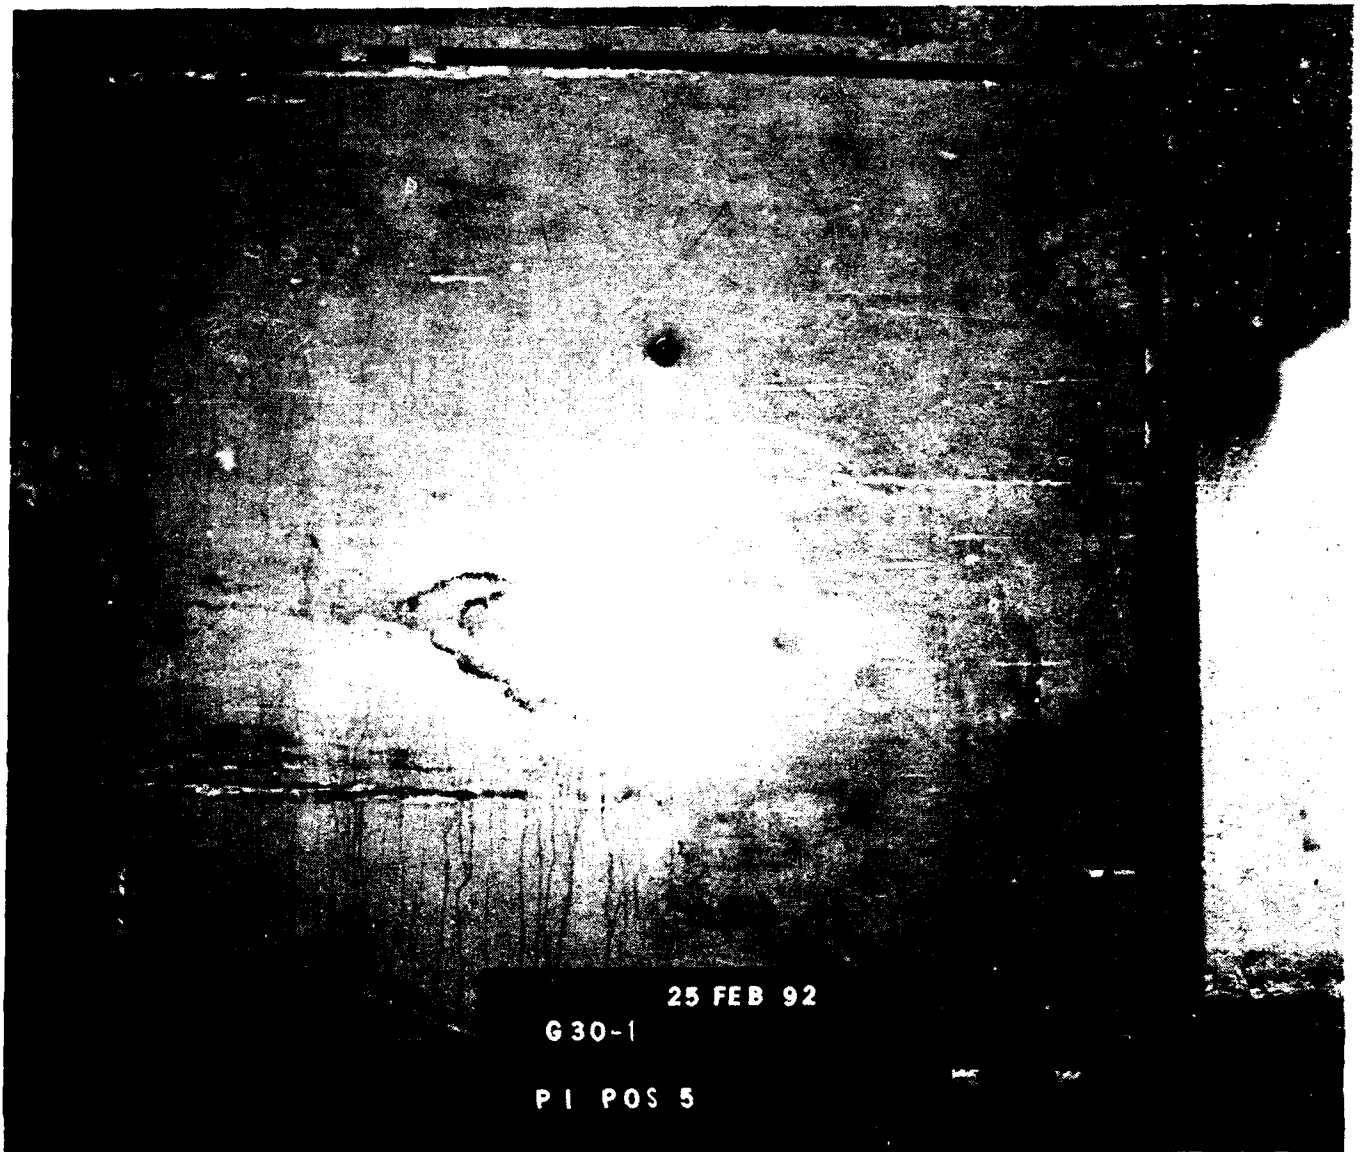
Figure A-12. Damage, Rear of BAD Pack, 30mm APDS Versus S-2

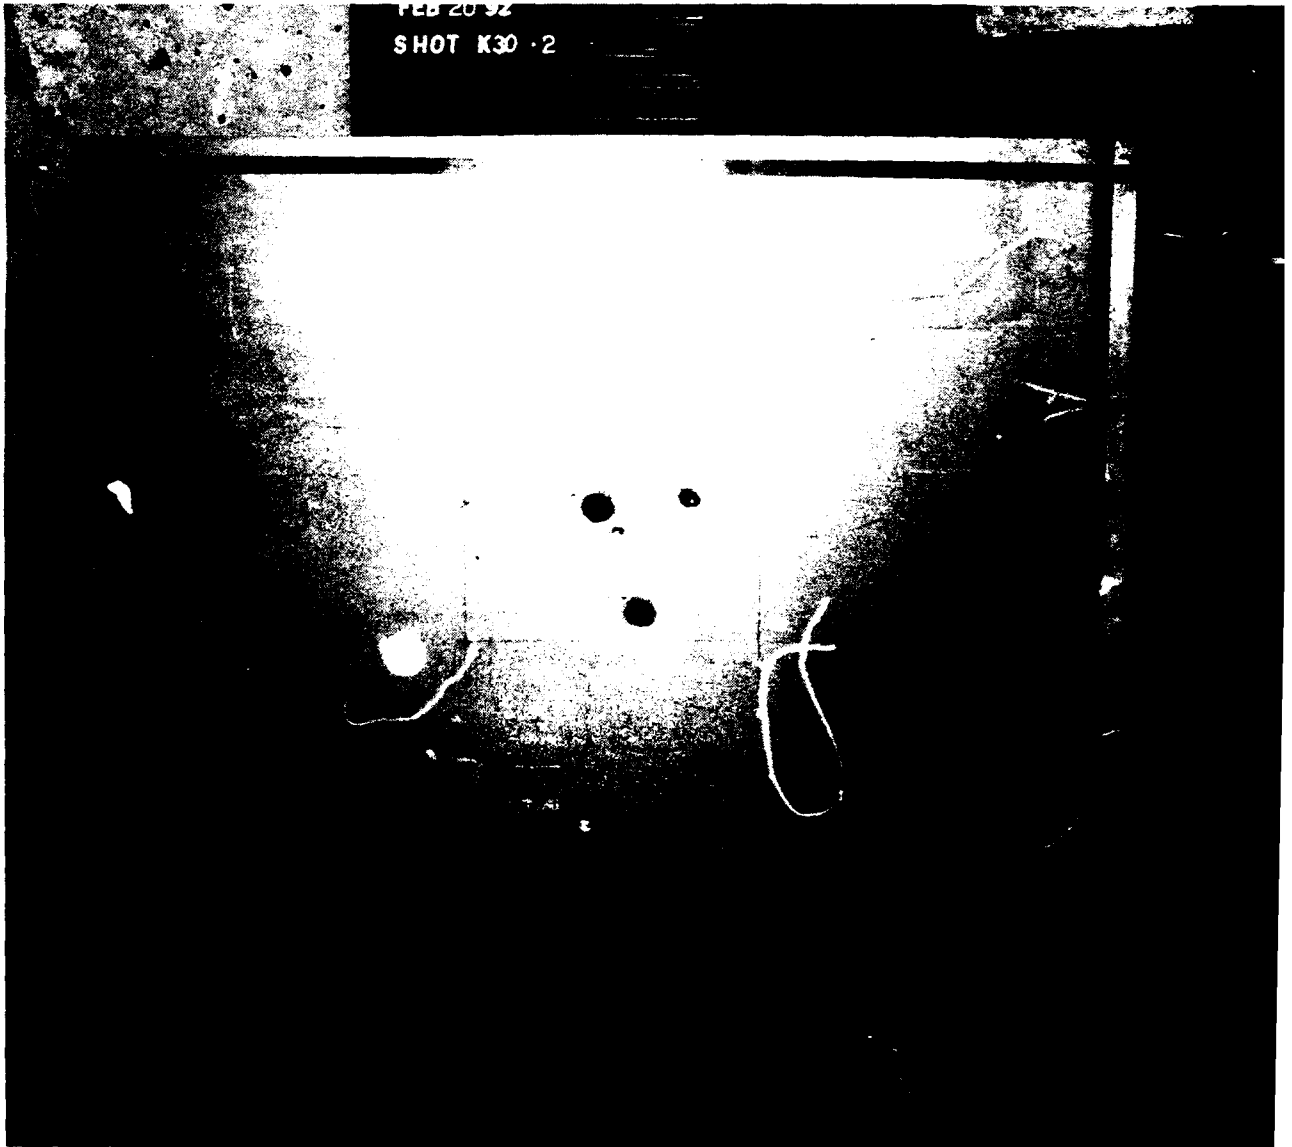
Figure A-15. Damage, Front of BAD Pack, 30mm APDS Versus Kevlar
