Report No. NAWCADWAR-93015-60

## **AIRCRAFT CARRIER EXPOSURE TESTS OF CAST MAGNESIUM ALLOYS**

**1 MARCH 1993**

**FINAL REPORT**

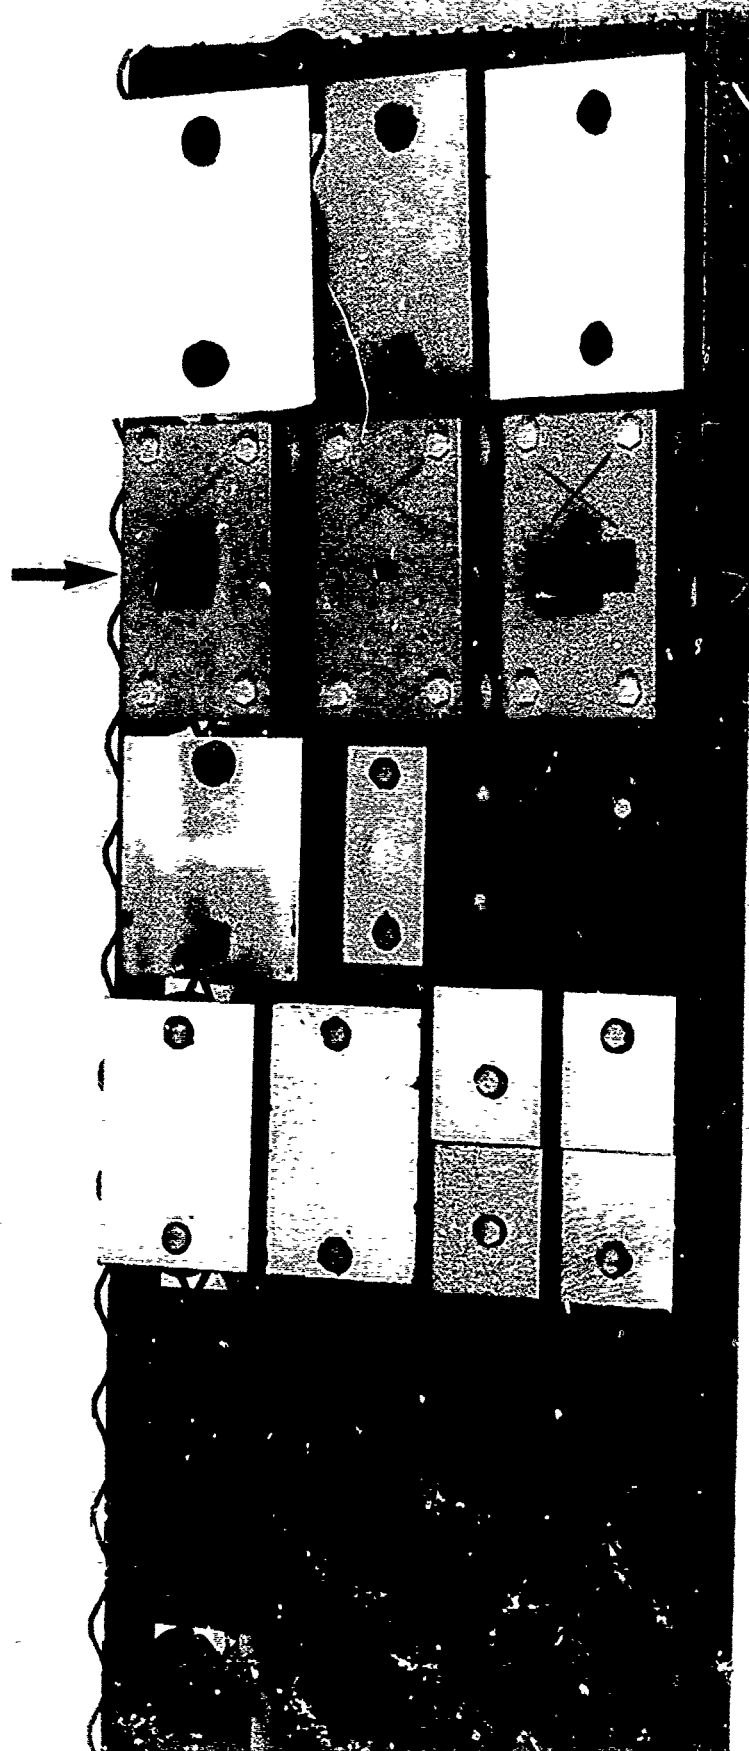
Figure 1. Magnesium Test Blocks Prior To Shipboard Exposure.

appearance of the magnesium alloy test specimens prior to shipboard exposure is shown in Figure 1 (second from the right) and Figure 2 (second from the left). Note the aluminum blocks attached to the top and bottom specimens. From top to bottom, the specimens are DF1471-3, DF1440-1, DF1312-3 (Figure 1) and DF1312-4, DF1440-2, DF1471-4 (Figure 2). Specimens 1312 are WE-43 magnesium alloy and specimens 1471 and 1440 are QE-22.
