Investigation of the MK83 Bomb Ablative Coating Failures

ARL-TR-222

October 1993

Sponsored by
Naval Air Warfare Center
Weapons Division
Point Mugu, CA 93042

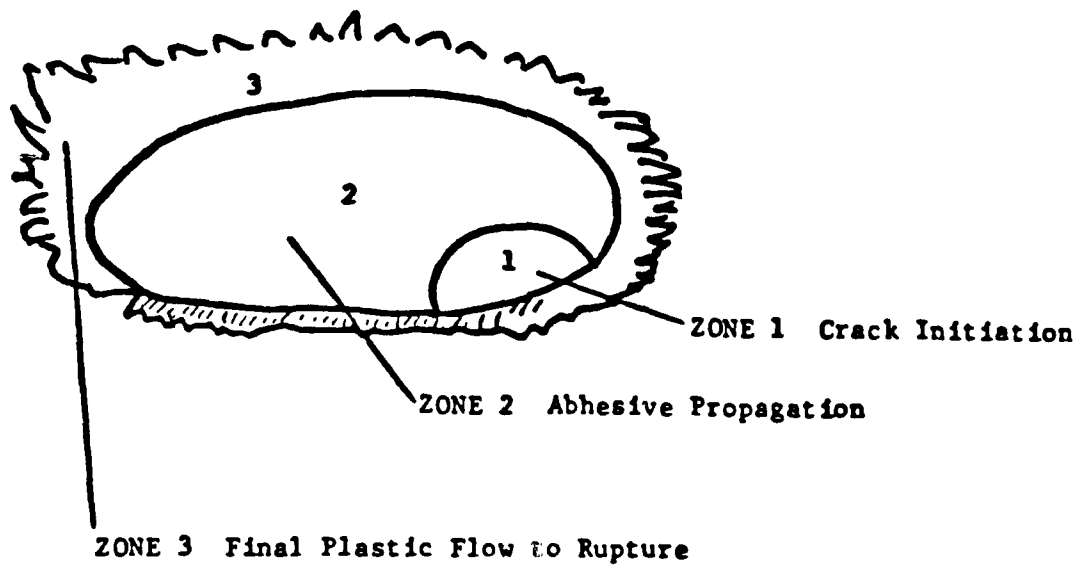
Specimen No. 3 was an ablative coating that was blistered by a bomb pallet saddle (see Figure 5). This blister consisted of ablative only with traces of the primer on its interior surface. The interior showed the failure initiation region as a thumbnail-shaped area (see Figure 6). The crack propagated along the ablative and primer interface (Zone 2) with no signs of flow or deformation until it finally reached Zone 3 where the local stress field exceeded the ablative's yield strength and the ablative flowed until rupture was complete. The high local stresses were due to the weight of the bomb concentrated on the area of two bomb pallet saddles.

Figure 6. Schematic of the blister fracture face.

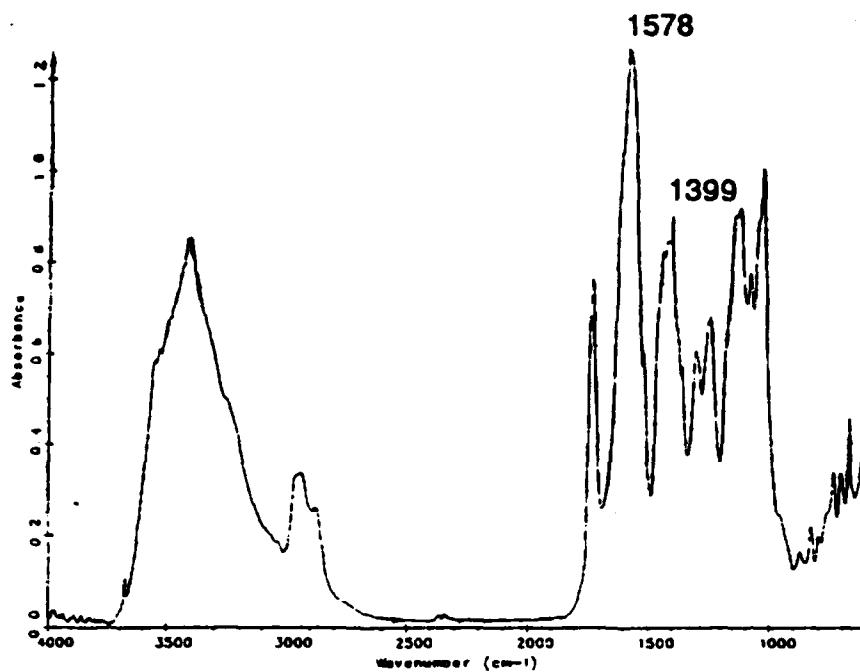
Attenuated total reflectance infrared spectroscopy was used to identify the crystalline spot on the interior primer surface of Specimen No. 2 and the fluid found on Specimen No. 4. Analysis of the crystalline spot on Specimen No. 2 (see Figure 7) revealed a spectrum that was similar to the spectrum obtained from the leached viscous fluid found on the bomb pallet saddle (see Figure 8). The peaks at 1580 cm⁻¹ and 1400 cm⁻¹ are typical of organic acid salts. These species may have formed when carboxylic acids generated by the oxidation or hydrolysis of a plasticizer (Dimethyl Phthalate) followed by reaction with aqueous salts. The aqueous salts would have originated from the contaminated zinc phosphate coatings and/or the dirty environments the bomb pallets were exposed to.

Figure 7. Infrared spectrum obtained from a crystalline spot on the interior primer surface of Specimen No. 2.

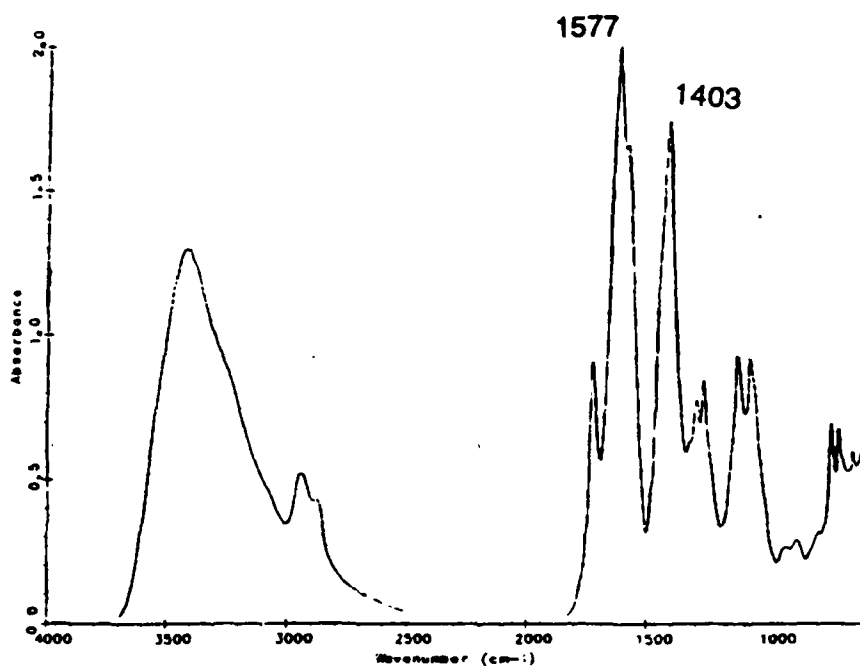
Further evidence supporting the presence of an organic acid salt was the decrease in the pH of distilled water from 6.1 to 5.6 when the leached viscous fluid from the bomb pallet saddle was dissolved in the water.

Figure 8. Infrared spectrum obtained from the leached viscous fluid found on Specimen No. 4, the bomb pallet saddle.

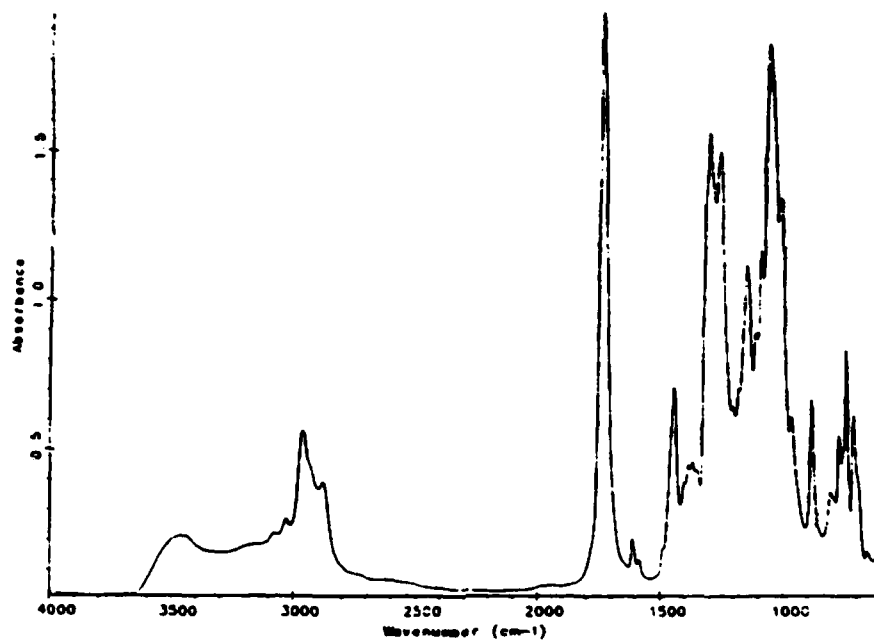
In a comparison of the spectra of an acetone extract of the ablative (see Figure 9), the leached viscous fluid and crystalline spot were similar as well; this suggests that the leached viscous fluid probably came from the polyester.

Figure 9. Infrared spectrum obtained from an acetone extract of the polyester ablative.
