United States General Accounting Office

NAVY SUPPLY

Improved Material Management Can Reduce Shipyard Costs

July 27, 1994

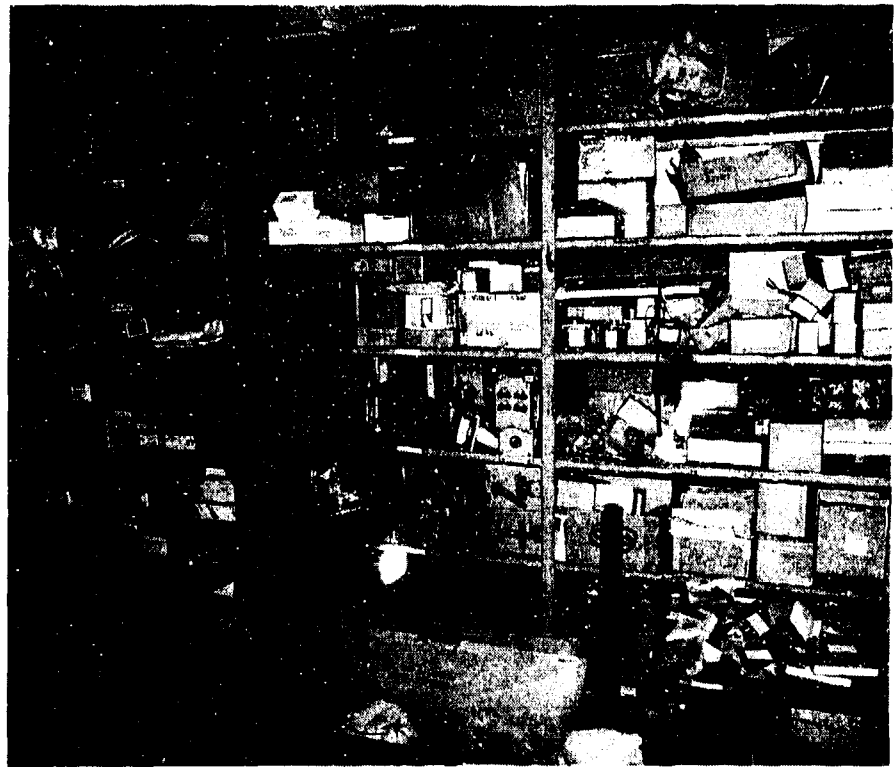
**Figure 3.1: Unrecorded Material in
Norfolk's Fire Control Work Center**

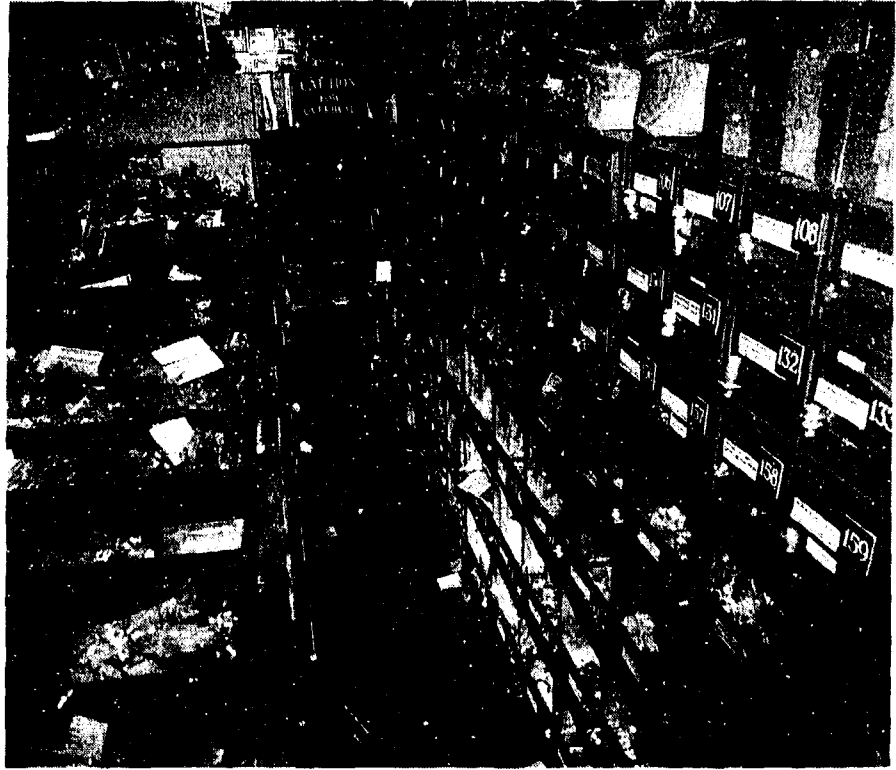
Figure 3.2: Unrecorded Material in
Norfolk's Plug Work Center
