US Army Corps
of Engineers
Construction Engineering
Research Laboratories

USACERL Interim Report FM-94/08
April 1994

Field Test Results of Corrosion-Resistant Coatings for Carbon-Steel Steam Condensate Return Lines

by
Vincent F. Hock
Henry Cardenas
James R. Myers

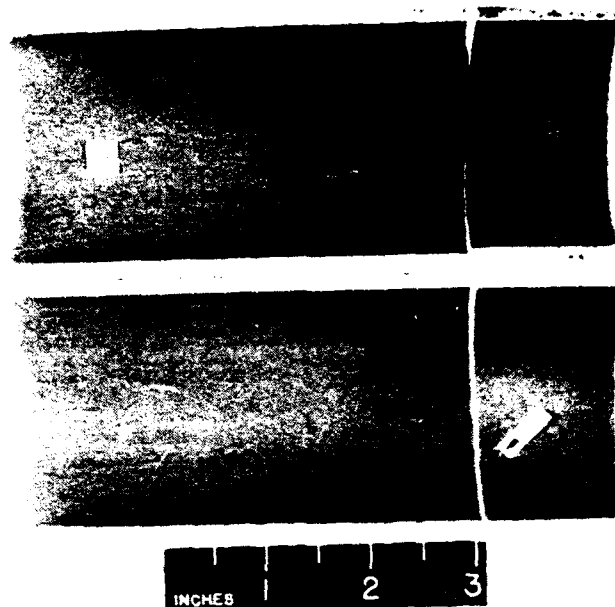
It was found that all the iron oxide deposits could be easily removed by wiping with a wet sponge. Beneath the deposits the coating was found intact in each case. All specimens, whether exposed for 170 or 450 days, appeared to incur at least partial discoloration, which varied over the surfaces (Figures 9 to 14). In Figures 11 and 13, highlighted arrows identify isolated regions where the coating had blistered. These sites were found to contain hydrated magnetite beneath the blisters, yet no major corrosion induced pits were observed. Stereomicroscopic examination and cursory scribe testing revealed that the condensate had caused some softening of the coating.

Figure 11. Cleaned pipe B-3, following 175 days of exposure.

Removing the condensate deposits permitted evaluation of the performance of the phenolic coatings. An immediately obvious impact of the environment was the variable discoloration observed on all six specimens (Figures 9 to 14). Environment-induced softening was also detected through limited scribe testing as well as stereomicroscopic examination. Localized occurrences of blistering occurred on specimens B-3 and B-5, indicating limited water permeation of the resin. Furthermore, since small amounts of hydrated magnetite were found, it may be possible that CO_2 breached the barrier. However, the lack of observed pitting may indicate that even the permeation of the barrier does not necessarily halt all protective benefit. The phenolic coating has thus far exhibited the capacity to lengthen the anticipated 10-year service life of a carbon-steel condensate return line by more than 10 percent.

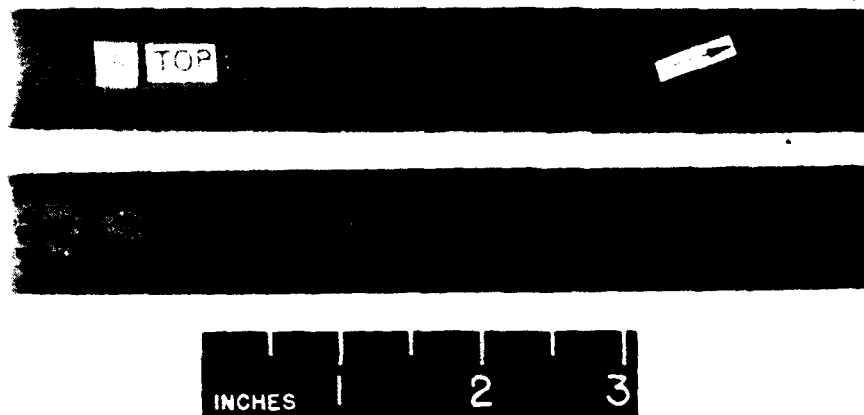
| Coated Specimen | Location (Bldg#) | Exposure (Days) | Appearance | Figure |
|---|---|---|--|---|
| B-5 | 9827 | 454 | Partial discoloration, slight blistering | 13 |

Figure 13. Cleaned pipe B-5, following 454 days of exposure.
