Technical Report REMR-CS-46  
March 1995

## **Repair and Maintenance of Masonry Structures: Case Histories**

*by Edward F. O'Neil*

# Repair and Maintenance of Masonry Structures: Case Histories

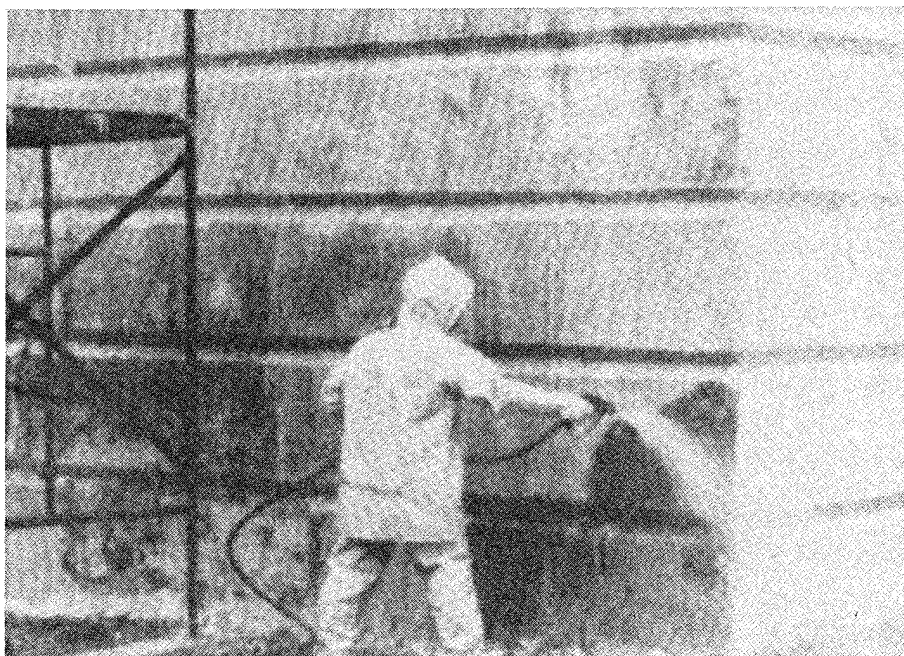
Figure 3. Field test of chemicals on courtyard wall

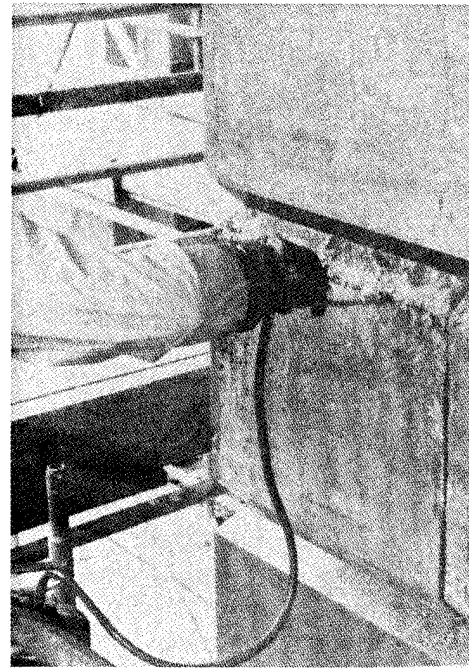
Figure 5. Application of stone strengthener to sandstone

Before the coating was begun, the stone was cleaned to ensure that no loose material was left on the surface. The coating material could be applied by brush, roller, or airless spray but was applied by the latter method because of all the detail in the carvings of the stone. Since it was to be sprayed on, it was diluted with up to 15 percent fresh water to thin it for even application through the spray nozzle.

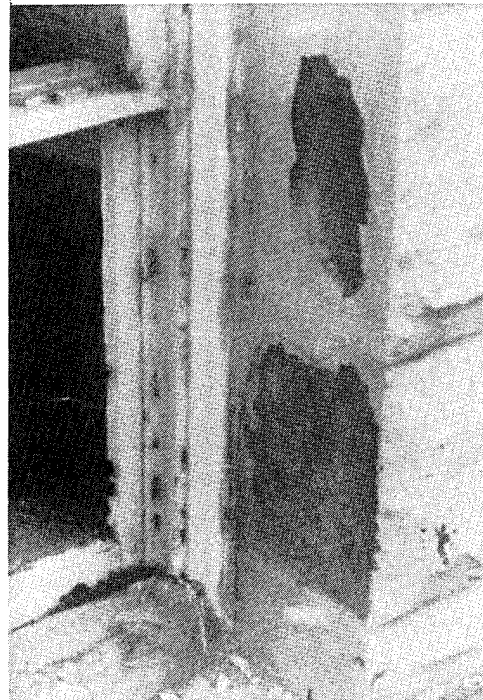
Figure 8. View of wall showing spalling damage to sandstone

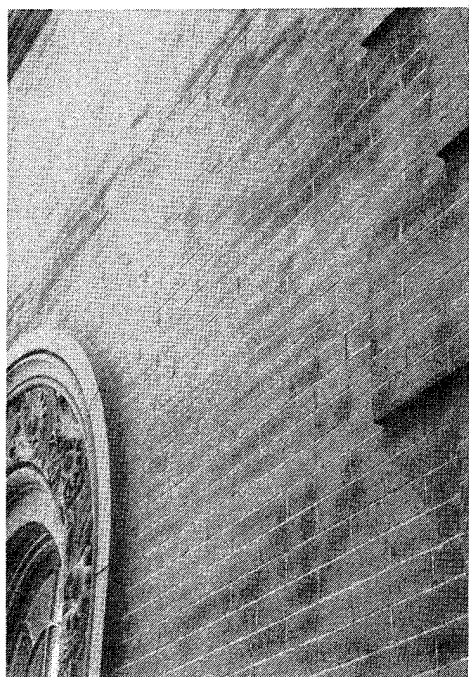
Figure 9. View of brick showing nozzle damage

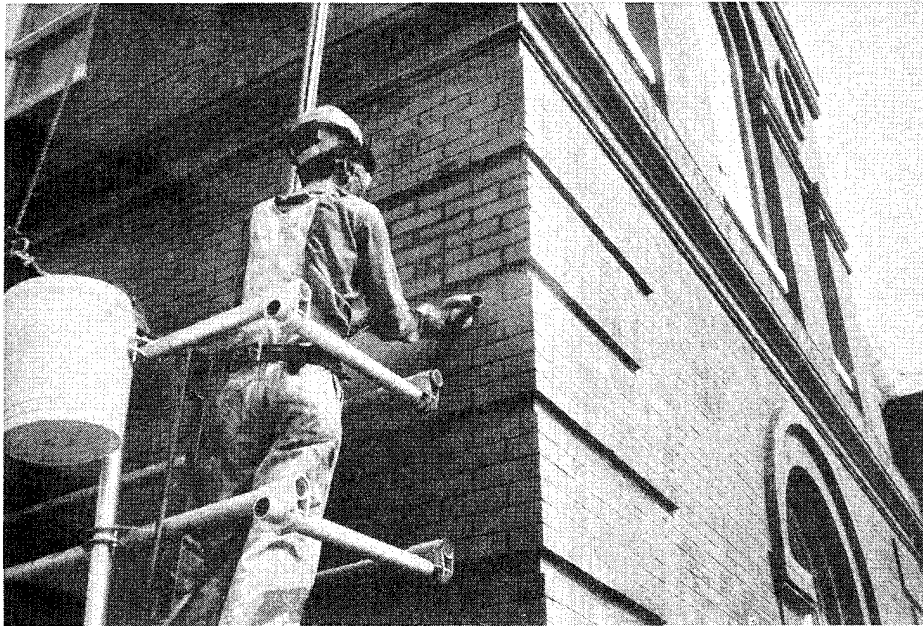
Figure 10. Worker routing bricks with small saw

The mortar used for the repointing was composed of 4 parts lime, 1 part portland cement, and 12 to 14 parts sand. This mixture was submitted and approved by the architect. The use of lime as binder in repointing mortar is encouraged because it produces a softer mortar than one made entirely from portland cement. Exactly matching a mortar to one that has been removed is not necessary (Mack, Tiller, and Askins 1980). The important points to remember about the replacement mortar are:

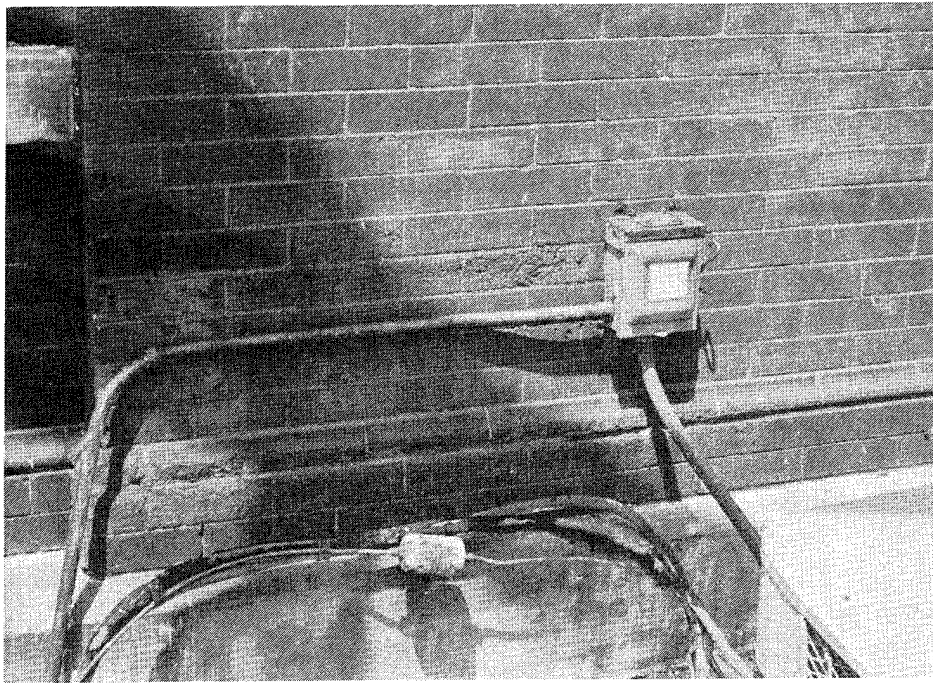
Figure 11. View of brick damage due to weathering

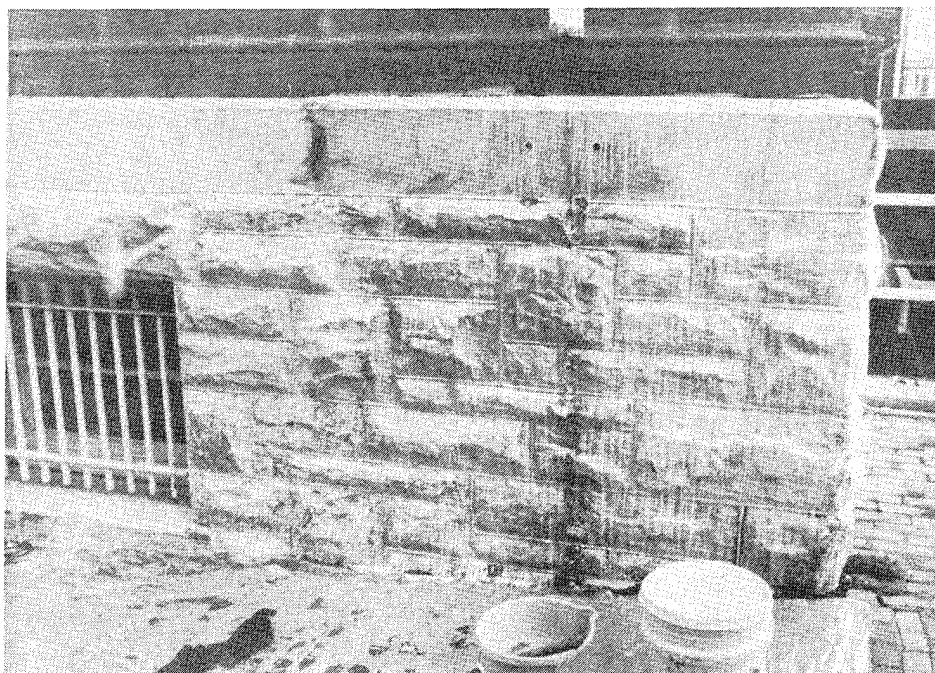
Figure 12. Limestone being cleaned with chemical spray

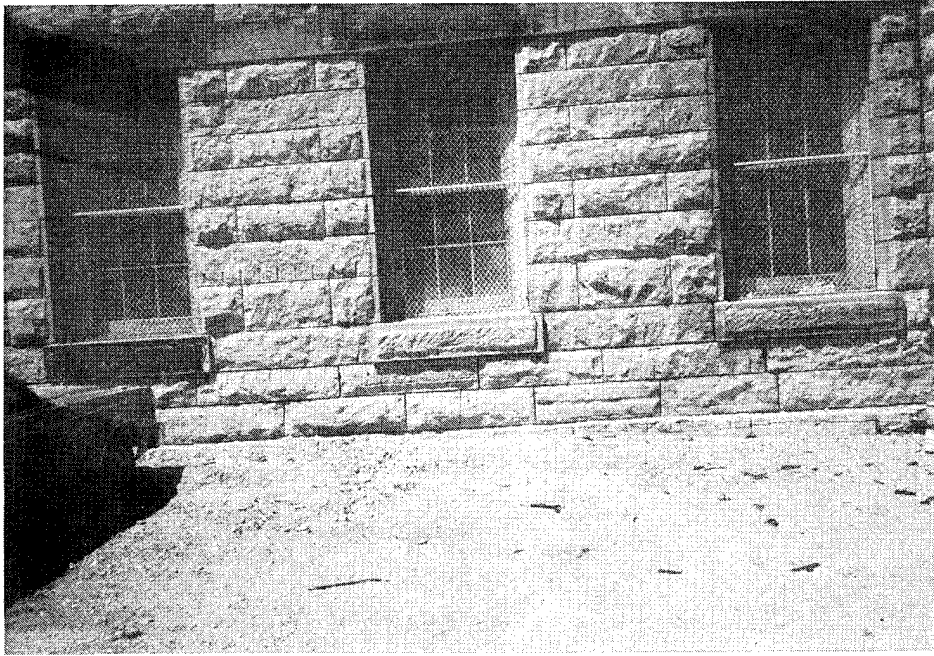
Figure 18. Sandstone sills during cleaning

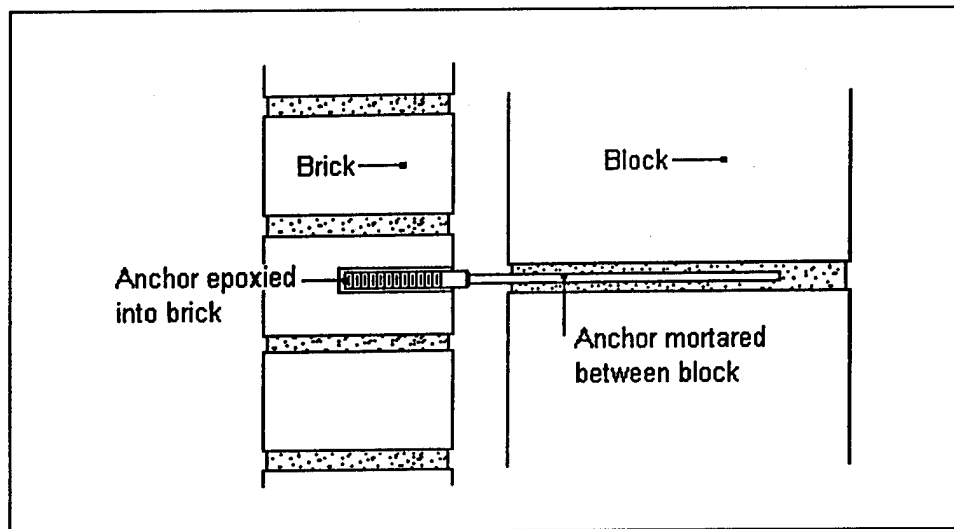
Figure 25. Sketch of anchor detail used to strengthen brick walls

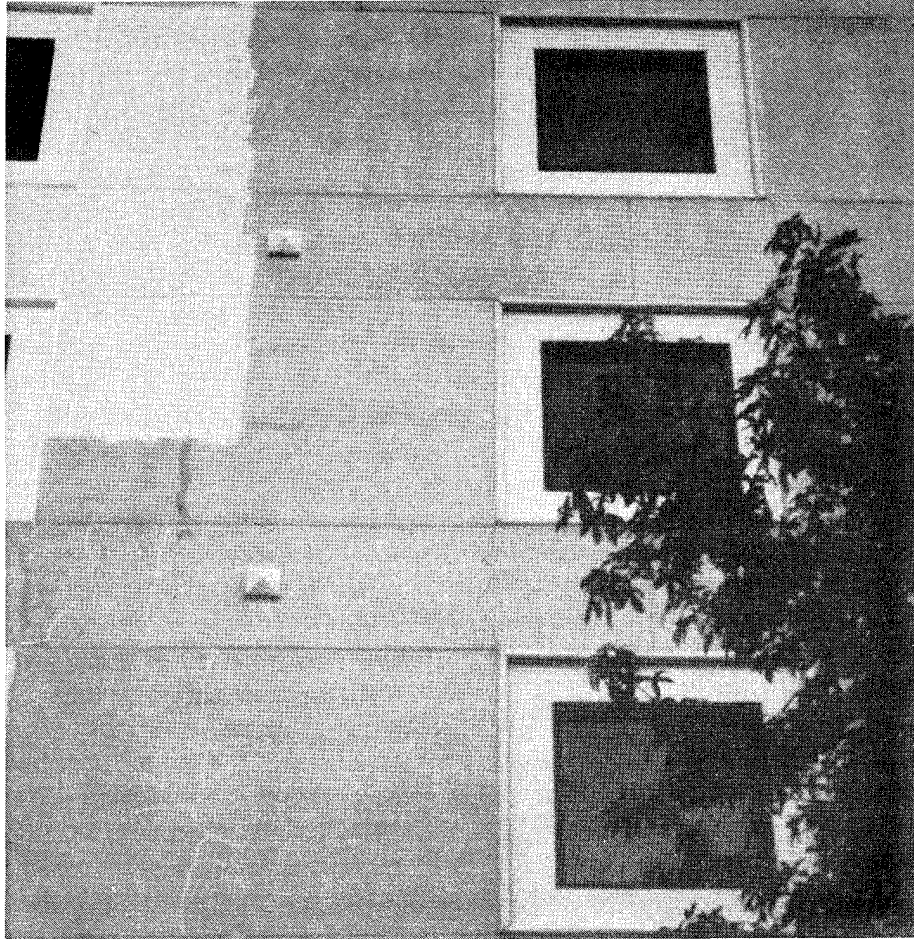
The engineering firm that was hired to evaluate the structure and provide a solution noted that much of the cracking was a function of problems with building expansion. There were expansion cracks and movement cracks on panels on all sides of the building. They found that the building had been built without planning for expansion joints between panels. Therefore, when

Figure 28. Vertical cracks in panels at left of window

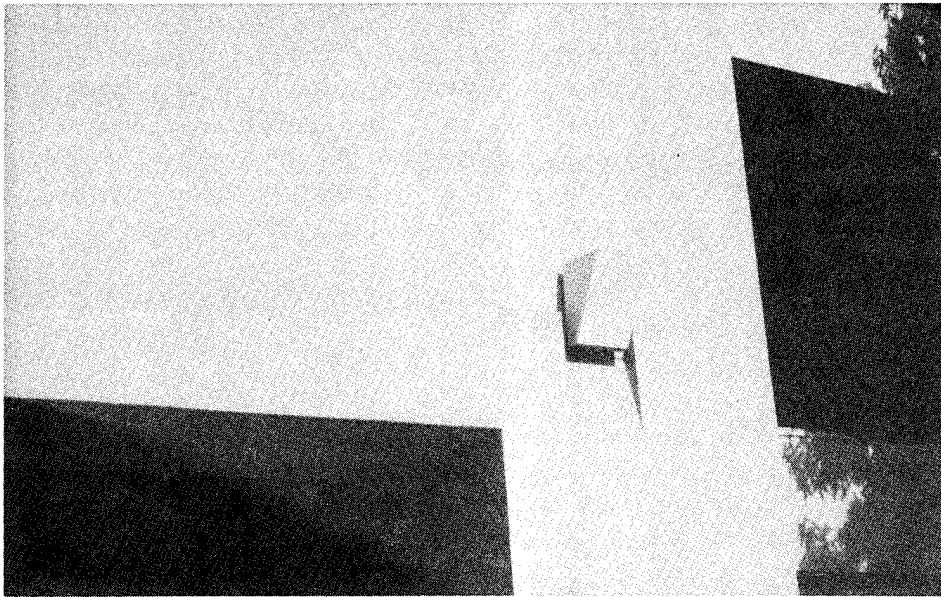
Figure 29. Cracking in panel at a corner

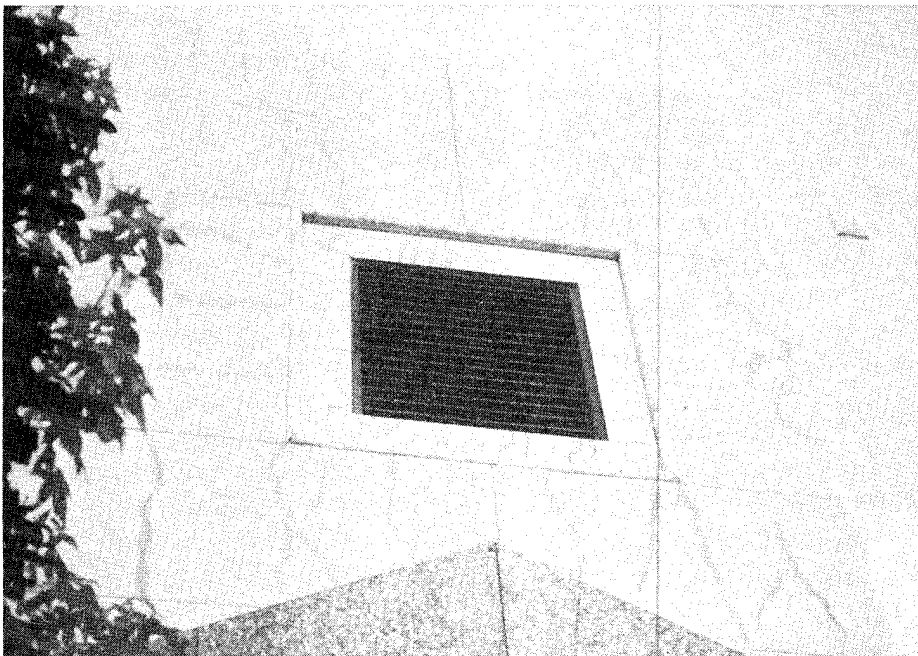
Figure 30. Shrinkage cracking in panels

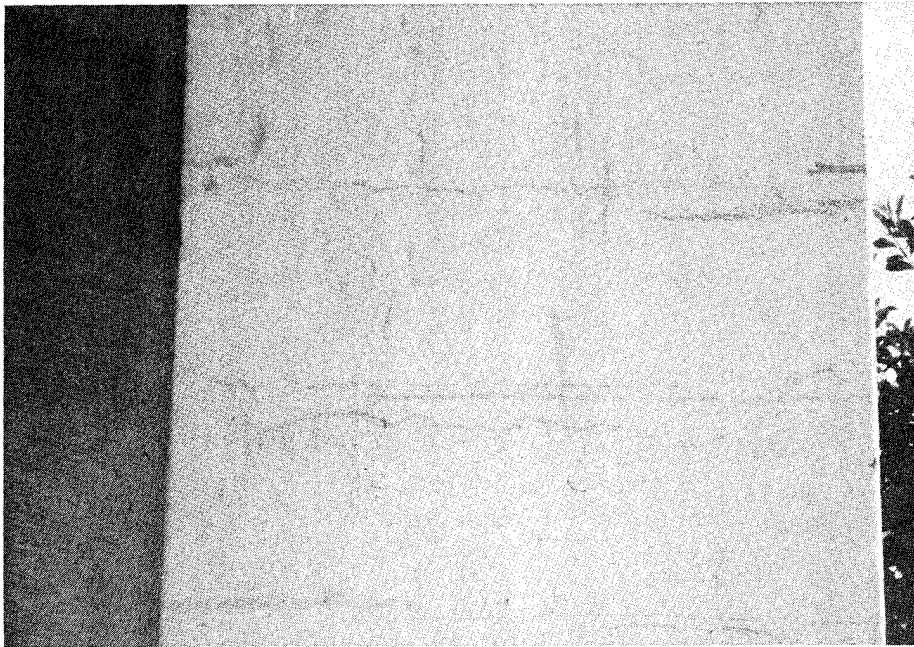
Figure 31. Cracked column panel showing smooth panel coating

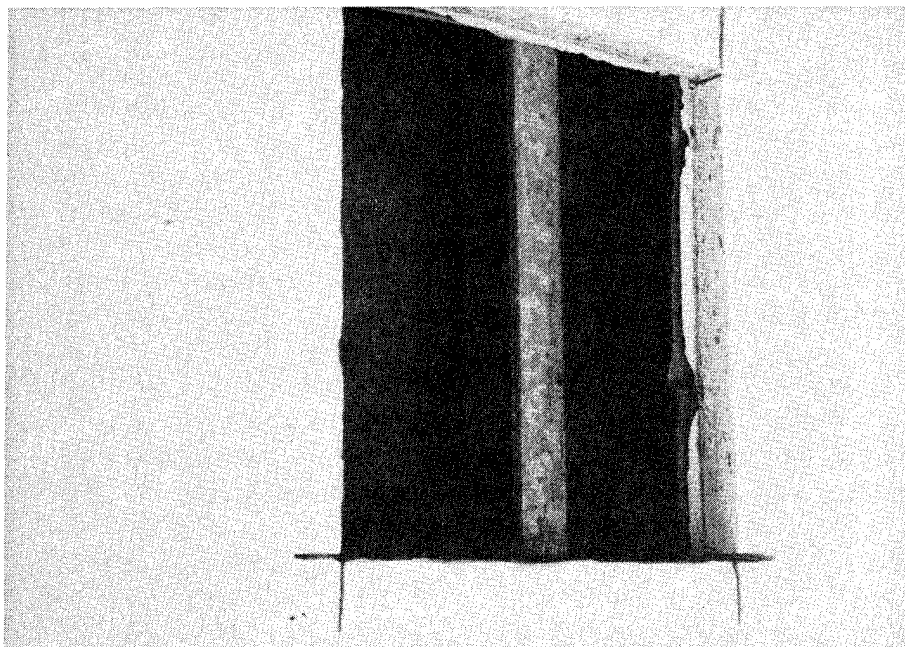
Figure 32. Smooth elastomeric coating applied on column panel

The method of applying the different elastomeric acrylic coatings depended upon the type of surface texture that was desired. In those areas where the coating was to be smooth and to be applied over an old smooth surface, the coating used was a high-flexibility, acrylic-polymer coating that was tinted to match the color of the building. The old smooth surface had been cleaned and all loose paint removed by the power washing. The smooth coating was then rolled on with conventional paint rollers and supplemented in difficult-to-reach areas by brush application. The first coat was allowed to dry for a period ranging from between 1 to 4 hr, depending upon ambient drying conditions. The first coat was followed by a second coat once the first had dried. Figure 32 shows this type of coating on one of the column panels. This provided a water-resistant, vapor permeable elastomeric coating.

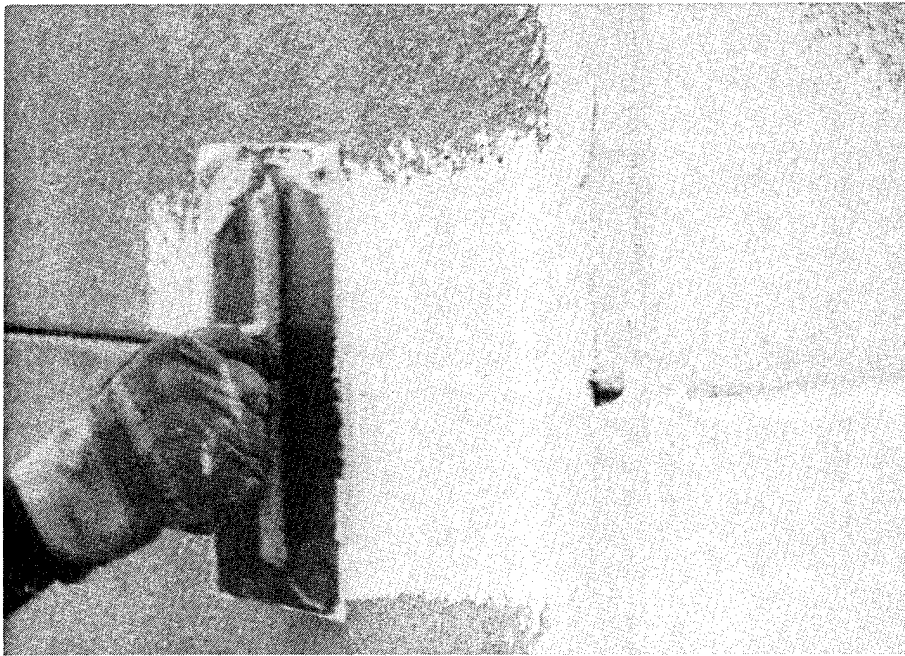
Figure 33. Application of the elastomeric base coat

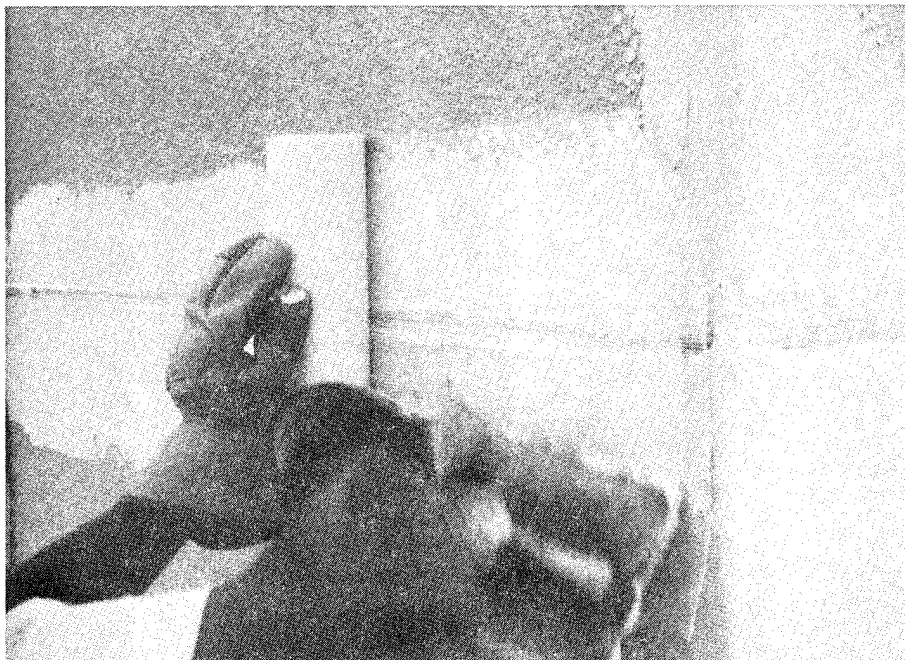
Figure 34. Trowelling of the mesh into place

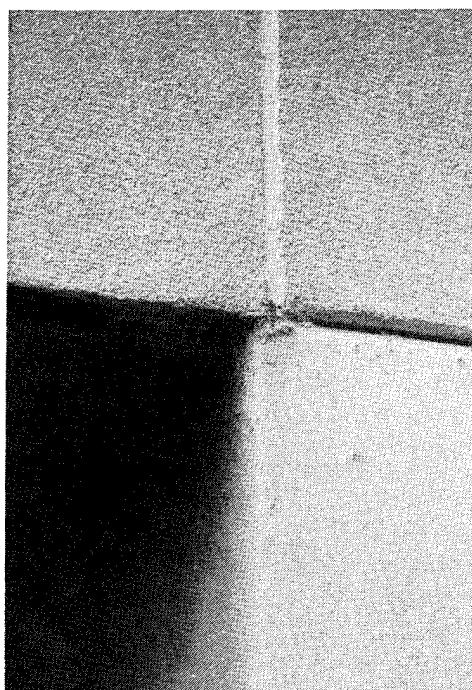
Figure 35. Contrast between base coat and finish coat

The final coating is the stucco-like coat. This coating is the same as the high-flexibility acrylic polymer coating with the addition of sand particles to the mixture. When trowelled onto the surface, this material simulates the cement stucco finish of the original building. It is also trowelled on in a 1/32-in.-thick coating. Figure 35 shows a corner detail in which the finished top coat is at the top of the figure and the base coat with the mesh is shown at the bottom.

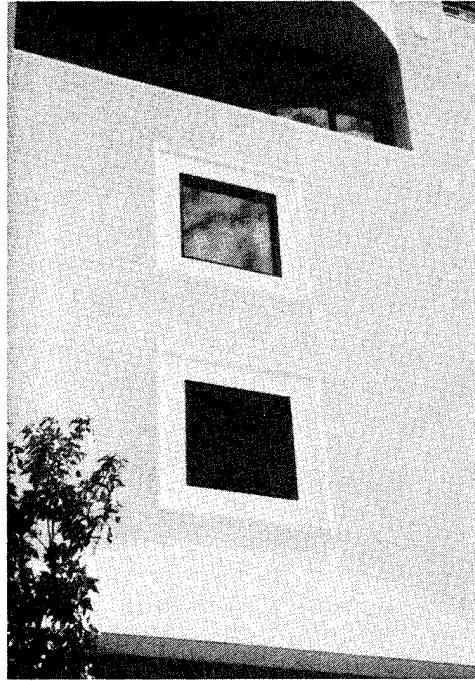
Figure 36. Repaired window frames

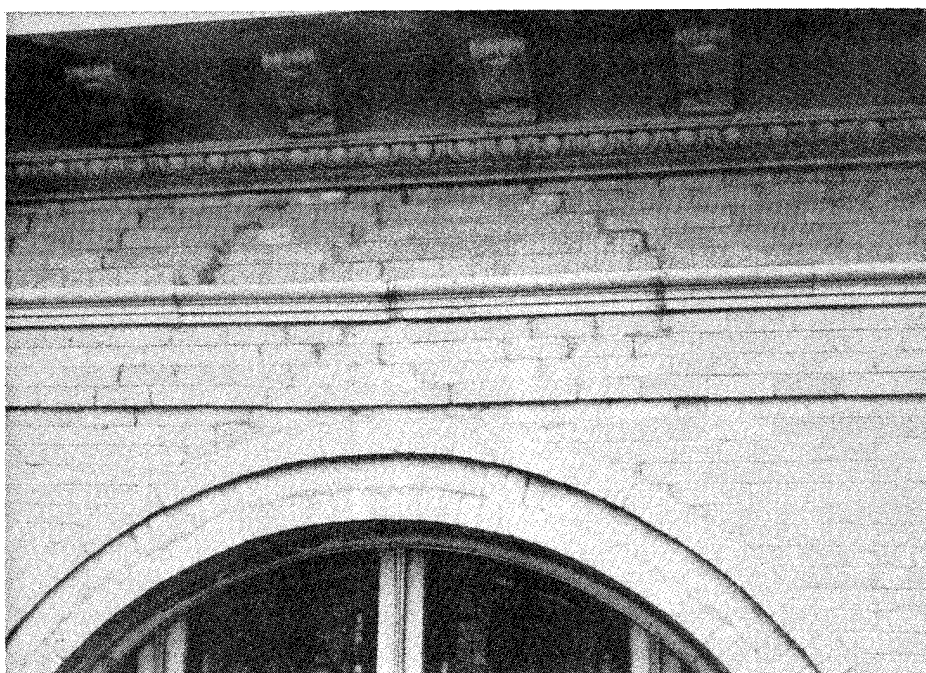
This case study is not only a restoration study, but also a structural study. The original reason for the restoration was to alleviate a problem of cracking in the east and west walls of the central chapel. Cracks in ceiling plaster over one of the wing chapels was the first reason to conduct a survey of the entire building. The building survey showed up a number of other cracks in the walls and the brickwork on the outside of the building. The major cracks were apparent in the east and west walls of the central chapel over the center of the most northern arch windows (Figure 39). The cracks were narrow at their base and became wider as they progressed up the wall. Some of the widest cracks could not be seen from within the chapel itself and had to be viewed from above the inside ceiling of the central dome. These cracks were on the order of inches wide and penetrated completely through the thickness of the wall. This led engineers to suspect that there was differential settlement of the building and that the front and back portions of the building were settling in different directions. A survey of elevations of the building was conducted and it was determined that the south face of the building had settled over 4 in. in relation to the north face.

Figure 39. Cracks over arch window in west facade

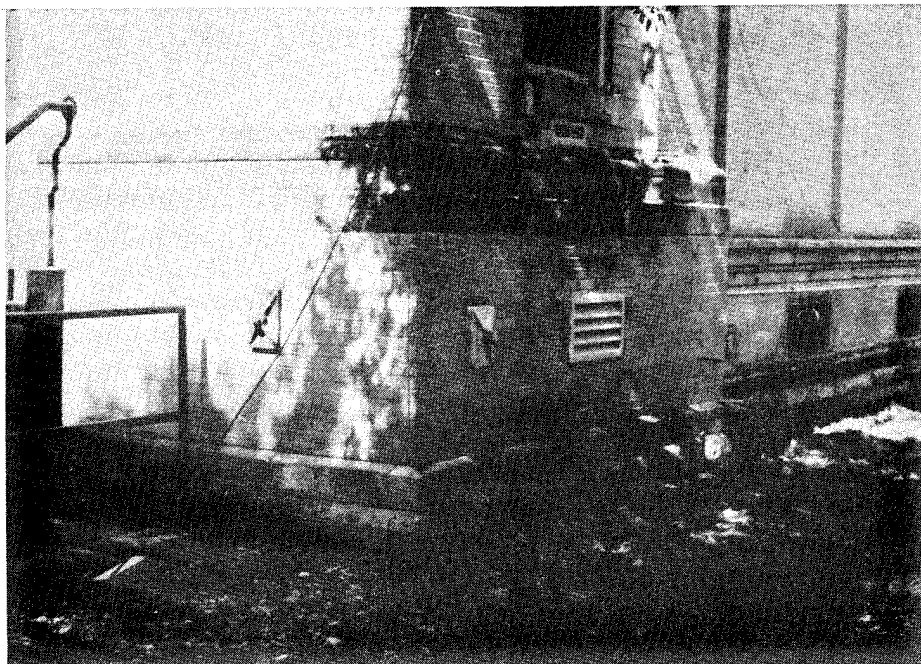
east-west direction (Figure 40). These had been in place from previous repairs. The tie rods that were to be installed during this renovation were to run north and south to address the separation of the building in this direction.

Figure 40. Existing tie-rod anchor in east facade at northeast corner

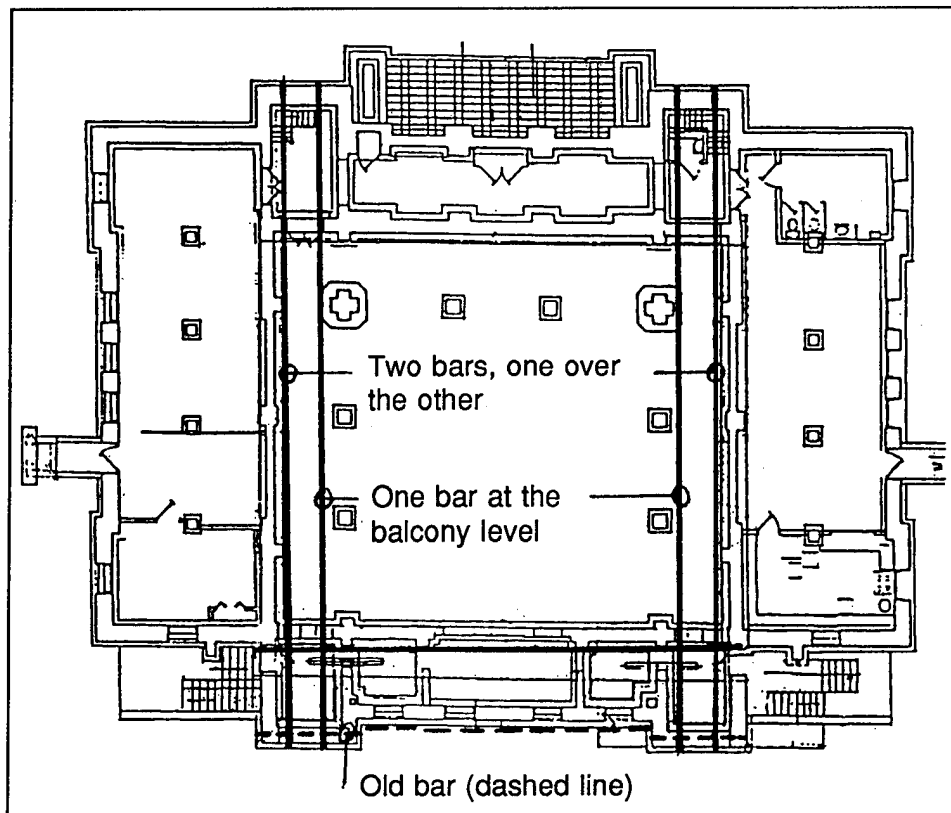
Figure 41. Plan of gift chapel showing location of tie rods

The design of the tie rods was based on trying to compensate for an overturning moment on the wall due to a 2-in. out-of-plumb condition of the north wall. The overturning moments due to the weight of the brick wall, the dead load of the roof bearing on the wall, and the live load of the roof bearing on the wall were summed and equated against a righting moment (one tie rod) at a height of 34 ft above the base of the wall. The tie rod and bearing plate were designed from the resulting force in the tie rod. Six such tie rods were

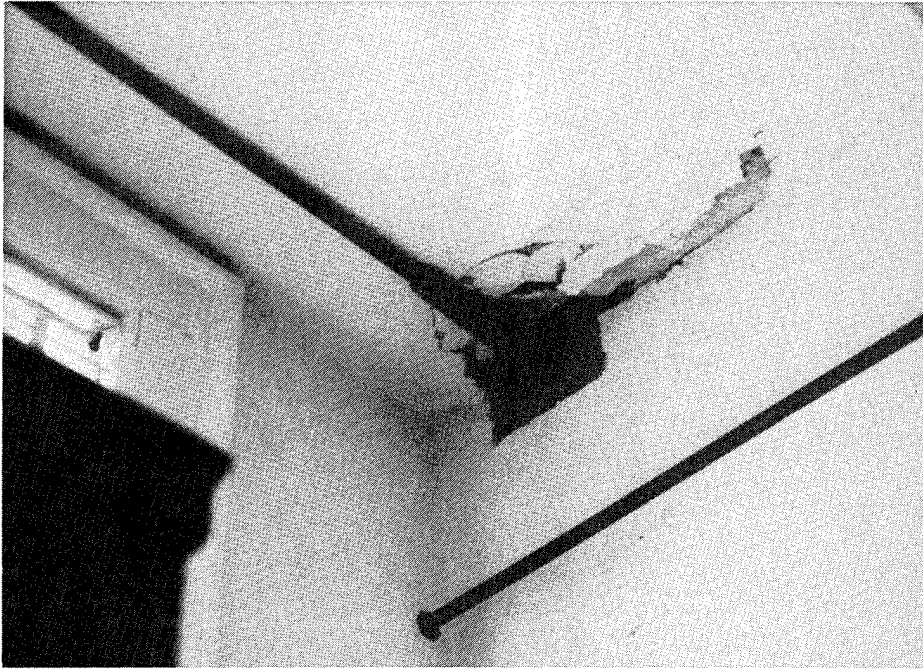
Figure 42. Two tie rods in the northeast corner of the chapel

In choosing the location of the rods, the engineering team gave much consideration to visibility, safety, and proper location. Consideration was given to routing the rods within the walls and inside the woodwork that runs around the balcony of the central chapel. However, the effort to accomplish such a feat was not economically feasible, and the rods were run adjacent to walls. Their final location was chosen so that their visibility would be limited. They were run near the floor, behind pews, and in corners between

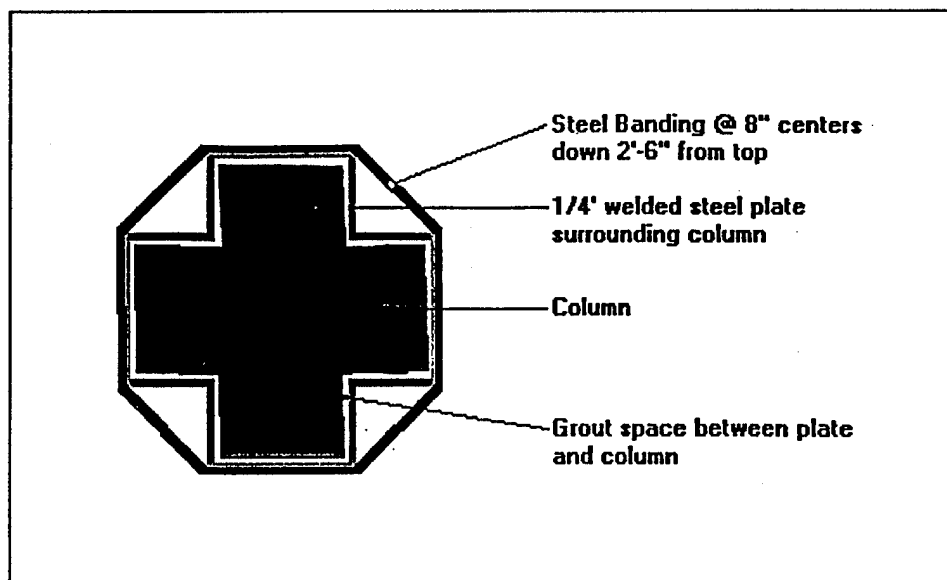
Figure 43. Sketch of repairs to the damaged columns

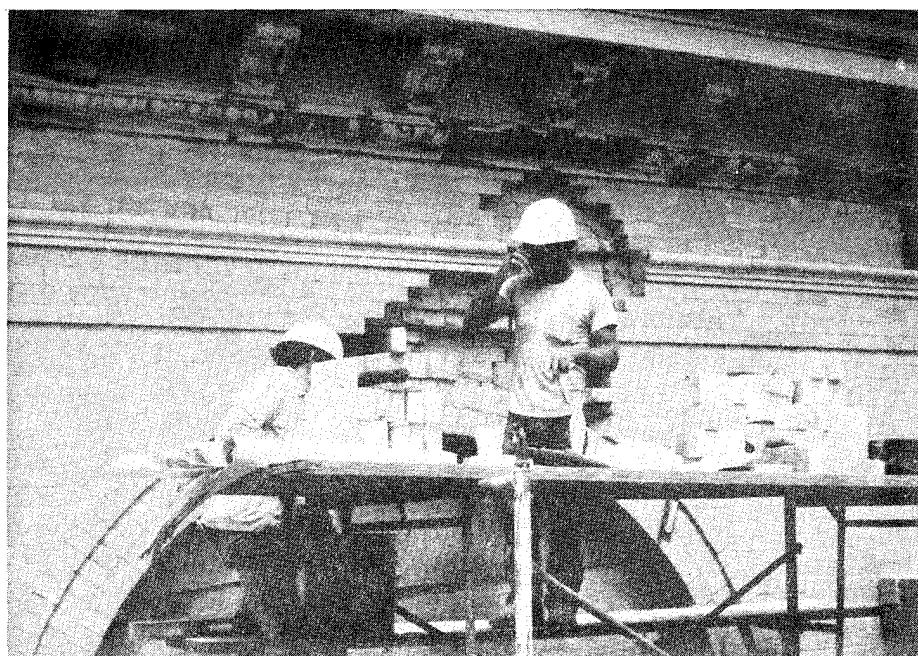
Figure 44. Rebuilding of arch window at northeast corner of central chapel

An arch-shaped form was built to use as a guide in replacing the bricks in the new arch. The masons reused any bricks that were not damaged during the dismantling of the wall. In instances where there was need for more bricks, they drew from a supply of bricks which they reclaimed when dismantling a brick chimney from the north facade of the chapel.

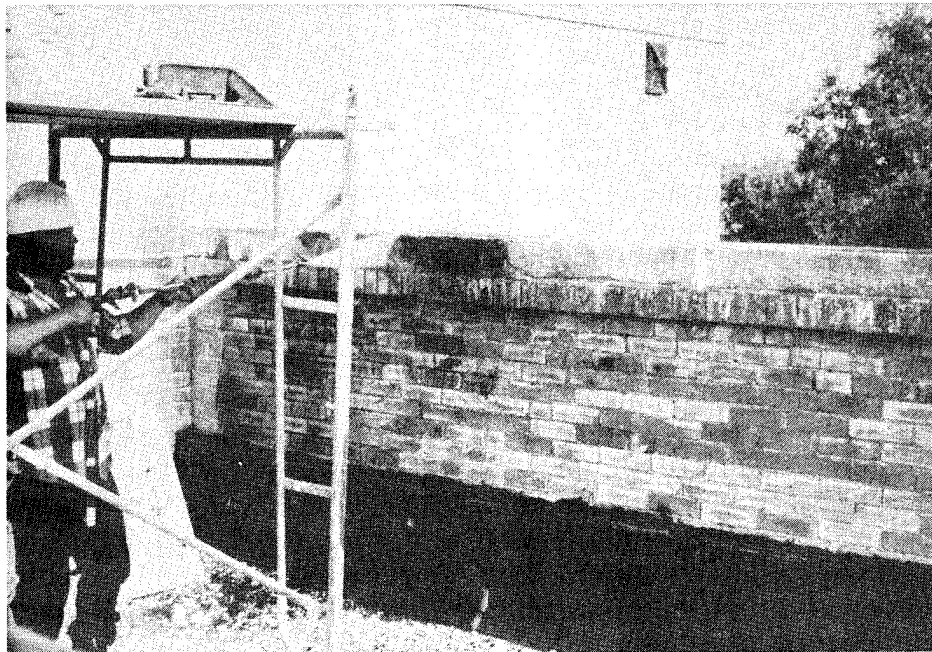
Figure 45. Medium pressure water cleaning of masonry

**Masonry cleaning.** While the masonry repair was going on, the chapel was being washed of the many years of dirt and grime it had collected. The contractor decided that the washing could be accomplished without using chemicals since the dirt on the bricks was only soil and some light coating of pollution. The decision to use no chemicals allowed him to wash before some of the repointing. He proceeded to wash with water at a medium pressure. Figure 45 shows a workman spraying the parapet walls on the roof of the east wing of the chapel. The water was sprayed on the bricks at a pressure of approximately 400 psi. This was considered strong enough to remove the grime and any loose mortar in the joints without damaging mortar that was strong. The entire chapel was washed from the top down to keep newly washed areas from being recontaminated from draining dirty water.

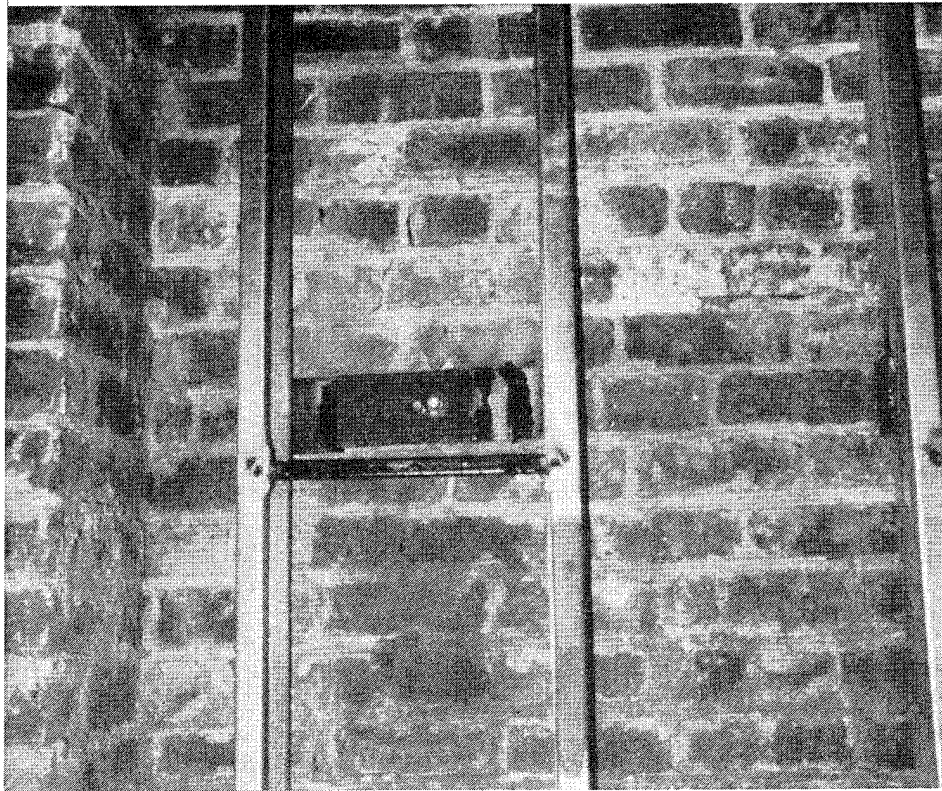
Figure 48. Overall view of structural studs and wall anchor

Tests were conducted to determine the strength of the epoxied bolts in the brick. Prior to the actual use of this system, three anchors were epoxied into brick test panels and were loaded to failure. One failed at 7,500 lbf, and the other two at 9,000 lbf, with all failures occurring in the anchor, not in the brick or in bond between the brick and the anchor. There were 4,900 bolts used in the wall renovation, and 520 of these bolts were subjected to pullout

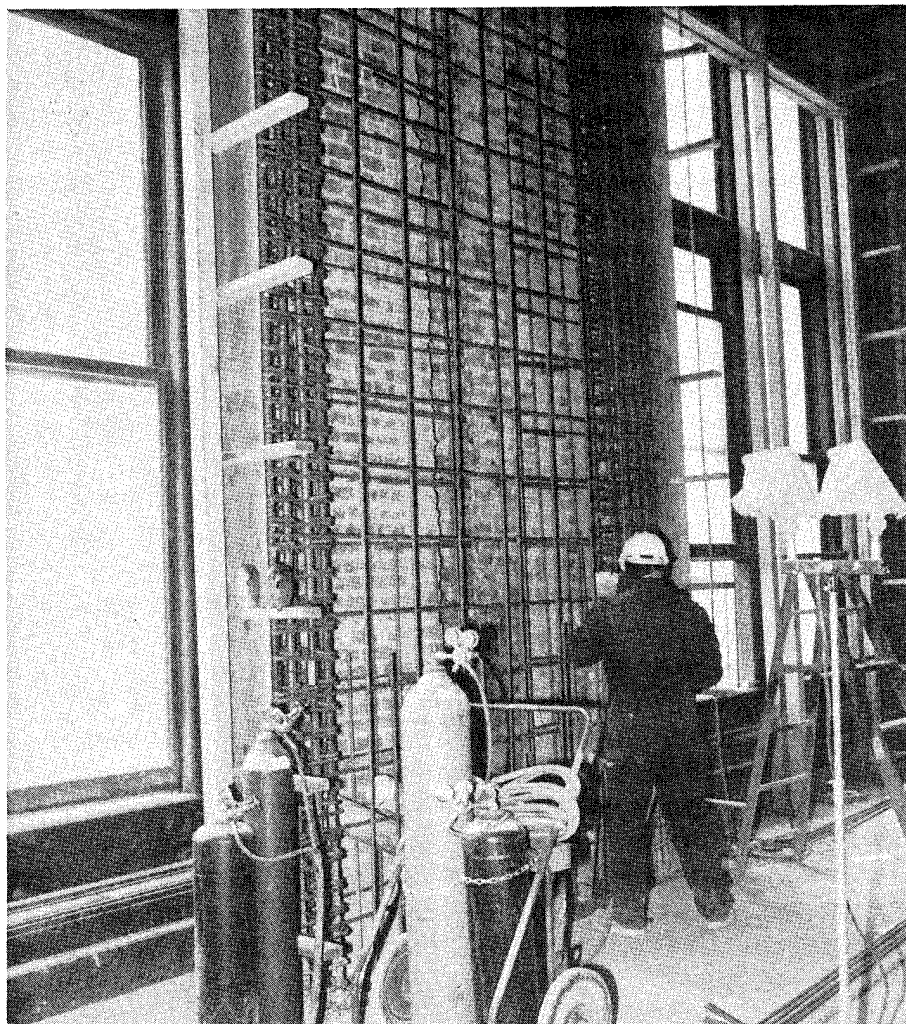
Figure 52. Strengthening of walls behind historical facades
