# Mark 20 Category II/III Instrument Landing System Operational Test and Evaluation, Functional and Performance Test Report

October 1995

DOT/FAA/CT-TN95/44

U.S. Department of Transportation  
Federal Aviation Administration

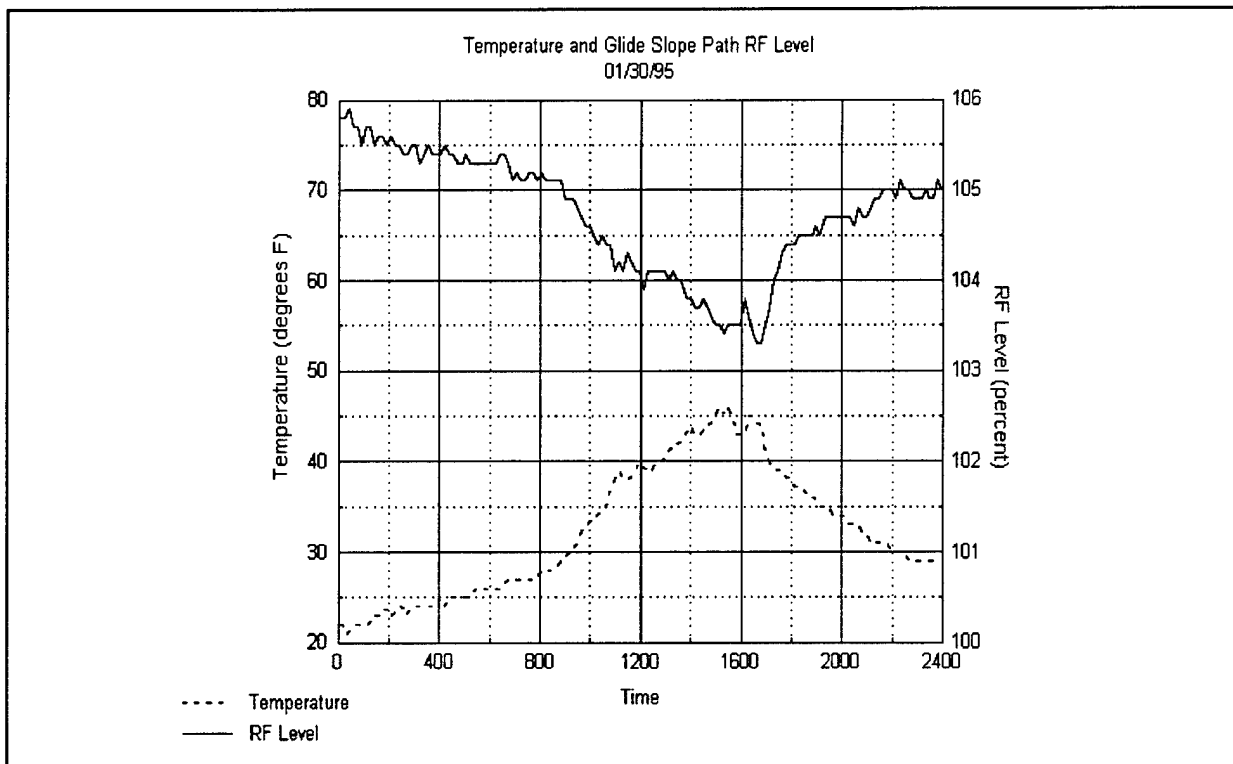
FIGURE 8. CORRELATION OF TEMPERATURE AND MONITORED GLIDE SLOPE PATH RF LEVEL FOR JANUARY 30, 1995

The only observed correlation between weather and the Mark 20 performance was temperature, and the course and clearance RF power for the localizer and glide slope. This correlation shows an approximate 2 percent change in RF level to a 20° Fahrenheit change in temperature. This change is relatively insignificant but could be a problem depending on the recalibration schedule. The monitors were calibrated at the test site during the summer months. Due to the change in average temperature during the winter months, the average RF levels were in the vicinity of 104 percent. The daily fluctuation in temperature varied the RF levels between 103 percent and 106 percent. At facilities with colder winter temperatures, a subsystem calibrated during the summer may drift out of RF level tolerance during the winter and vice versa. Only output power of the subsystem is affected as the impedance characteristics of exposed cable and antennas change with the temperature. This condition will not affect the quality of guidance because Carrier and Sidebands (CSB) and SBO signals are attenuated at the same rate, but some outages could occur due to RF levels exceeding alarm limits. Figure 8 shows the temperature and glide slope path RF level for January 30, 1995. The monitored weather and Mark 20 parameters for the month of January 1995 are contained in appendix C.

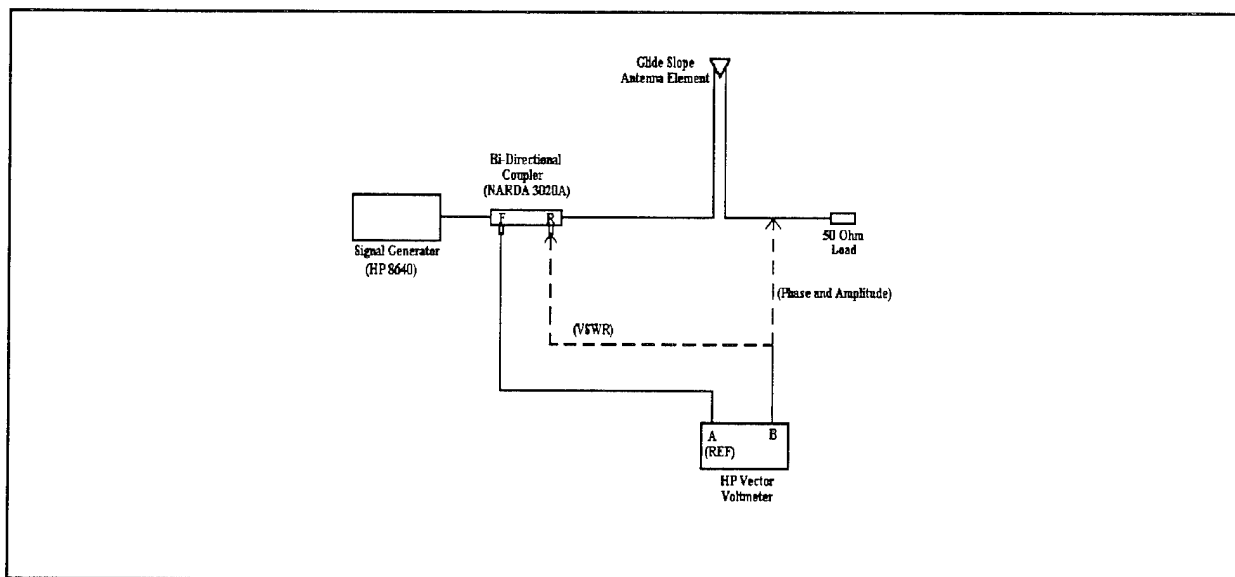
FIGURE 9. TEST CONFIGURATION FOR MEASURING VSWR, PHASE, AND AMPLITUDE OF GLIDE SLOPE ANTENNAS DURING ICE LOADING TESTING

Figure 9 shows the configuration for testing ice loading effects. Table 1 indicates the date, time, conditions, VSWR, phase, and magnitude of the measurements made on the antennas. This data indicates that no significant changes in measured parameters were observed during ice loading or antenna heater operation. The maximum variations from the baseline measurements were: VSWR: 0.03, Phase: 1.3°, and magnitude: 0.28 dB. Based on these measurements, it appears that the antenna heaters are not required. The data collected also indicates that antenna heater operation does not affect the radiated signal. During this testing period (8 months) no antenna heater failures occurred. Because the glide slope electronic equipment had not been delivered at the time of this test, these measurements were obtained using a signal generator for the provided signal, thus no signal in space measurements were possible and no determination of actual provided guidance can be made.
