**Aviation Life Support Equipment Retrieval Program:
Report of Aircraft Mishap 95-4, Involving the
HGU-56/P Army Aviation Helmet**

March 1996

**U.S. Army Aeromedical Research Laboratory
Fort Rucker, Alabama 36362-0577**

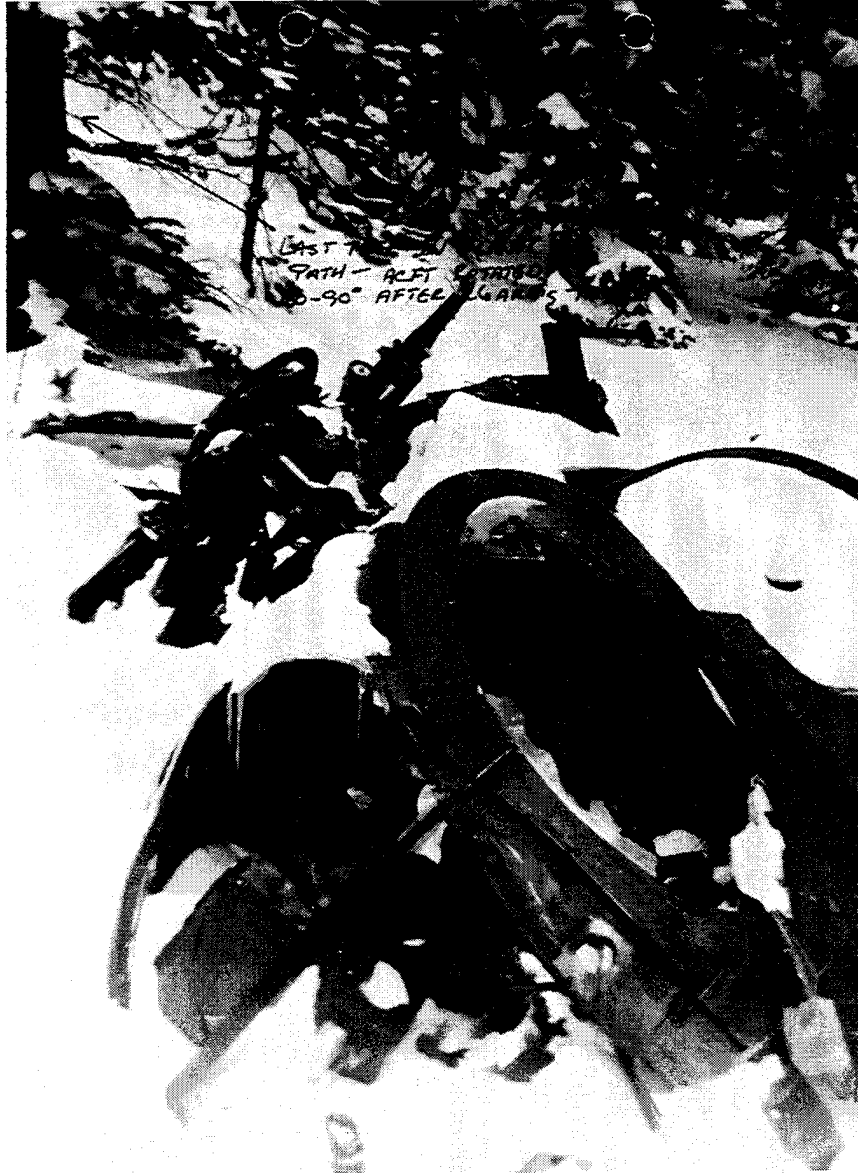
The aircraft first came in contact with the trees at a forward speed of approximately 12 knots, in a right 30-degree roll, with the nose pitched down 10 degrees, descending at approximately 500 feet/minute. The flight path and impact angle was 57 degrees down. The aircraft sustained major damage to its right side as it descended through the trees impacting the ground at 9 Gs. The aircraft yawed 75 degrees from the initial impact heading and came to rest on its right side. Because the livable space was not compromised and the crash forces were within human tolerance, the crash was deemed survivable.

Figure 1. The AH-6J at the crash site.

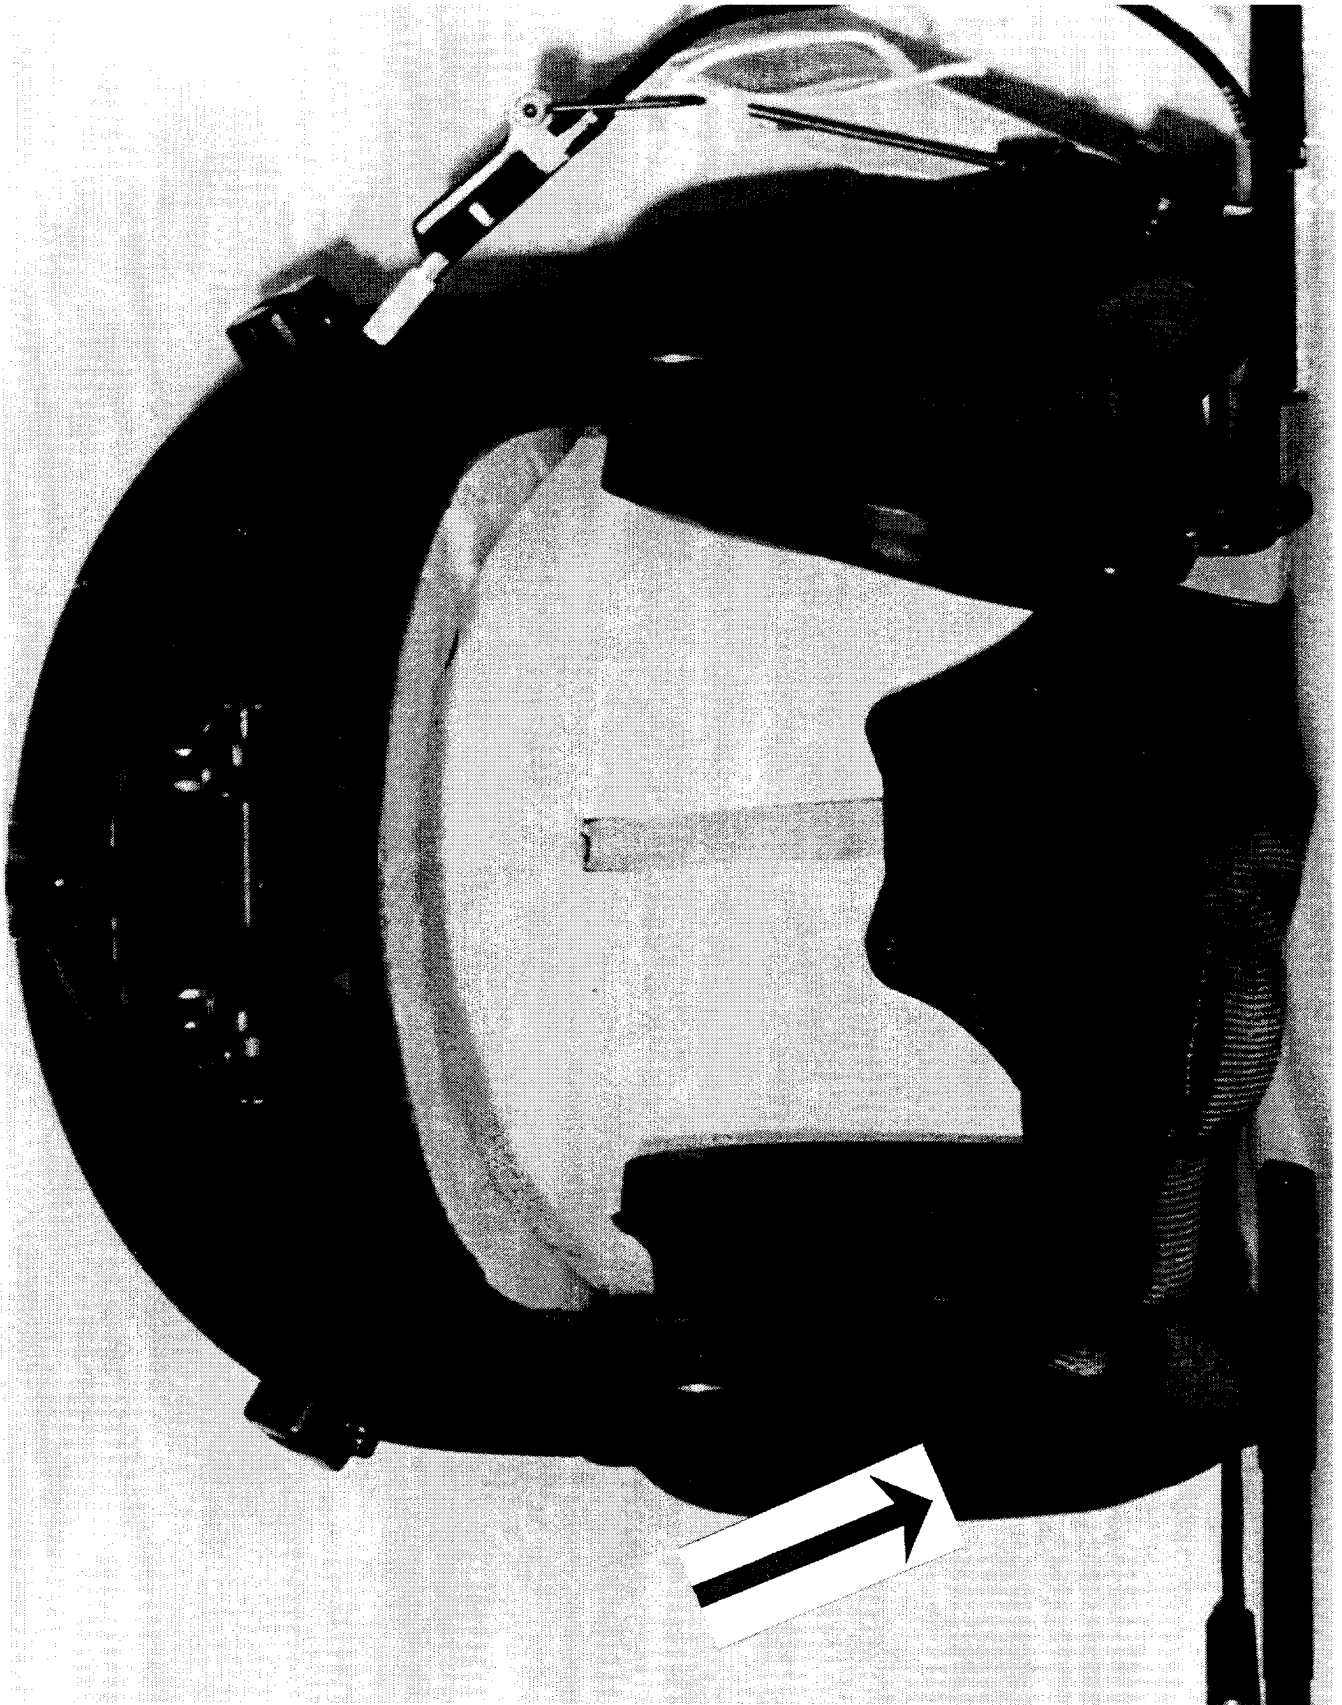
Both occupants were wearing the new HGU-56/P Army aviation helmet. The copilot's helmet was undamaged in the mishap. The ALSERP team analyzed the damaged HGU-56/P worn by the pilot in command in accordance with USAARL Policy No. 95-55 (1985). This impact, from an undetermined type of surface, caused a 3½-inch complete shell fracture on the eardome from front to rear and a 1-inch horizontal hairline fracture on the same eardome from rear to front (Figs. 2- 3). A complete tear down and inspection revealed no other damage. The energy-attenuating earcup did not exhibit markings indicative of deformation. Therefore, it is not likely that the earcup was exposed to significant impact forces.

Figure 2. The damaged HGU-56/P Army aviation helmet.

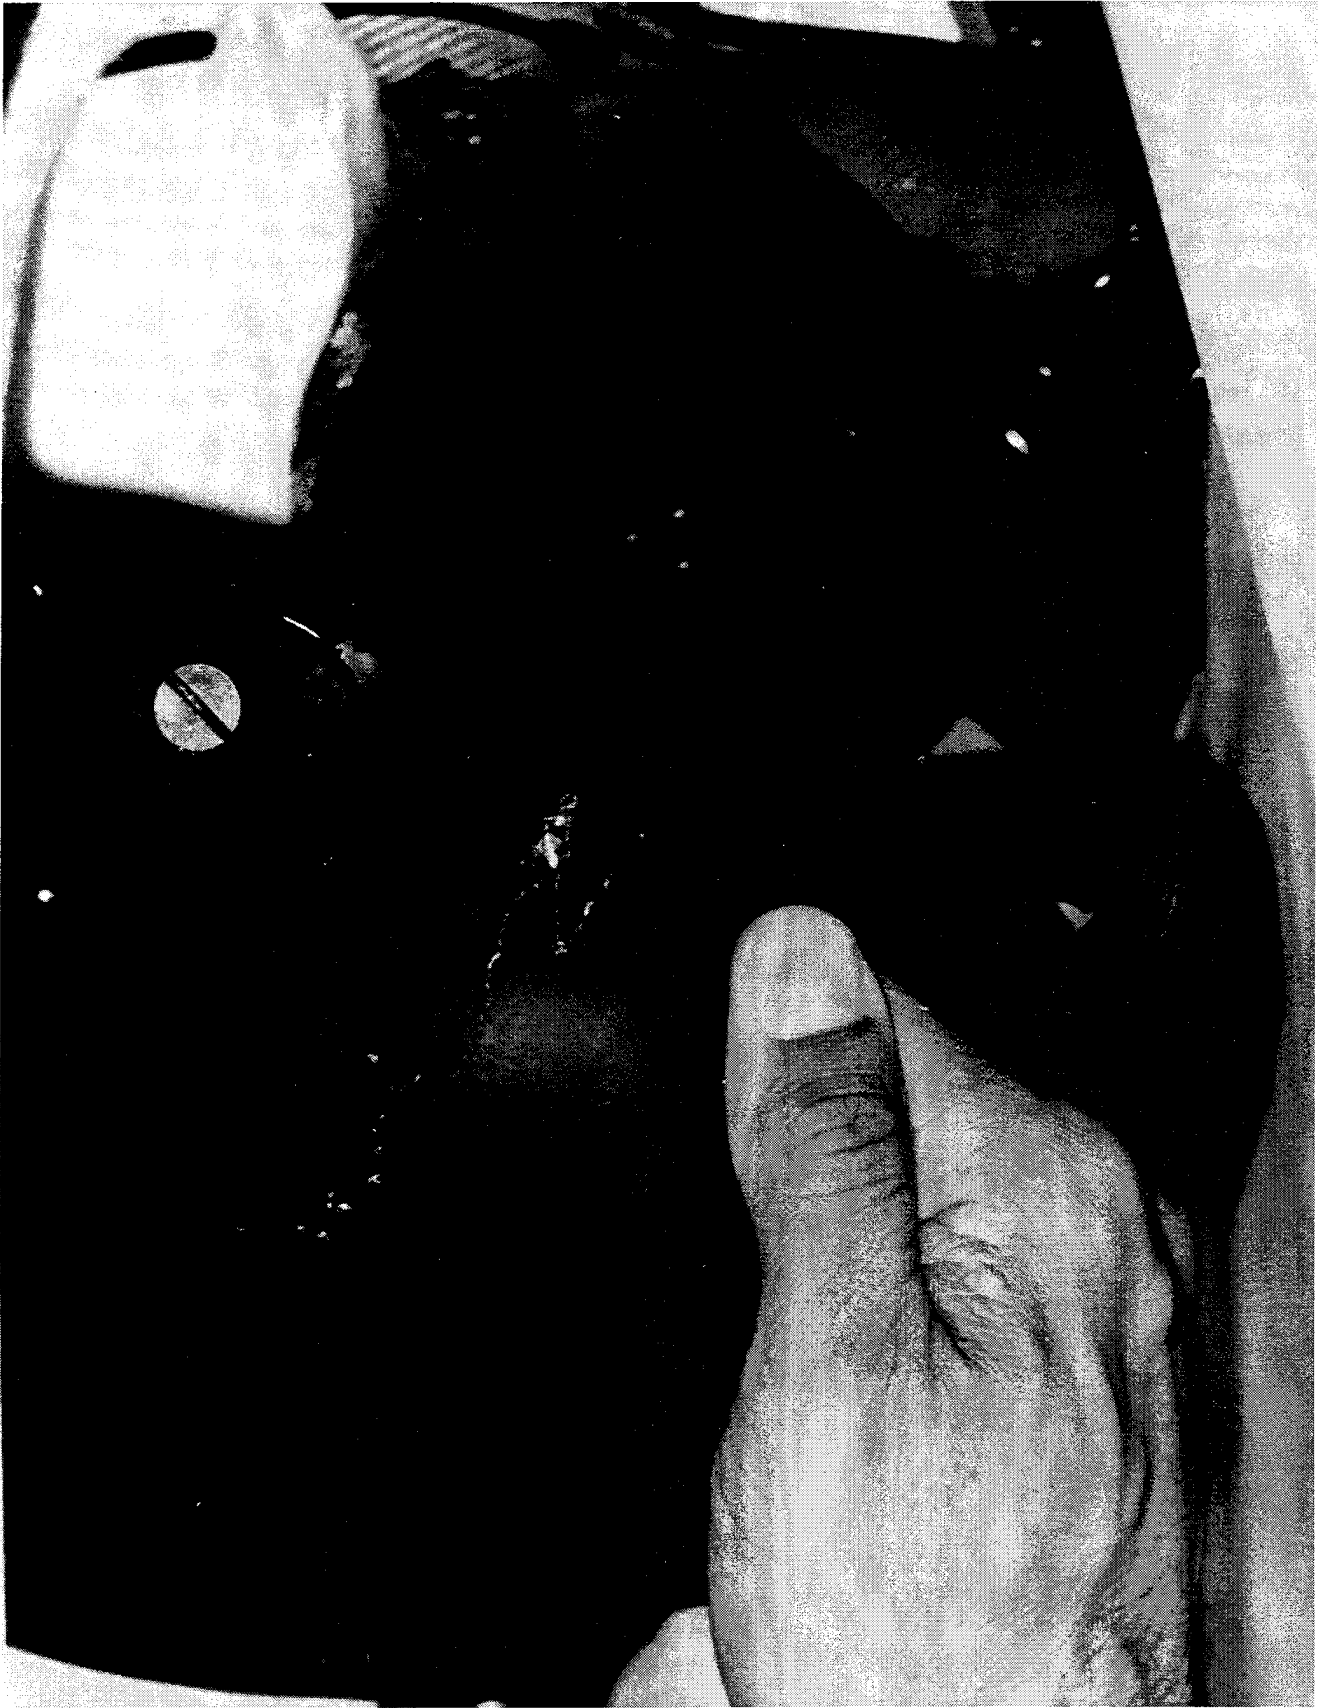
The first HGU-56/P recovered from a mishap provided adequate protection to the crewmember. The helmet was retained on the wearer's head indicating proper fit and function of the retention assembly. Although it was rendered unserviceable in the mishap from a sharp blow to the bottom right eardome, the impact forces were not transmitted to the pilot's head. The facial laceration and contusion to the pilot's chin are not attributable to the HGU-56/P. The energy-attenuating earcups did not appear to have been exposed to significant impact. The crash forces encountered in this mishap did not cause the protective capabilities of this helmet to be fully challenged.

Figure 3. The impact to the right eardome was sufficient to completely fracture the helmet.
