NASA Contractor Report 178246

## Test Results for Composite Specimens and Elements Containing Joints and Cutouts

P. T. Sumida, R. C. Madan, and A. V. Hawley

Douglas Aircraft Company  
McDonnell Douglas Corporation  
Long Beach, CA 90846

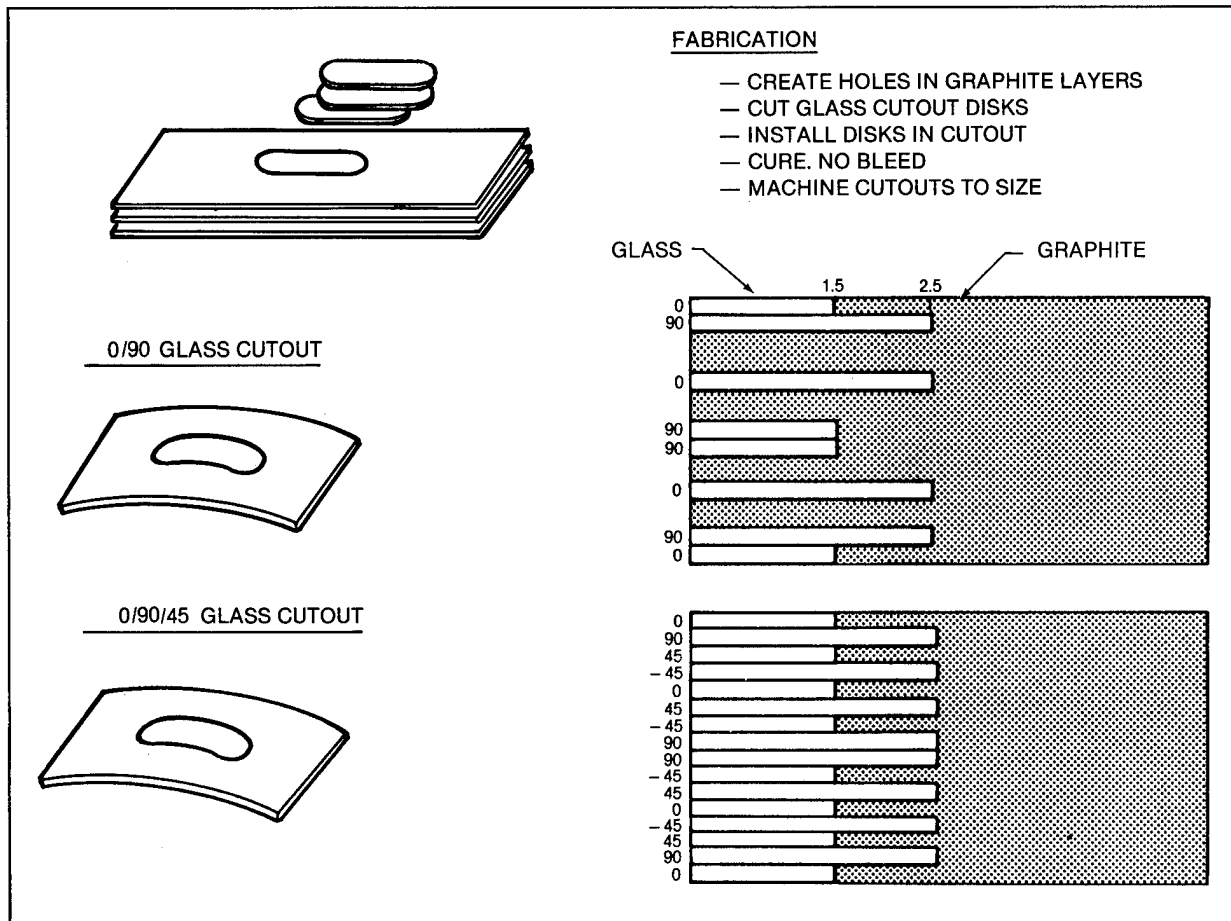
The first glass/graphite hybrid cutout panels were fabricated using the Style 120, Type E fiberglass. The fabrication approach was to lay up glass prepreg disks into cutouts made in the carbon tape layers. Upon removal from the autoclave, the -503 and -507 unstiffened panels exhibited excessive bowing and warping, as depicted in Figure 3-4. The resin content of the E-glass cloth was found to be too high to achieve the proper mechanical strength properties and to arrive at the desired cured ply thickness. In order for the glass softening material to be effective in this application, it was critical that the cured thickness per ply be close to that of the adjoining carbon tape layers. S2 glass was subsequently chosen as the preferred softening material.

**Figure 3-4. Distortion of Glass/Graphite Cutout Panels**

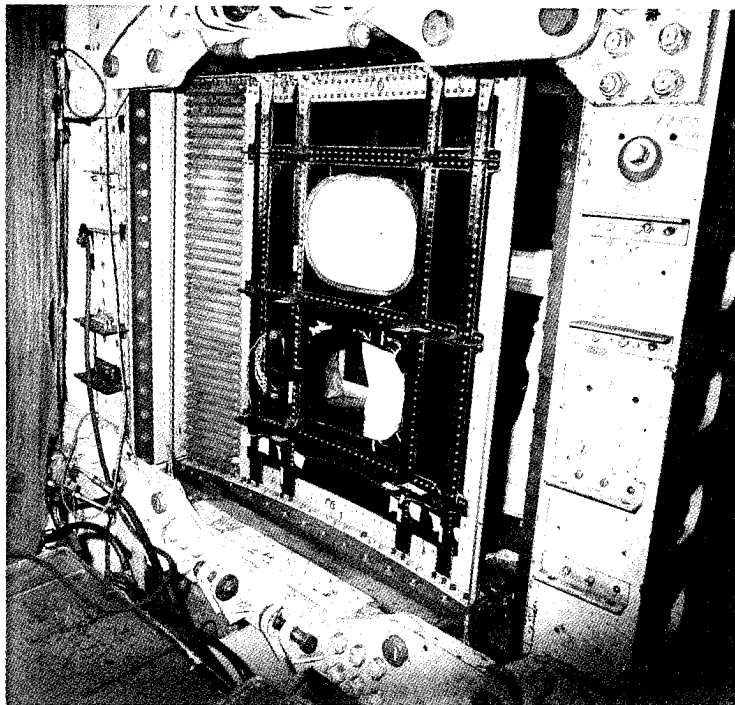
**Figure 3-10. Installation of Composite Window Belt Panel Assembly into Test Fixture**

An engineering disposition was made regarding the condition of the bonded subassembly. It was determined that a pattern of 3/16-inch-diameter fasteners through the base flanges of the longeron and shear-tee details and the skin panel would provide the structural integrity required for a valid panel assembly test. The fasteners through the center shear-tee and through the base flange closest to the window cutouts of the other two shear-tees were countersunk on the outside of the fuselage skin. The fasteners through the discontinuous longeron base flanges were also countersunk on the outside surface of the fuselage skin. It was determined that countersinking the fasteners through the longerons in this region would provide an opportunity for testing a window cutout panel with extensive rework.

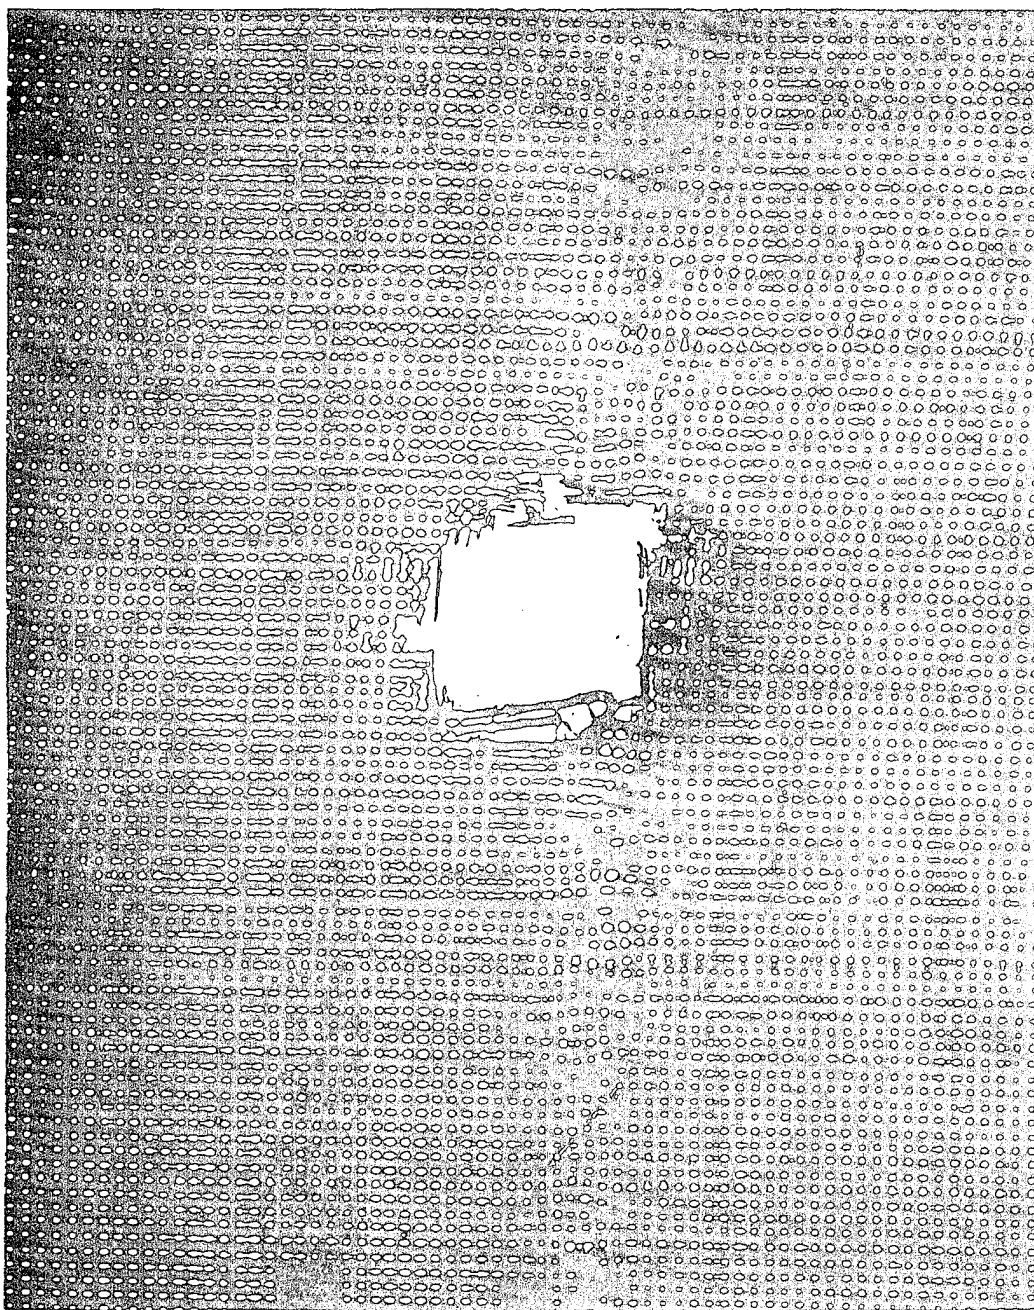
Table 4-1 gives actual discharge measurements for each of the specimens. Table 4-2 gives a detailed description of the damage sustained by each panel. The -505 panel (interwoven aluminum wire protection system) displayed the least damage (mainly top ply damage), while the unprotected panel displayed the most damage (penetration through all 12 plies). It should be noted here that the interwoven aluminum wire system was significantly thicker (cured thickness  $\cong 0.021$  inch) than the nickel-coated graphite cloth system (cured thickness  $\cong 0.011$  inch). X-ray photographs, showing the extent of damage to the nickel-coated fibers and the aluminum wires, are included for typical -505 and -507 panels in Figures 4-4 through 4-8.

**Figure 4-4. X-Ray of -505 CAI Specimen Showing Damage to Nickel-Coated Fibers**

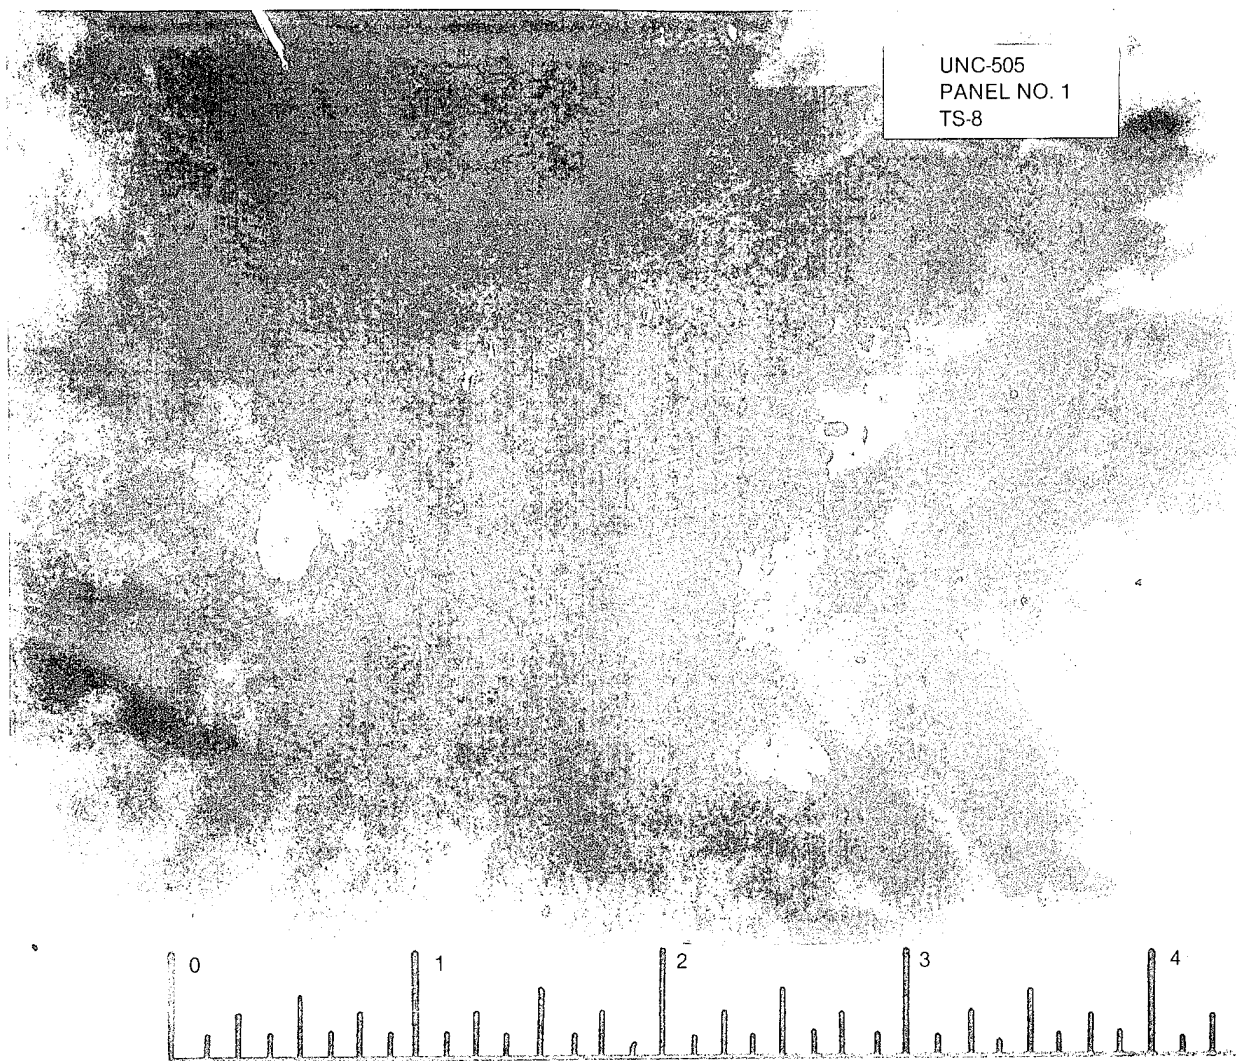
Figure 4-5. After Strike Damage on Wire-Woven Panel (UNC-505-2)

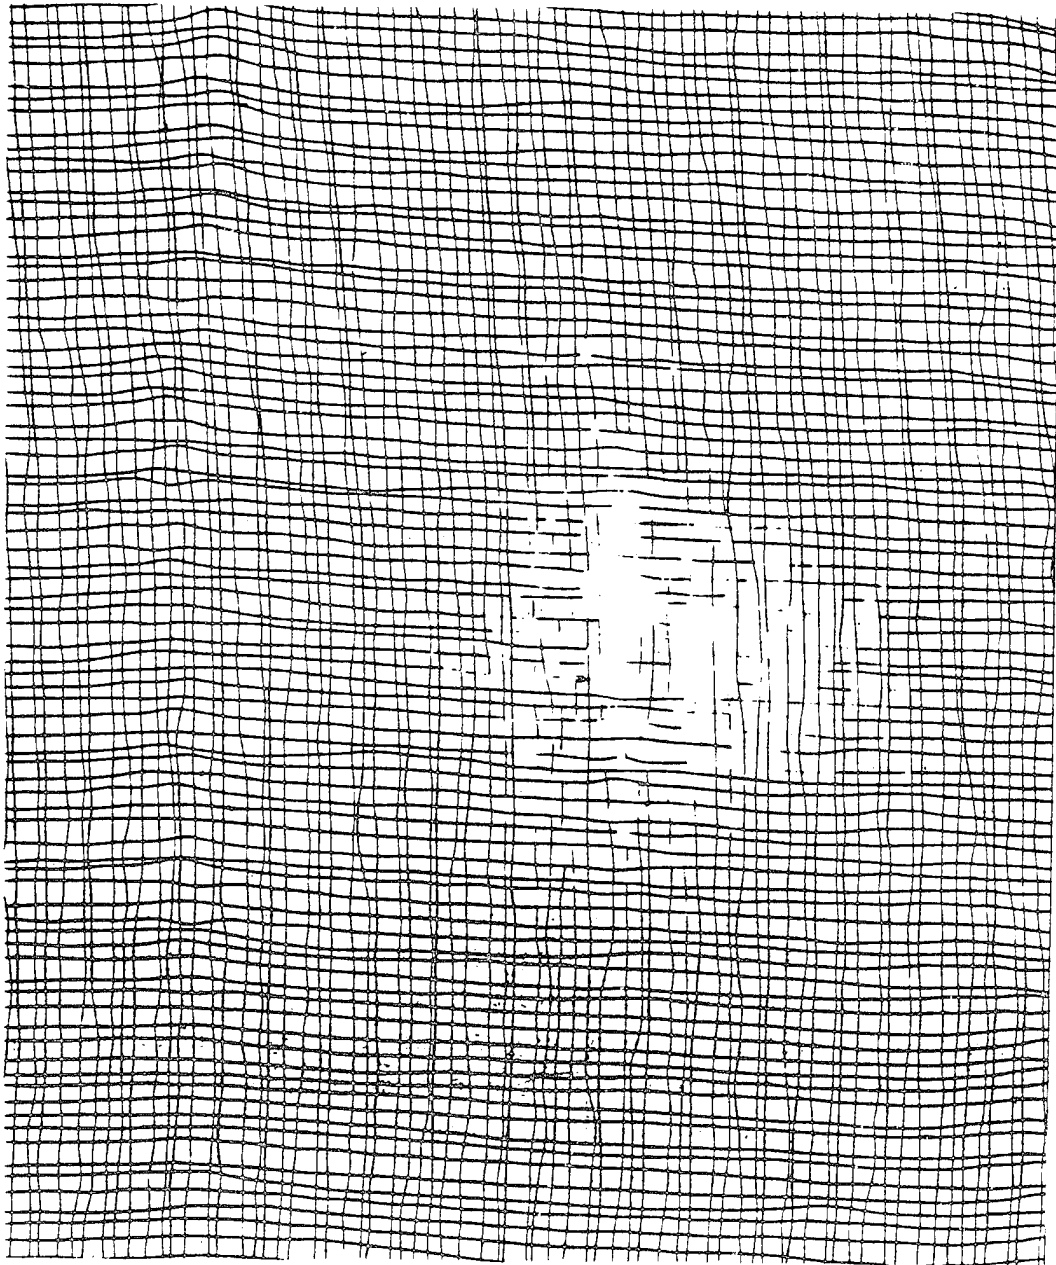
Figure 4-6. X-Ray of -507 CAI Specimen Showing Damage to Aluminum Wires

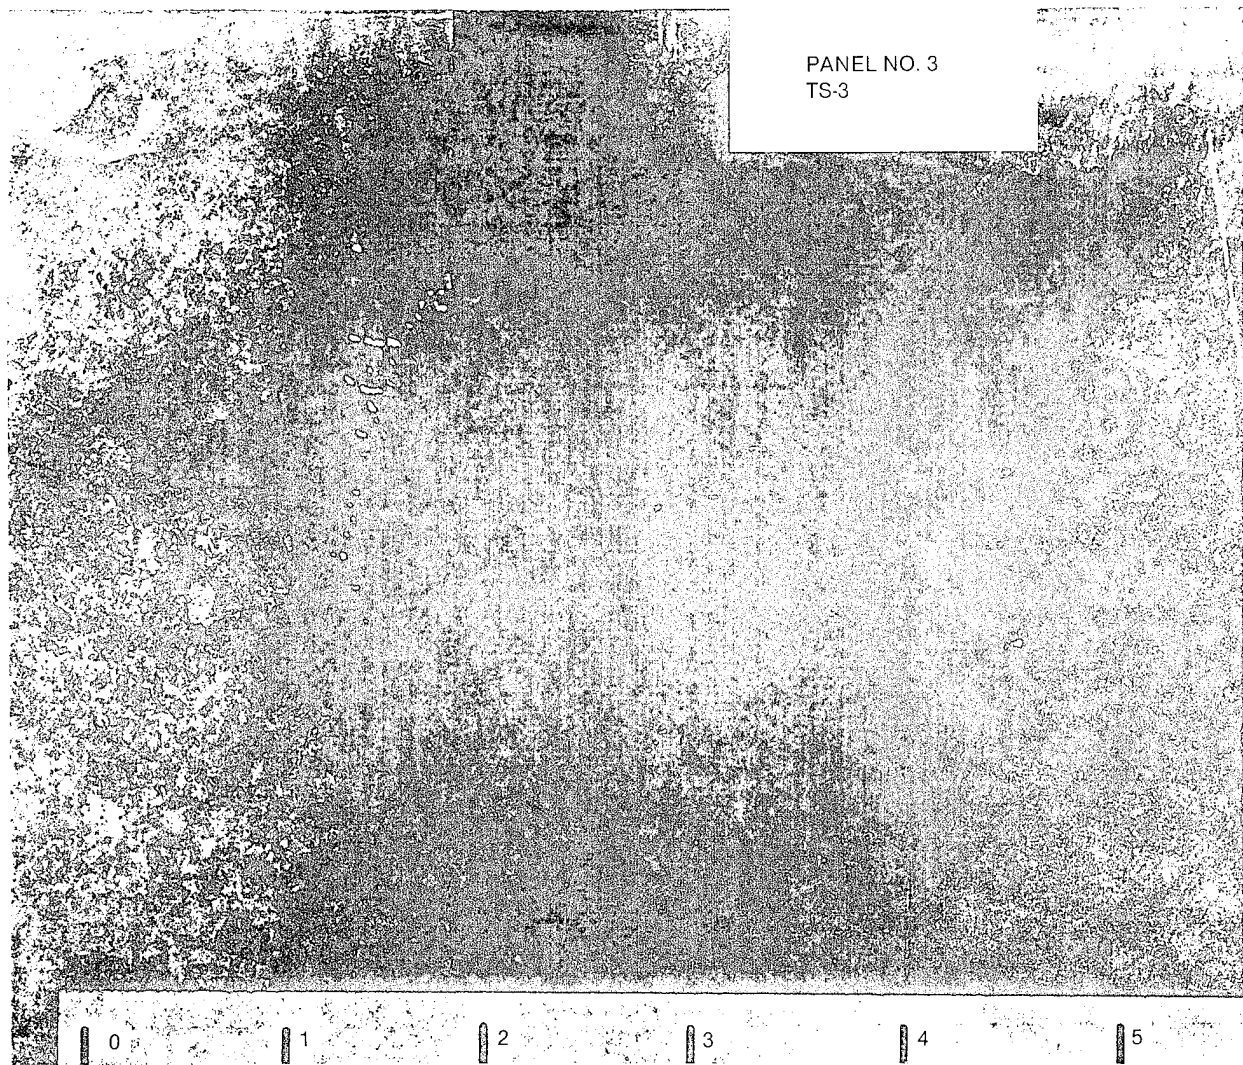
Figure 4-7. After Strike Damage on Nickel-Coated Panel (UNC-507-3)

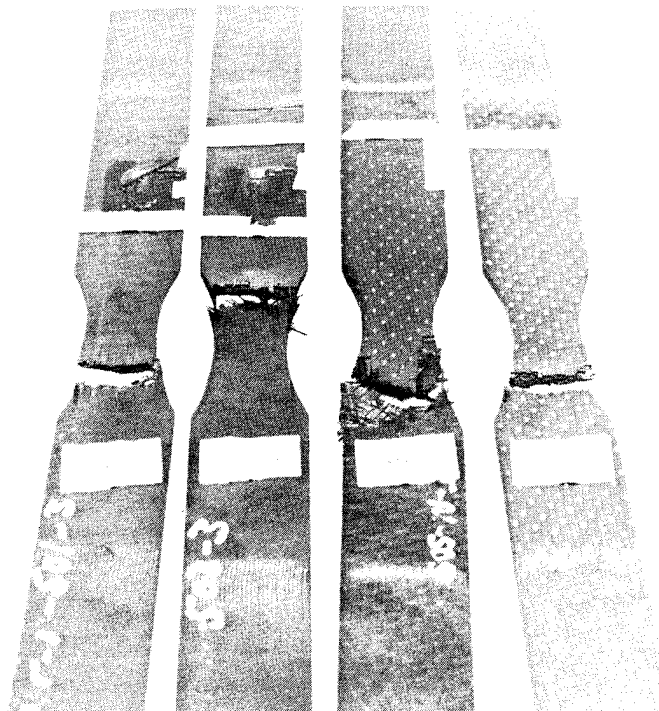
Two sets of unnotched tension specimens were fabricated and tested. The original specimens were “dog-boned” in an attempt to avoid failures at the grips of the test machine. None of these specimens, however, actually failed at the minimum cross section (Figure 5-3). The redesigned specimens were simply 7.50-inch by 1.12-inch strips with no dogbone or doublers. It was observed that there was only a slight increase in the ultimate tension strength of lay-ups No. 2, 3, and 4. Lay-up No. 1, however, showed a substantial increase in strength of just over 37 percent. In an attempt to reconcile this discrepancy, specimens from both sets were inspected for thickness, ply count, and ply orientation, but no anomalies were discovered.

**Figure 5-3. Failures of the Dogboned UNT Specimens**

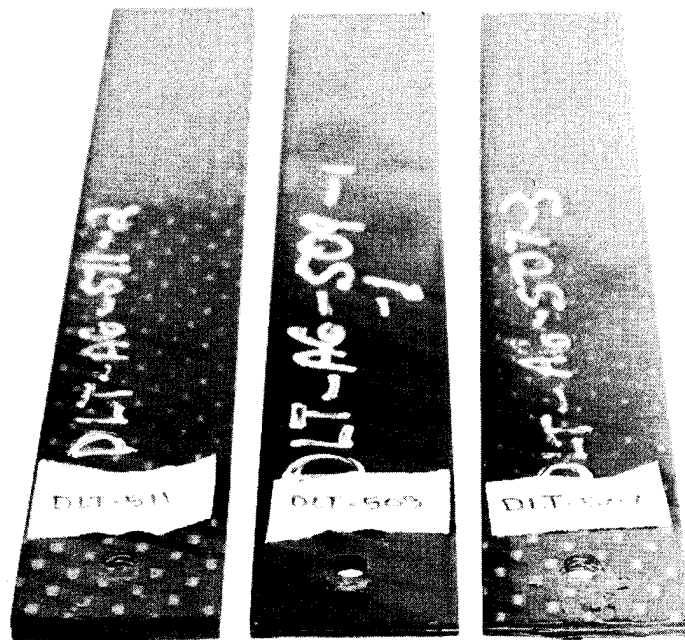
Figure 5-6. Bearing and Shear-Out Failures of Wide DLT Specimens ( $W/D = 6$ )

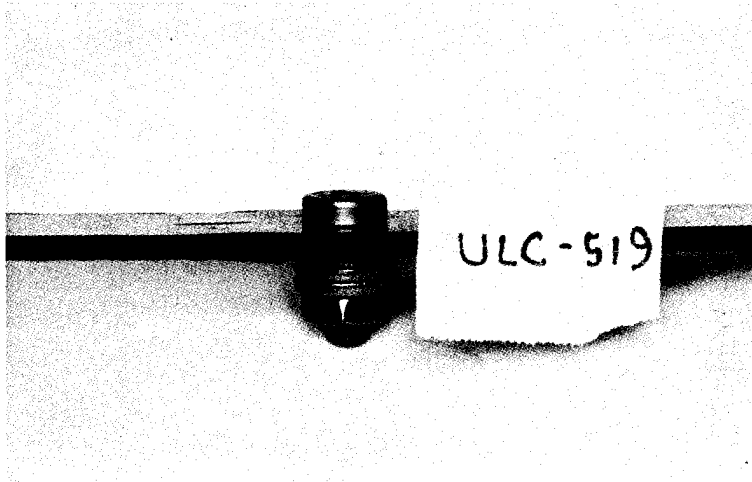
**Figure 5-9. Typical Failure of ULC Specimen with 3/16-Inch Fastener (Lay-Up No. 4)**

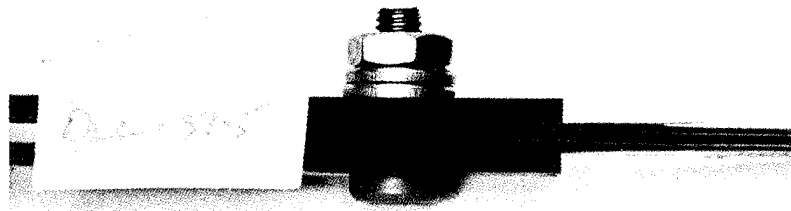
Figure 5-11. Typical Failure of Narrow DLC Specimen (Lay-Up No. 2)

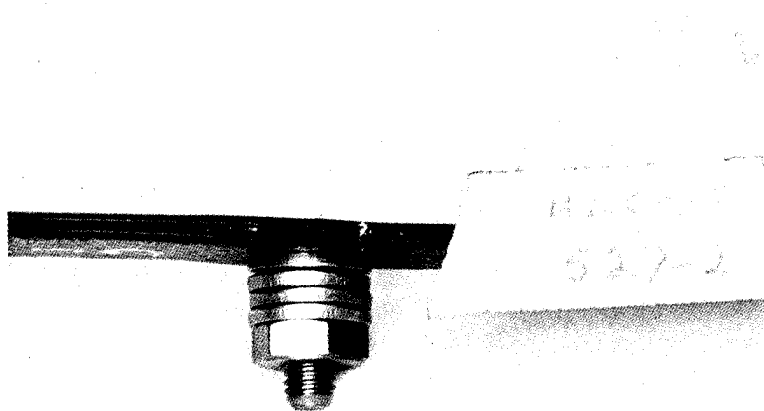
**Figure 5-15. Typical Failure of Countersunk ULC Specimen (Tested With Fastener)**

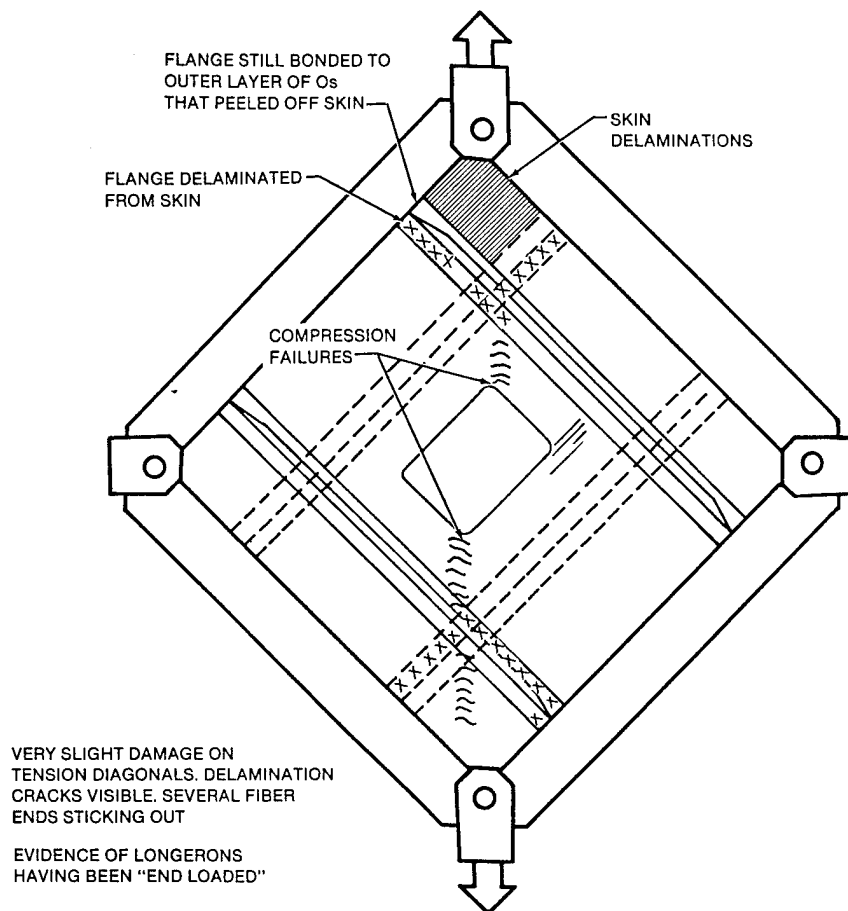
As noted in Figure 5-26, there was also some very slight damage observed on the tension diagonals, as well as some slight brooming at the ends of the stiffeners, indicating that they had been end-loaded by the thick steel doublers bonded to the periphery of the panel. The loads carried by the latter, however, are not considered to have been significant.

**Figure 5-26. Failure Locations for -501 Shear Cutout Panel**

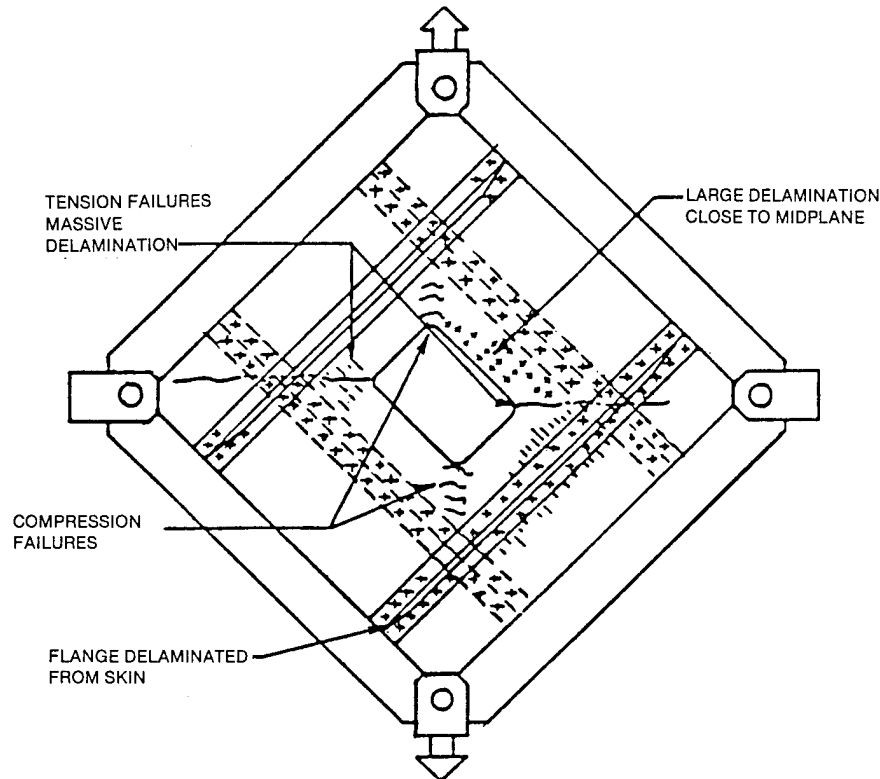
Figure 5-28 is a sketch of the softened panel (-503) after failure. Strain gage data taken at the bottom corner indicate roughly linear behavior to about 60 kips. At 70 kips, measured strains at the bottom corner began to drop off rapidly with increasing load (down from  $-11,629 \mu\text{in./in.}$  at 70 kips to  $-5,360 \mu\text{in./in.}$  at 80 kips). Visual examination revealed very localized delaminations in both compression corners. These delaminations occurred on the side of the panel with the photoelastic film only a few layers from the outside surface. They were also located very close to the points of tangency of the corner radii to the straight sides. The load was then increased to 100 kips. Unlike the -501 (baseline) panel, very little growth of the delaminations was detected as the loads were increased to panel failure, which occurred at 121,110 pounds.

**Figure 5-28. Failure Locations for -503 Shear Cutout Panel**

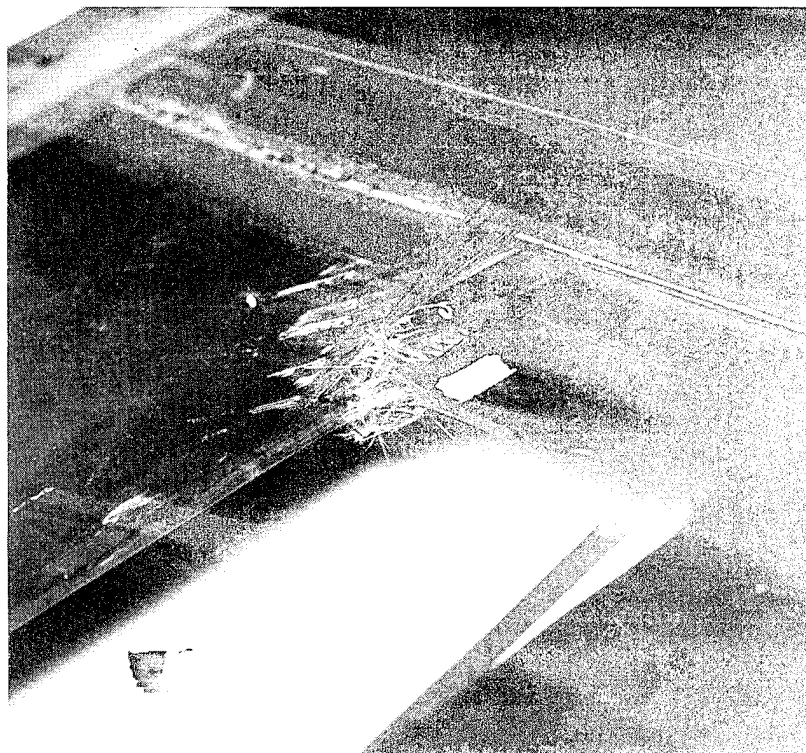
As previously noted, the ultimate failure of the -505 shear panel was precipitated by a partial failure of the test fixture. Strain gage data taken at the bottom (compression) corner indicated very low strains and became nonlinear very quickly (at about 30 kips). Photoelastic measurements indicated higher strains, which remained roughly linear over the range of loads surveyed (0-30 kips). Strain gage data taken at the left (tension) corner remained linear to about 60 kips. While holding the load at 70 kips, a loud noise was heard. Delaminations in both the compression corners were observed. At 108,900 pounds, the load fixture failed, loading the panel eccentrically and forcing a premature failure. Figure 5-29 shows stiffener separation (note the outer layer of 0s which peeled from the skin and are still attached to the stiffener) and the massive delaminations which occurred at the cutout.

**Figure 5-29. Posttest Photograph of Shear Cutout Panel (-505)**

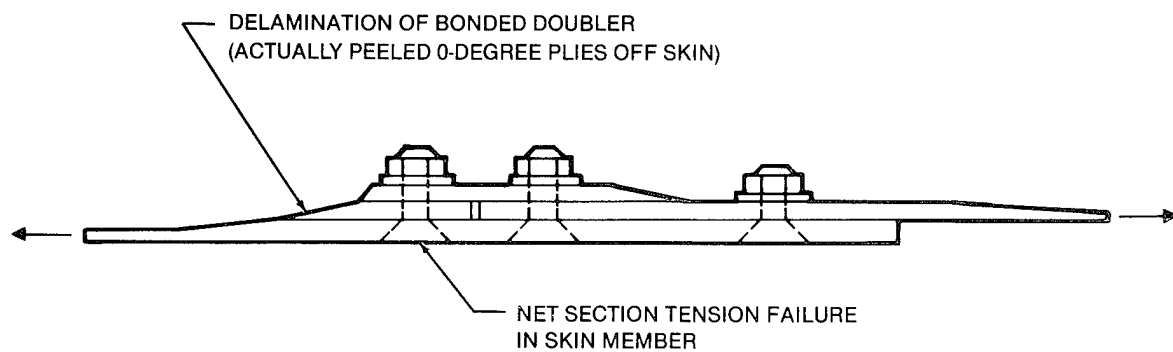
**Figure 5-32. Failure Mode of Tailored Longitudinal Splice Specimens**

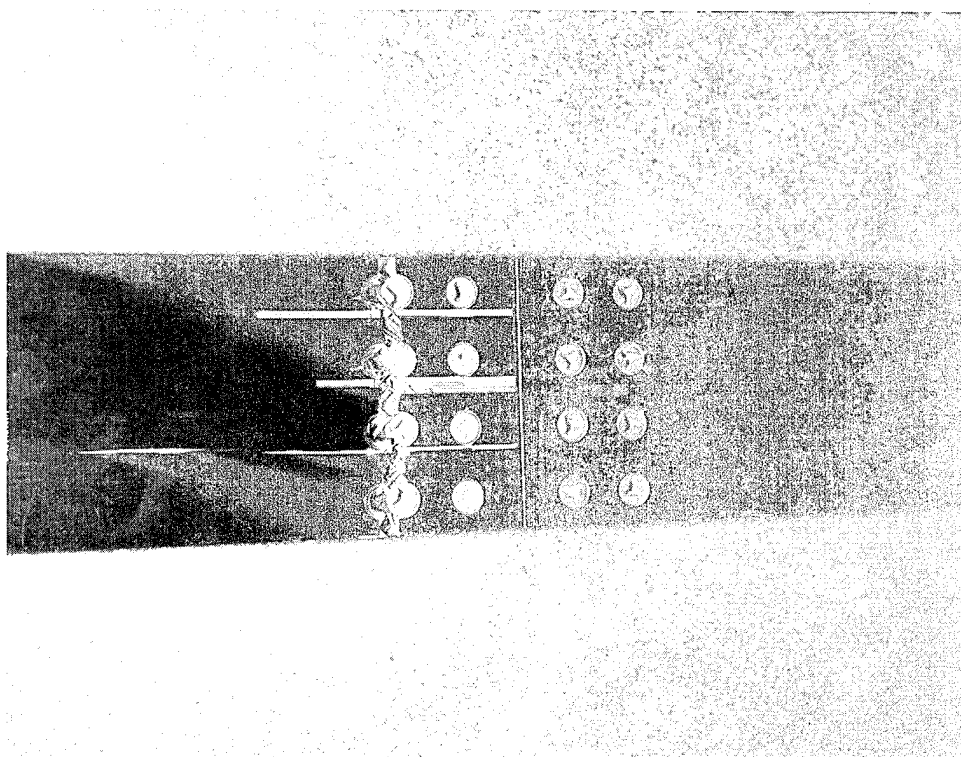
Figure 5-33 shows the failed baseline transverse skin splice specimen. The failure mode was net-section tension through the countersunk skin at one of the outermost rows of fasteners. Fastener rotation and bearing damage was minimal at the other three rows. This was typical of the two specimens assembled without sealant. The failed -1 specimen (assembled with sealant) appeared quite different, however. The ultimate failure apparently was partially tension through the outermost row of fasteners, and partially a combination of fastener failure and fastener pull-through. In addition, all four rows of fasteners exhibited significant fastener rotation with the accompanying bearing damage.

**Figure 5-33. Failed Baseline Transverse Skin Splice Specimen**

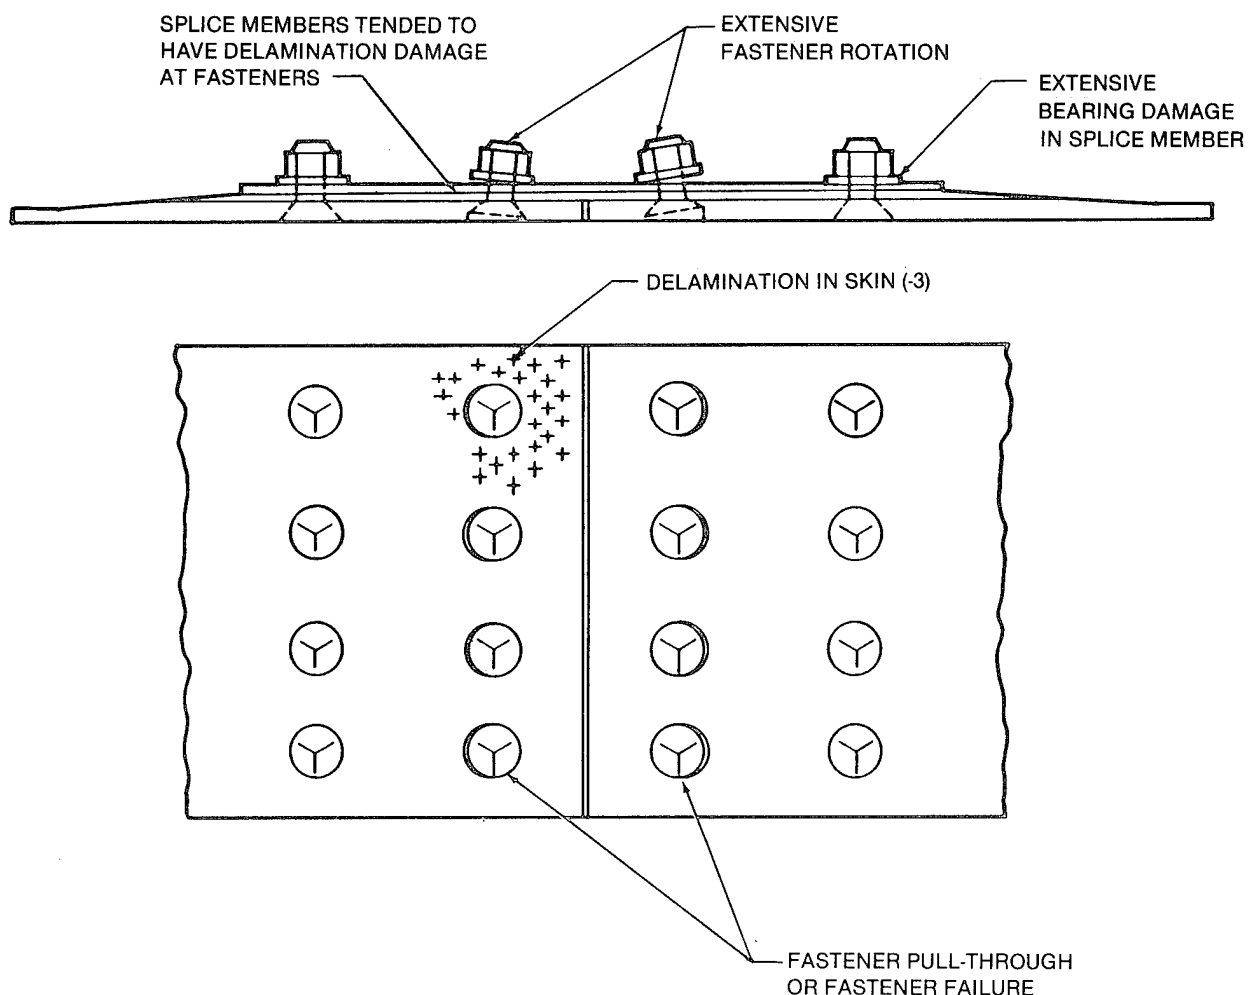
The presence of the sealant (for the -1 specimen) significantly reduced the strength of the tailored transverse splice specimen. The failure mode, for the most part, appears very similar to that of the -2 and -3 specimens (i.e., extensive bearing damage in the splice member at the outside rows of fasteners with the ultimate failure occurring at one of the inside rows due to fastener failure). Fastener failure for the specimens tested without sealant always occurred at the fastener head, through the tri-wing recess. Fastener failures for the -1 specimen, however, occurred at the opposite end near the first thread.

Figure 5-34. Failure Mode for Tailored Transverse Skin Splice Specimens

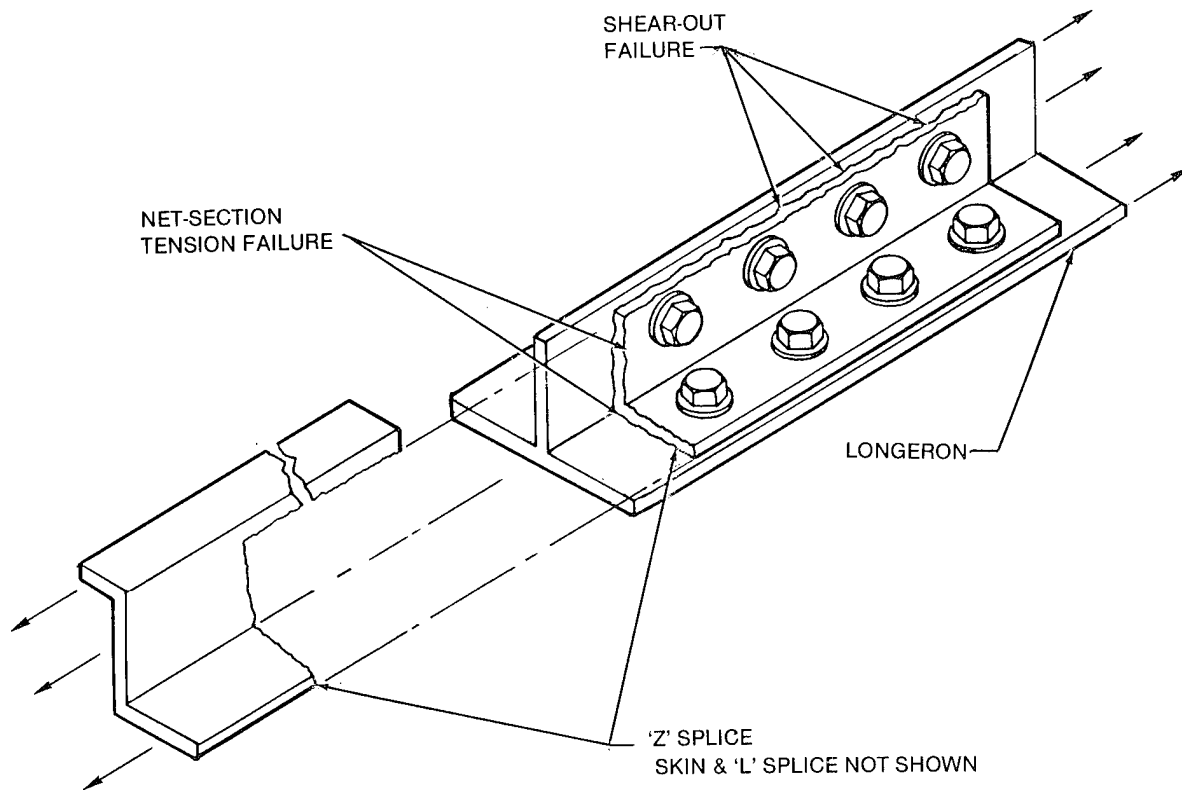
**Figure 5-37. Failure Mode of Longeron Splices (Tension Specimen)**

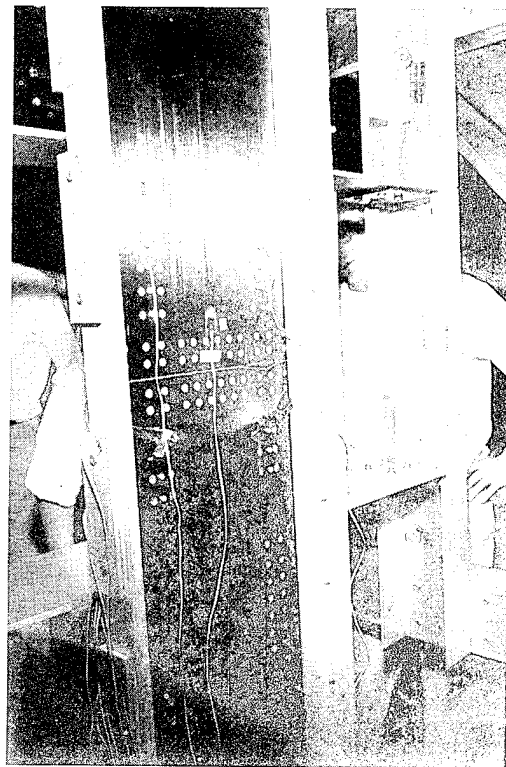
Figure 5-39. Failure of Longeron/Skin Splice Panel (Compression Specimen)

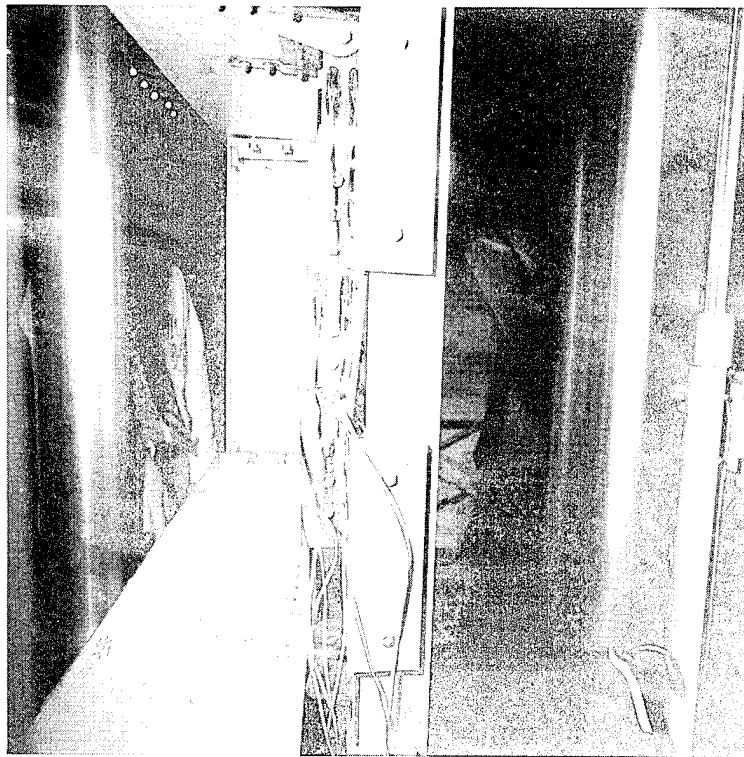
**Figure 5-40. Failure of Longeron/Skin Splice Panel (Compression Specimen)**

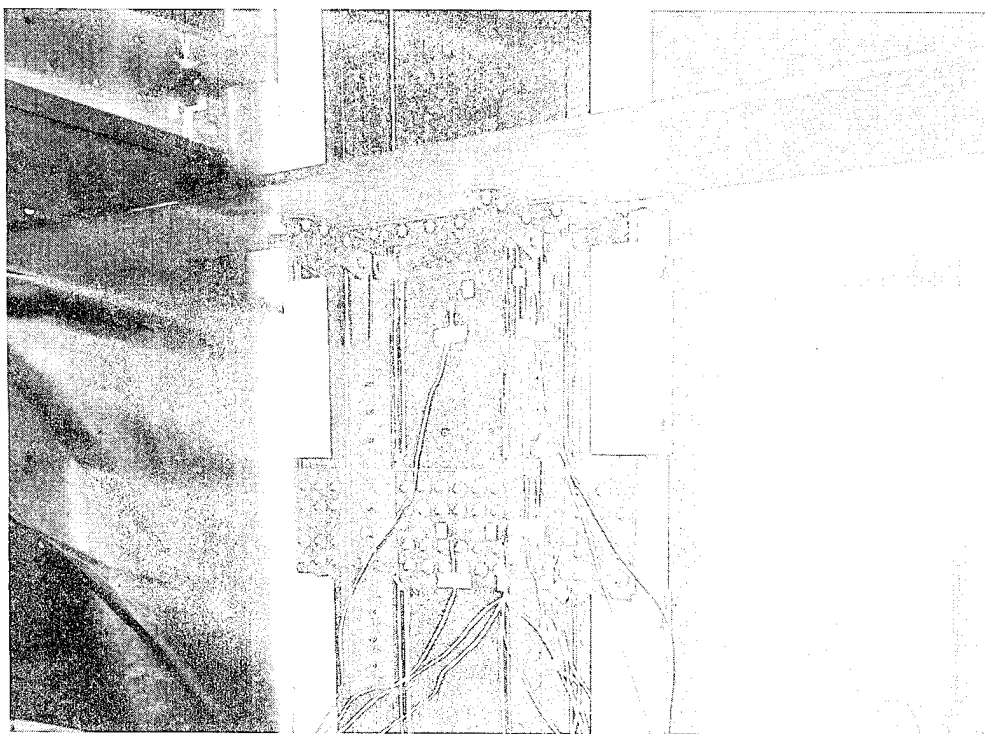
**Figure 5-41. Failure of Longeron/Skin Splice Panel (Compression Specimen)**

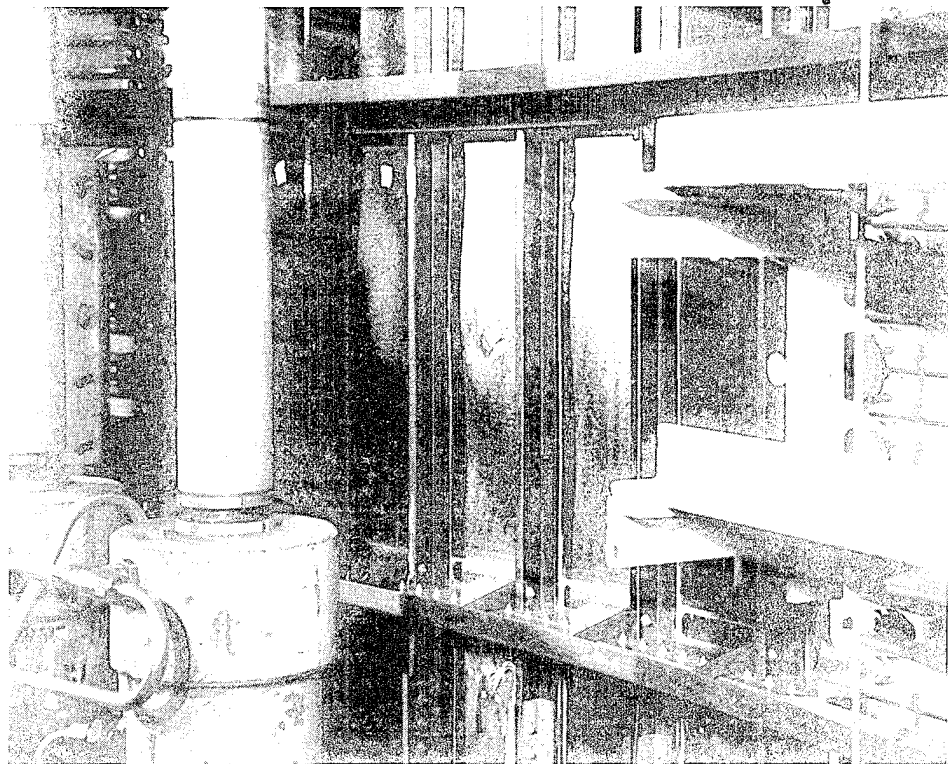
**Figure 5-43. Group D Transverse Skin Splice Panel — Partially Failed**

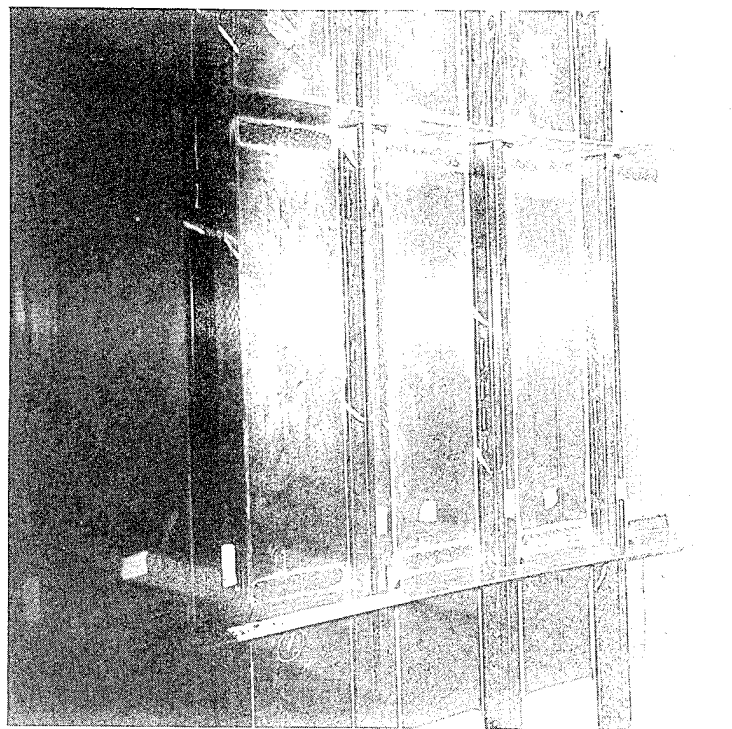
**Figure 5-44. Areas of Delamination of Transverse Skin Splice Panel (from NDI)**

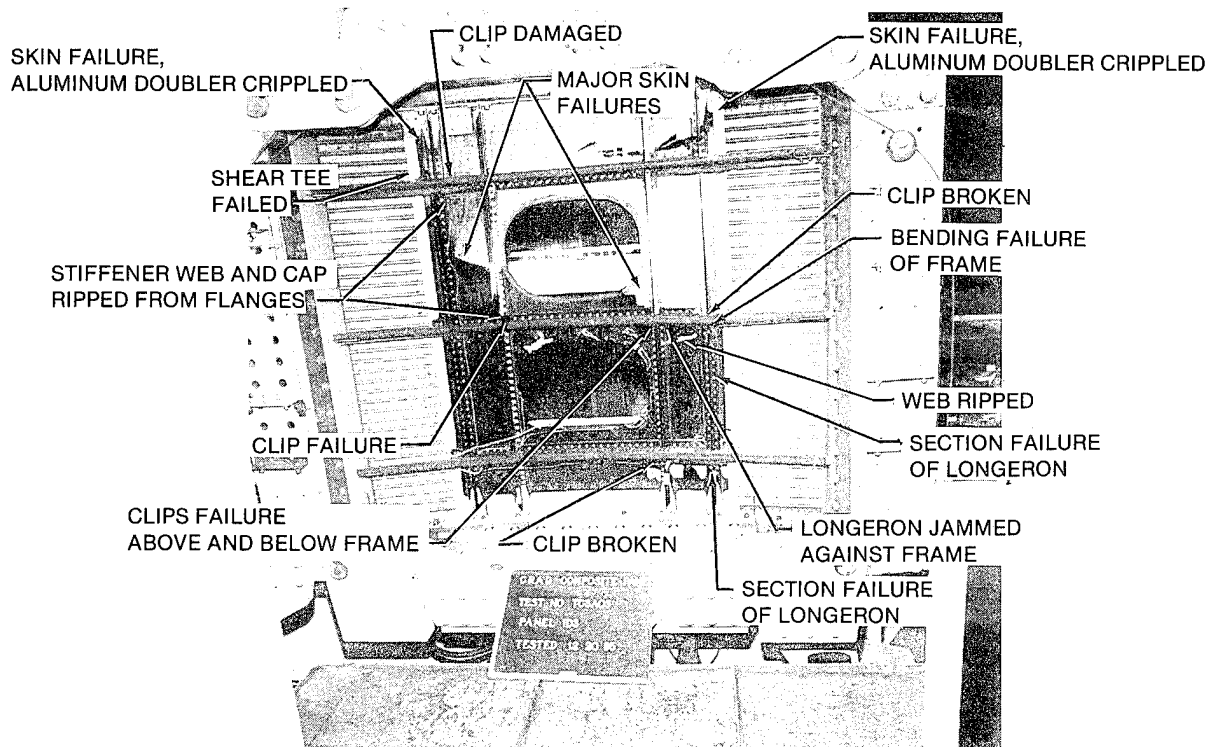
Figure 5-46. Group D Window Belt Panel Showing Failure Locations

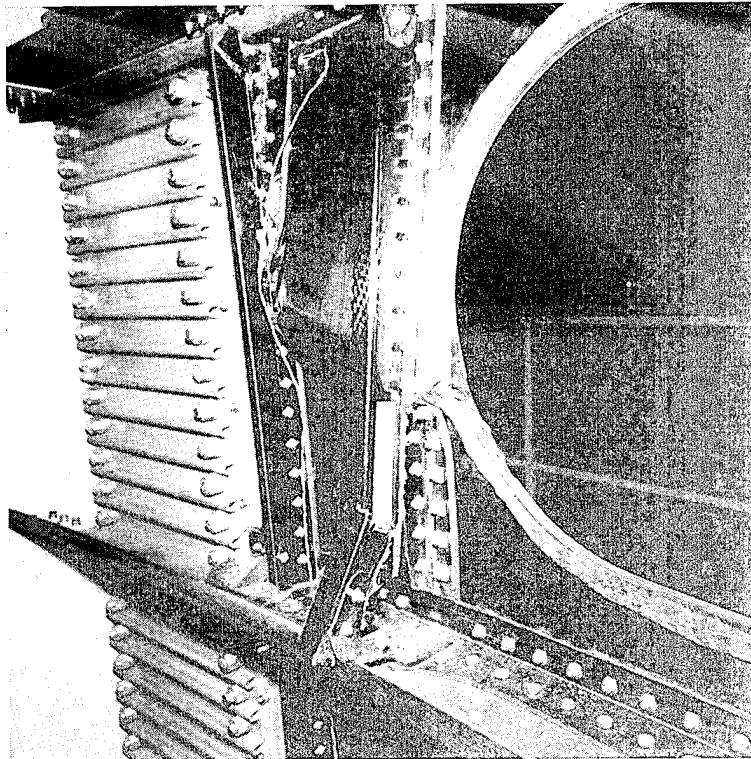
**Figure 5-47. Group D Window Belt Panel — Area of Initial Failure**

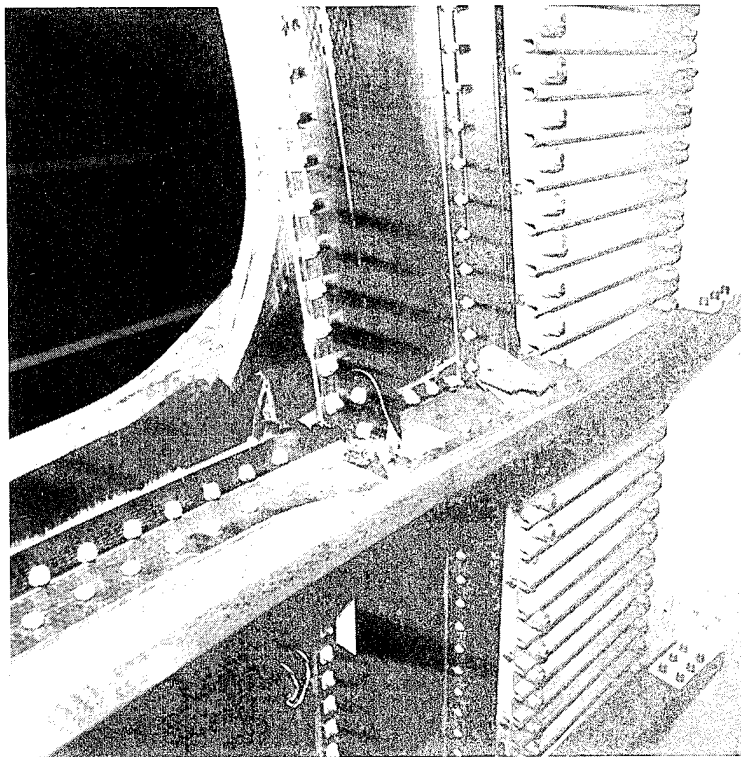
**Figure 5-48. Group D Window Belt Panel — Failure of Skin, Longerons, and Frame**

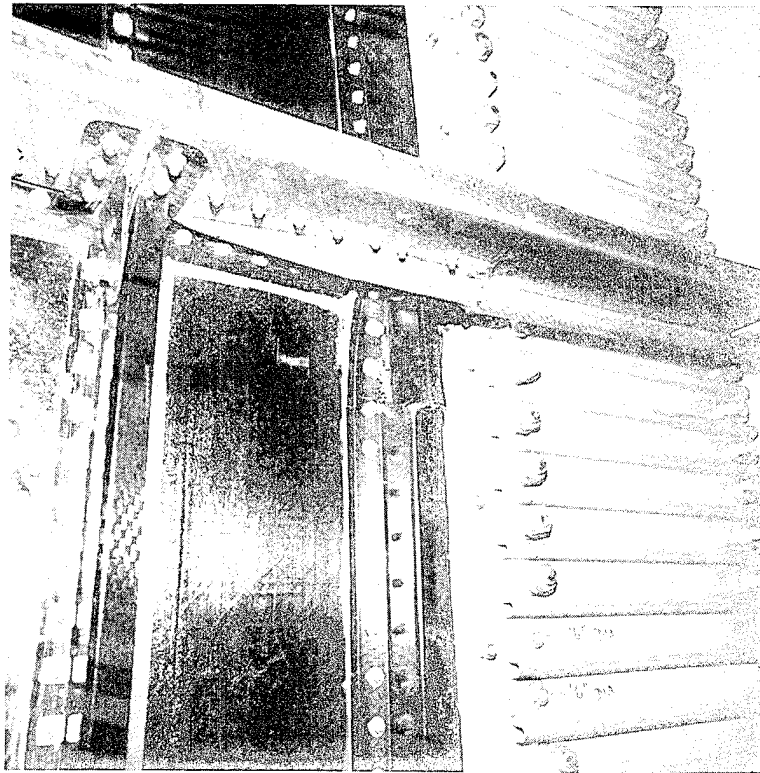
**Figure 5-49. Group D Window Belt Panel — Failure of Skin, Longerons, and Frame**

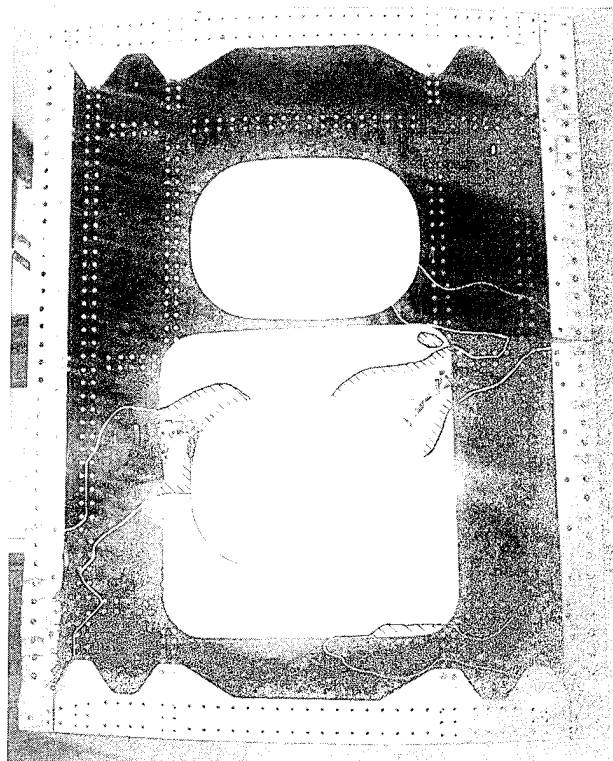
**Figure 5-50. Group D Window Belt Panel — Areas of Skin Damage Detected by NDI**
