Technical Report HL-96-18  
September 1996

# Channel Stability Study, Flamingo Wash, Las Vegas, Nevada

by *Ronald R. Copeland, Lisa C. Hubbard*

Prepared for U.S. Army Engineer District, Los Angeles

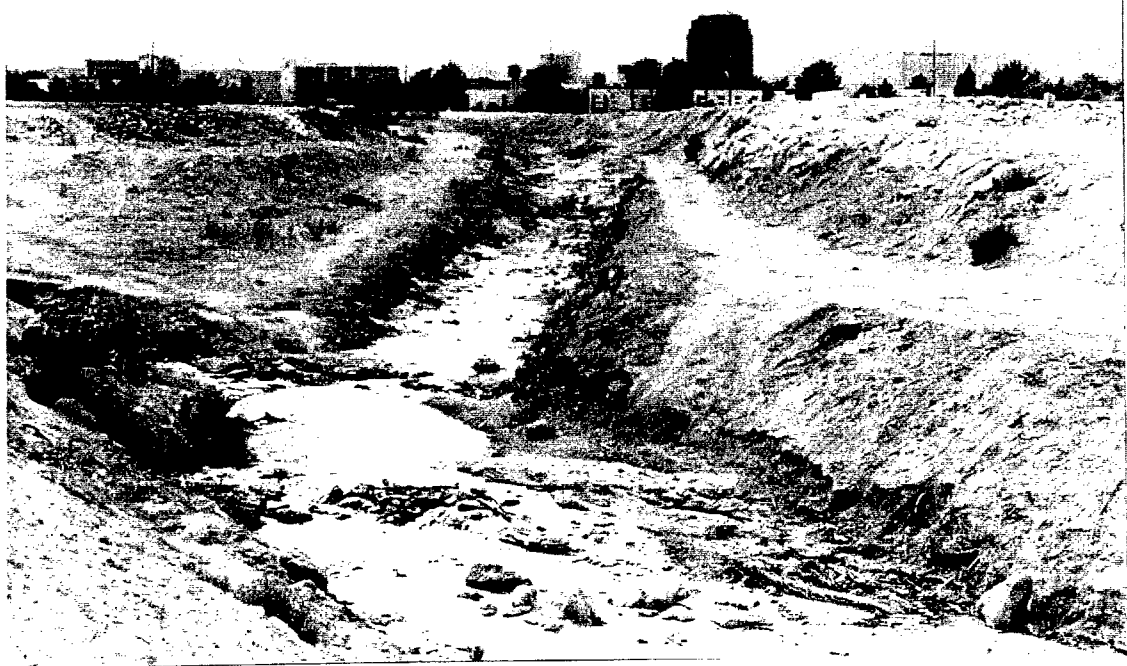
Figure 9. Flamingo Wash - Reach 6, looking upstream from the Tropicana Wash confluence, April 1995

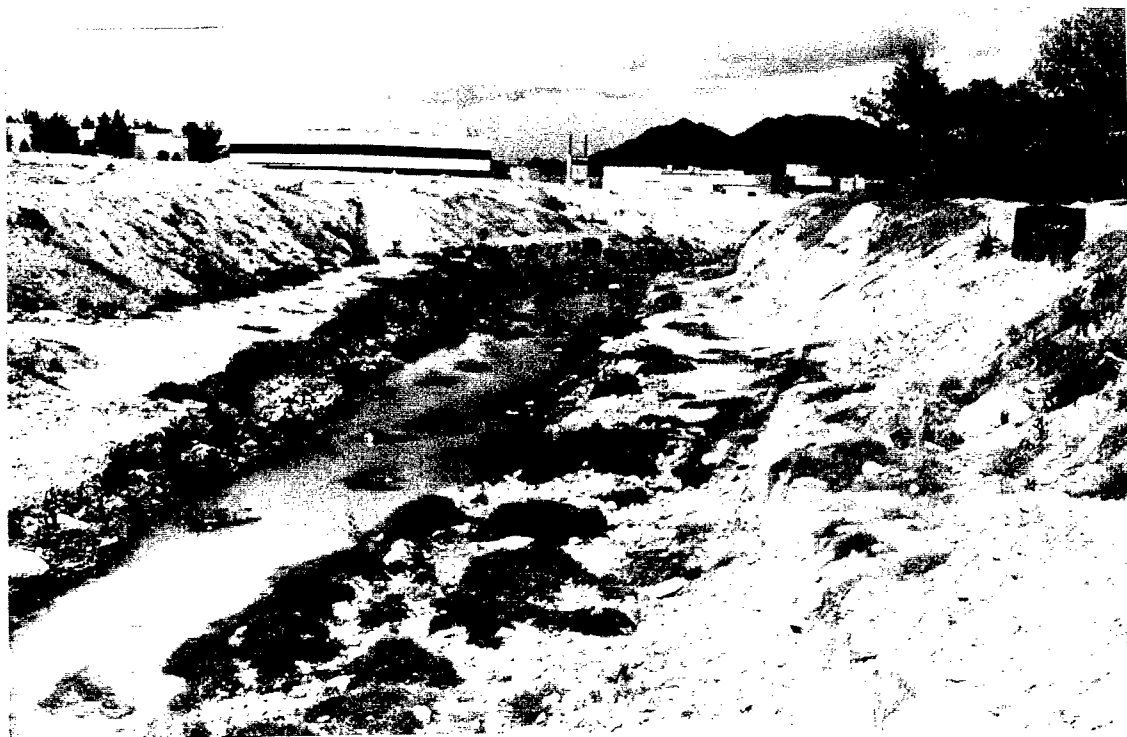
Downstream from Cambridge Street the graded channel generally had a trapezoidal shape with a 10-ft-wide low-flow channel cut to a depth of 4 to 5 ft (Figure 10). The nearly vertical upper banks consisted of sand and gravel. The bank material was quite hard even though the presence of significant cohesive material was not apparent. The upper layers of these banks were composed of loose material. Concrete-lined bank protection extended about 100 ft upstream from Maryland Parkway on the right bank, and about 300 ft upstream on the left bank. The concrete-lined side slopes were not keyed into the bed. Generally, the bottom elevation of the slab was at the existing channel bed elevation. However, erosion had occurred at the base of the lined side slopes at several locations (Figure 11). Further erosion could undercut the slabs and cause failure along a significant reach of the channel. Geometric irregularity associated with slab failure would accelerate the local erosion process. A plan view of reach 7 is shown in Plate 7.

Figure 10. Flamingo Wash - Reach 7, looking downstream from Cambridge Street, April 1995

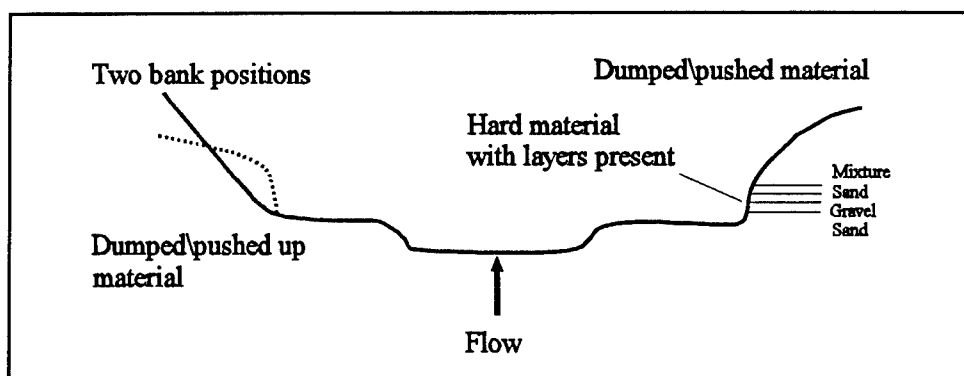
Figure 13. Flamingo Wash - Reach 8, Typical channel cross section between Maryland Parkway and concrete-lined channel

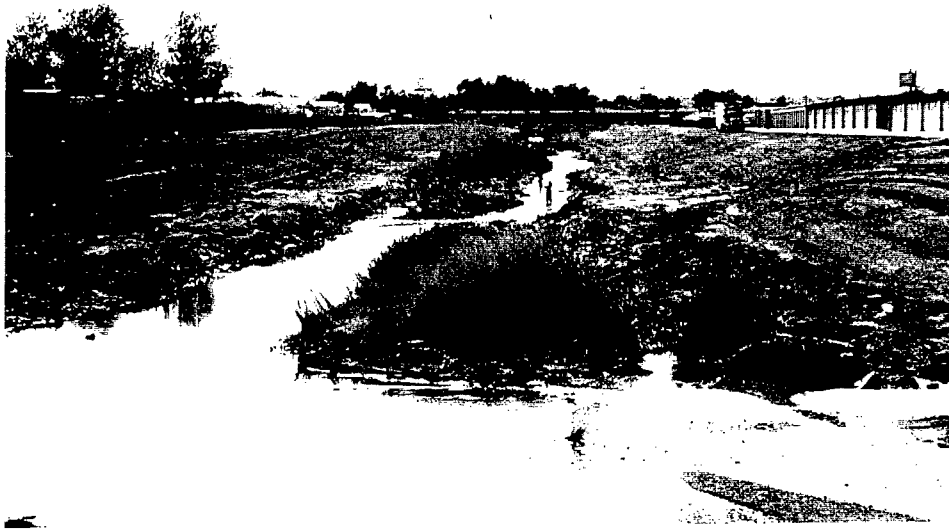
Downstream from Interstate 515 was a graded trapezoidal channel with a cut low-flow channel. The low-flow channel became more poorly defined as it approached Lamb Boulevard. The main channel in this reach was wider, and the banks were not as steep as further upstream. In August 1994 meandering was observed in the 1- to 2-ft deep and 30- to 40-ft wide low-flow channel. Gabions placed on the right bank, just downstream from Interstate 515, were in danger of failing due to backwashing. Other than this short reach of gabions there was no bank protection in the reach. In August 1994 grass that had been growing in the channel bed was yellow and appeared to have been recently sprayed with herbicide. The low-flow channel had been reshaped by April 1995, removing signs of deposition and meandering (Figures 22 and 23).

Figure 22. Flamingo Wash - Reach 16, looking upstream from Lamb Boulevard, August 1994

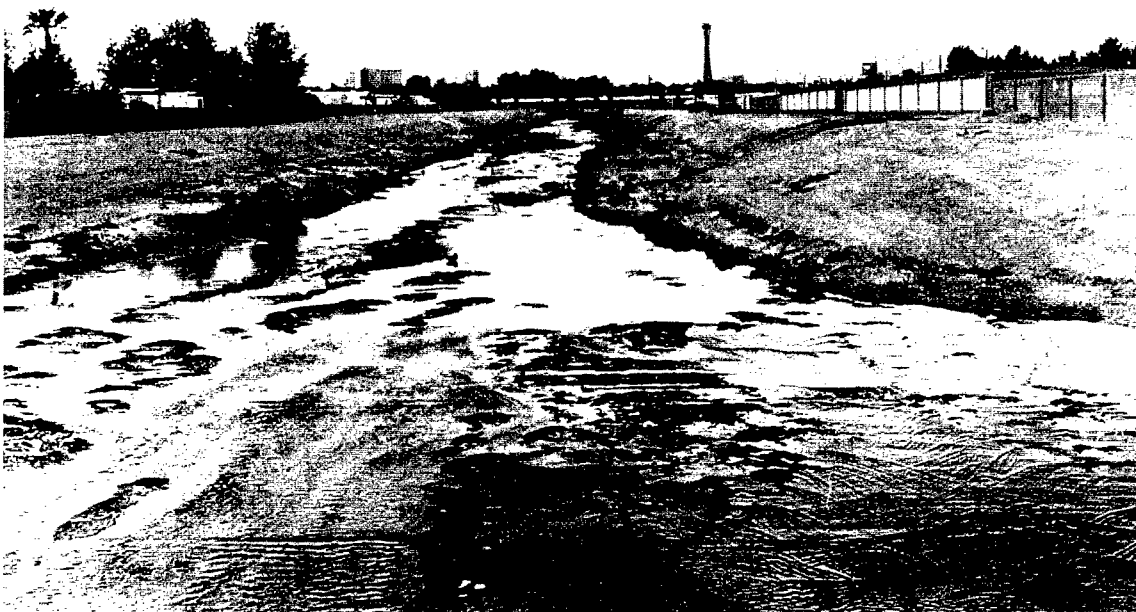
Figure 23. Flamingo Wash - Reach 16, looking upstream from Lamb Boulevard, April 1995

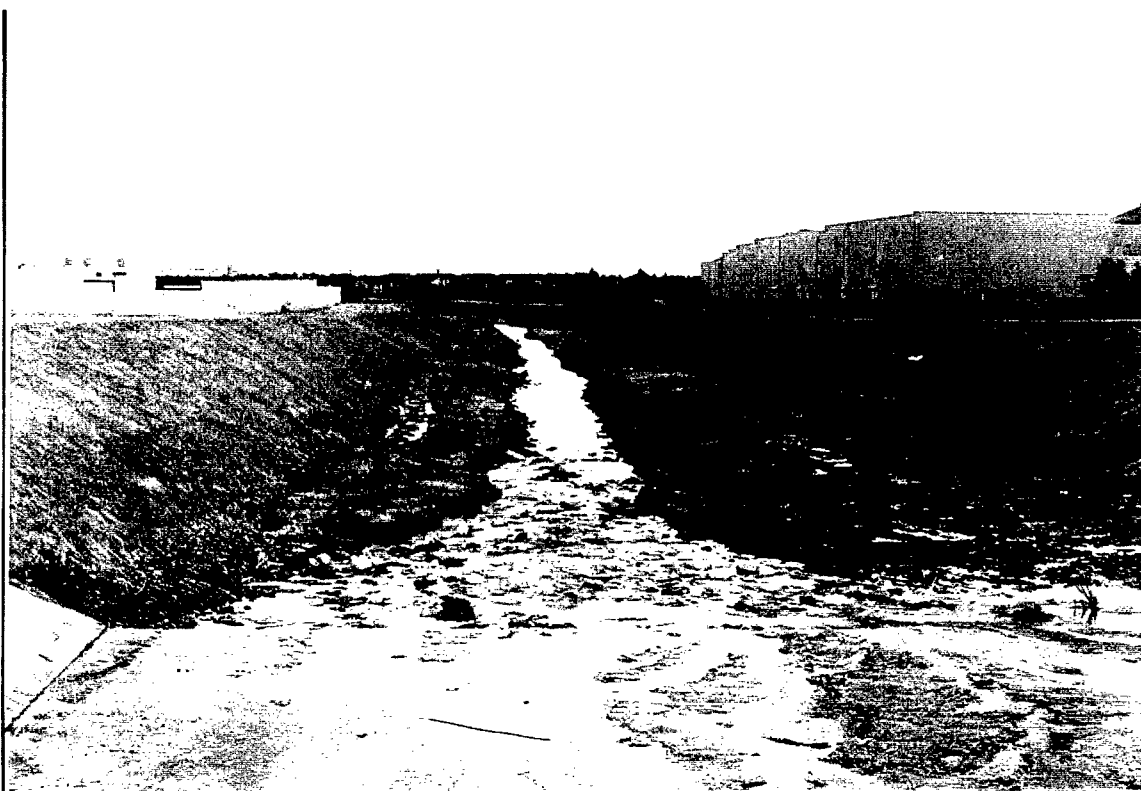
Figure 25. Flamingo Wash - Reach 17, looking downstream from Lamb Boulevard, April 1995
