DSTO-TR-0366

Evaluation of Innovative NDI
Methods for Detection of
Widespread Fatigue Damage

P. Khan Sharp,
D.E. Rowlands and G. Clark

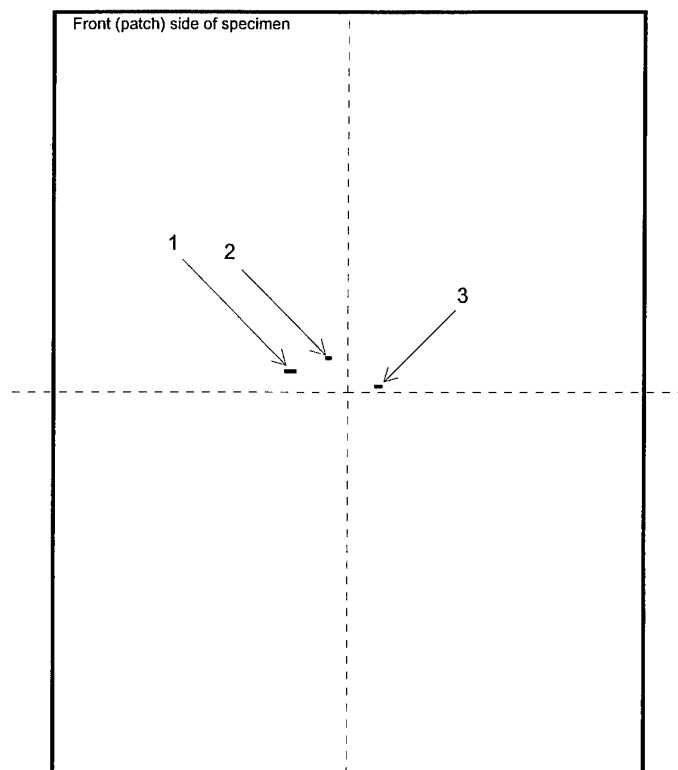
The crack was located approximately 58 mm from the left hand edge. Though there were still indications at approximately 65 mm and 70 mm the signal was being dominated by the crack located 58 mm from the edge. This indicates that there was one large crack at 58 mm and two small cracks at 65 mm and 70 mm. The fact that the zero load differential reading was slowly creeping up also indicated that a crack was present.

Figure 23: A schematic of the location of the three cracks detected by the structural integrity monitor (Model 2). Crack No.1 was large and starting to swamp the signal from cracks No. 2 and No. 3.

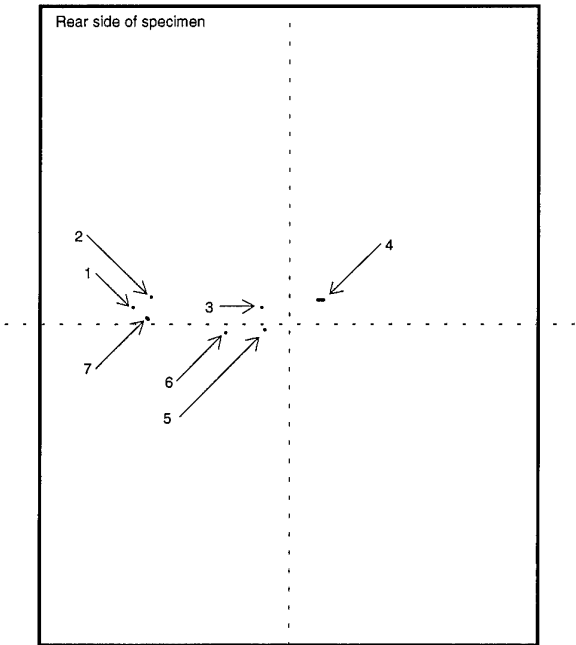
Figure 28 is a schematic of the crack locations observed after program 29. Plate No. 24 clearly shows a number of cracks present, Figure 29.

Figure 28: More cracks were located as shown in this schematic. Note that crack No.4 does not appear on this image.

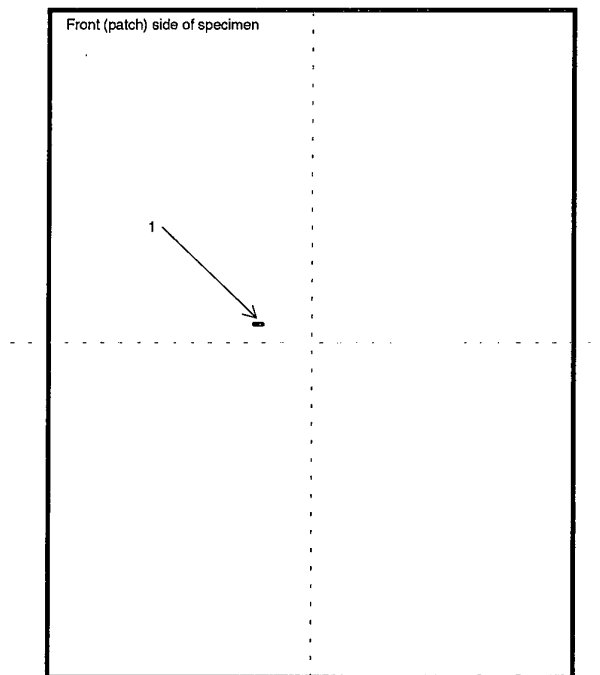
The structural integrity monitor patch was removed from the front of the specimen and a hologram taken of the specimen front. Figure 30 shows the location of the crack found by holographic interferometry, Figure 31. There are indications of three other cracks. The located crack is the main crack found by the structural integrity monitor.

Figure 30: A schematic of the large crack located on the structural integrity monitor side after the patch was removed. The location agrees with the large crack found by the structural integrity monitor.

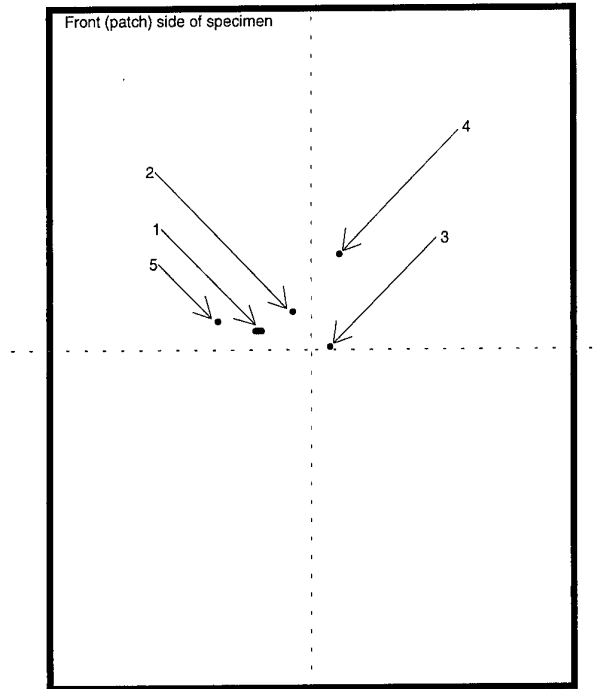
Figure 35: The five cracks located by fluorescent dye penetrant on the front of the specimen (structural integrity monitor side). The visual intensities are a good indication of the crack size and are as follows; crack 1-very bright, crack 2-bright, crack 3-bright, crack 4-weak and crack 5-weak
