RECONNAISSANCE REPORT OF DAMAGE TO HISTORIC MONUMENTS IN CAIRO, EGYPT FOLLOWING THE OCTOBER 12, 1992 DAHSHUR EARTHQUAKE

**Reconnaissance Report of Damage
to Historic Monuments in Cairo, Egypt
Following the October 12, 1992 Dahshur Earthquake**

Technical Report NCEER-93-0016

August 19, 1993

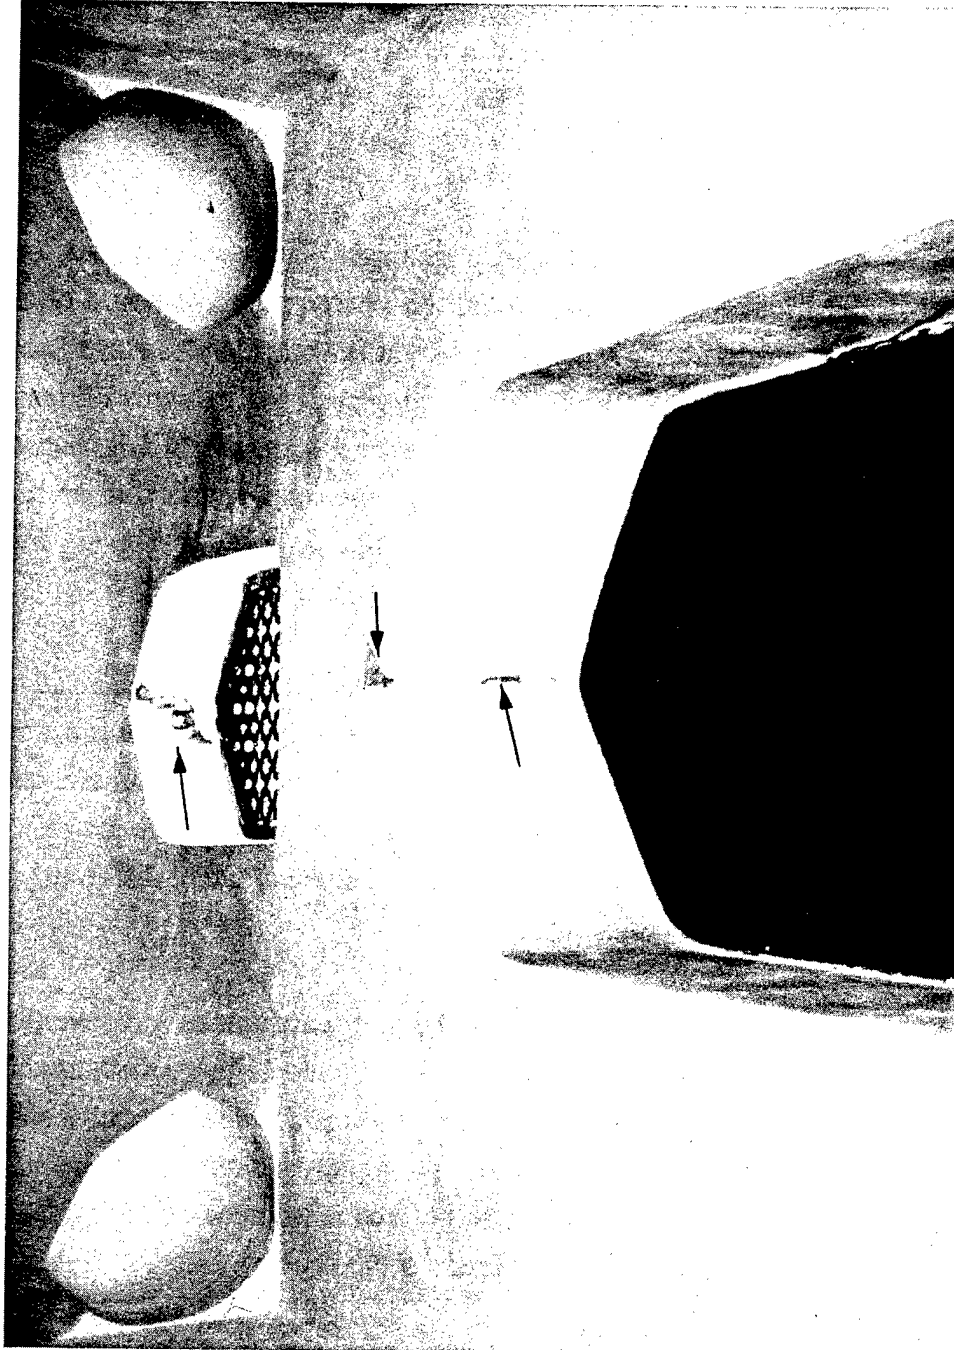
FIGURE 4-10 Wall and small dome at Abu Sufein Church showing cracks and spalling at top of arches

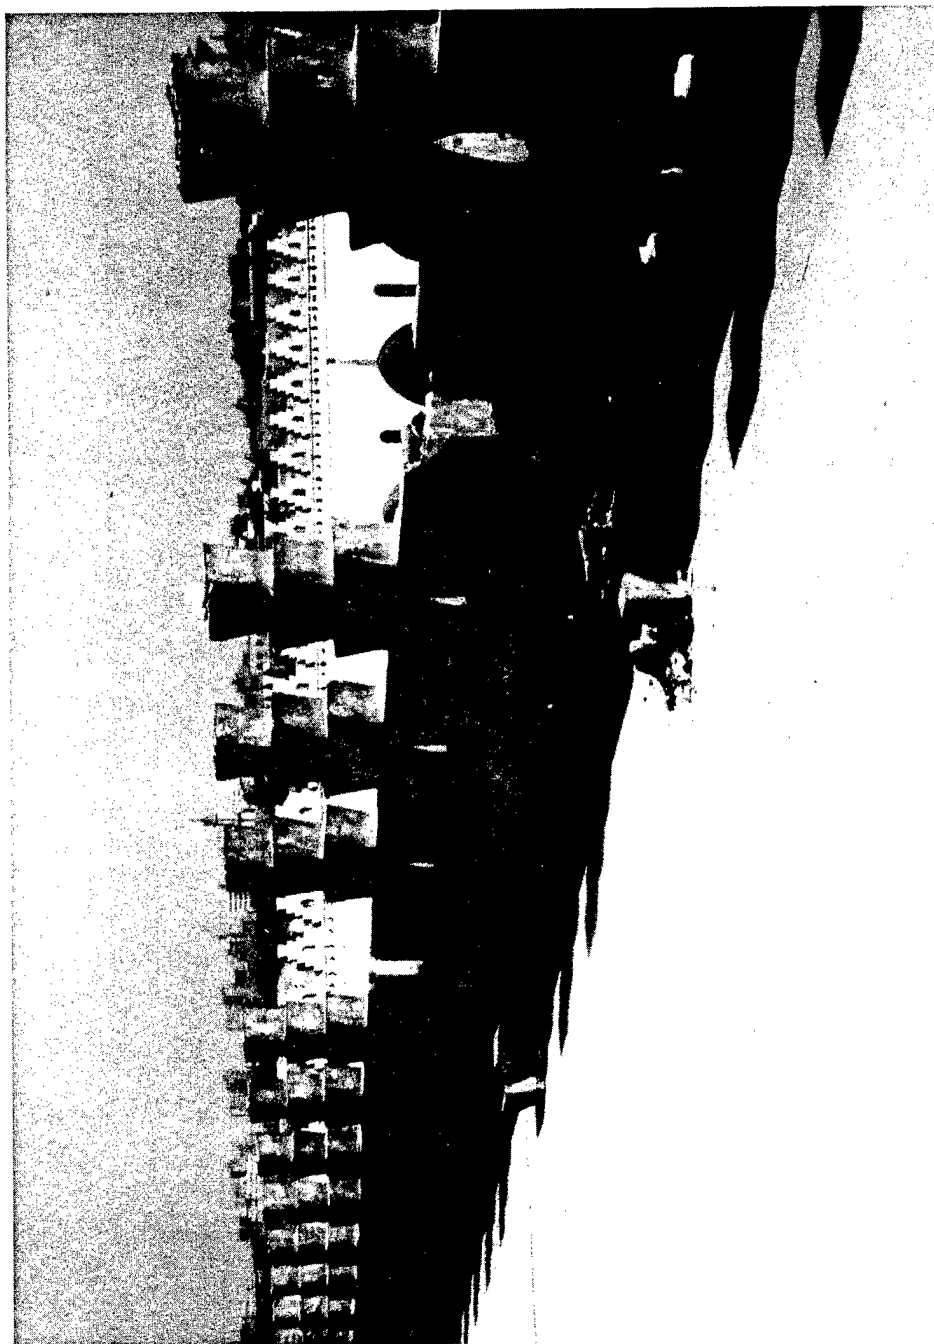
FIGURE 4-15 Walkway above arcade at al-Hākim Bi-Amrillāh Mosque
showing fallen parapets

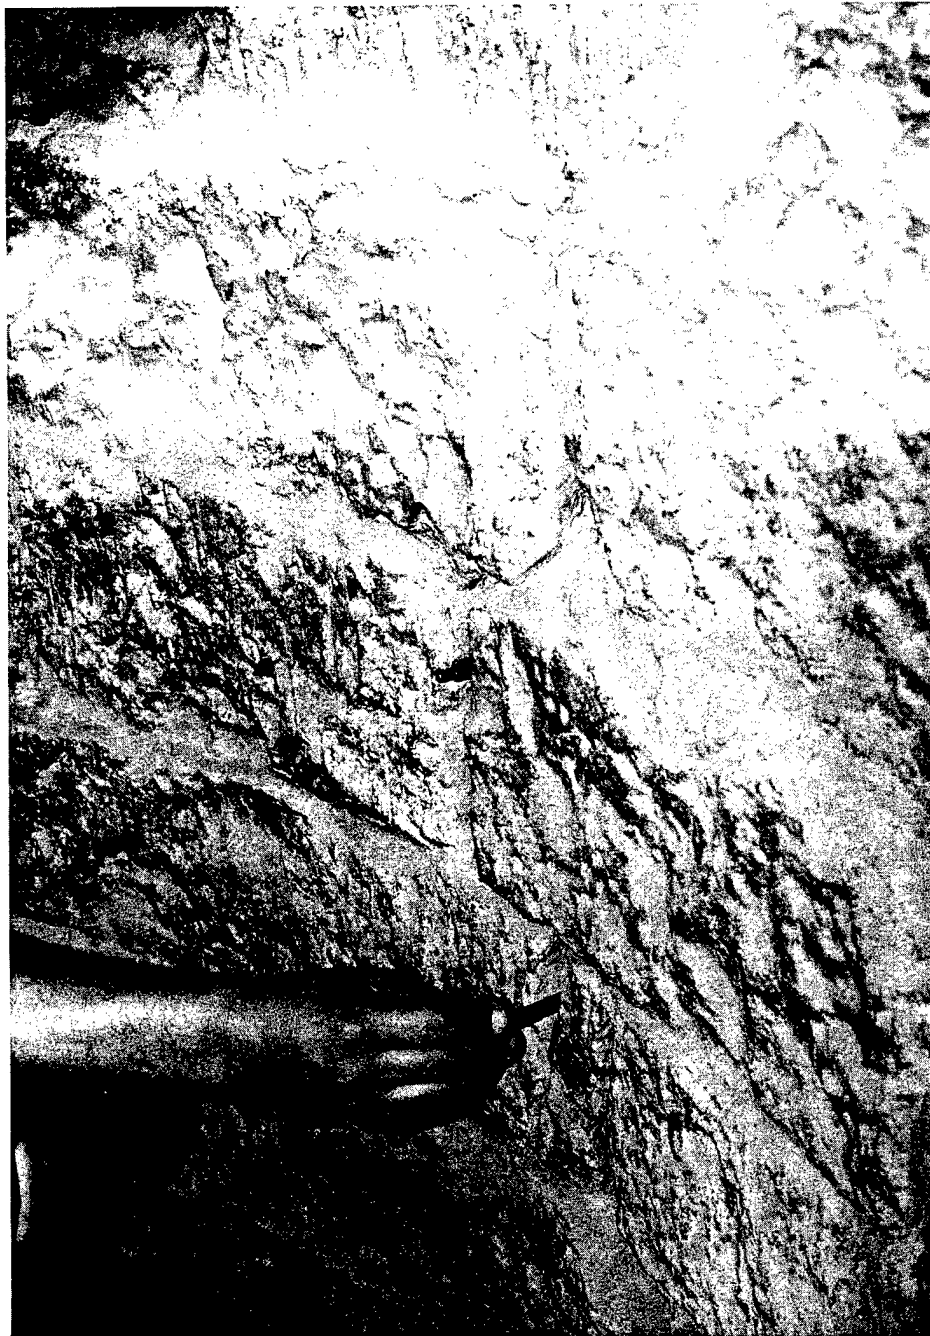
FIGURE 4-29 Interior of southern minaret wall at Mosque, Mausoleum, and Madrasa of Sultān Hasan showing large vertical crack

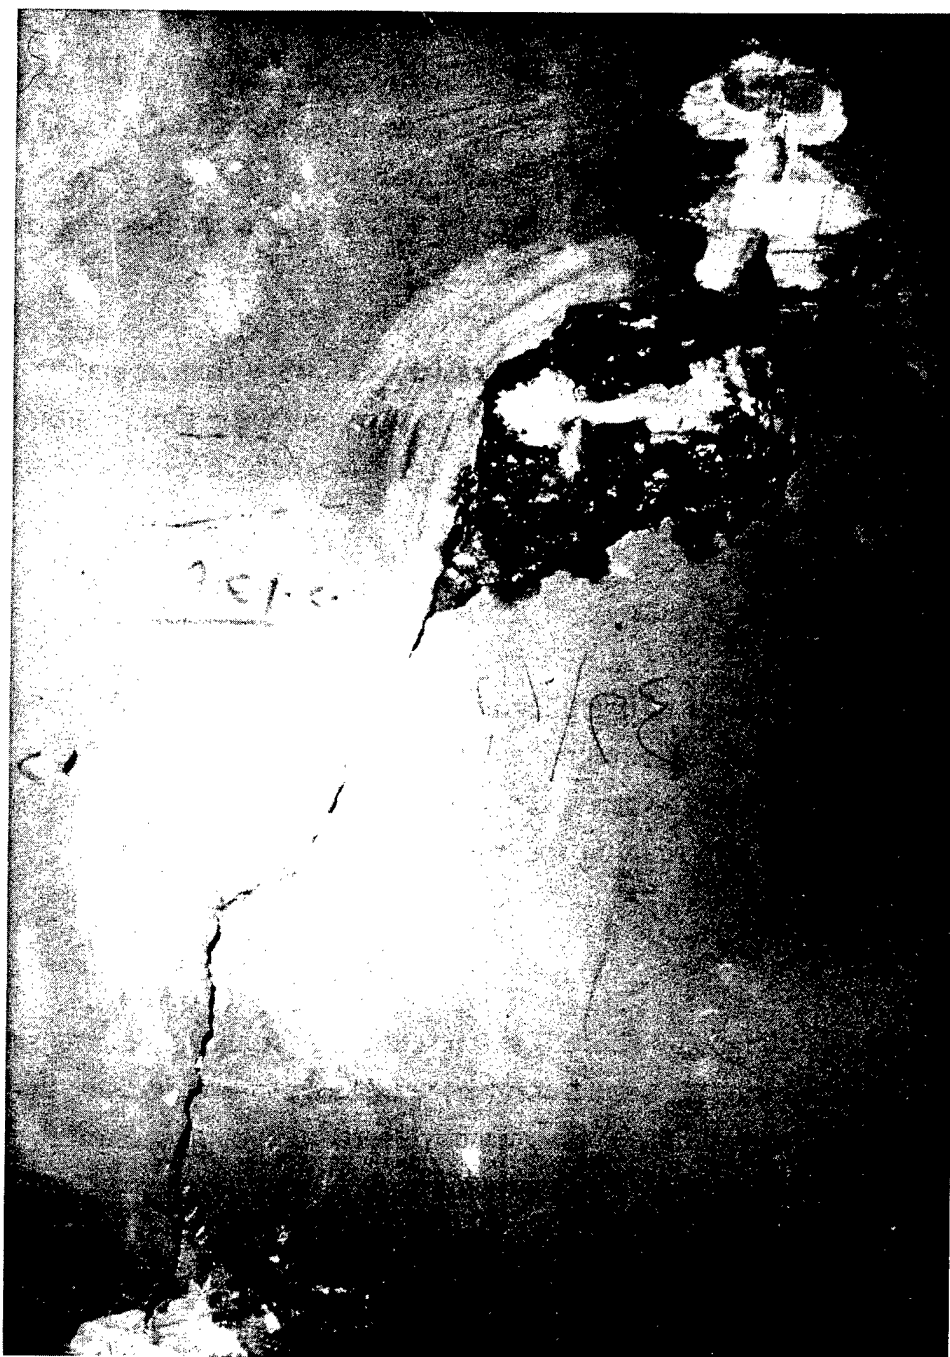
FIGURE 4-39 Interior wall of el-Moalloqa Church showing cracks and deformations

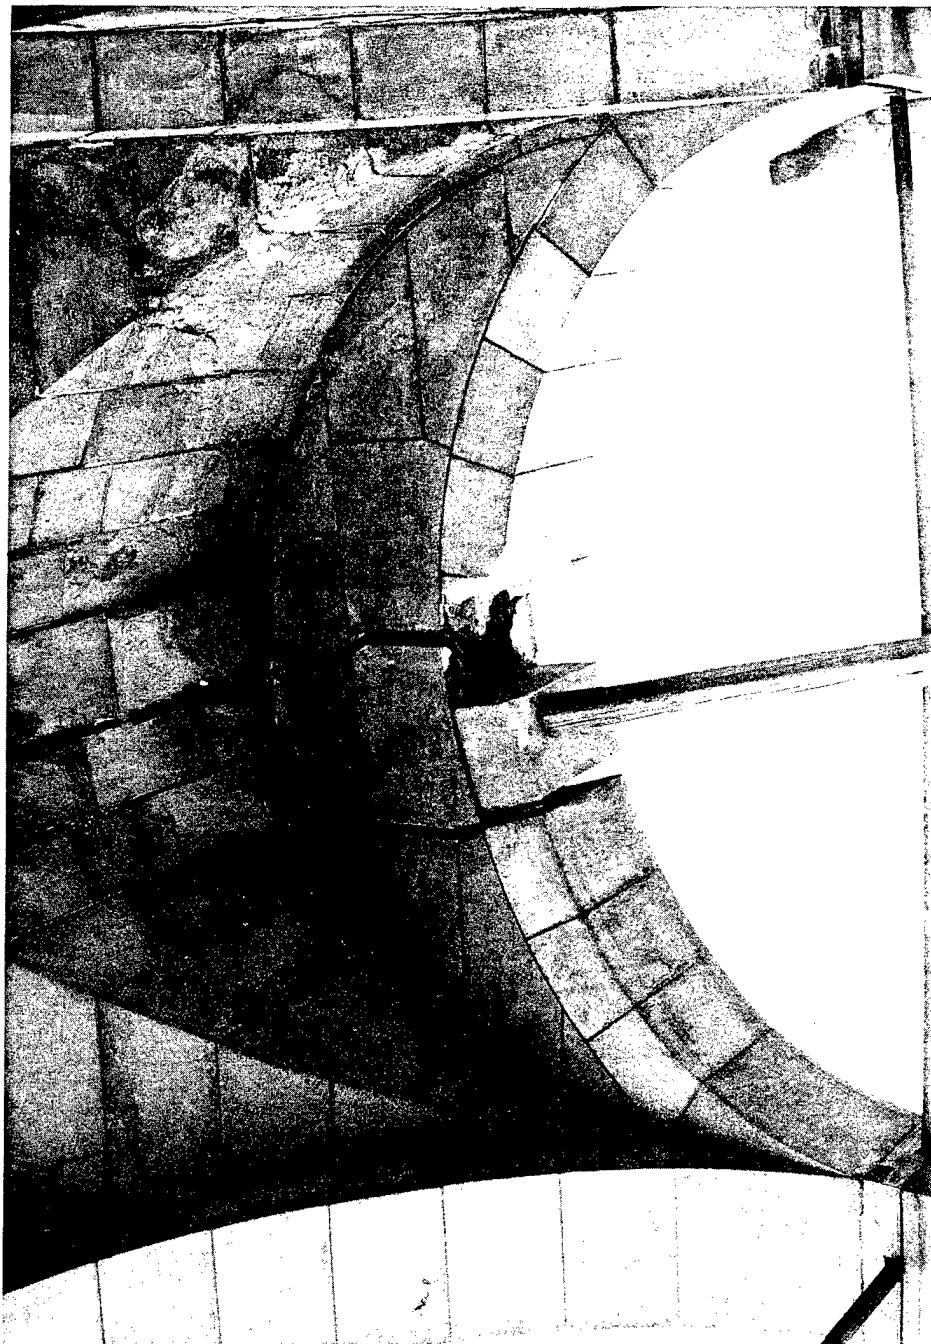
FIGURE 4-49 Arch of portico to Saraya el-Adl at Citadel showing missing stone, large cracks, separation, and distortion

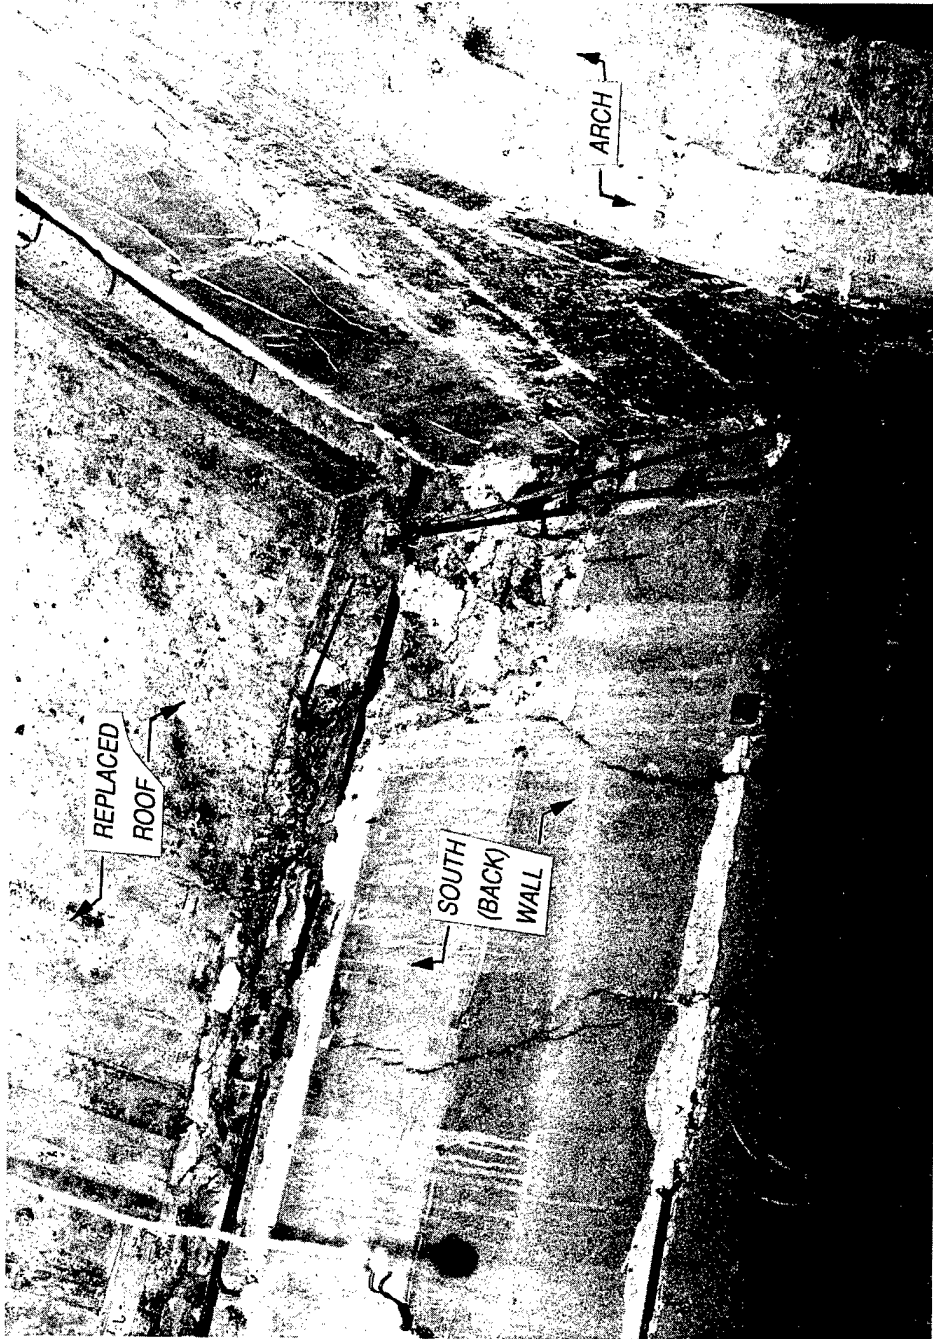
FIGURE 4-51 Interior south wall of Saraya el-Adl looking up at contact between wall, arch, and concrete ceiling showing cracks, separation, and distortions

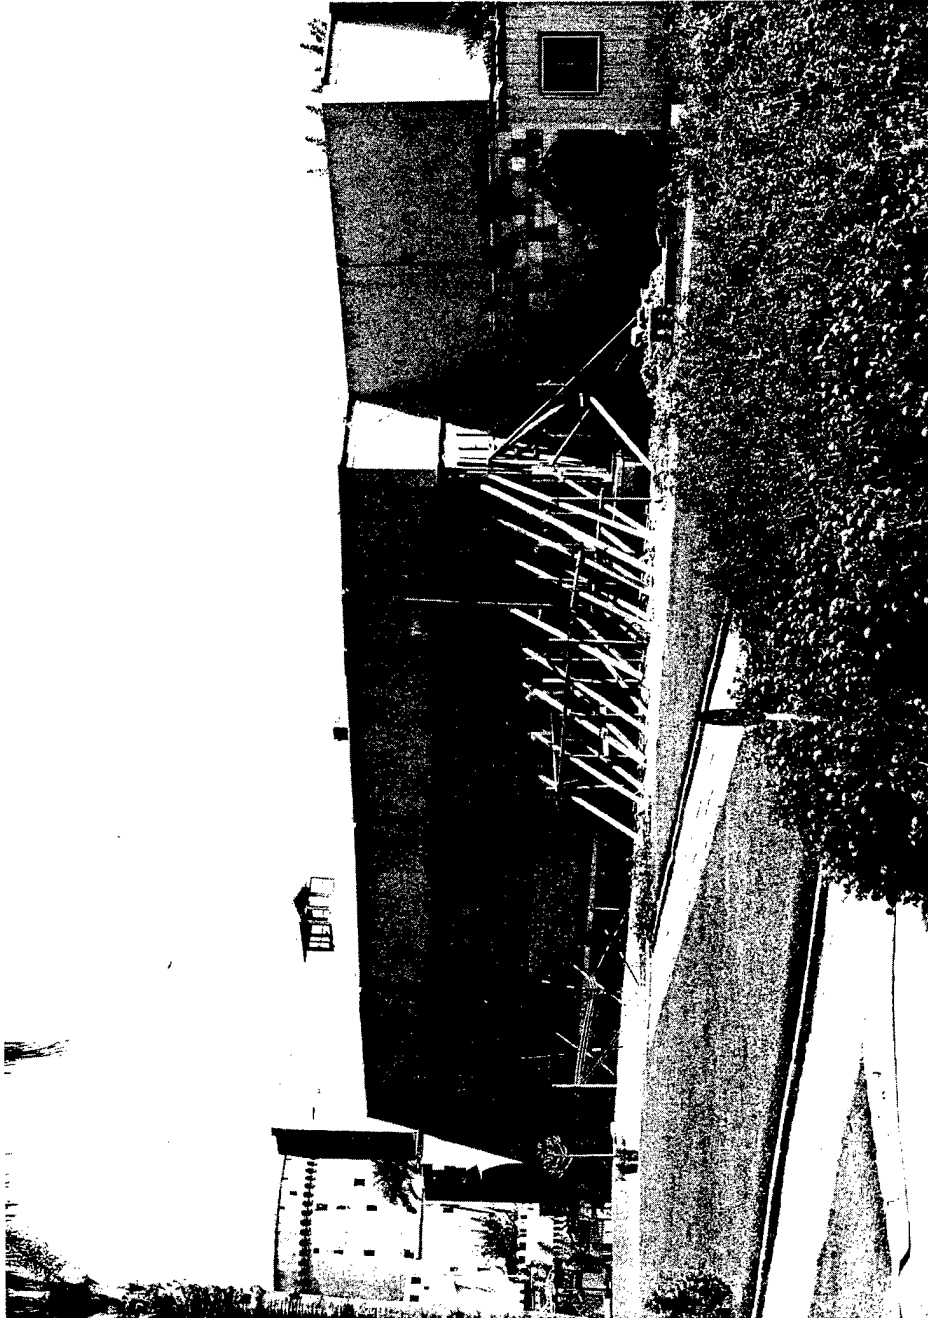
The Mint at the Citadel is a small, one-story, stucco-covered brick structure located near the Bāb al-Gabal. Damage to walls and small domes of the structure was extensive but very isolated to the southwest corner as shown in figures 4-52 and 4-53. External bracing had been placed but the cracks seemed to widen over the week of the team's visit. The combination of the severity and isolated nature of this damage suggests that fill and/or rubble exists beneath the foundation at this corner. Underpinning of the foundation may provide a means to correct this problem and prevent severe damage in the future.

FIGURE 4-52 Collapsed southwest corner of Mint at Citadel showing large crack and separation and external bracing
