ARMY RESEARCH LABORATORY

# Investigation of Corrosion on Inland Petroleum Distribution System Aluminum Pipe Grooved Ends Caused by Rubber Gaskets

ARL-TR-1449

August 1997

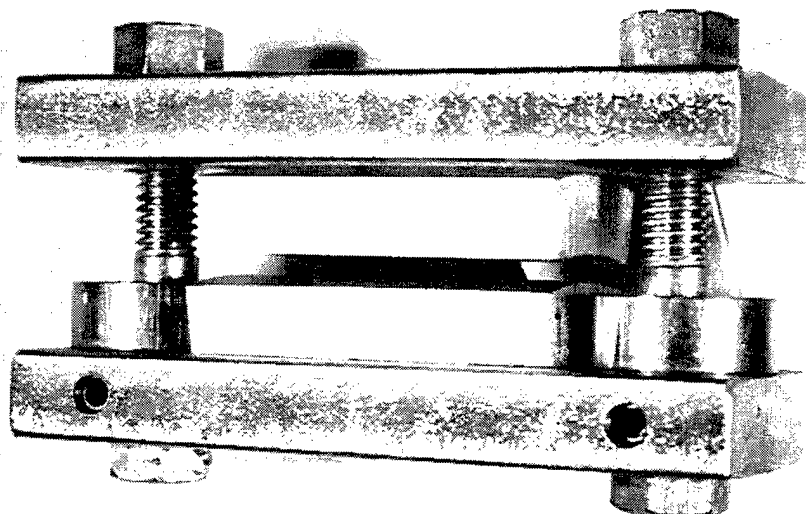
Figure 4. View of the flat rubber specimen placed between two small, curved aluminum pipe pieces in the stainless steel clamp for the accelerated corrosion test (actual size). The specimen is in contact with both bare aluminum surfaces.
