Technical Report CHL-97-17  
August 1997

# Periodic Inspection of Humboldt Bay Jetties, Eureka, California

## Report 1

### Base Conditions

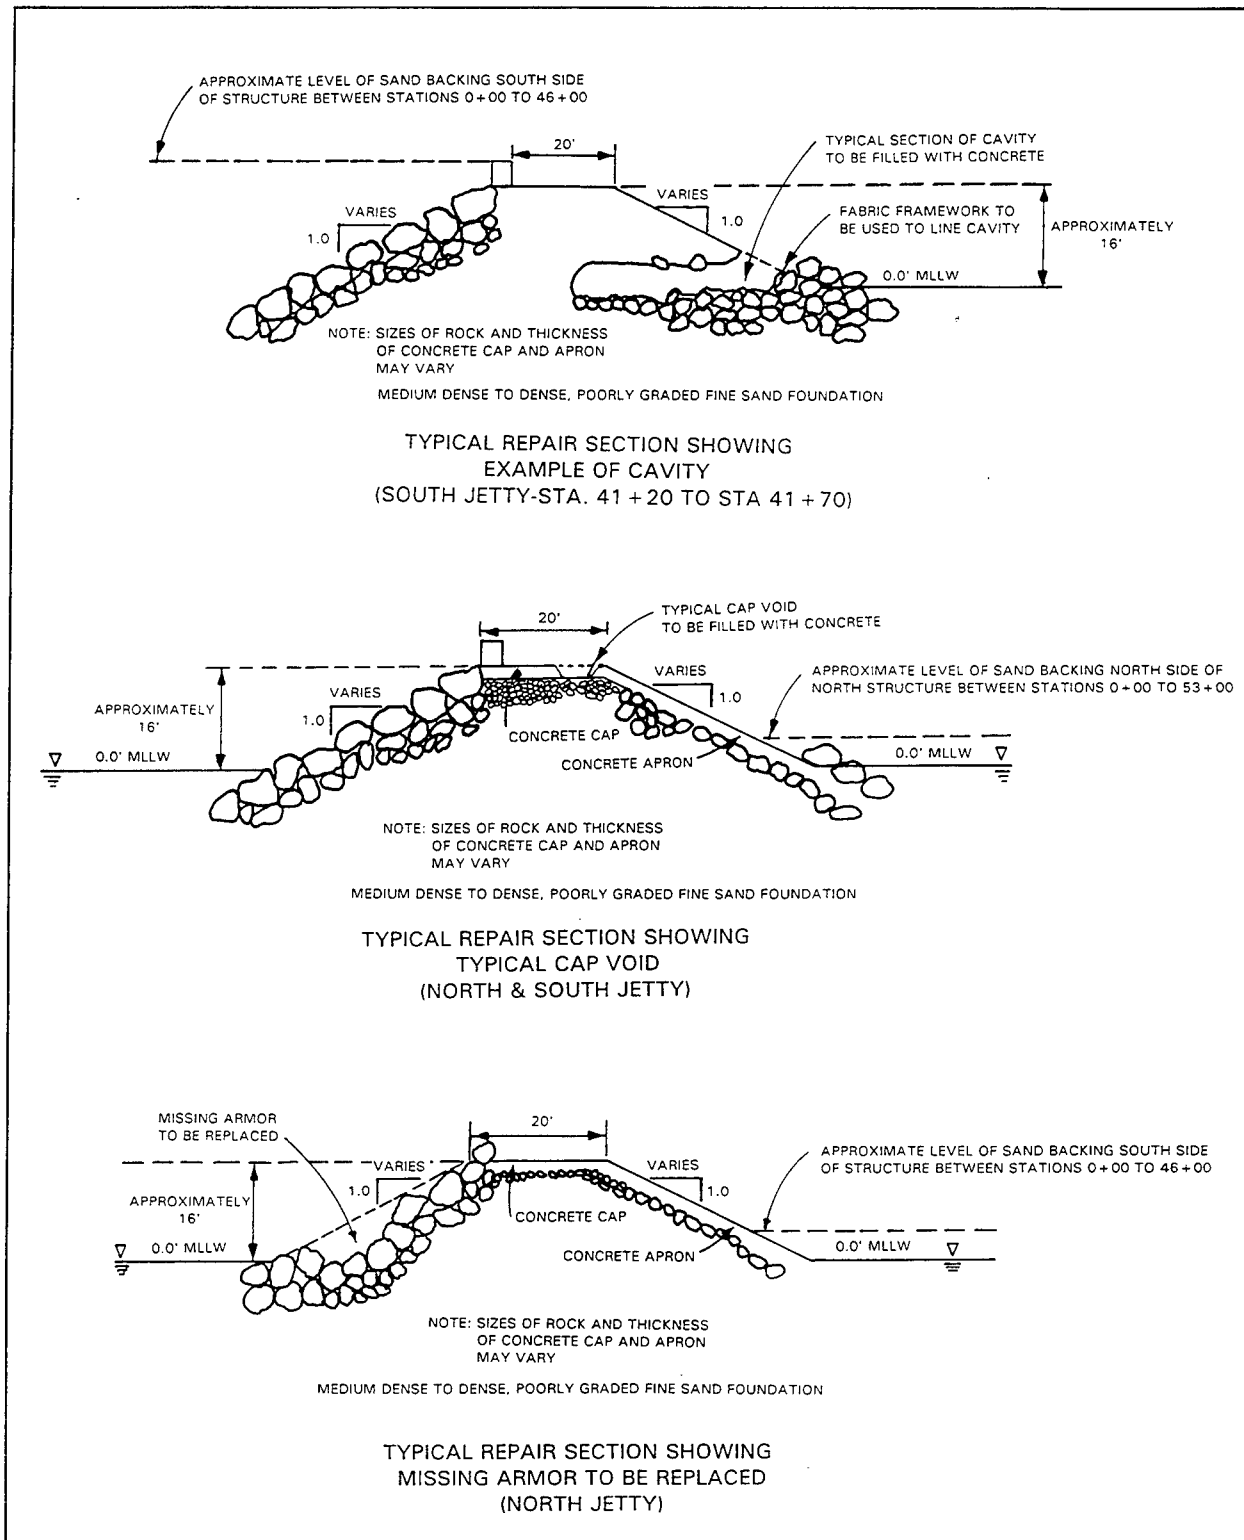
In 1988, substantial repair work was done on both of the jetties. Repairs involved the use of approximately 181,440 kg (2,000 tons) of stone for slope repair and 765 cu m (91,000 cu yd) of concrete for the filling of voids in the structure (USAED, San Francisco 1988). Figure 5 shows typical repairs made in 1988, and Figure 6 provides a plan view of Humboldt Bay, the jetty structures, and the navigation channels as of December 1994.

Figure 5. Typical repairs made to jetties in 1988

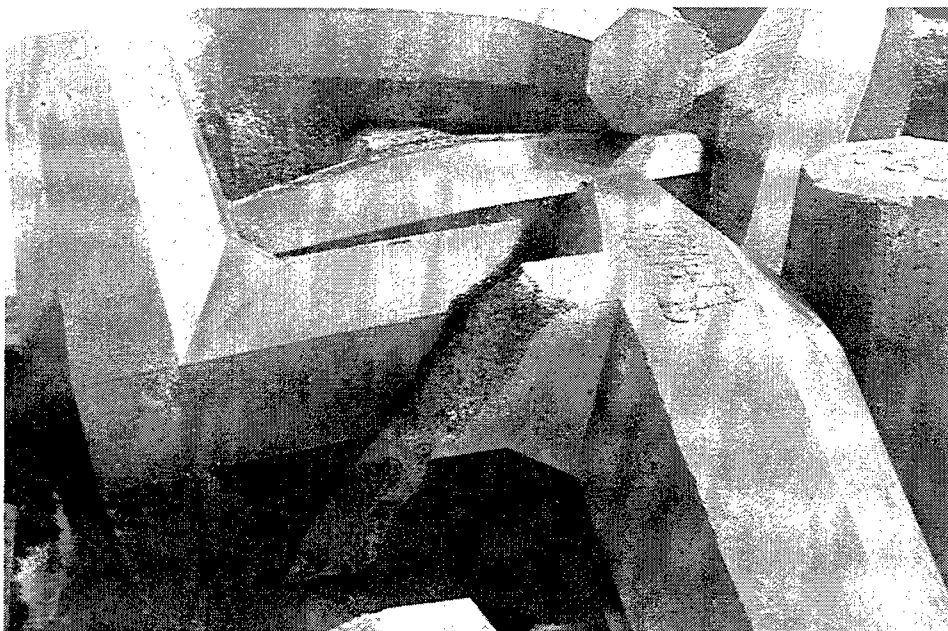
approximate center line of the structure. At the heads of the structures the baselines were projected seaward along the axis of the jetties. Thirty-four broken or cracked dolosse (seventeen on each jetty) were identified during the walking survey. Armor units with hairline cracks on one side were not counted; only those that were cracked all the way through were considered a break for recording purposes. Breaks were categorized as occurring in the shank or the fluke and as straight across or at some angle to the dolos limb. The shank is the central beam of a dolos, and the flukes are the beams on the ends of the armor unit. The broken units on the north jetty consisted of seven mid-shank breaks, eight shank-fluke breaks (shank broken in vicinity of fluke), and five fluke-shank breaks (fluke broken in vicinity of shank). One unit had two breaks. Breaks on the south jetty were characterized as follows: two units, mid-shank breaks; eight units, shank-fluke breaks; and seven units, fluke-shank breaks. Of the 35 breaks, 27 were straight breaks and 8 were angled breaks (approximately 45 deg or greater). Representative broken dolosse are shown in Figures 17-20.

Figure 17. Dolos with angled, mid-shank break

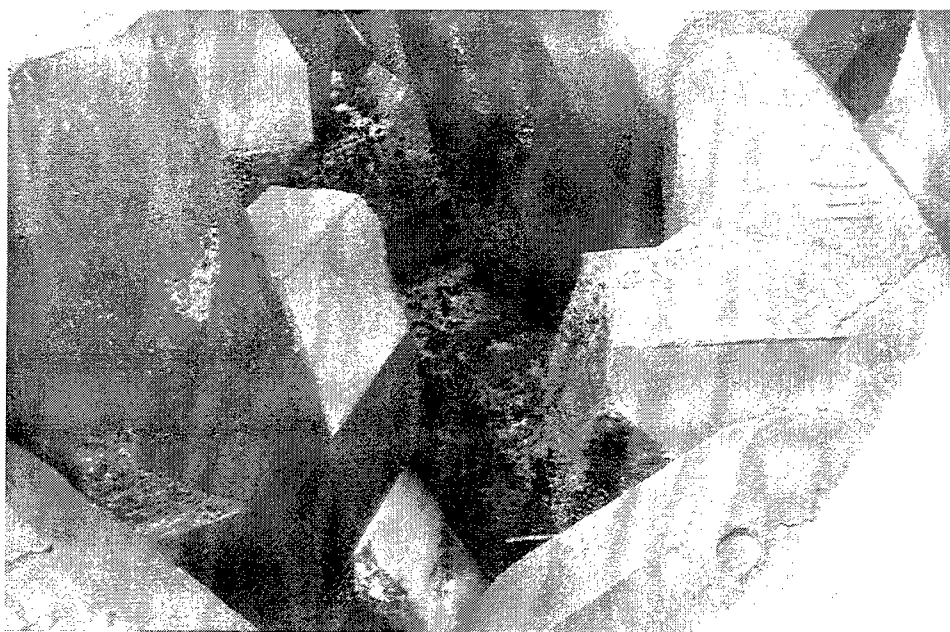
Figure 18. Dolos with straight, mid-shank break

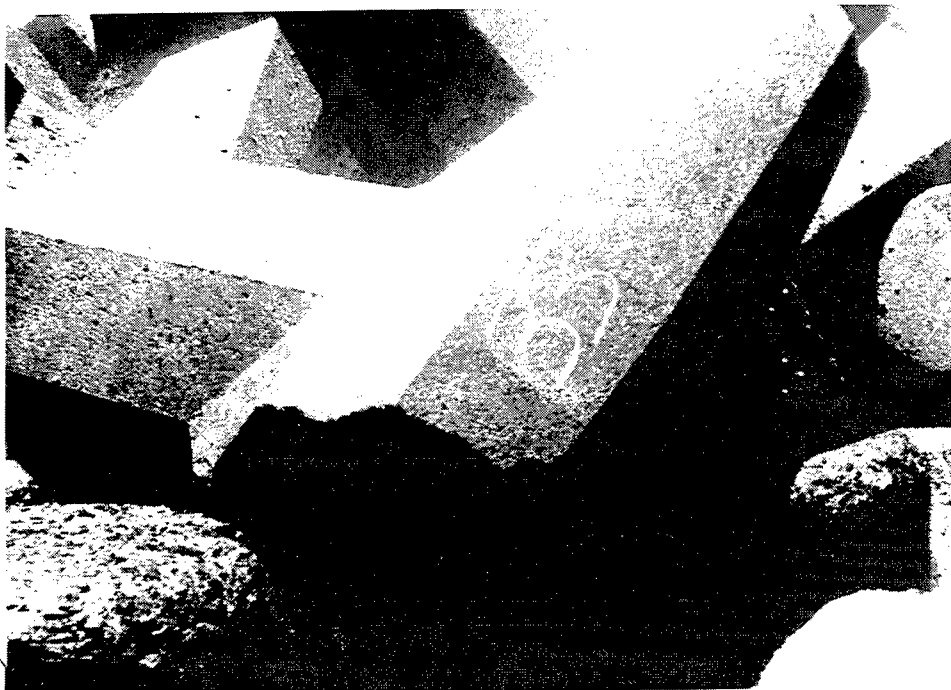
Figure 19. Dolos with straight fluke-shank break

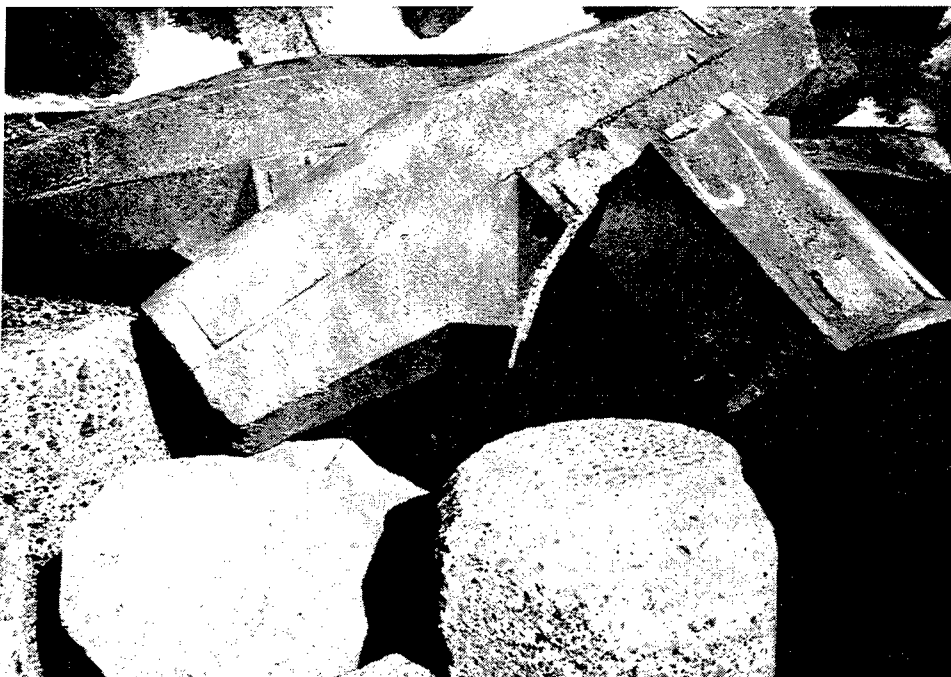
Figure 20. Dolos with straight, shank-fluke break

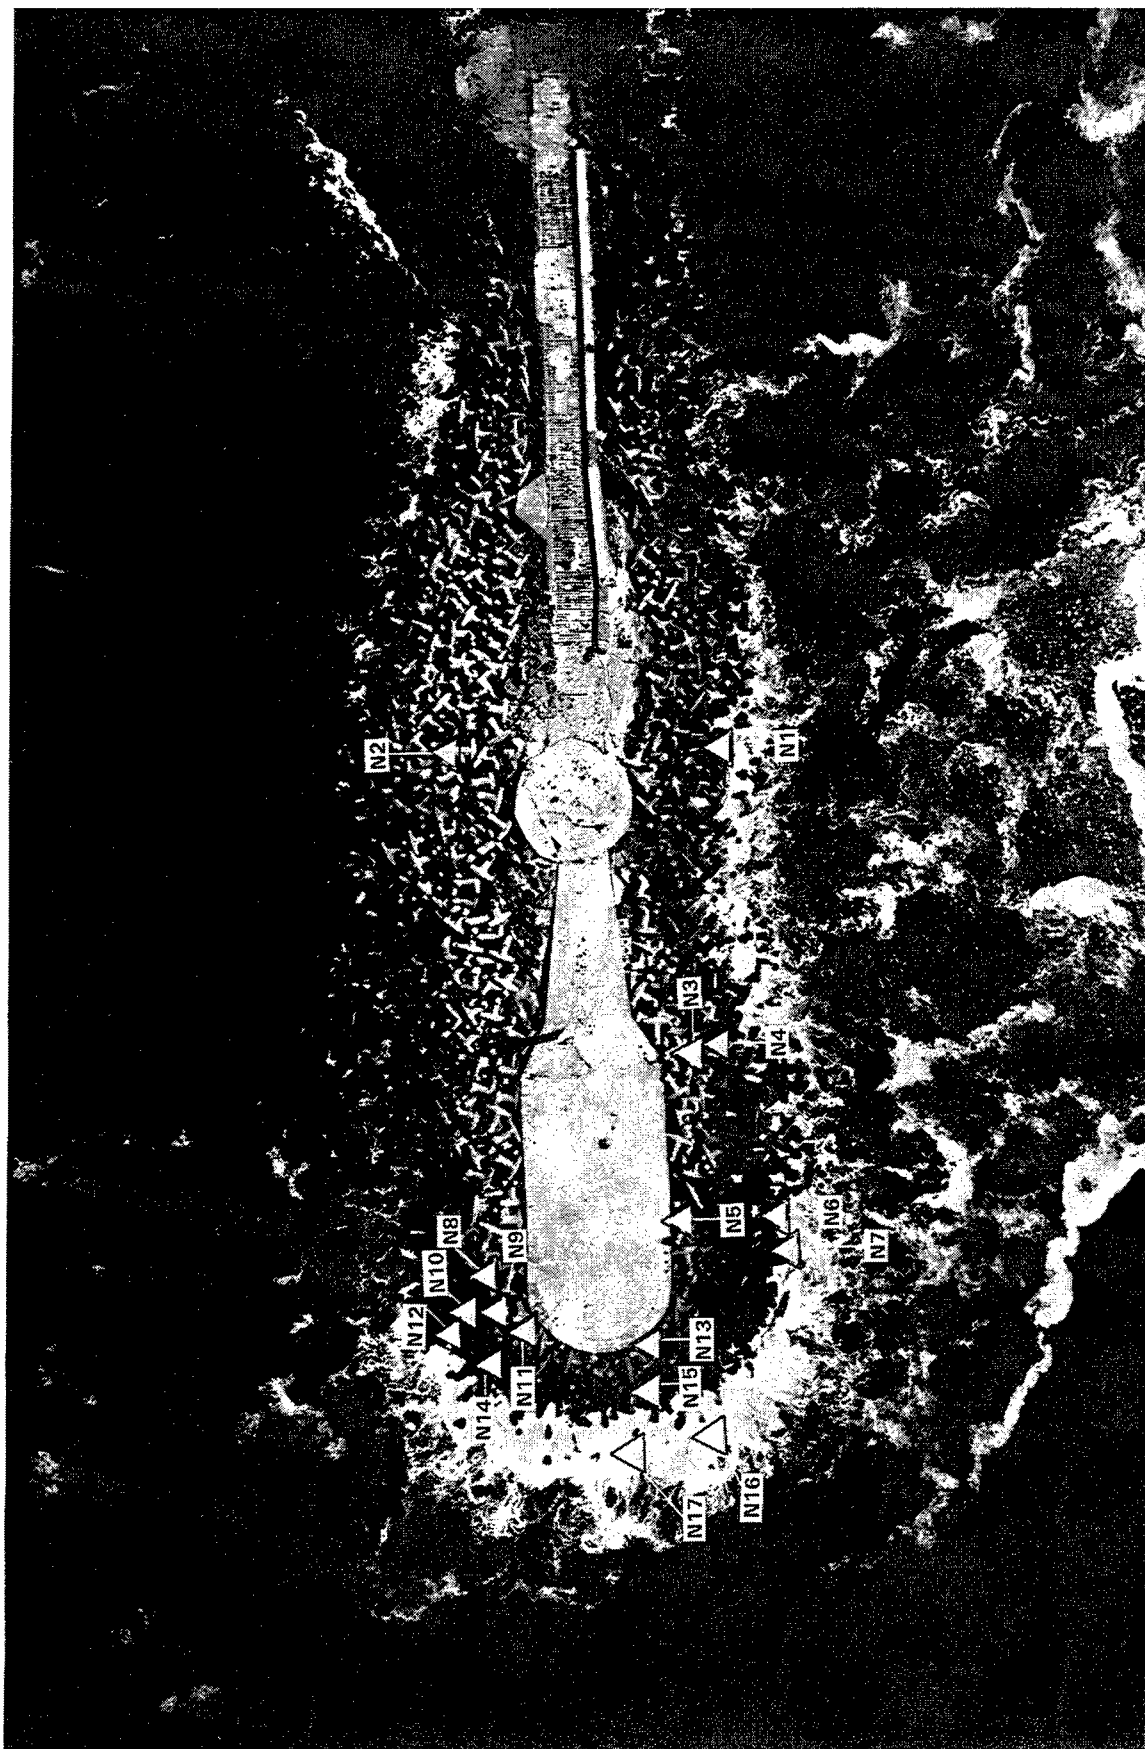
Approximate locations of the broken/cracked dolos armor units are shown in Figures 21 and 22, respectively, for the north and south jetties; and detailed data obtained during the broken armor unit inventory are shown in Table 4. Armor unit numbers identified in Figures 21 and 22 correspond to those listed in Table 4. As shown on the figures, broken units are concentrated along the seaward ends of the jetties. Eighty-eight percent of the broken units on the north jetty and seventy-one percent of those on the south jetty are located around the monolithic structures at the jetty heads. In addition, more broken dolosse were observed on the south sides of the structures than on the north. If the approximate center lines of the jetties are projected seaward along the axes of the structures, 59 percent of the broken units on the north jetty and 65 percent of those on the south jetty are located on the southern side of the jetties. With regard to distance downslope from the jetty caps, most the broken dolosse appear to be located in the active wave zone. Detailed data obtained during the broken armor unit survey will allow for an accurate indication of new breaks when the structure is revisited at some point in the future.

Figure 21. Approximate locations of broken/cracked dolos armor units on the north jetty

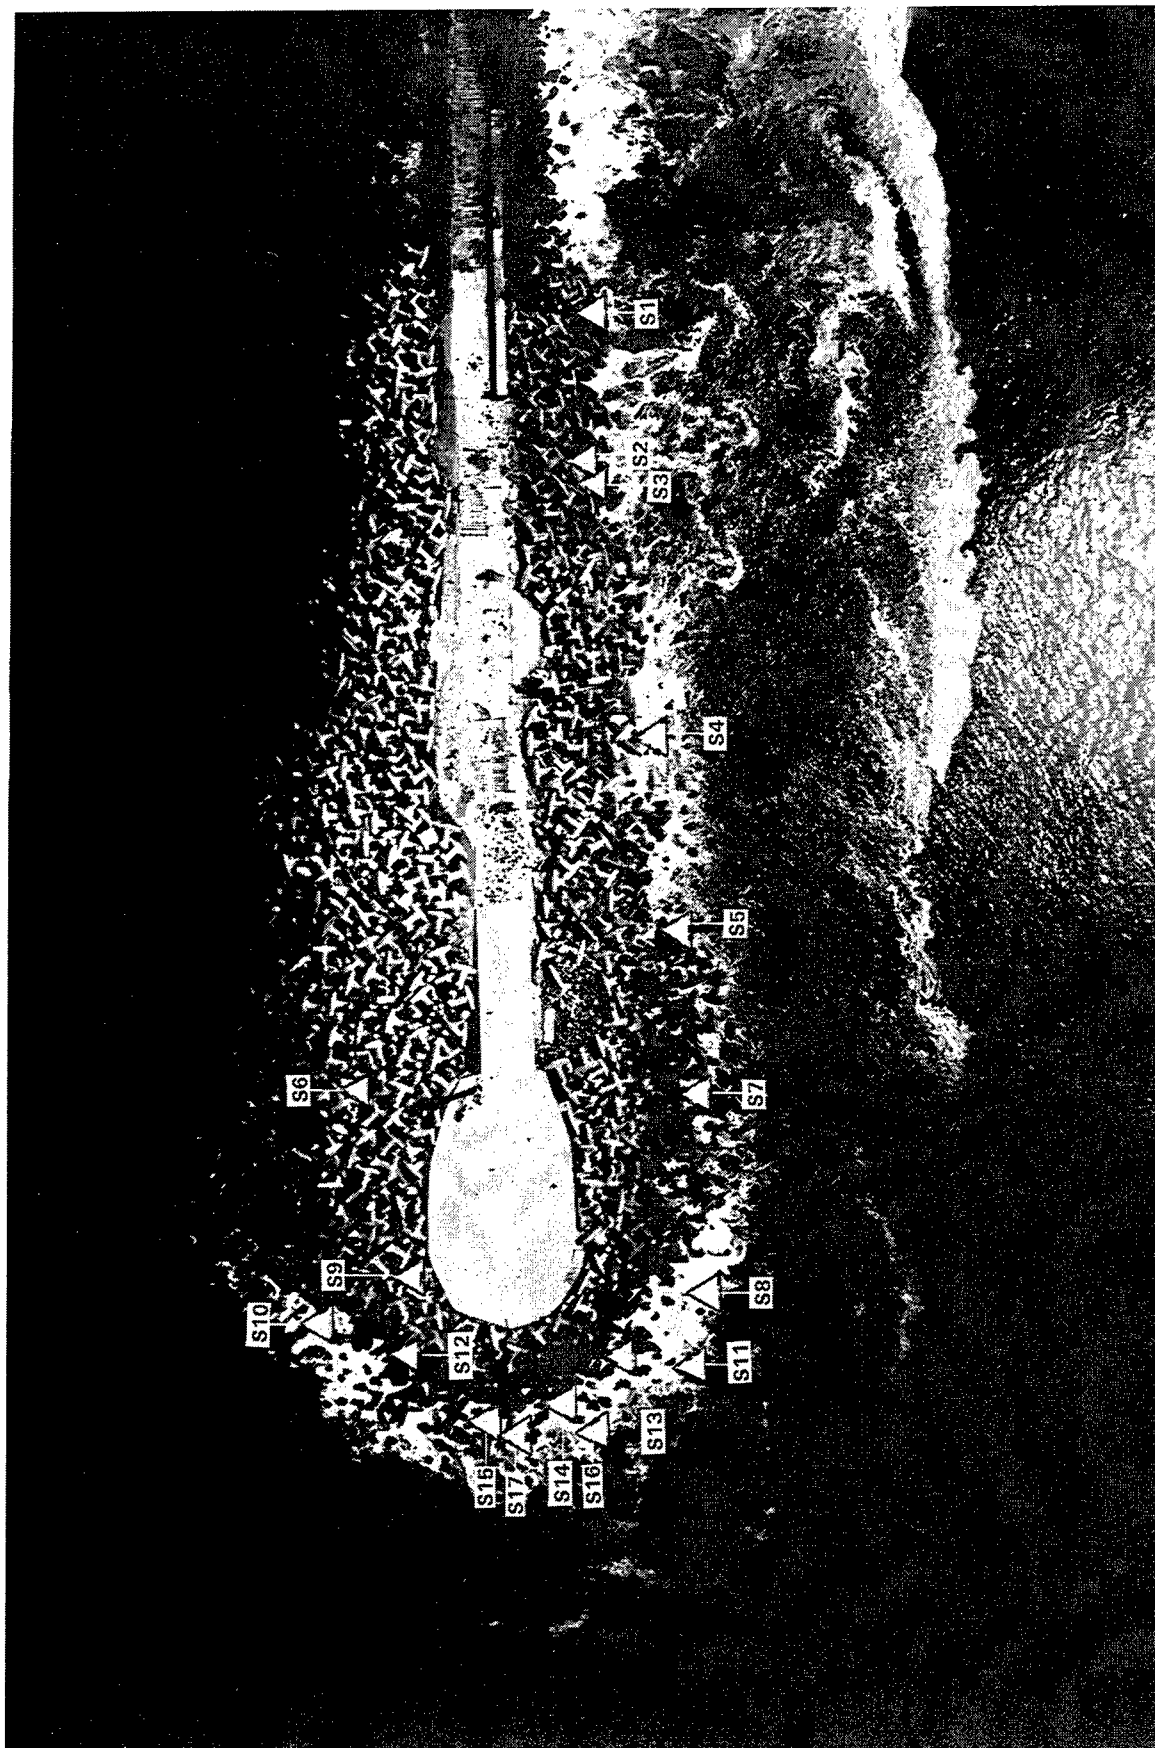
Figure 22. Approximate locations of broken/cracked dolos armor units on the south jetty
