**DOT/FAA/AR-96/119**

# **Vertical Drop Test of a Beechcraft 1900C Airliner**

Robert McGuire and Dr. Tong Vu

Final Report

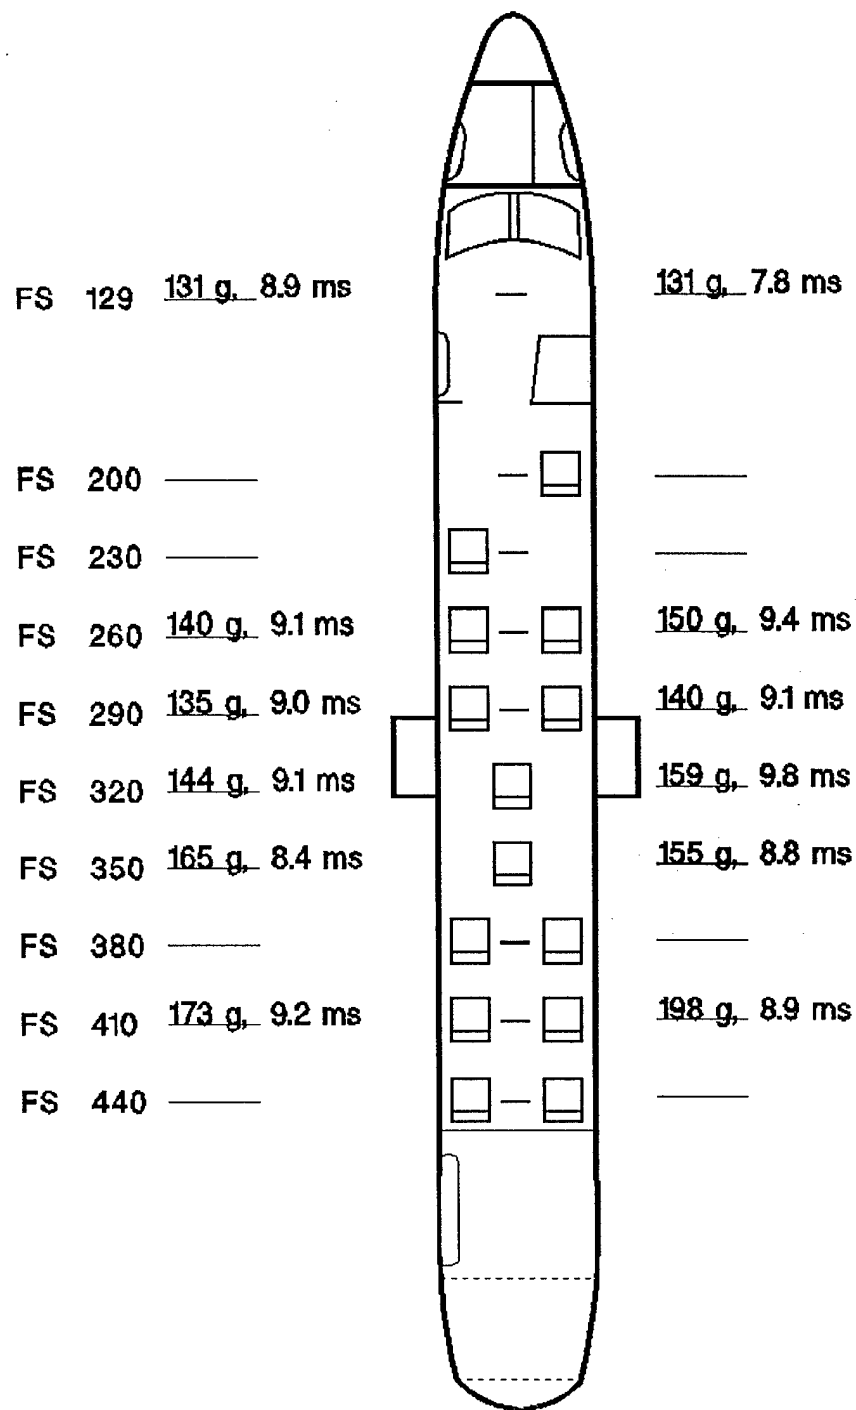
FIGURE 6. FLOOR SEAT TRACK ACCELERATIONS ( $G_{\max}$ )

The normalized acceleration data of the floor seat track, the side wall seat track, and the side wall as well as the impact pulse duration's are presented in figures 6, 7, and 8 respectively. Tables 5, 6, and 7 show  $G_{\text{peak}}$  values,  $G_{\text{max}}$  values, and time duration of  $G_{\text{max}}$  pulse. The results of two lateral sensors at FS 200 right side and FS 260 left side are shown in appendix A, figures A-17 and A-18, respectively.

NOTE: P = Pilot/left side, C = Copilot/right side  
 Invalid data at FS 200 due to affect of WSU seat collapse

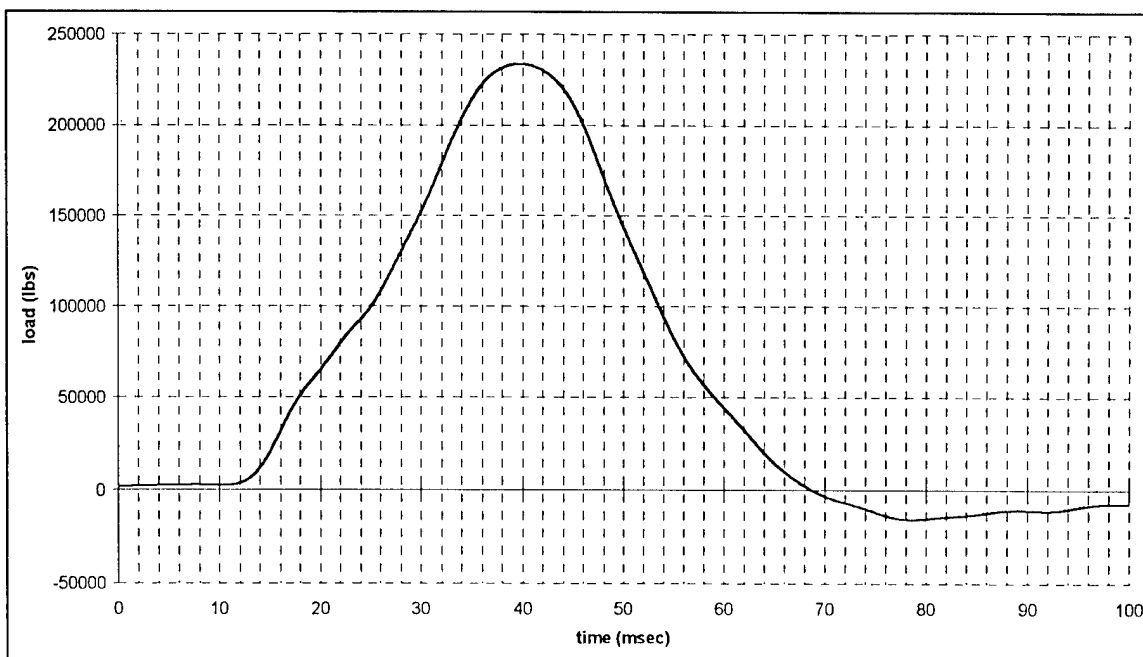
FIGURE 9. PLATFORM TOTAL LOAD

The platform data are presented in appendix A, figures A-52 to A-65. The platform accelerations were recorded by two accelerometers mounted underneath the center of the platform. Figure A-64 shows that the impact and rebound accelerations of the platform were about 50 and 52 g's, respectively. The impact load was measured by the 12 load cells that supported the platform. Posttest observation clearly showed that two rows of platform load cells had bottomed out. This might cause the total measured impact load to be less than the actual impact load. The total measured impact load is presented in figure 9.

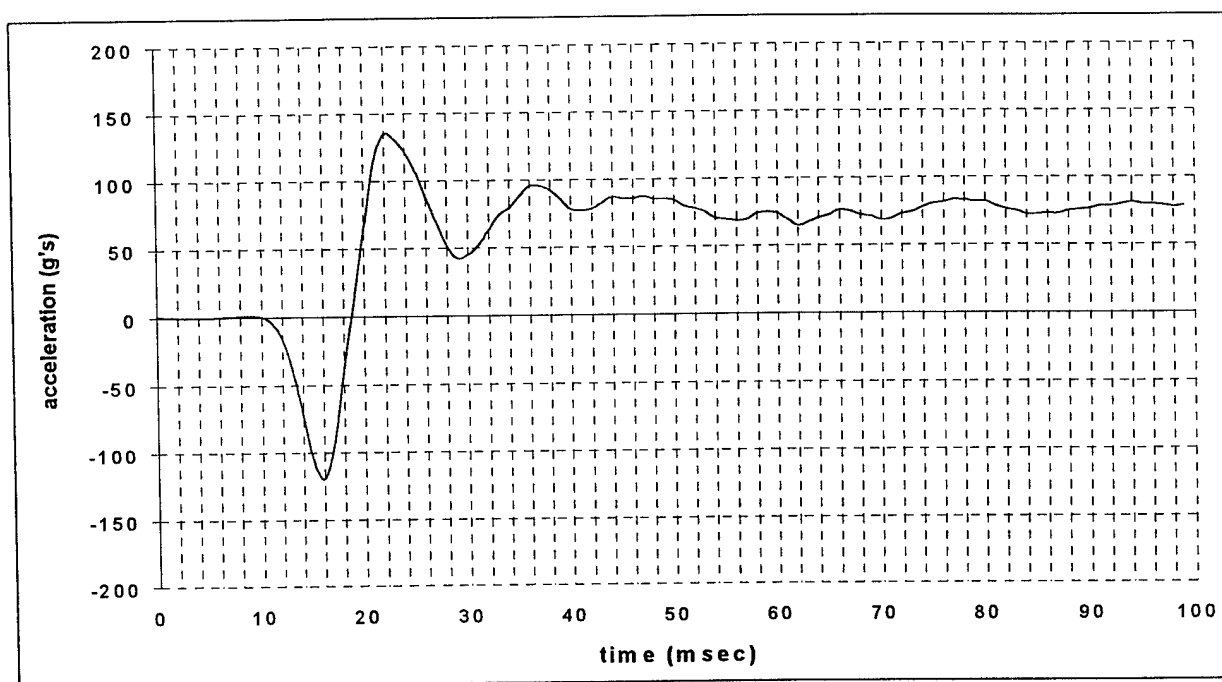
FIGURE A-3. FS 200 FLOOR, LEFT SEAT TRACK VERTICAL ACCELERATION

Posttest inspection of the fuselage showed that the sensor at FS 200 mounted on the left floor seat track was dislodged during the impact, and a small piece of the right floor seat track near the sensor was broken due to the collapse of the WSU/EA seat. Therefore the data recorded on this sensor were invalid.
