Technical Report REMR-CS-60
September 1998

Repair, Evaluation, Maintenance, and Rehabilitation Research Program

Performance Criteria for Concrete Repair Materials, Phase II Field Studies

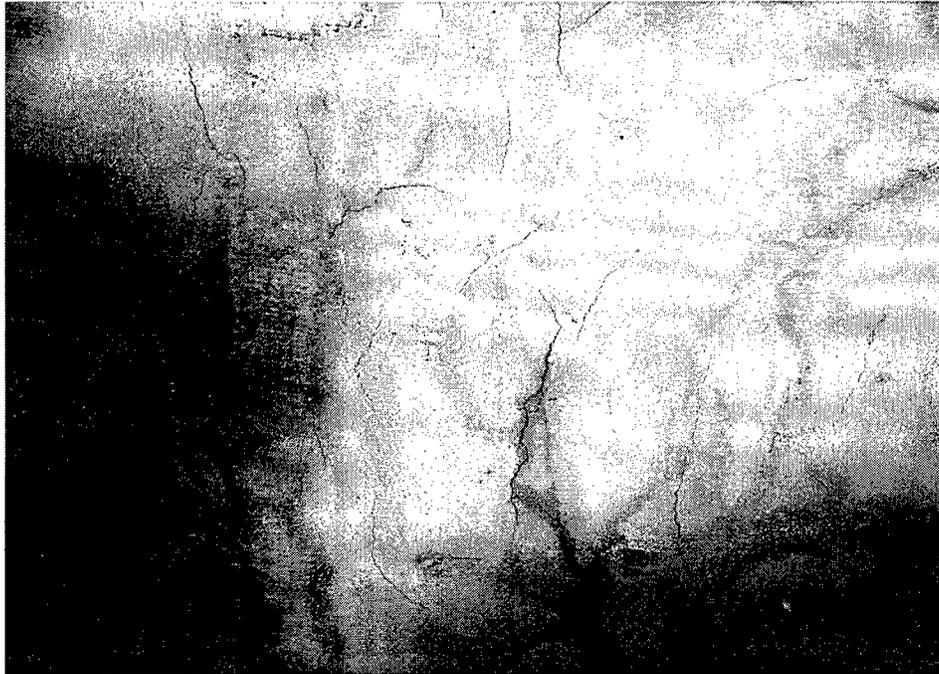
Figure 12. Severe cracking, Material No. 5 (Florida)

recommendations, the mixture was not extended with aggregate in the Florida tests. Despite immediate sprinkling with water after finishing, early age, plastic-shrinkage cracking occurred in each of the three repairs (Figure 12).

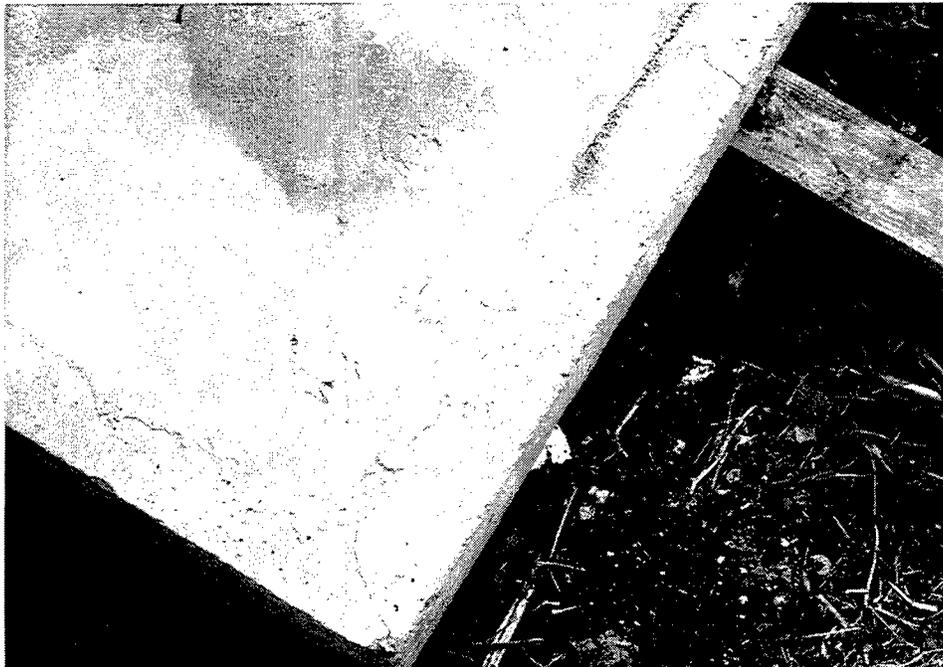
Figure 13. Cracks in the cavity walls, Material No. 5 (Florida)

The rapid setting of Material No. 5 was accompanied by a high heat of hydration. Expansion of the repair material associated with the high temperature rise was sufficient to cause cracking in the precast concrete cavity walls (Figure 13). Subsequent cooling and restrained contraction of the repair material may have contributed to the early age cracking observed. Consequently, the manufacturer recommended that the mixture be extended with coarse aggregate for the remaining tests. Early age cracking in Repair 6C was also attributed to plastic shrinkage.

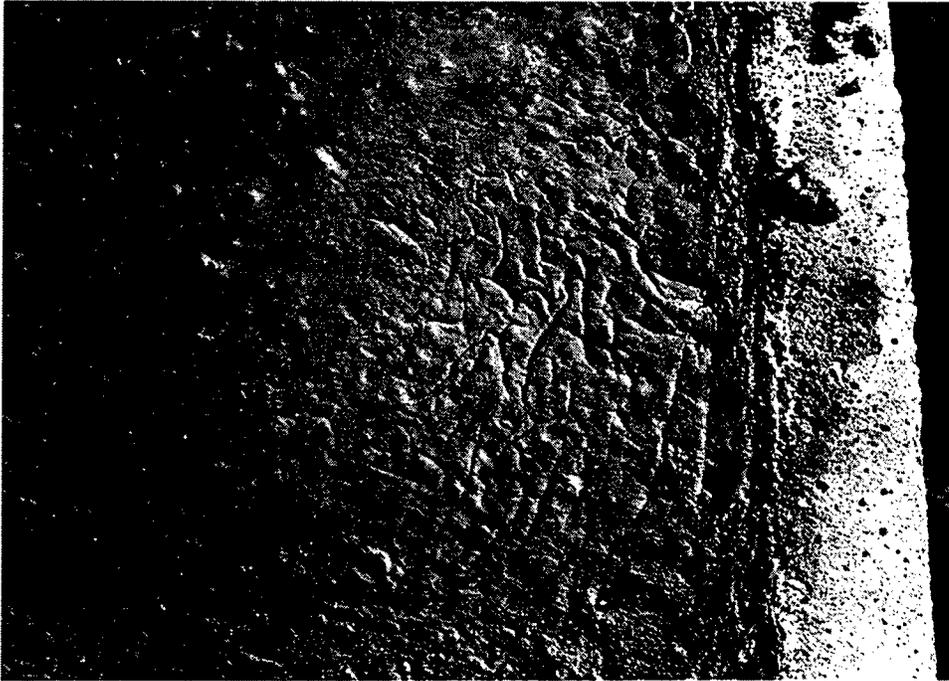
Figure 14. Very cohesive material (No. 10), sticky, difficult to finish (Florida)

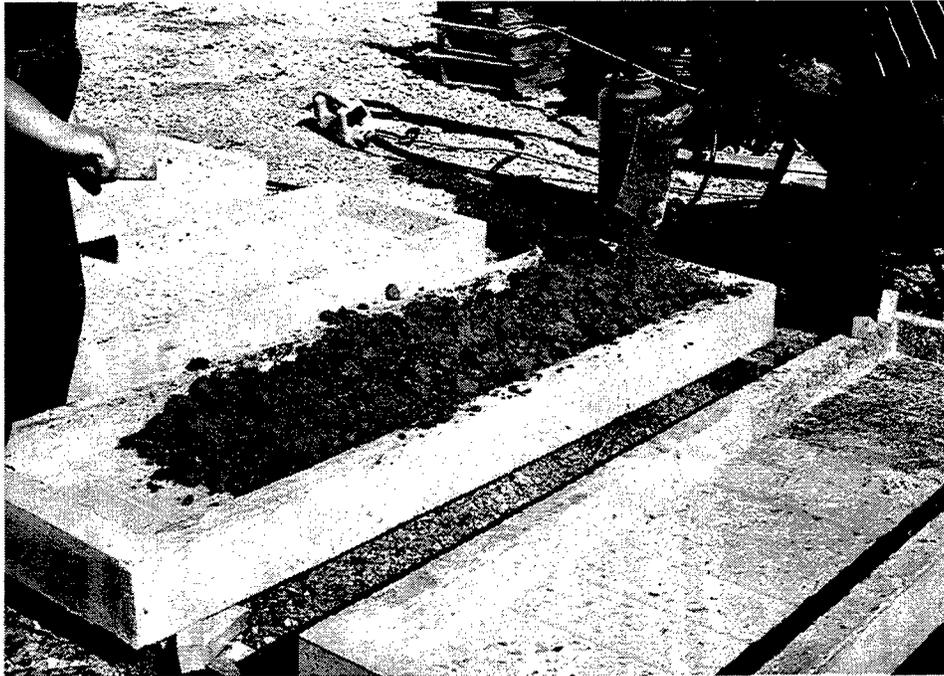
Figure 16. Example of a material (No. 8) that was very difficult to place and finish (Illinois)

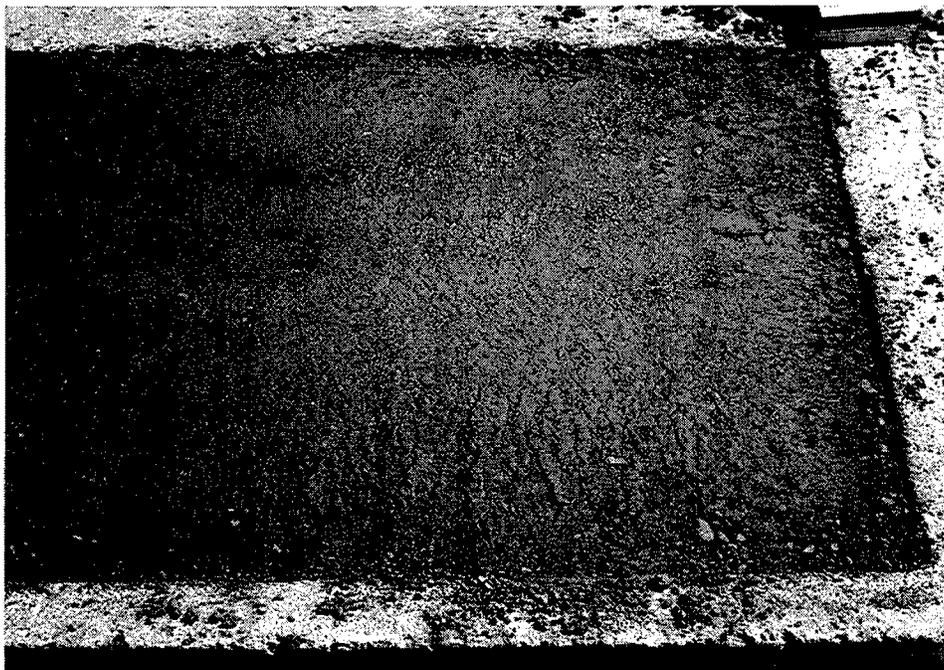
12	09/14/94	11:45 AM	87.5	62	Difficult to finish. Figure 17.

Figure 17. Material (No. 12) that was not easy to finish (Illinois)

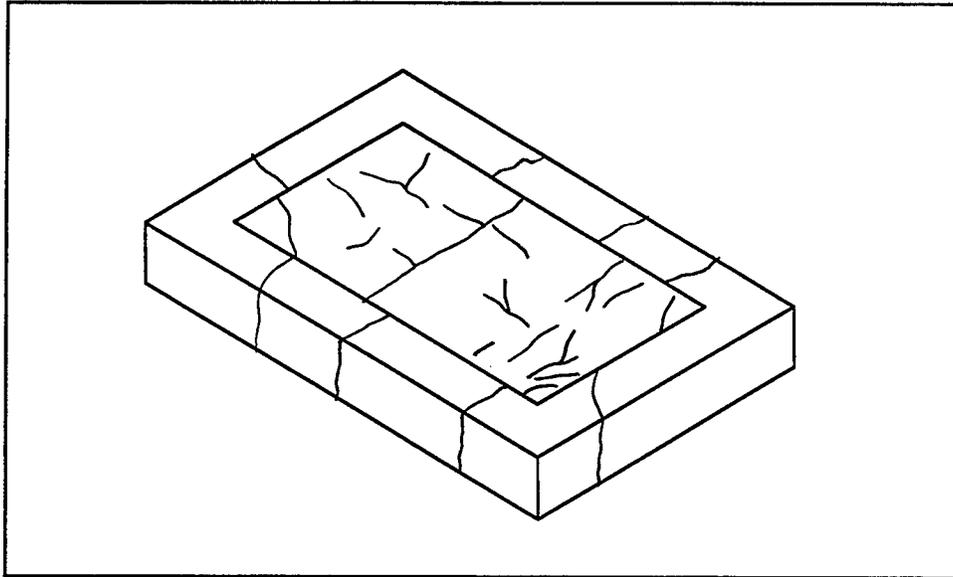
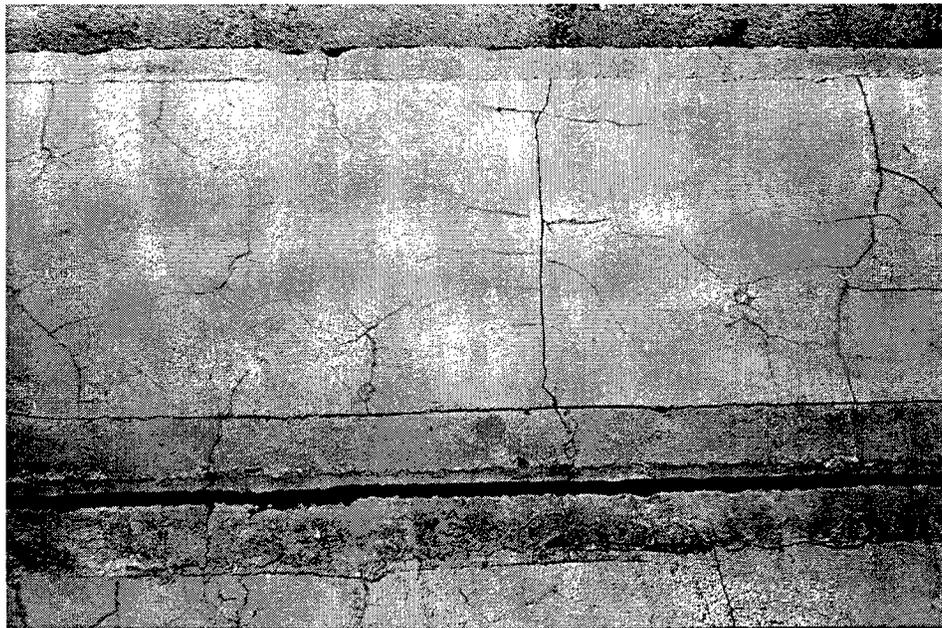
Figure 29. Cracking of Material No. 5A (Florida)

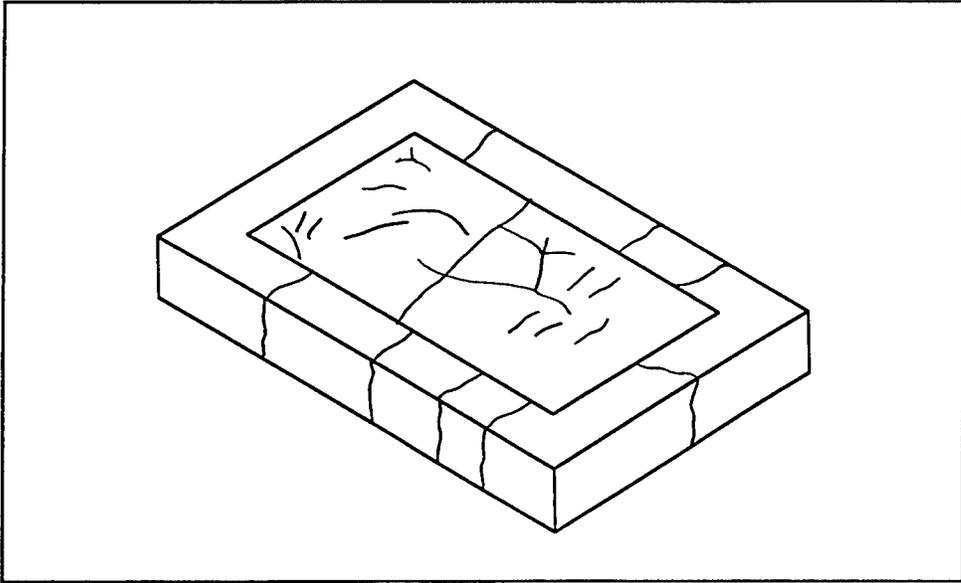
Figure 30. Cracking of Material No. 5B (Florida)

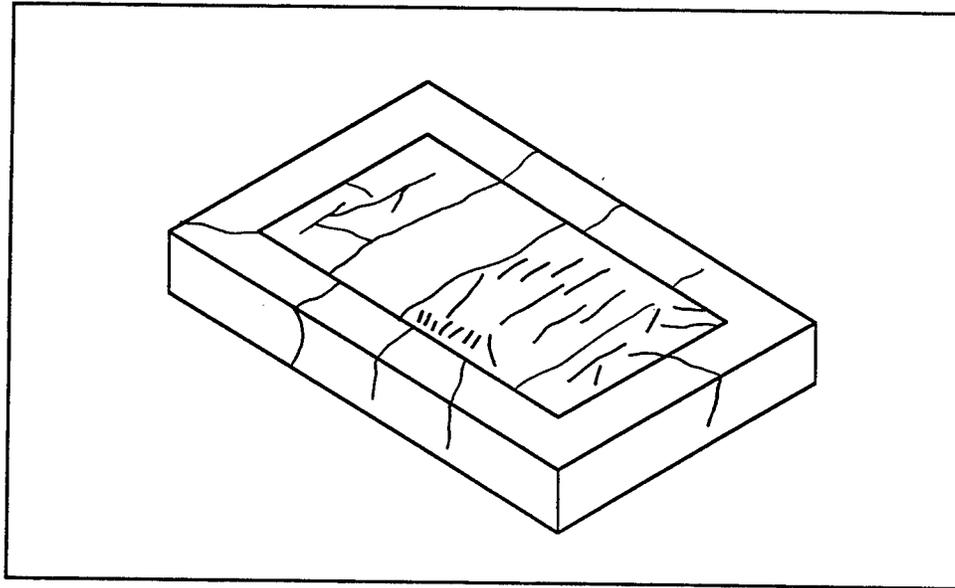
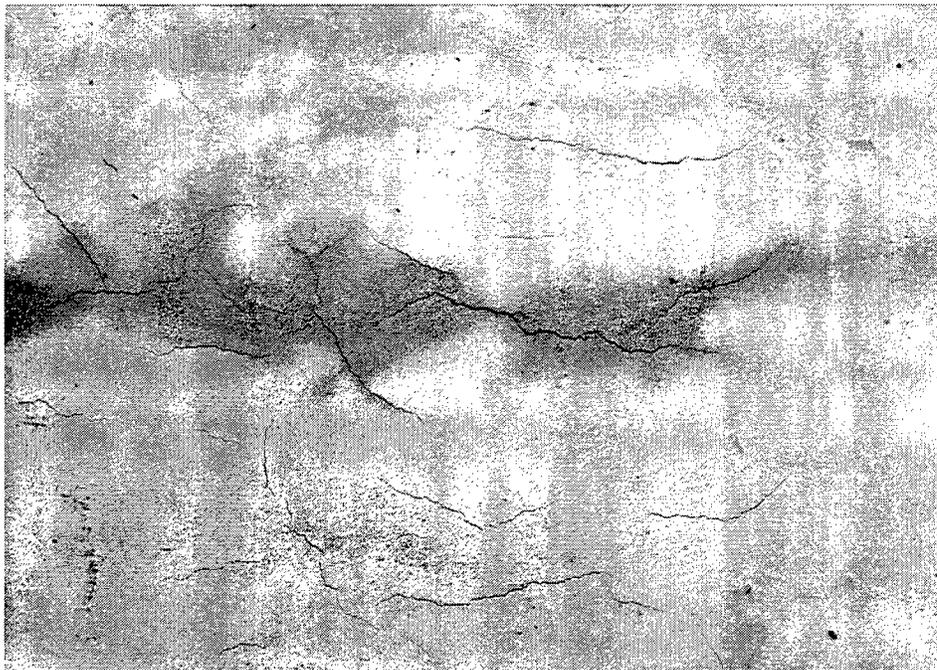
Figure 31. Cracking of Material No. 5C (Florida)

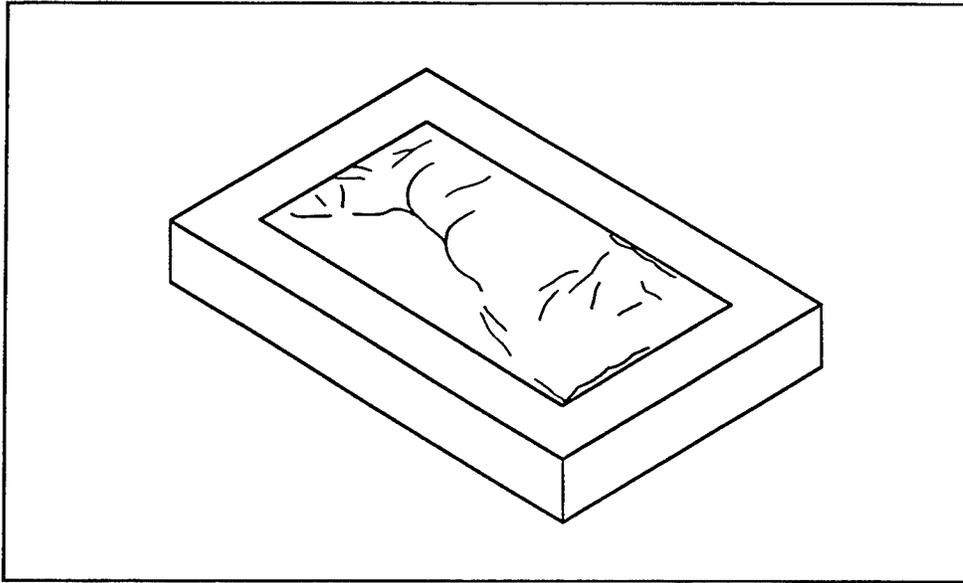
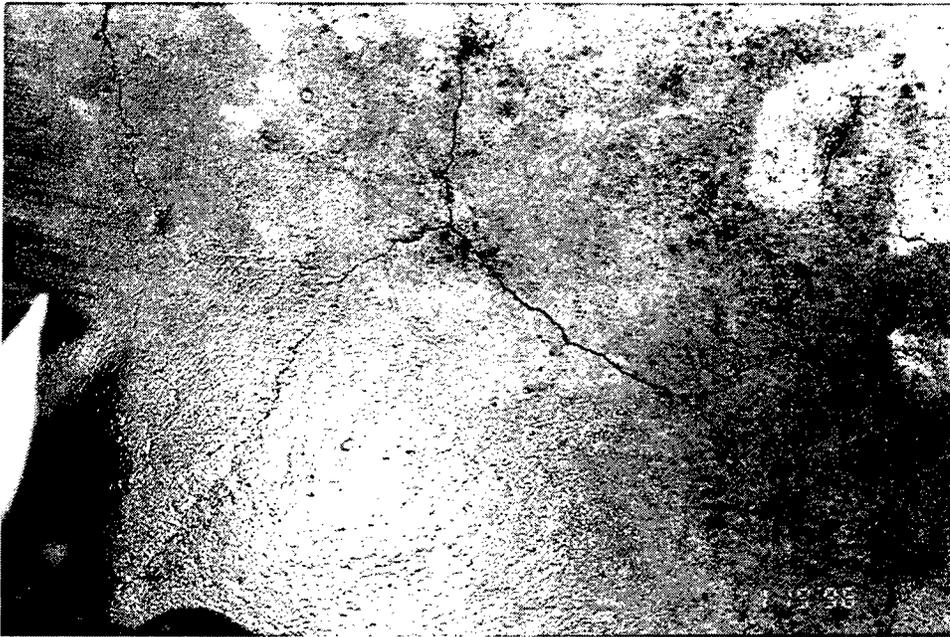
Figure 32. Cracking of Material No. 6C (Florida)

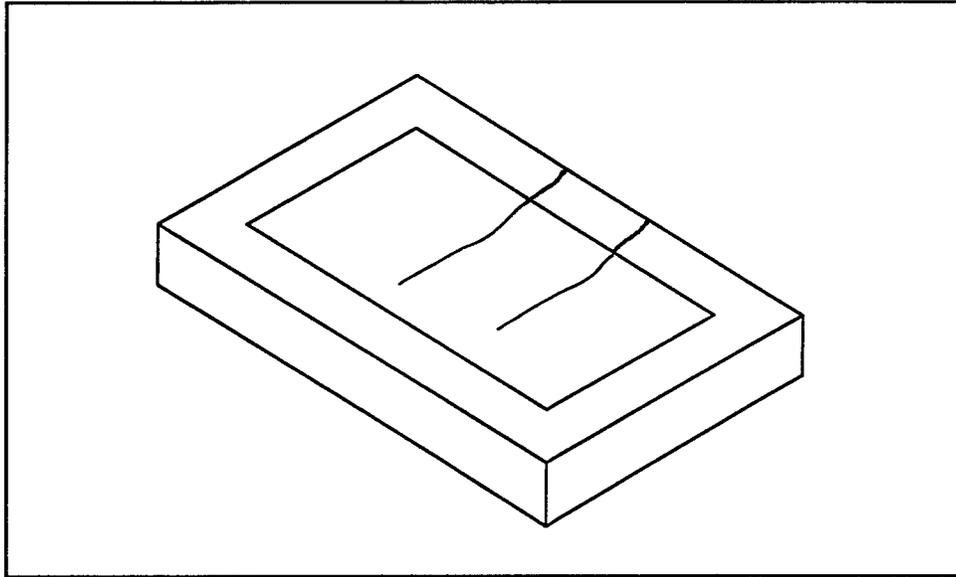
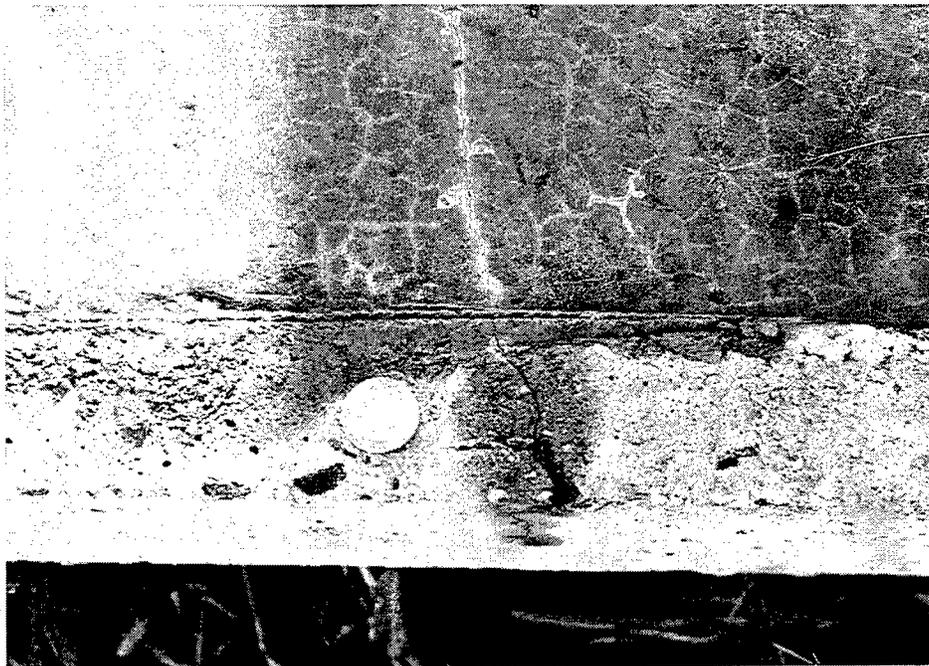
Figure 34. Cracking of Material No. 5C (Illinois)

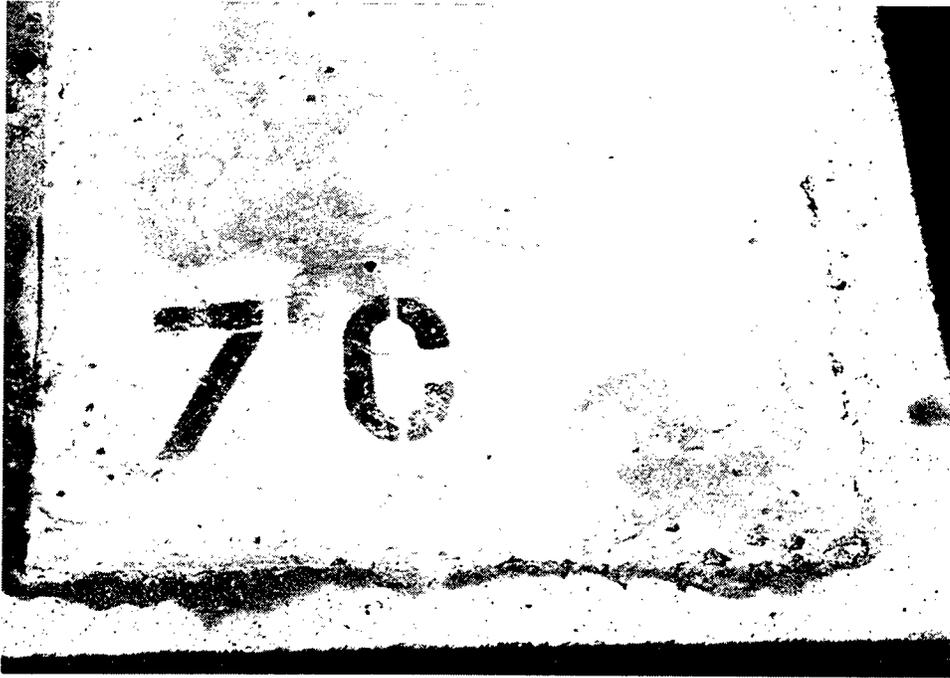
Figure 35. Surface crazing of Material No. 7C (Illinois)

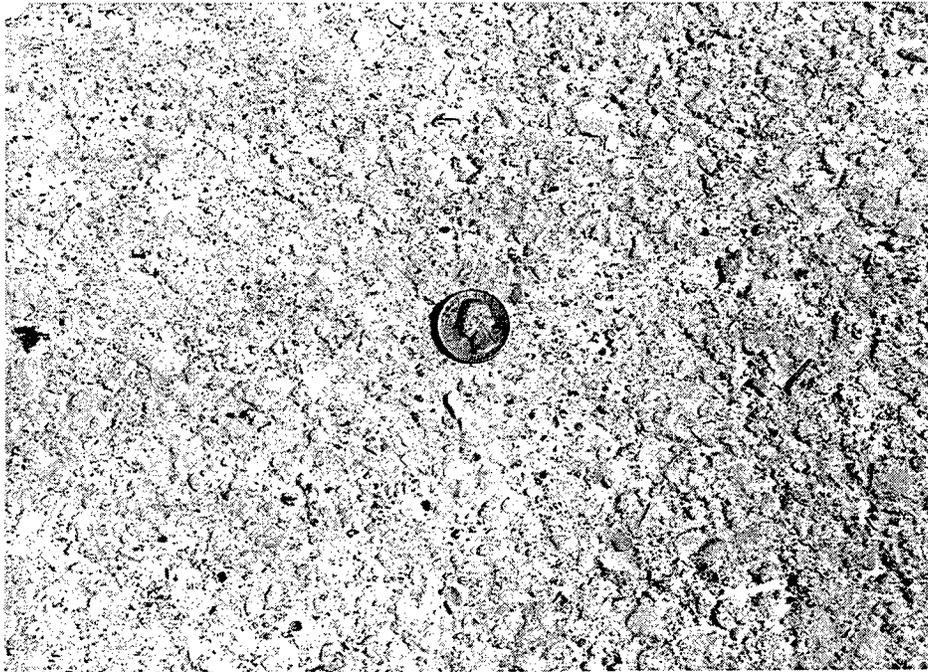
Figure 37. Surface deterioration of Material No. 12C (Illinois)

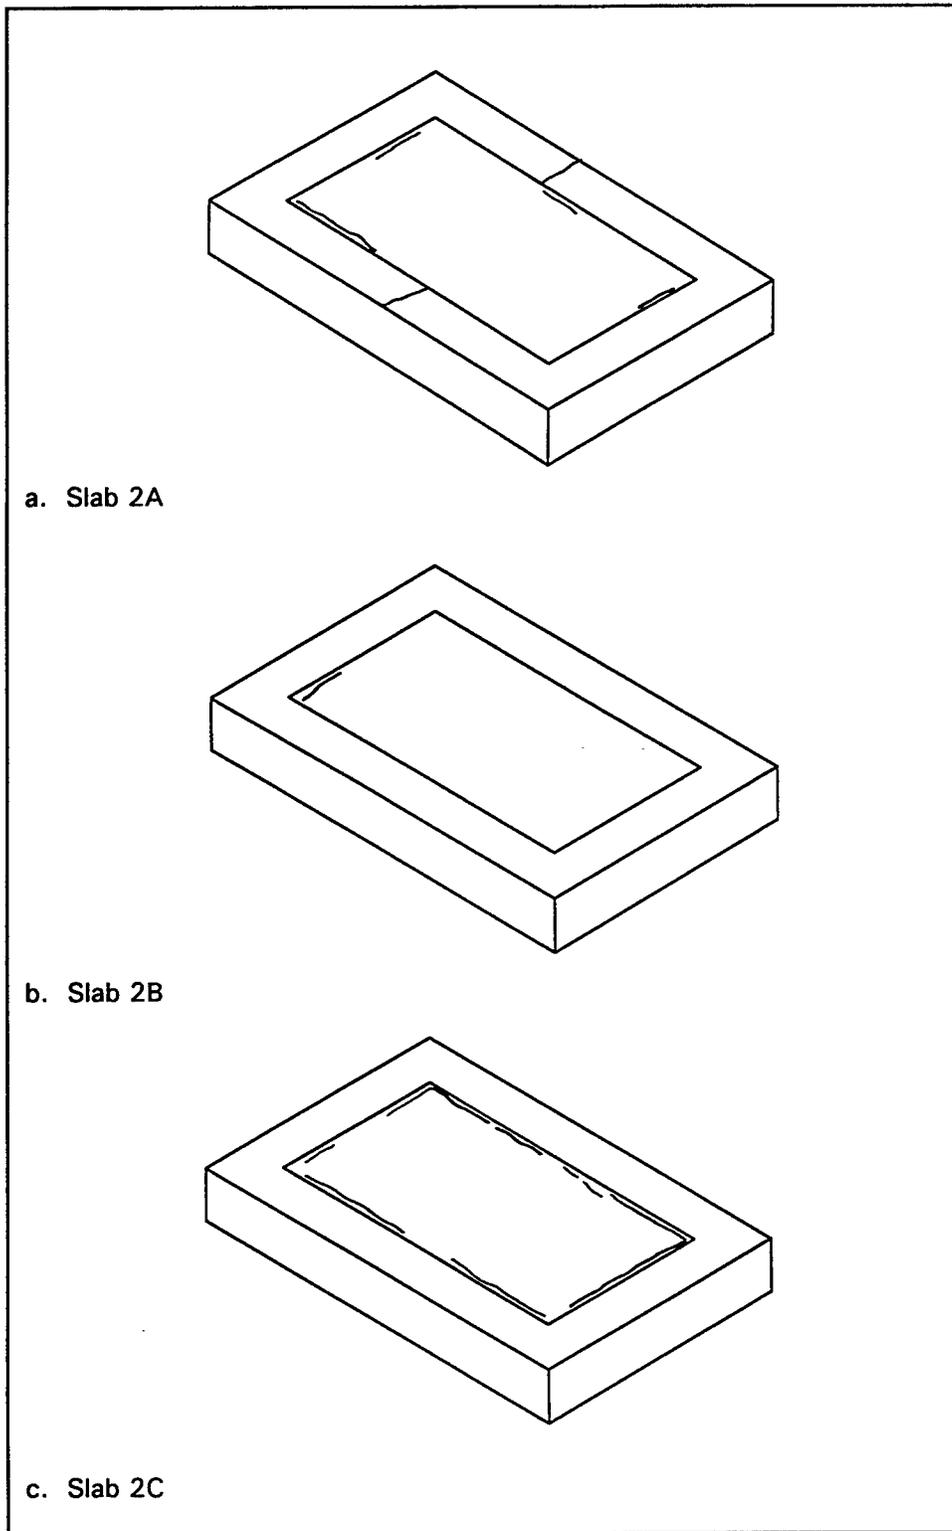
Figure 38. Edge cracking associated with Material No. 2 (Arizona)

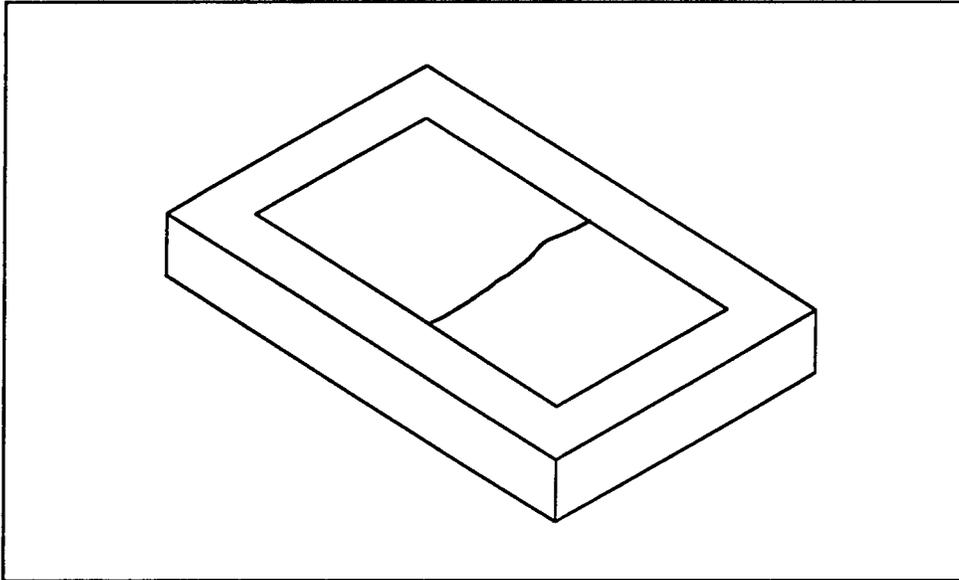
Figure 39. Cracking of Material No. 3B (Arizona)

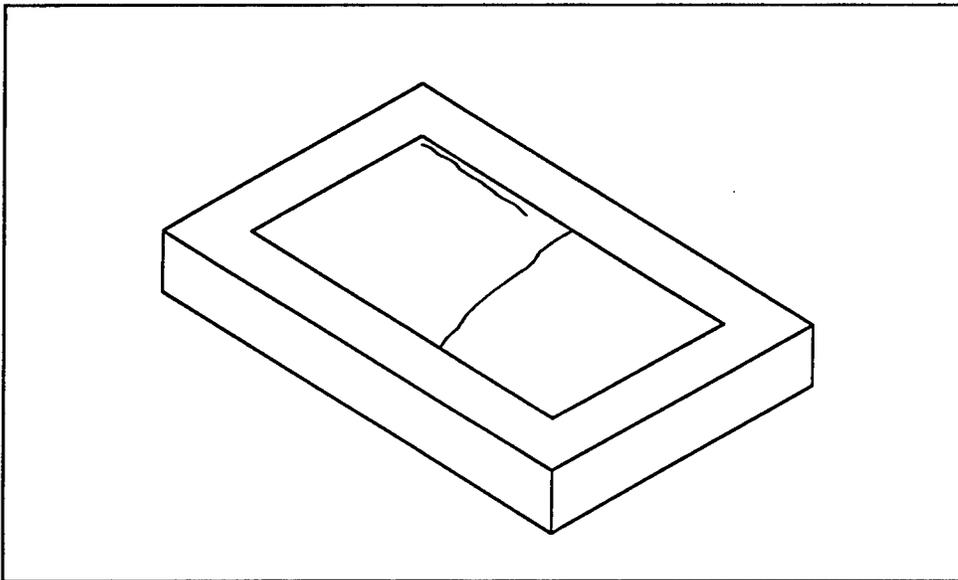
Figure 40. Cracking of Material No. 5B (Arizona)

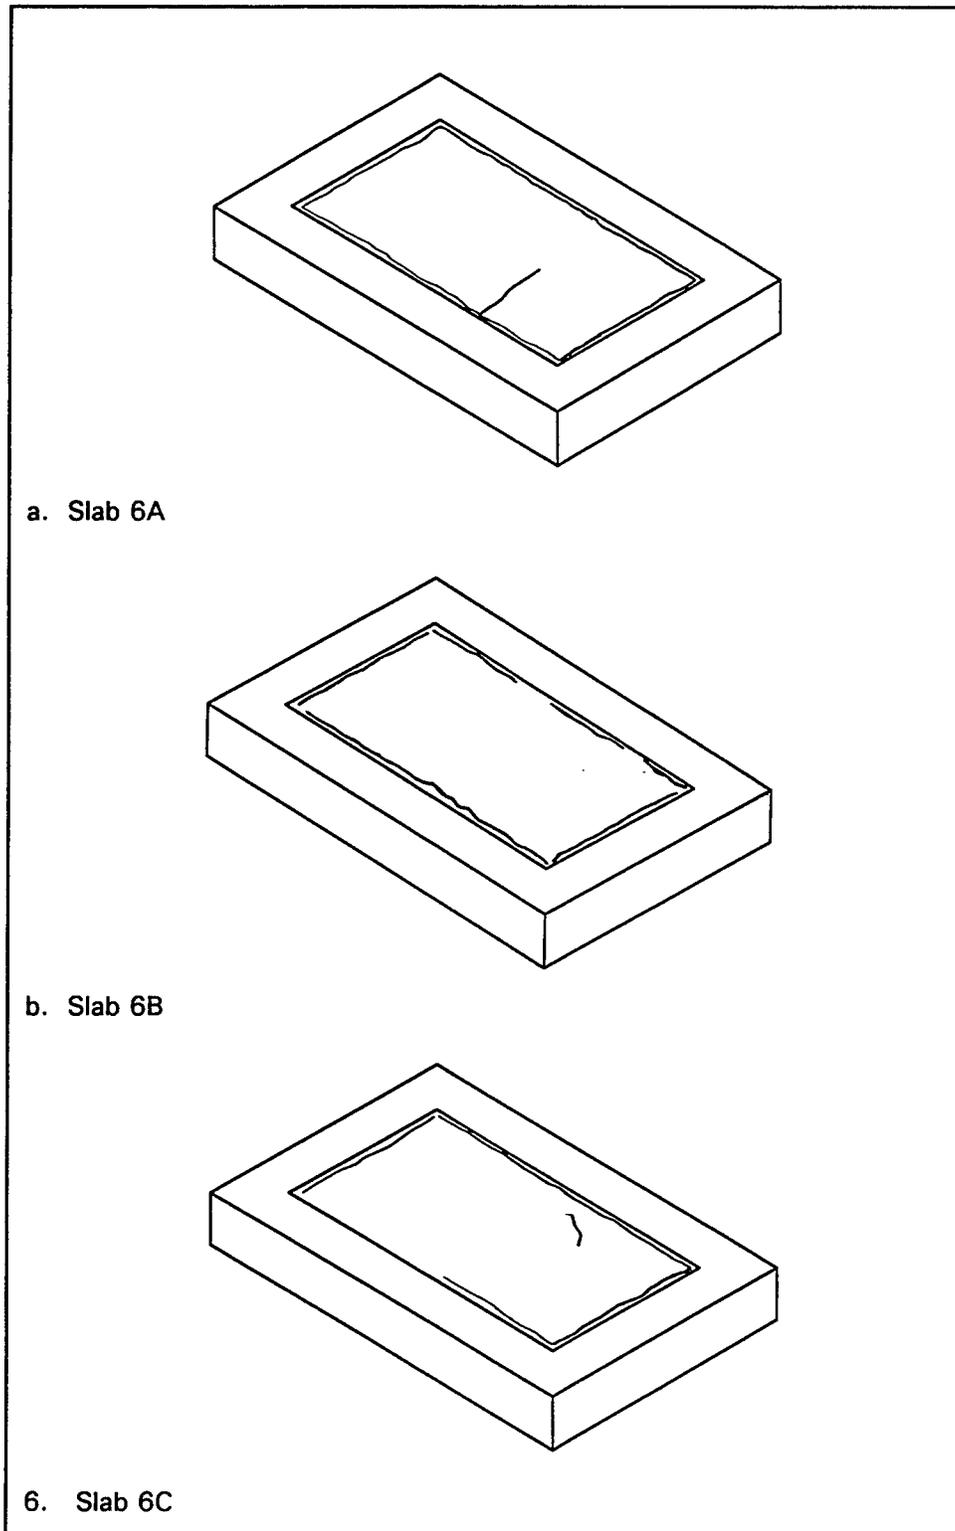
Figure 41. Cracking of Material No. 6 (Arizona)

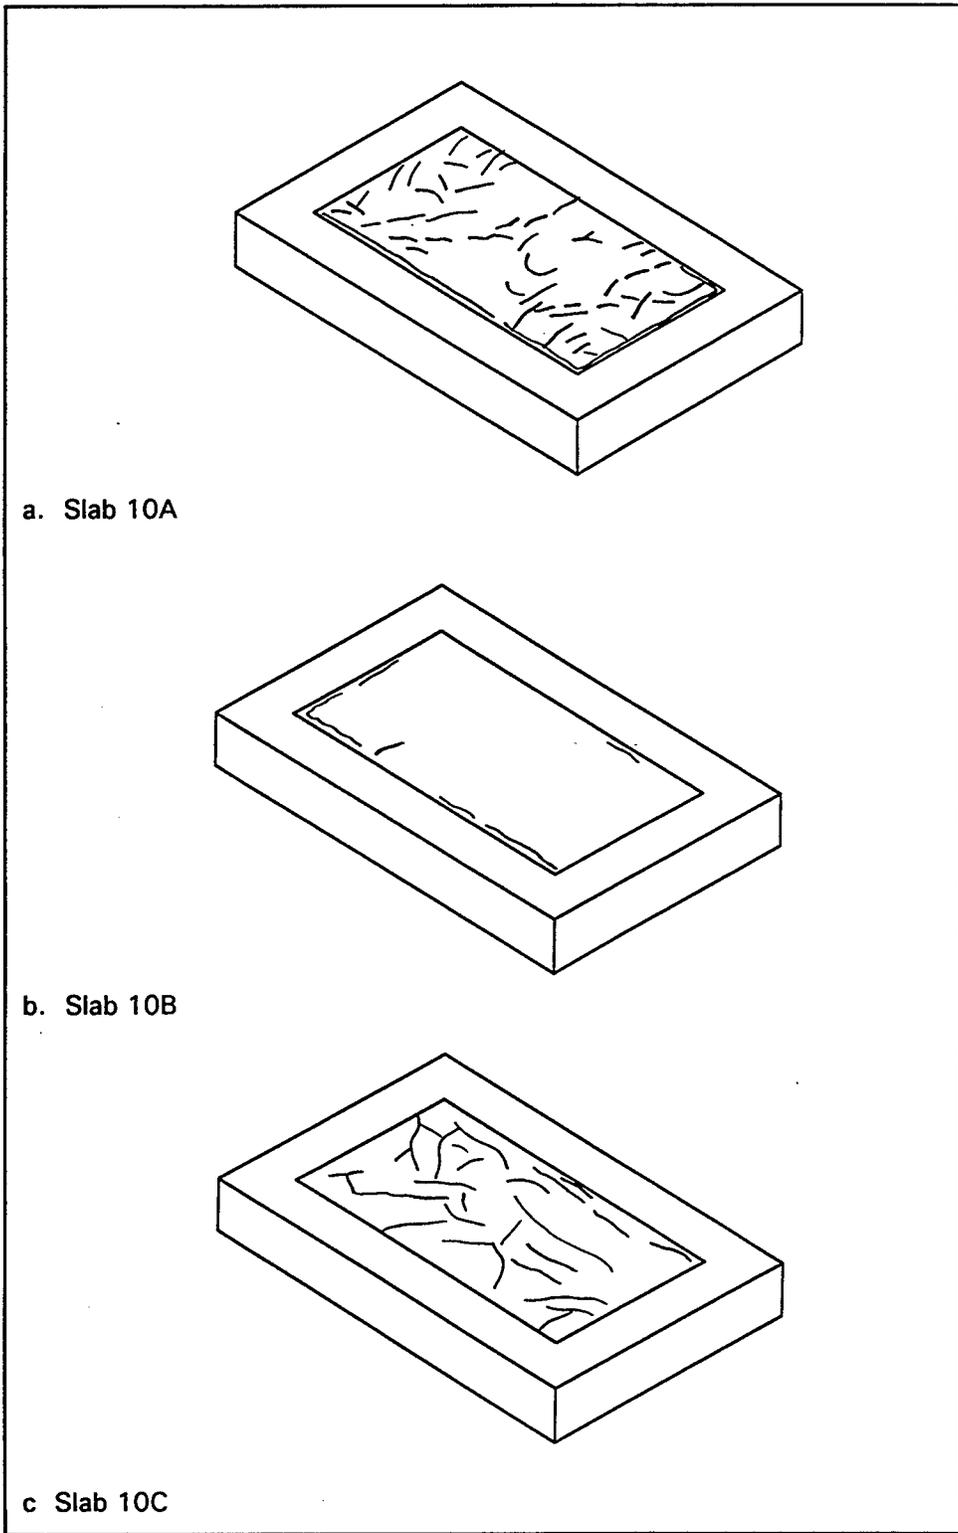
Figure 43. Cracking of Material No. 10 (Arizona)

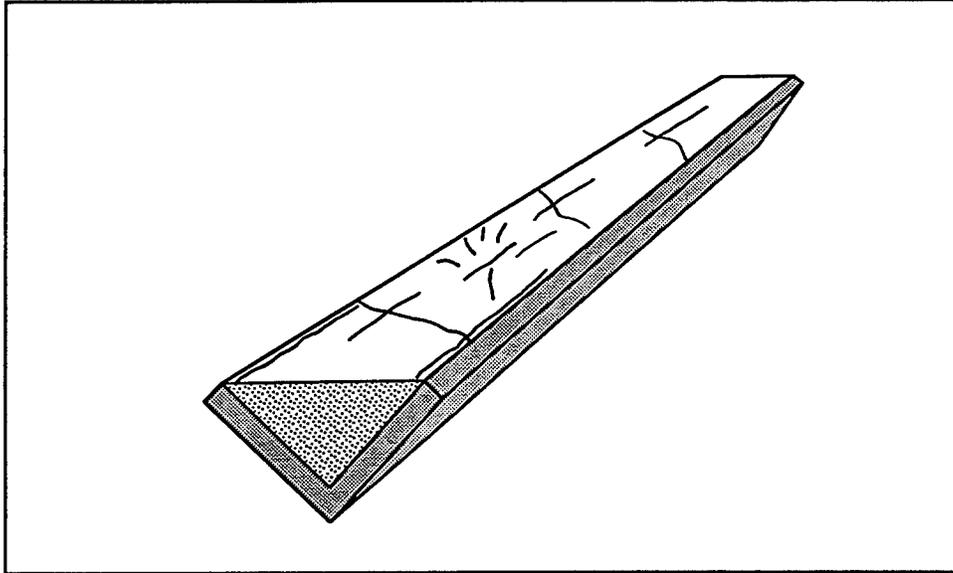
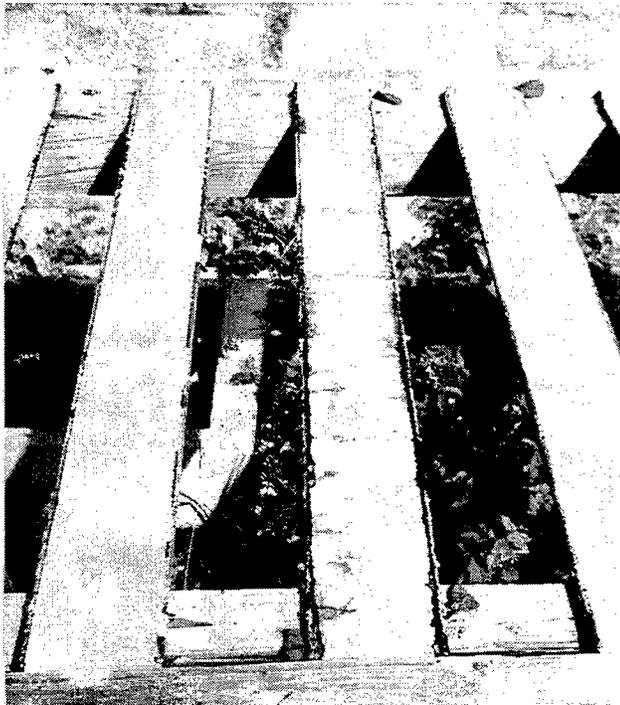
Figure 46. Cracking of Material No. 5 (Florida)

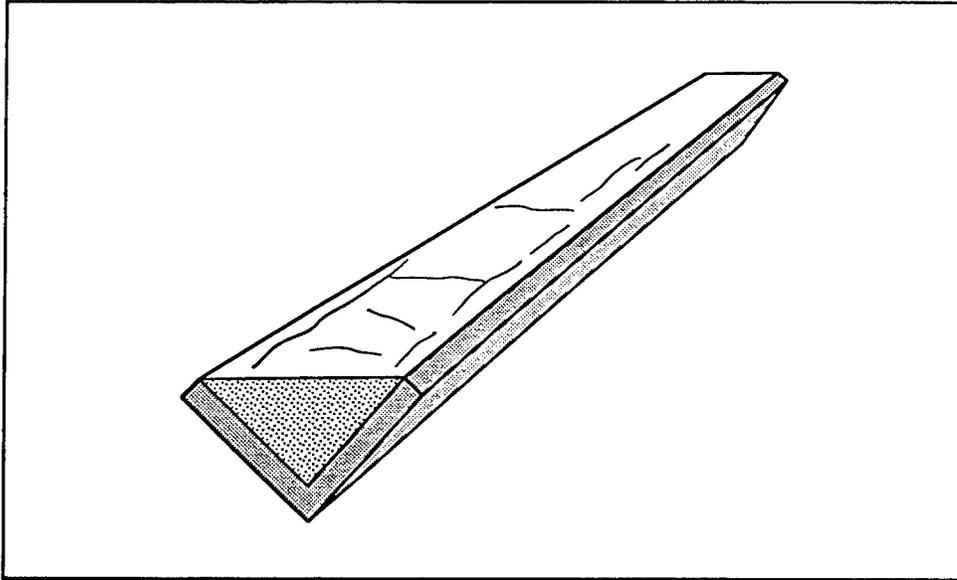
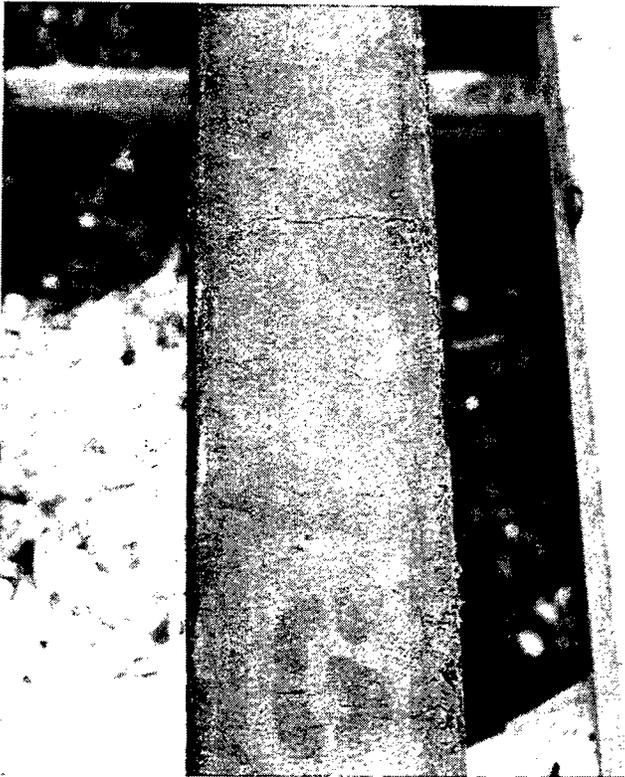
Figure 47. Cracking of Material No. 6 (Florida)

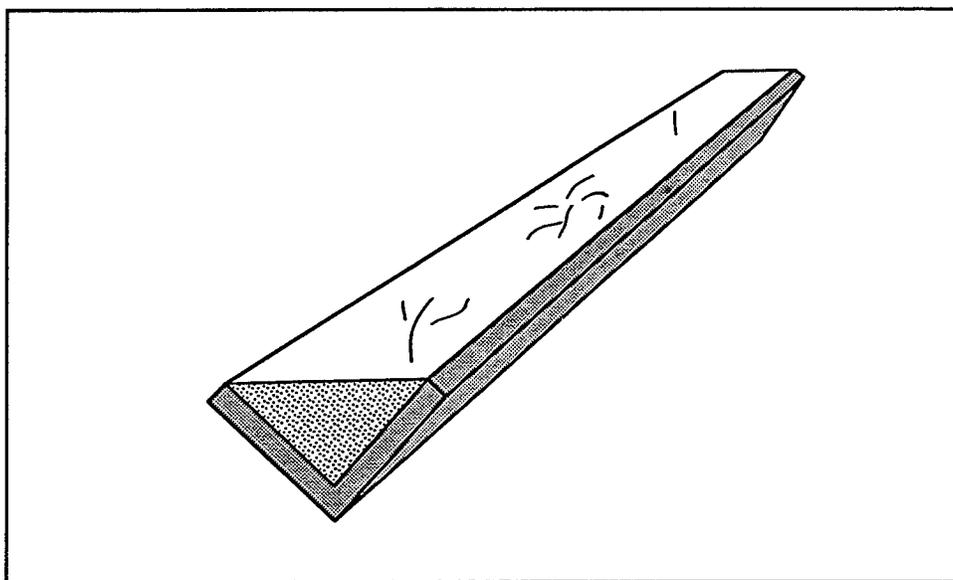
Figure 48. Cracking of Material No. 7 (Florida)

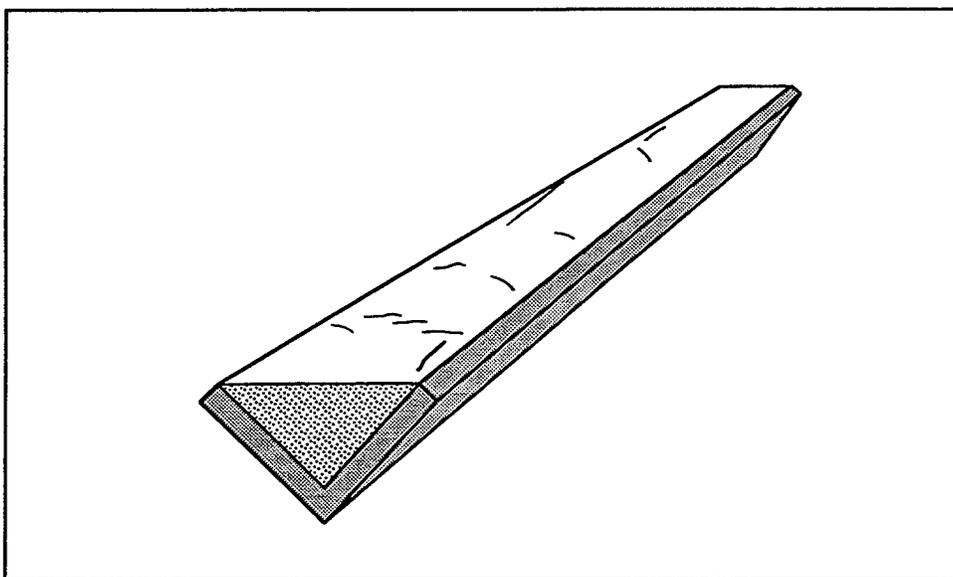
Table 12 Results of German Angle Tests - Florida		
Material No.	Date of Placement	Observation
1	08/04/94	No cracks.
2	08/02/94	No cracks.
3	08/02/94	Debonding cracks along the edges, and minor cracks from the edge toward the center.
4	08/03/94	No cracks.
5	08/01/94	Fine cracks and edge debonding cracking noted in first inspection (7 days age); two additional cracks at 28 days; large crack at 440 days. Figure 46.
6	08/02/94	Longitudinal cracks and two transverse cracks noted in first inspection (7 days age); one additional crack at 170 days; two additional cracks at 380 days. Figure 47.
7	08/04/94	Minor surface crazing noted at 14 days. Figure 48.
8	08/01/94	No cracks.
9	08/05/94	No cracks.
10	08/05/94	No cracks.
11	08/04/94	Minor surface crazing noted at 7 days. Figure 49.
12	08/05/94	No cracks.

Figure 49. Cracking of Material No. 11 (Florida)

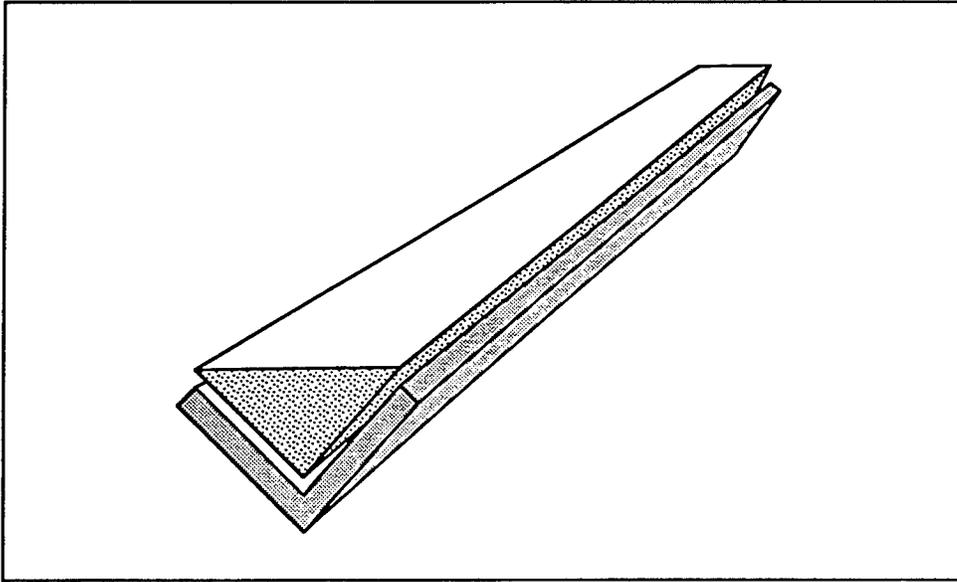
Figure 50. Debonding of Material No. 5 (Illinois)

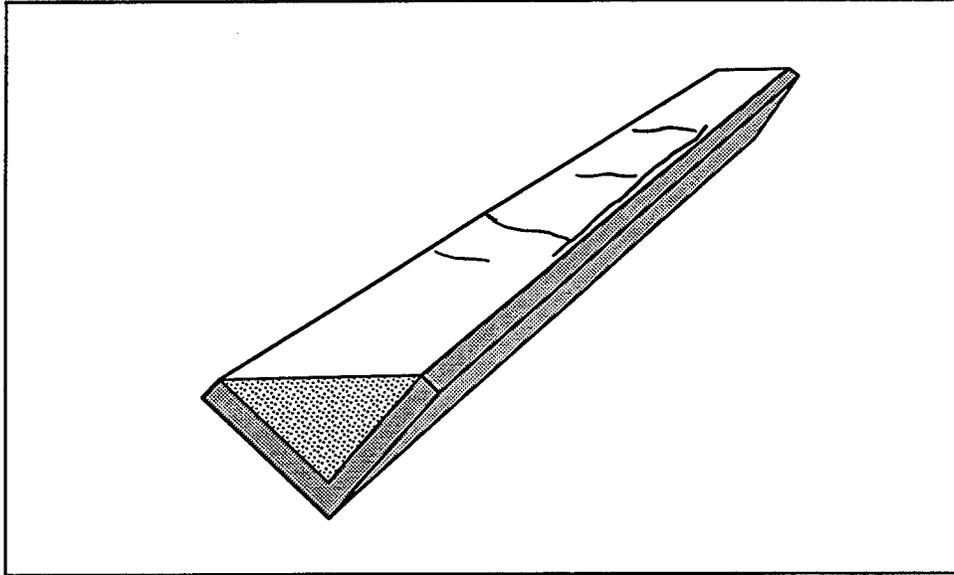
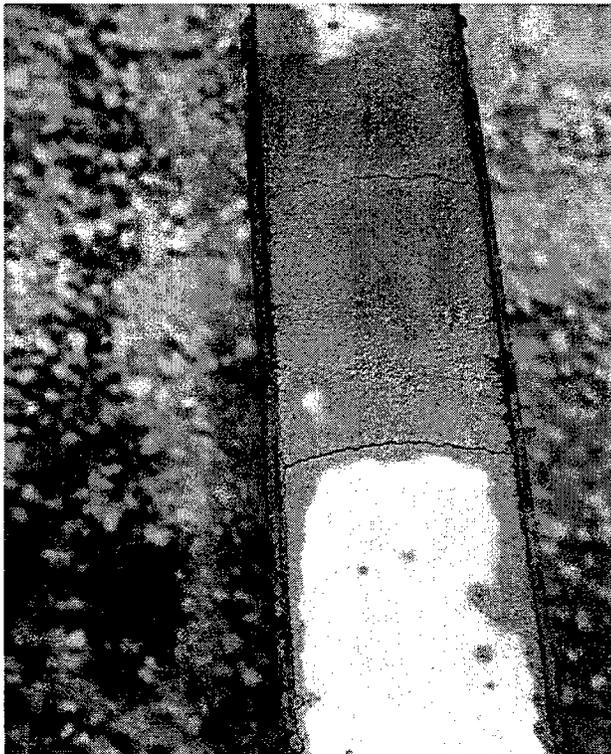
Figure 51. Cracking of Material No. 6 (Illinois)

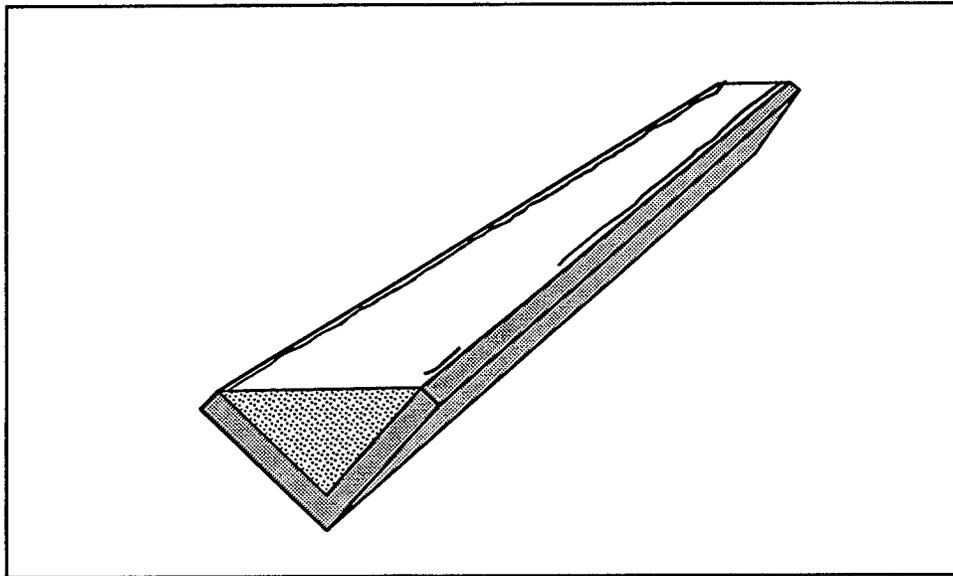
Figure 52. Cracking of Material No. 3 (Arizona)

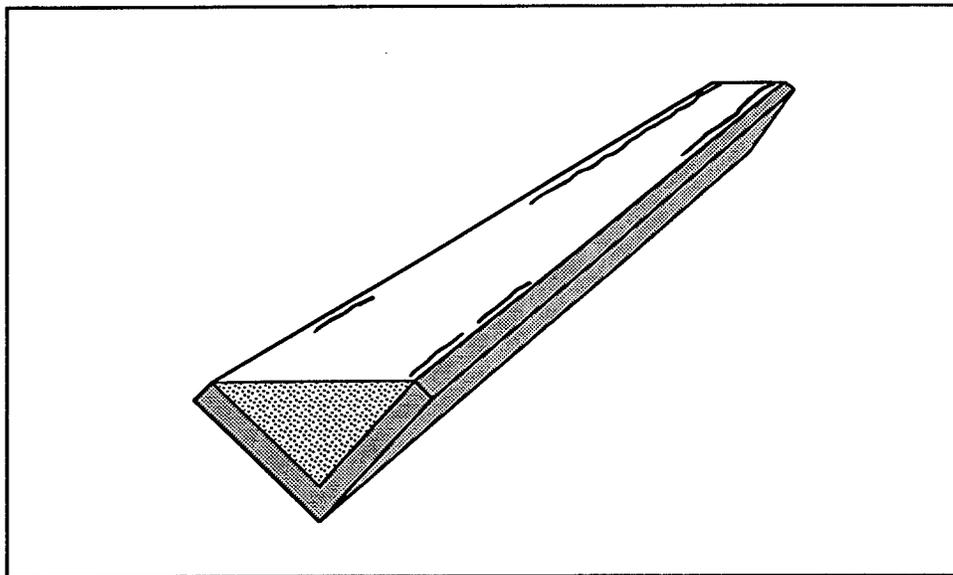
Figure 53. Cracking of Material No. 6 (Arizona)

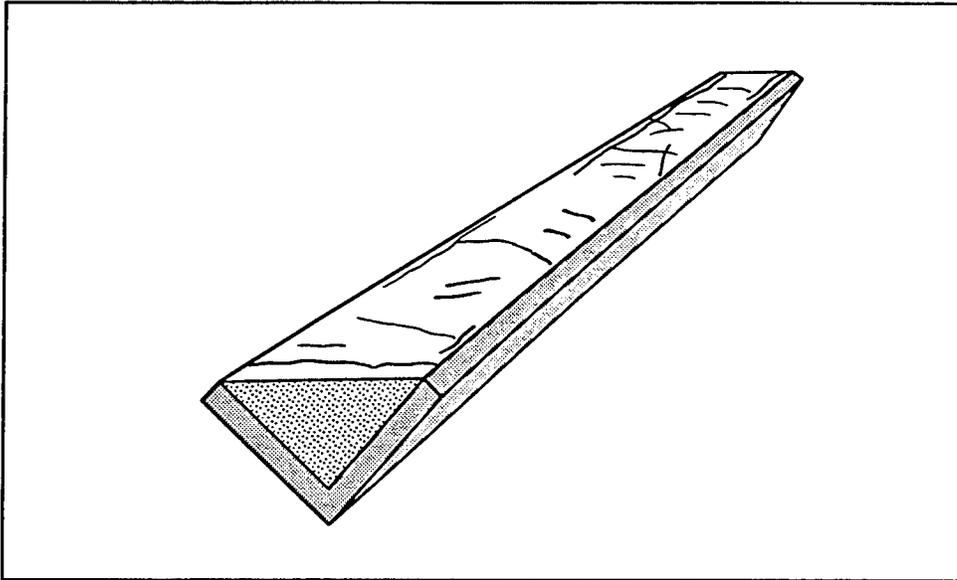
Figure 54. Cracking of Material No. 7 (Arizona)

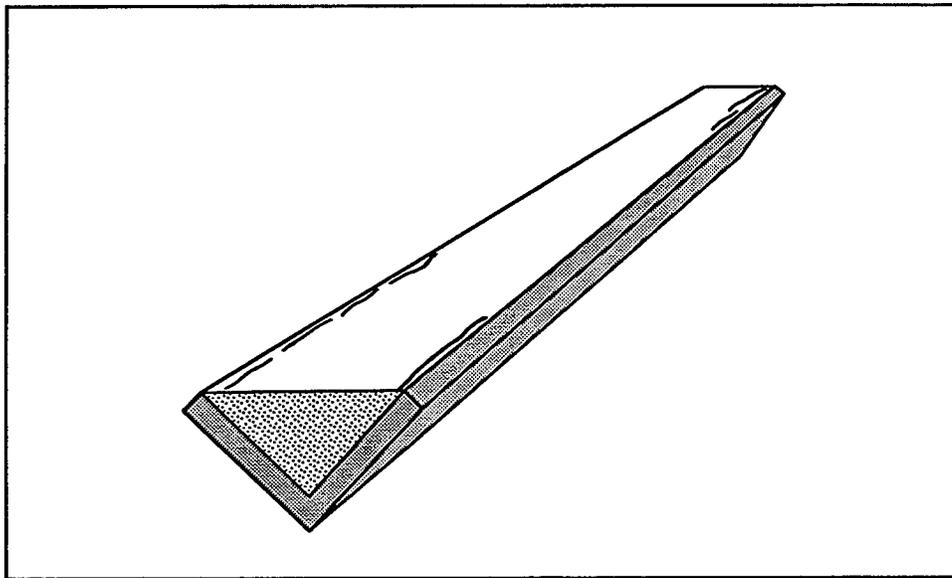
Figure 55. Cracking of Material No. 8 (Arizona)
