Technical Report REMR-CS-60
September 1998

Repair, Evaluation, Maintenance, and Rehabilitation Research Program

Performance Criteria for Concrete Repair Materials, Phase II Field Studies

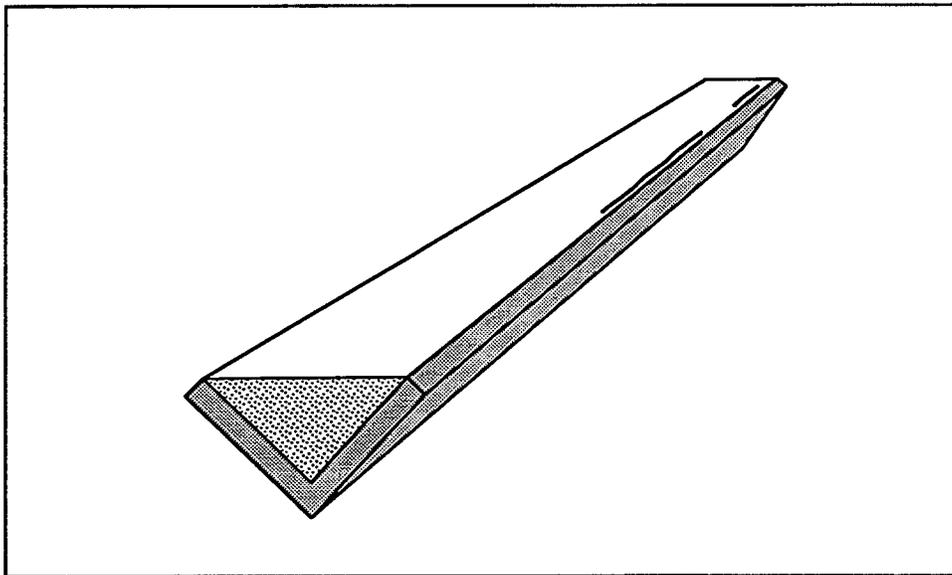
Figure 56. Cracking of Material No. 9 (Arizona)

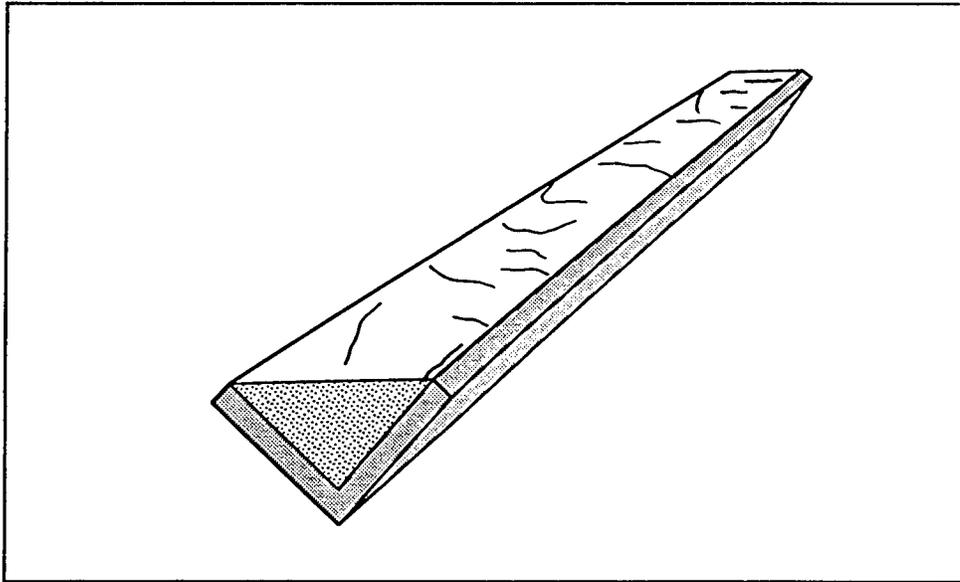
Figure 57. Cracking of Material No. 10 (Arizona)

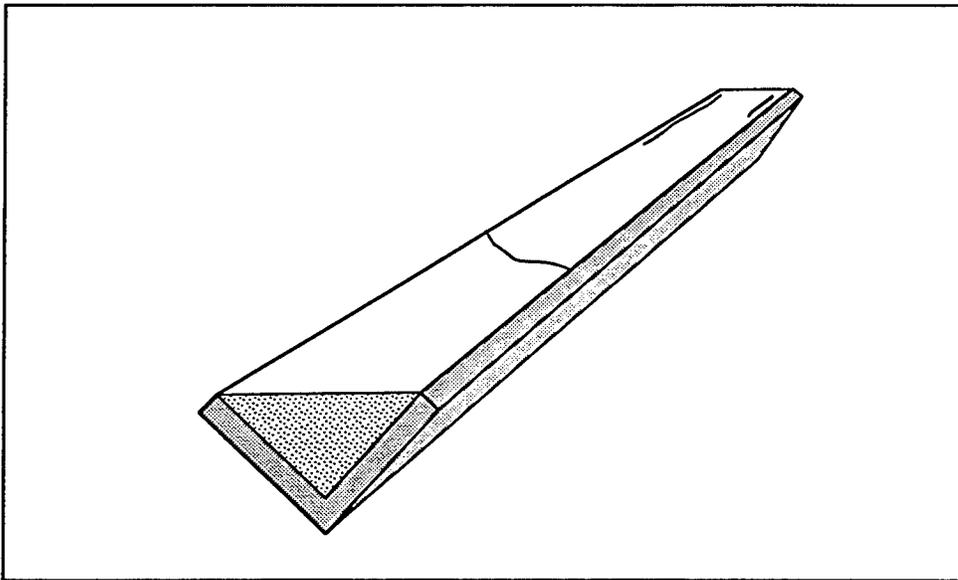
Table 14 Results of German Angle Field Tests - Arizona		
Material No.	Date of Placement	Observation
1	12/06/94	No cracks.
2	12/06/94	No cracks.
3	12/06/94	Three cracks noted at 7 days. Figure 52.
4	12/07/94	No cracks.
5	12/07/94	No cracks.
6	12/07/94	Two cracks noted at 7 days; three additional cracks at 21 days; one additional crack at 35 days. Figure 53.
7	12/07/94	Twelve cracks noted at 7 days; two additional cracks at 21 days; one additional crack at 28 days; two additional cracks at 35 days; one additional crack at 42 days; one additional crack at 170 days; four additional cracks at 200 days; one additional crack at 240 days. Figure 54.
8	12/08/94	Two cracks noted at 7 days; five additional cracks at 170 days. Figure 55.
9	12/08/94	One crack noted at 7 days; one additional crack at 35 days. Figure 56.
10	12/08/94	Thirteen cracks noted at 7 days; one additional crack at 35 days. Figure 57.
11	12/09/94	One crack noted at 7 days; one additional crack at 21 days; one additional crack at 200 days. Figure 58.

Figure 58. Cracking of Material No. 11 (Arizona)
