National Transportation Safety Board
Washington, D.C. 20594

Safety Recommendation

In reply refer to: A-99-51 through -54

On October 15, 1998, Delta Air Lines flight 915, a McDonnell Douglas MD-88, N902DE, experienced an uncontained failure¹ in the No. 2 (right) engine, a Pratt & Whitney (P&W) JT8D-219, immediately after takeoff from Logan International Airport, Boston, Massachusetts. The pilots reported that, just after takeoff, they felt a light thump, the airplane yawed to the right, and the cockpit instrumentation indicated that the No. 2 engine had lost power. The pilots then declared an emergency and returned to Boston. None of the 128 passengers, 4 flight attendants, and 2 pilots on board were injured. The airplane was operating on an instrument flight rules flight plan under the provisions of 14 Code of Federal Regulations Part 121 as a regularly scheduled passenger flight from Boston to Atlanta, Georgia.

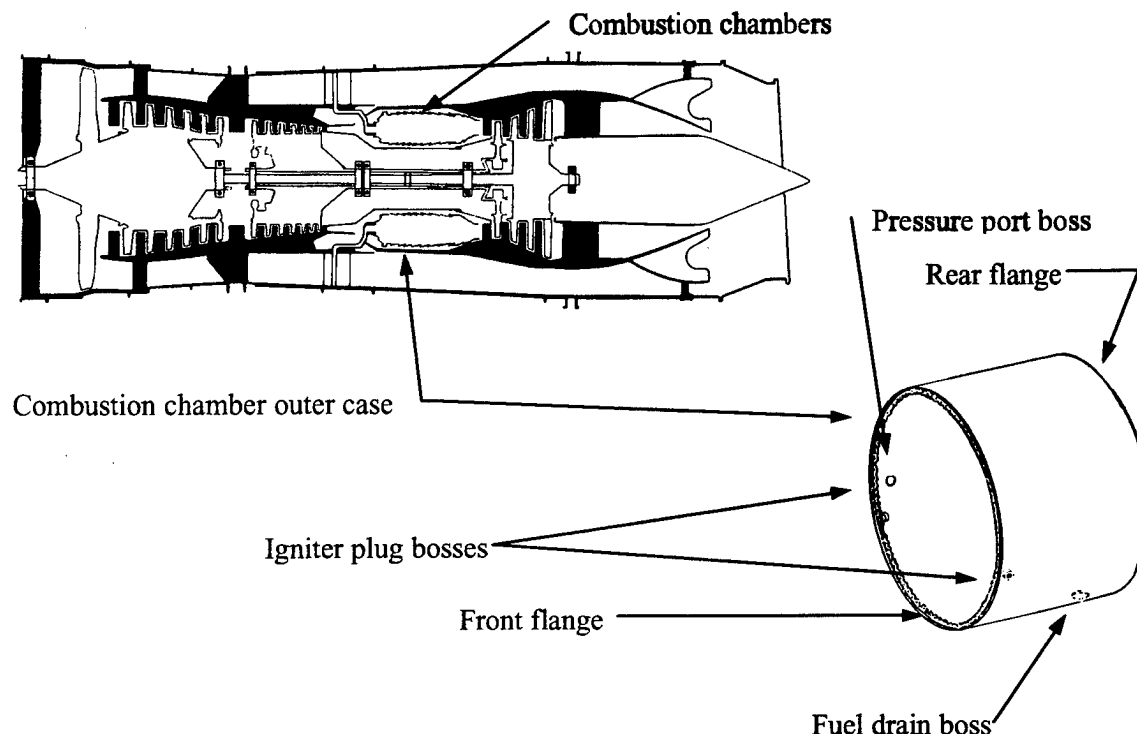
The CCOC is a barrel-shaped structure that houses the combustion chambers and contains four circular-shaped bosses, mounted on which are two igniter plugs, a pressure port, and a fuel drain (see figure 1). The ruptured CCOC was assembled in six pieces: the front flange³ and body, the four bosses, and the rear flange. The front flange and body of the case and the four bosses were made of AMS [Aerospace Material Specification] 5613 410 stainless steel,⁴ and all of the

Figure 1. JT8D-200 engine cross section showing the location of the CCOC, and an enlarged view of the CCOC showing the location of the bosses and the case's front and rear flanges.

The ruptured CCOC was examined at the National Transportation Safety Board's materials laboratory. This examination revealed a fatigue fracture that had multiple origins along the weld on the exterior side of the fuel drain boss. The fracture had propagated about 150° around the boss and then axially, about 1½ inches forward and ½ inch rearward. The fatigue striations indicated that the crack had existed for approximately 1,340 cycles before the CCOC ruptured. The fracture originated from a mechanically thinned area of the boss' flange that had grinding marks consistent with previous work. The measured thickness of the boss flange adjacent to the fatigue fracture was 0.080 inch; however, the fuel drain boss' engineering drawing required a thickness of 0.099 to 0.109 inch.
