PB00-910401  
NTSB/AAR-00/01  
DCA97MA058

# NATIONAL TRANSPORTATION SAFETY BOARD

## AIRCRAFT ACCIDENT REPORT

CONTROLLED FLIGHT INTO TERRAIN  
KOREAN AIR FLIGHT 801  
BOEING 747-300, HL7468  
NIMITZ HILL, GUAM  
AUGUST 6, 1997

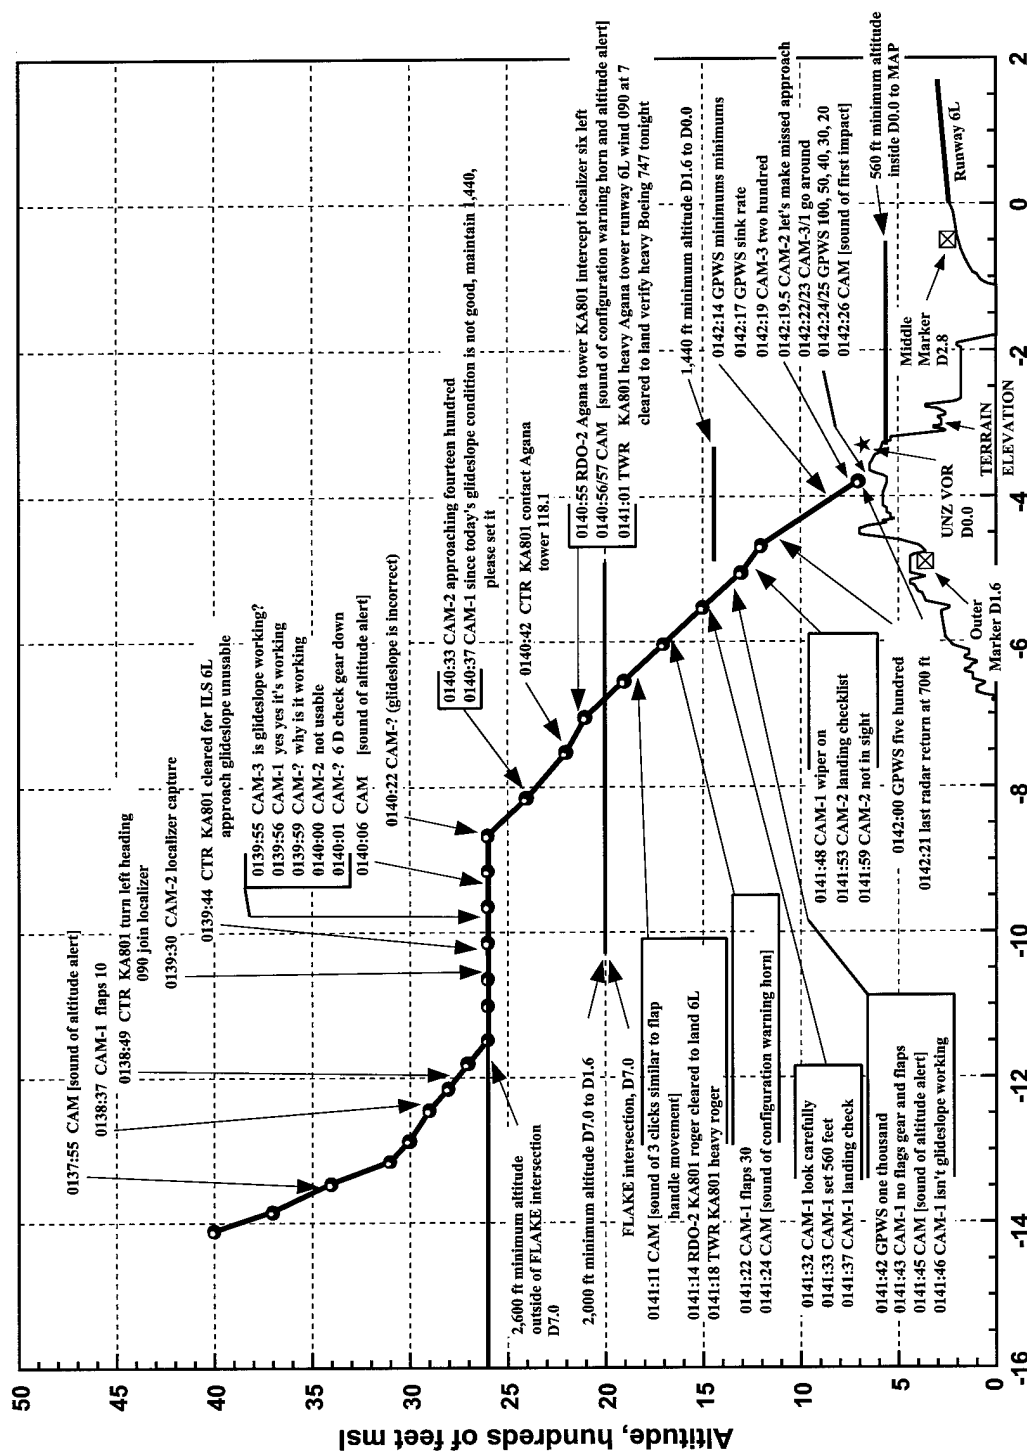
Figure 2. Side view of FAA radar data with selected ATC and CVR communication excerpts.

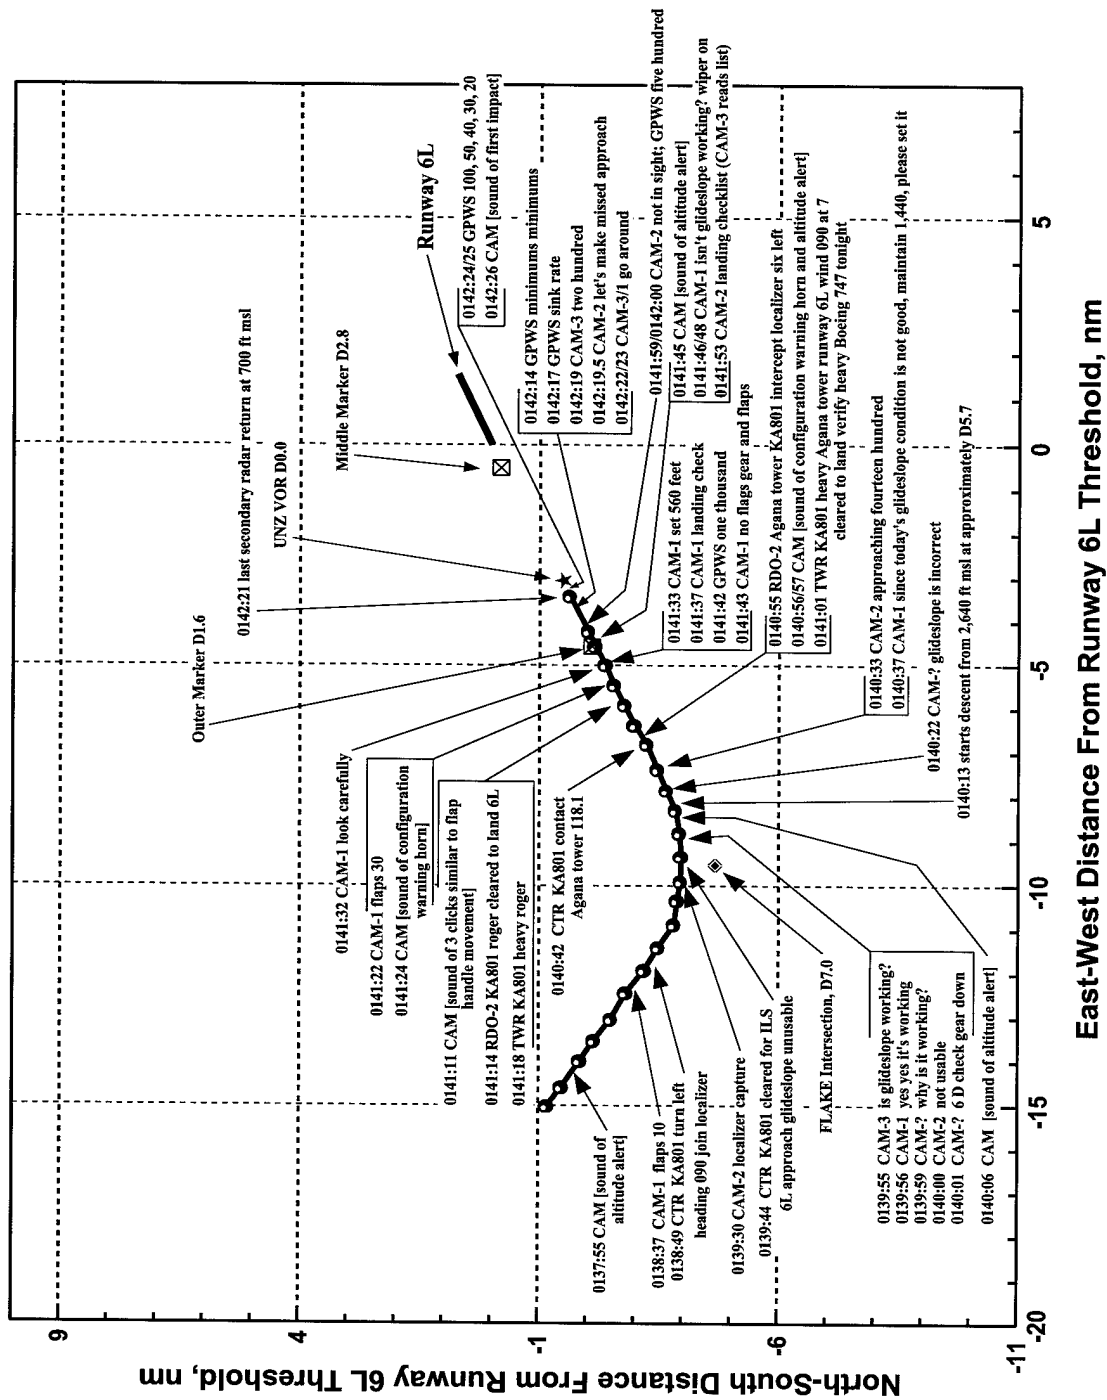
Figure 3. Overhead view of FAA radar data with selected ATC and CVR communication excerpts.

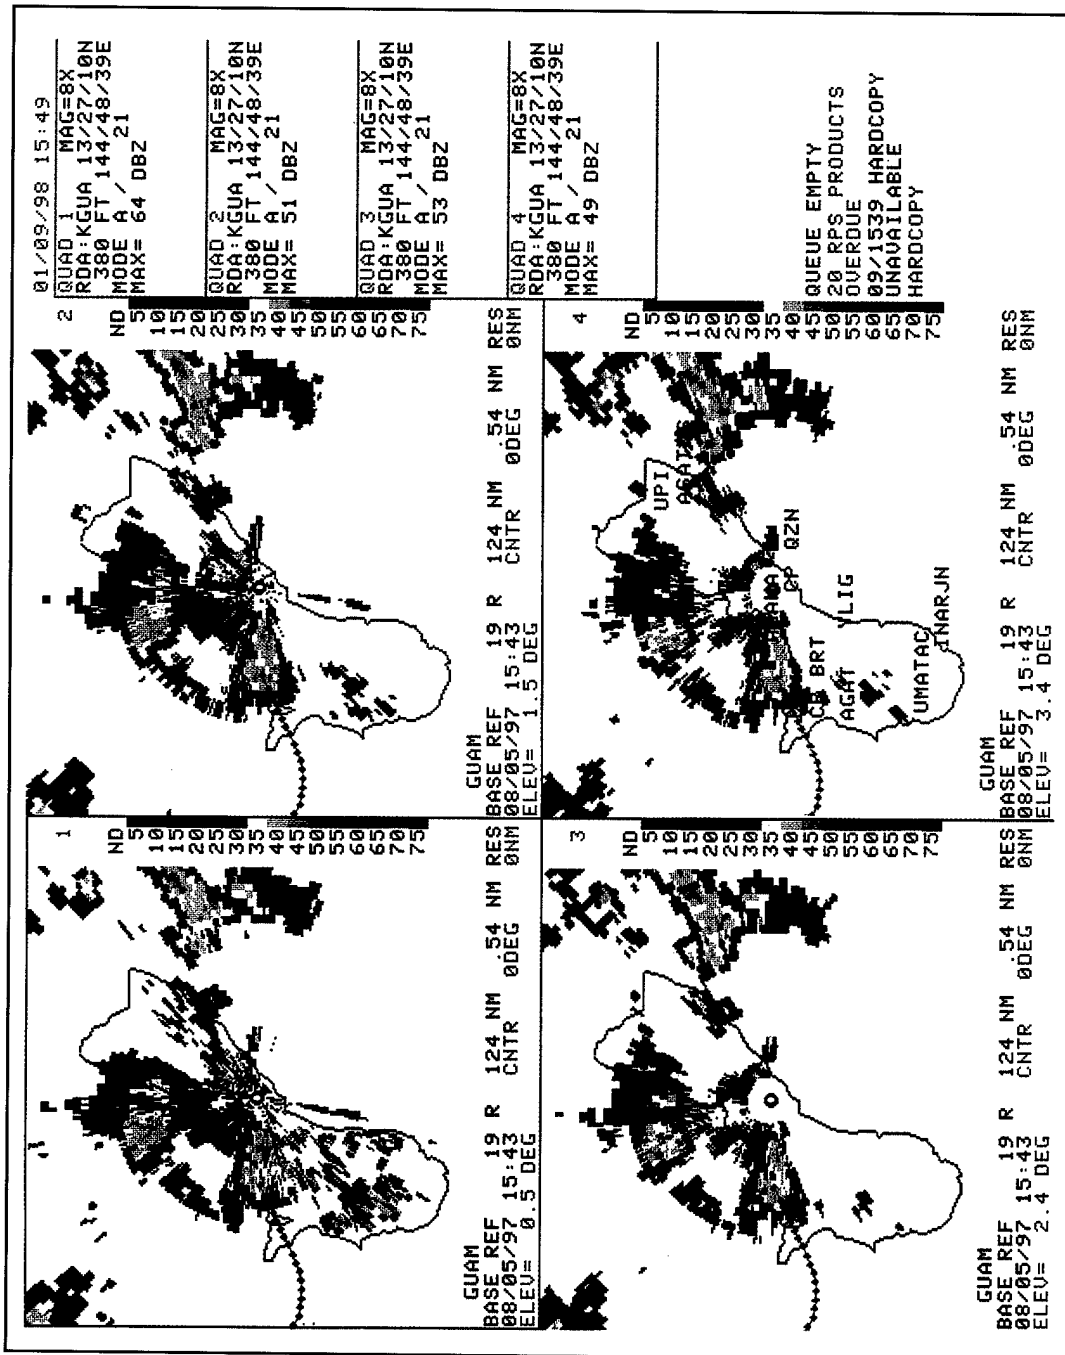
**Figure 6.** WSR-88D four-panel base reflectivity product for Guam.
