# The First United States Army Aircraft Accident Report

(September 1908)

I have the honor to submit the following detailed report of the accident to the Wright Aeroplane at Ft. Myer, Virginia, on September 17, 1908.

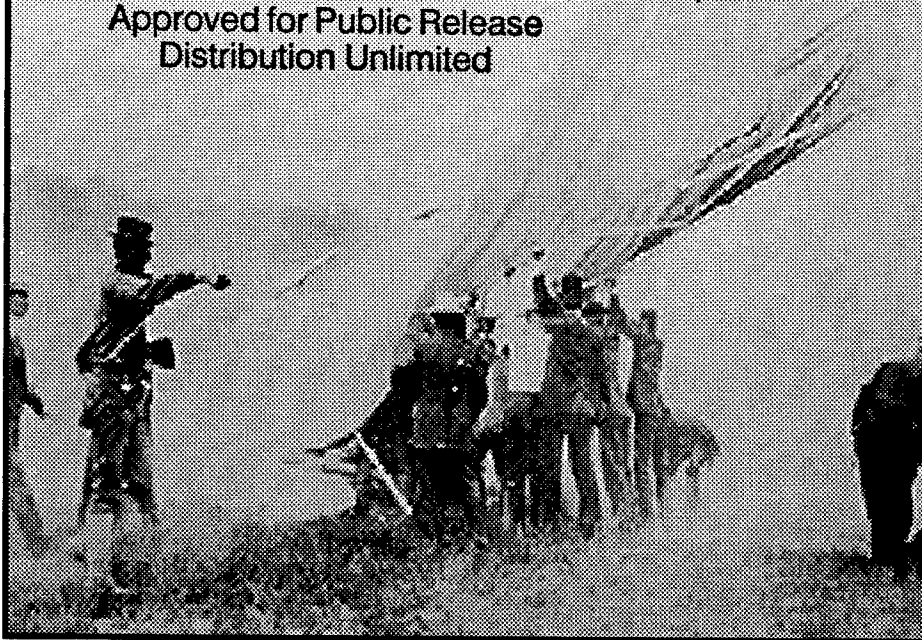
**The first U.S. Military aviation mishap involving powered flight occurred before the Army even owned an airplane. The crash was at Fort Myers, Virginia, on 17 September 1908. The occasion was the final flight in the acceptance trials of the first aircraft purchased from the Wright brothers.**

**Lieutenant Thomas E. Selfridge was flying with Orville Wright. After they had been airborne about 3 or 4 minutes, the aircraft suddenly nosed over and crashed at a steep angle. Lt Selfridge was fatally injured and died several hours later. Orville was seriously injured and hospitalized for 7 weeks.**

**The Army ordered an investigation to learn the cause of the mishap. The investigation consisted of observing the remains of the crashed aircraft and taking witness statements. The board found a new, longer propeller contacted a rudder guy wire and eventually caused the wire to come out of its socket. This allowed the rudder to fold sideways, and the pilot lost control.**

**And it worked. The Wright brothers designed an improved version of their aircraft with structural changes which ensured the propellers could not hit any guy wires. This marked the beginning of the flight safety program so familiar to us today.**
