Periodic Inspection Report No. 4  
West River  
Townshend, Vermont

# Townshend Lake

October 1996

US Army Corps  
of Engineers

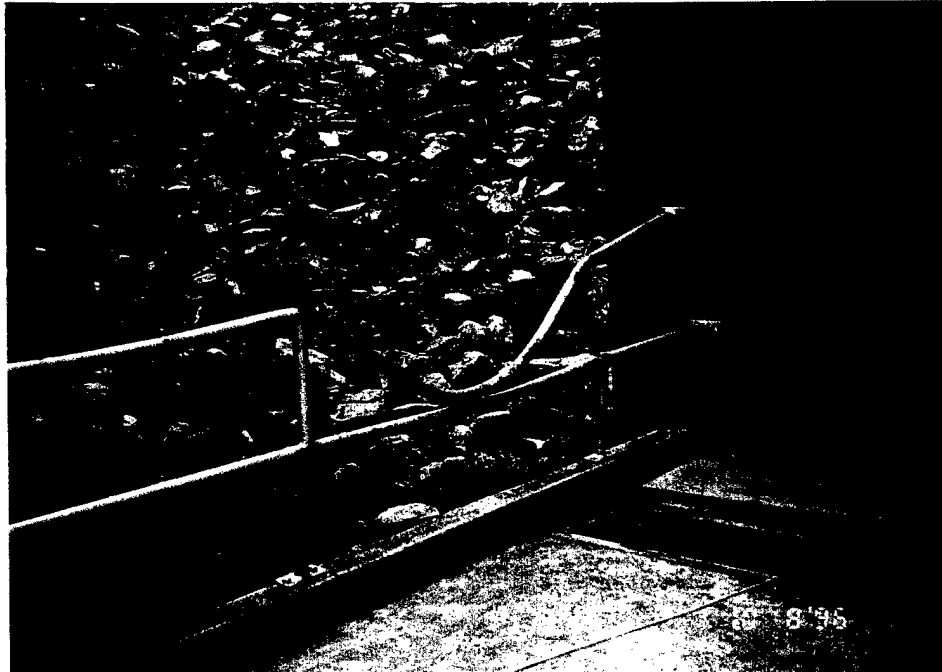
PHOTO A-9. Damaged railing section at the south east corner of the upstream control platform.

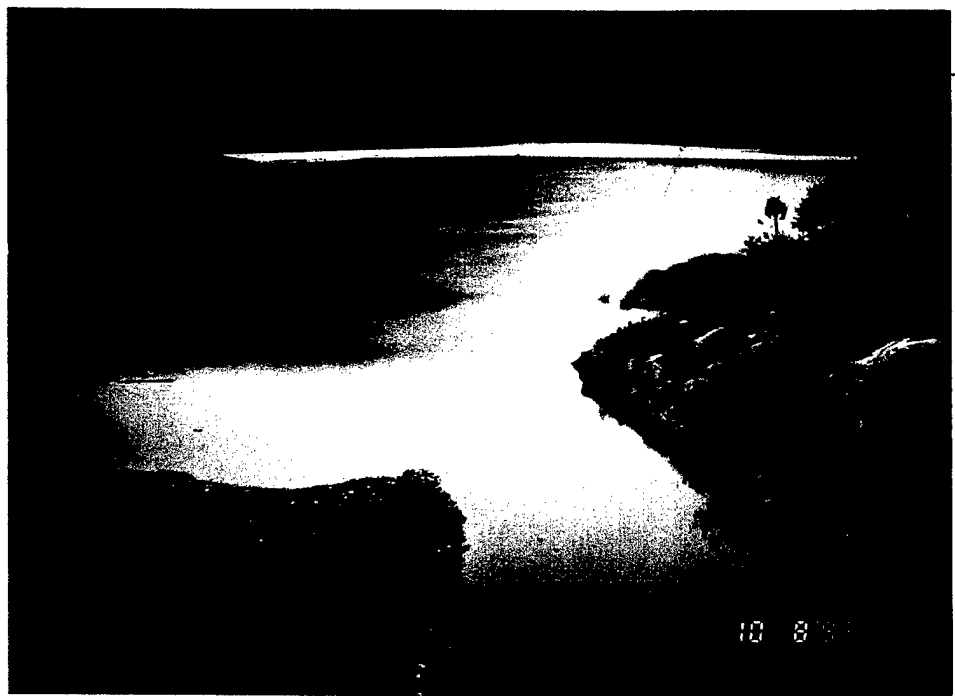
(a) Inlet Channel. The inlet channel is in good condition with no major obstructions. See photo D-3, Appendix II.

Photo D-3 Upstream view of inlet channel

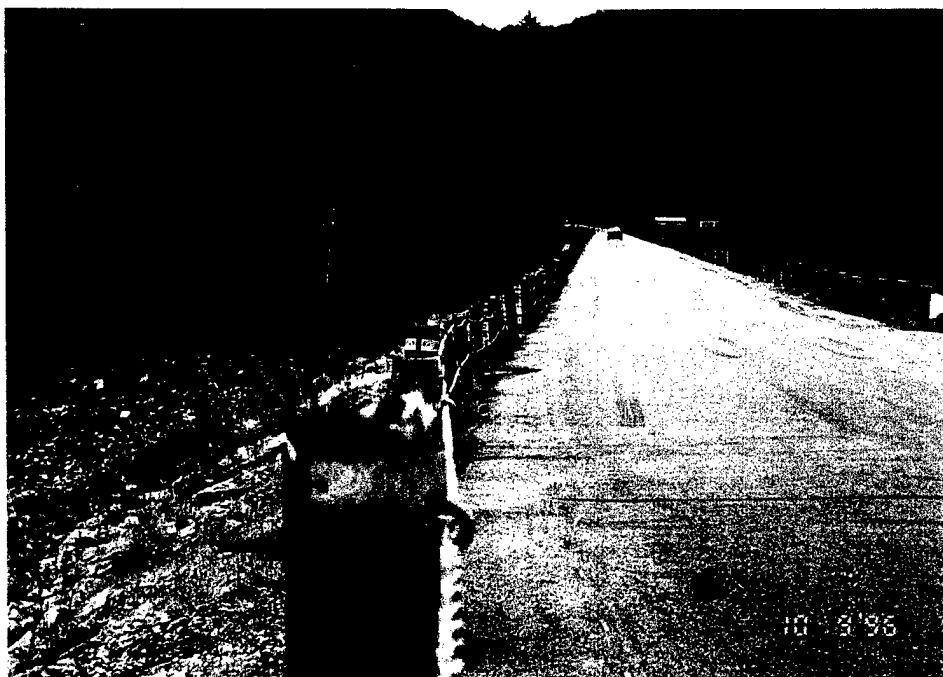
PHOTO E-3: Crest of dam, looking towards right abutment. Note posts moved out of alignment by snow plows.

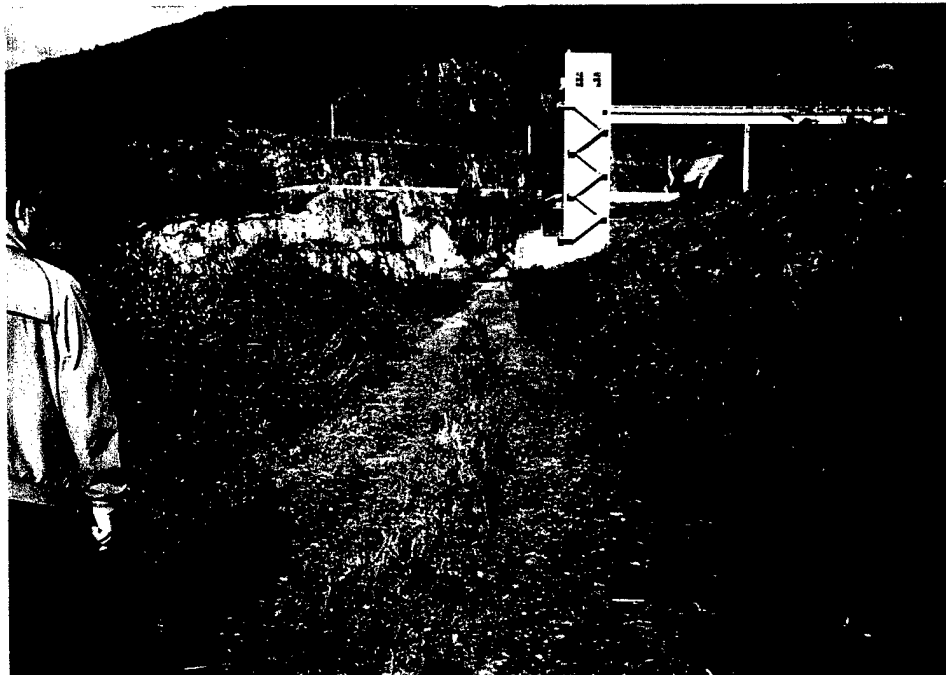
PHOTO E-5: View of edge of lower portion of upstream impervious blanket. Note heavy brush growth.

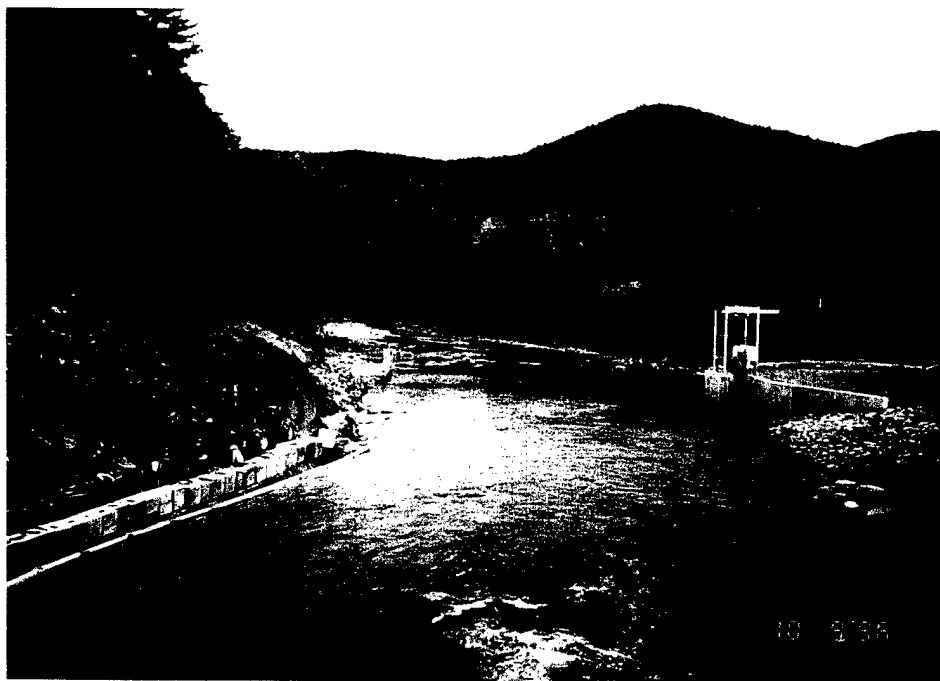
PHOTO E-13: Construction underway to repair banks of outlet channel.
