September 2000

BORDER PATROL

Procurement of MD 600N Helicopters Should Be Reassessed

GAO/GGD-00-201

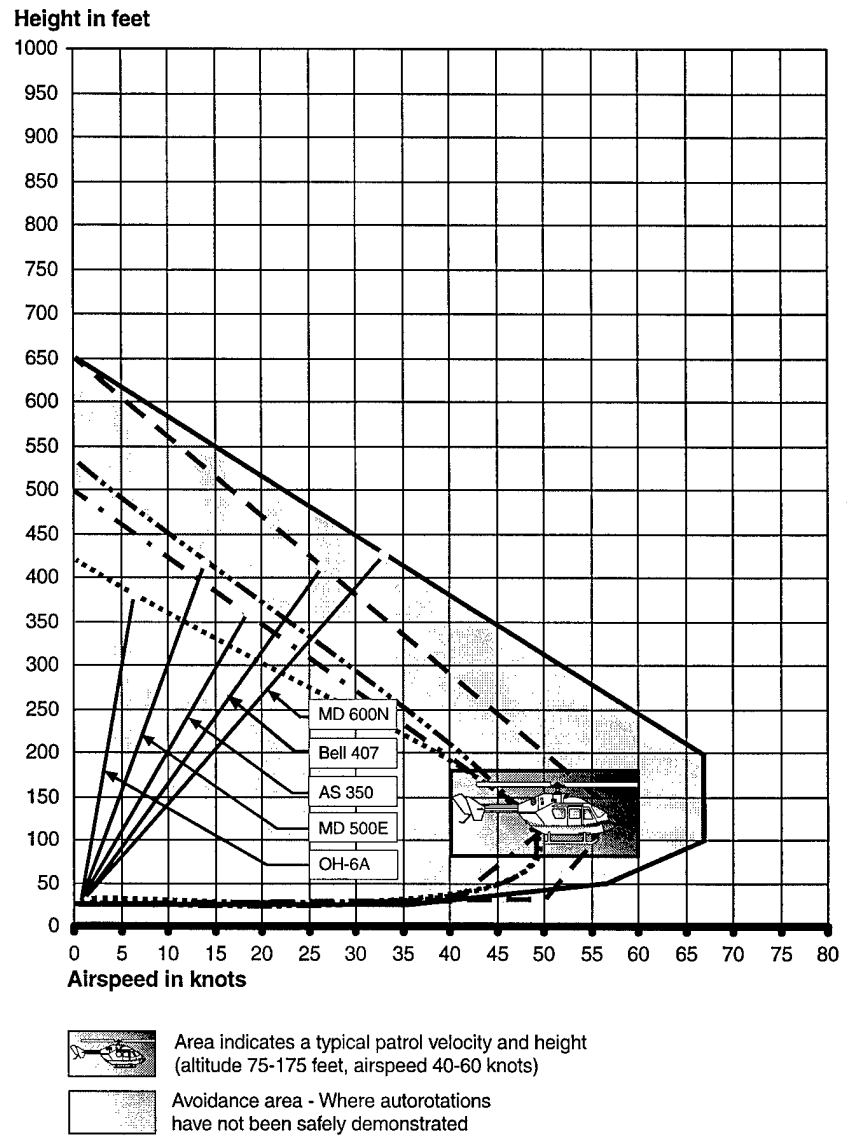
Figure 3: Height/Velocity Curves for MD 500E, MD 600N, Bell 407, American Eurocopter AS 350, and Hughes OH-6A

Most of the pilots we interviewed believed that the autorotation characteristics of the MD 600N are inappropriate for much of the flying performed during Border Patrol air operations missions. Autorotation is a pilot-recovery maneuver performed in the event of an engine failure that keeps the main rotor blades moving so that the aircraft descent can be controlled. Aircraft height and airspeed factors to be avoided during autorotation are depicted as a height/velocity curve.⁸ Pilots are instructed

MDH officials stated that the pilots based their concerns on a misunderstanding of the height/velocity curve rather than on the helicopter's operational characteristics. According to MDH, the MD 600N's height/velocity curve appears to cover more area because of more stringent testing conditions used for establishing the curve.⁹ However, we examined the height/velocity curves for several helicopters that were tested at or estimated for sea level. The MD 600N height/velocity curve had a larger area to avoid (see fig. 3). A senior FAA certification official said that this is a valid means for showing how different aircraft height/velocity curves relate to the height and airspeed of a typical Border Patrol mission.

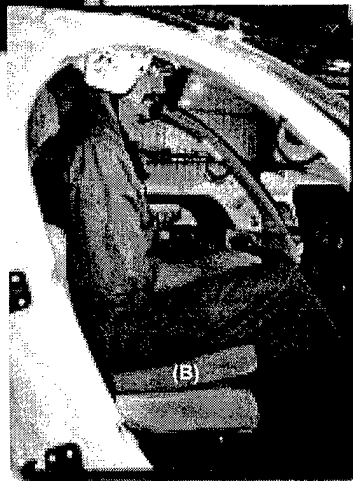
(B) Some pilots reported using seat cushions provided by Air Operations headquarters or their own cushions to relieve some of the discomfort caused by the seats in the MD 600N.

Air Operations officials agreed that the seats in the MD 600N are uncomfortable. Pilots had said they wanted padded seats, so the officials said they asked for high-quality seats during the procurement.¹⁷ Air Operations officials recently took action to replace the seats provided under the original procurement. Seats tested by Border Patrol pilots during the flight evaluations for the stability augmentation system have been ordered and are being manufactured, as of September 21, 2000, according to INS.

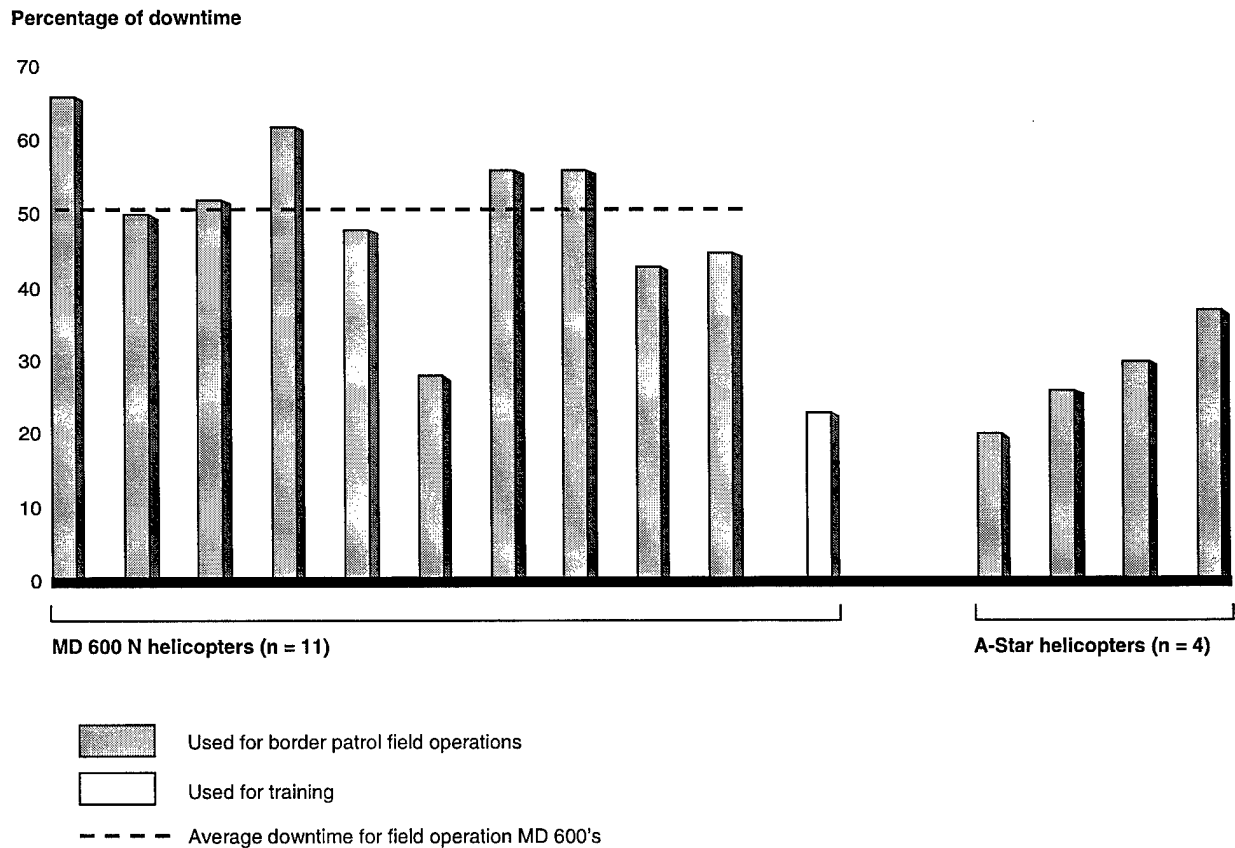
Figure 5: Downtime for Border Patrol 600N Helicopters

A major concern of most sector chiefs and their staffs was the significant amount of time in which the MD 600N helicopters were unavailable for use or "down." Air Operations records for December 1998 to March 2000 show that the 10 MD 600Ns assigned to Border Patrol field operations were unavailable, on average, over 50 percent of the time.¹⁸ This downtime included any time that the helicopters were not operational due to avionics repair, maintenance, or while waiting for parts. In comparison, the four Border Patrol Eurocopter "A-Star" helicopters were down 28 percent of the time during the same period. Reasons for the downtime included delays in obtaining an engine repair contract, slow manufacturer approval for modifications, and parts availability.

An Air Operations official said that specific helicopters may have had problems that explained why they were inoperable. The official stated that, for example, two MD 600Ns were down due to foreign object damage to

the engines. The damage was discovered in November 1999, but the helicopters were not returned to service until March and April 2000, respectively, because Air Operations was without an engine repair contract from October 1999 to June 2000. Emergency engine repairs were requested in late November but not authorized until mid-February 2000.
