**Loading, Degradation and Repair of
F-111 Bonded Honeycomb Sandwich
Panels - Preliminary Study**

DSTO-TR-1041

**Airframes and Engines Division
Aeronautical and Maritime Research Laboratory**

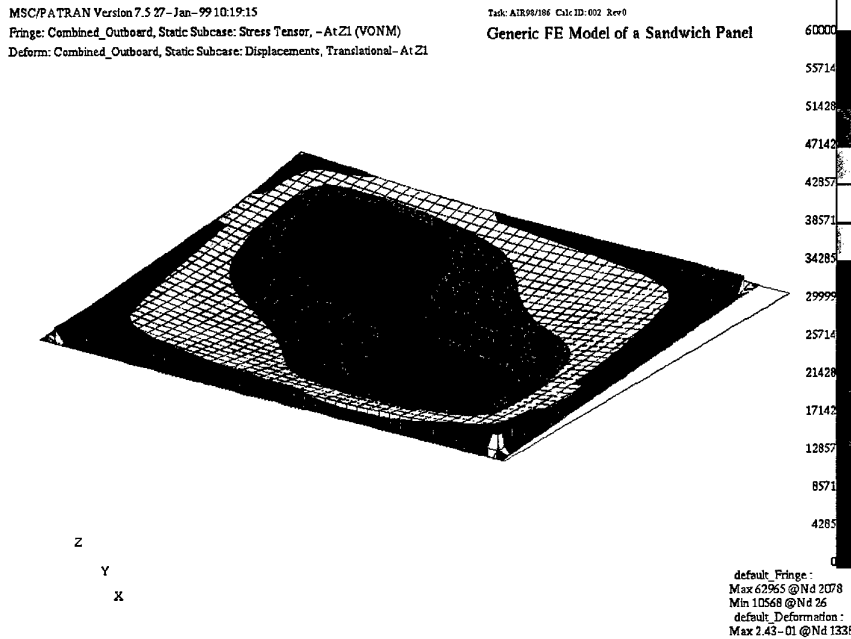
The results of the FE analysis indicate that the stresses in the centre of the panel for all load cases, individual and combined, agree very well with the OEM face analysis calculations. A stress contour plot of the panel under combined ultimate loads is shown in Figure 11.

Figure 11: Contour plot of inner face stresses

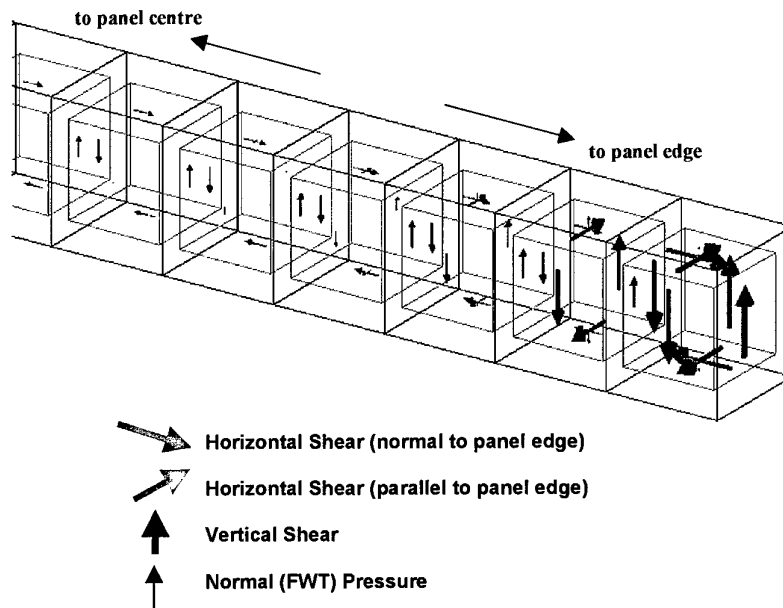
Closer examination of the internal load distribution in the core can be seen in Figure 13. This figure also shows how the shear stresses dominate the total core stress field.

Figure 13: Internal loads in honeycomb core near the panel edge
