FOREIGN OBJECT DAMAGE: CAUSES AND PREVENTION

1 January 1970 through 31 December 1976

by
MSG Jerry E. Mills

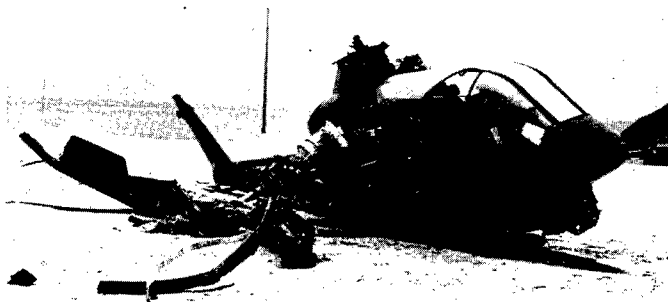
FIGURE 9c

- AH-1G, OH-6A major accidents, \$210,552 damage - During flight unsecured items blew out of ammo bay and passenger areas, hitting tail and causing tail rotor failure. (figures 9a, 9b, and 9c)

FIGURE 9a
Deflector assembly . . .

FIGURE 9b
caused tail rotor system to depart aircraft... and caused this.

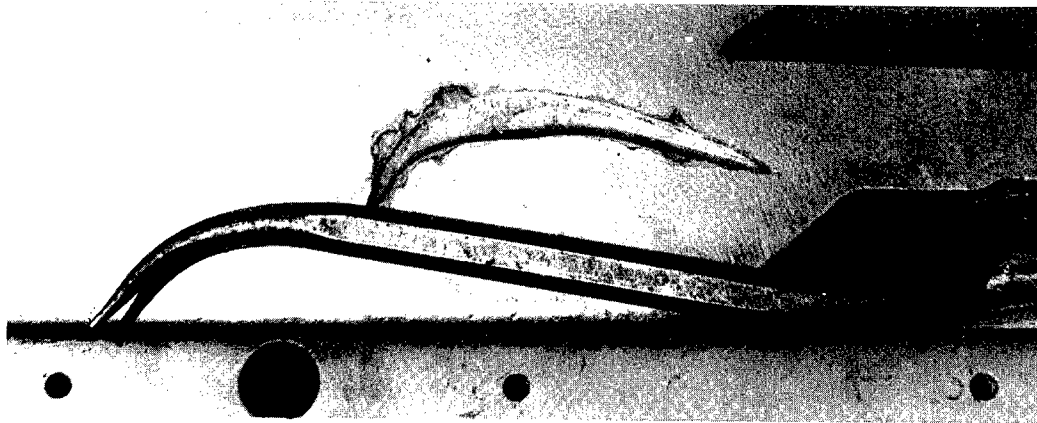
FIGURE 16

Figures 15 and 16 show damage to a UH-1H main transmission support case. A crew chief noticed something wedged between the transmission and side structural panel. Removal of the panel revealed the damage. It is suspected the cotter key removal extractor was dropped in the transmission well while work was being performed in the area of the main rotor hub assembly 25 to 30 hours before discovery. Damage resulted in replacement of the main transmission.

FIGURE 15.—Cotter key extractor found in transmission support case.

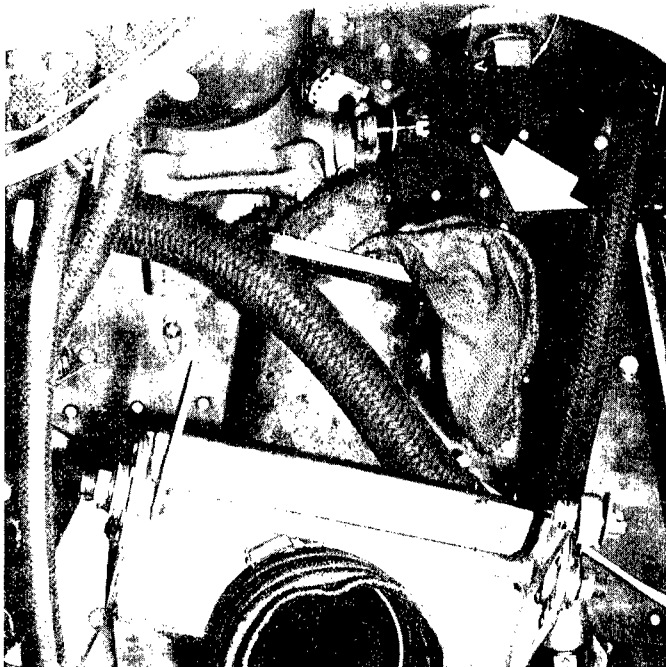
FIGURE 17.—Rag lodged in carburetor induction elbow assembly.

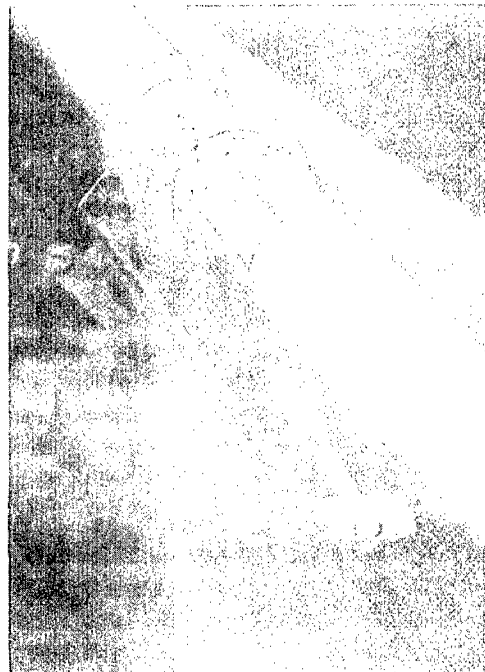
- UH-1H incident, \$230 damage - Postflight inspection revealed hole in tail rotor drive shaft tunnel

cowling. Further inspection revealed a ratchet and mallet were left under No. 4 tail rotor drive shaft when drive shaft bearing was replaced the previous day. The maintenance was inspected and signed off by a technical inspector. The technical inspector and the crew chief, who performed the daily inspection, failed to find the tools! (figures 18a, 18b, and 18c)

Ratchet mechanism, gear to ratchet, and hammer found in UH-1 drive shaft tunnel cowling.

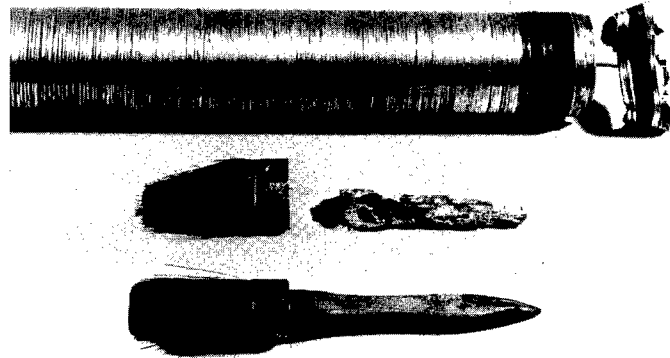
- UH-1H minor accident, \$4,366 damage - Landing approach was made and terminated at hover. During hover, sound was heard and directional control was lost. After one complete clockwise rotation, aircraft touched down. The third section of the tail rotor drive shaft had failed due to FOD caused by paint brush. (figure 20)

FIGURE 20.—Sheared tail rotor drive shaft caused by paint brush. New brush is shown with brush that caused damage.

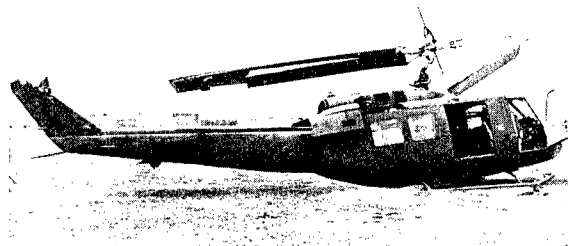
- UH-1H major accident, \$73,000 damage - Aircraft was in level flight when loud bang was heard and tail rotor loss occurred. Aircraft hit hard and blades struck ground. Engine inlet cover had been left on roof of aircraft during preflight. Cover struck red tail rotor blade, and tail rotor, 90-degree gearbox, and a portion of the drive shafting separated from aircraft. (figures 27a, 27b, and 27c)

FIGURE 27a.—Unsecured engine inlet cover . . .

FIGURE 27b.—
. . . struck tail rotor . . .

FIGURE 27c.—
. . . and caused this.
