AIRCRAFT ACCIDENT REPORT

**CRASH DURING LANDING
FEDERAL EXPRESS, INC.
MCDONNELL DOUGLAS MD-11, N611FE
NEWARK INTERNATIONAL AIRPORT
NEWARK, NEW JERSEY
JULY 31, 1997**

NTSB/AAR-00/02

DCA97MA055

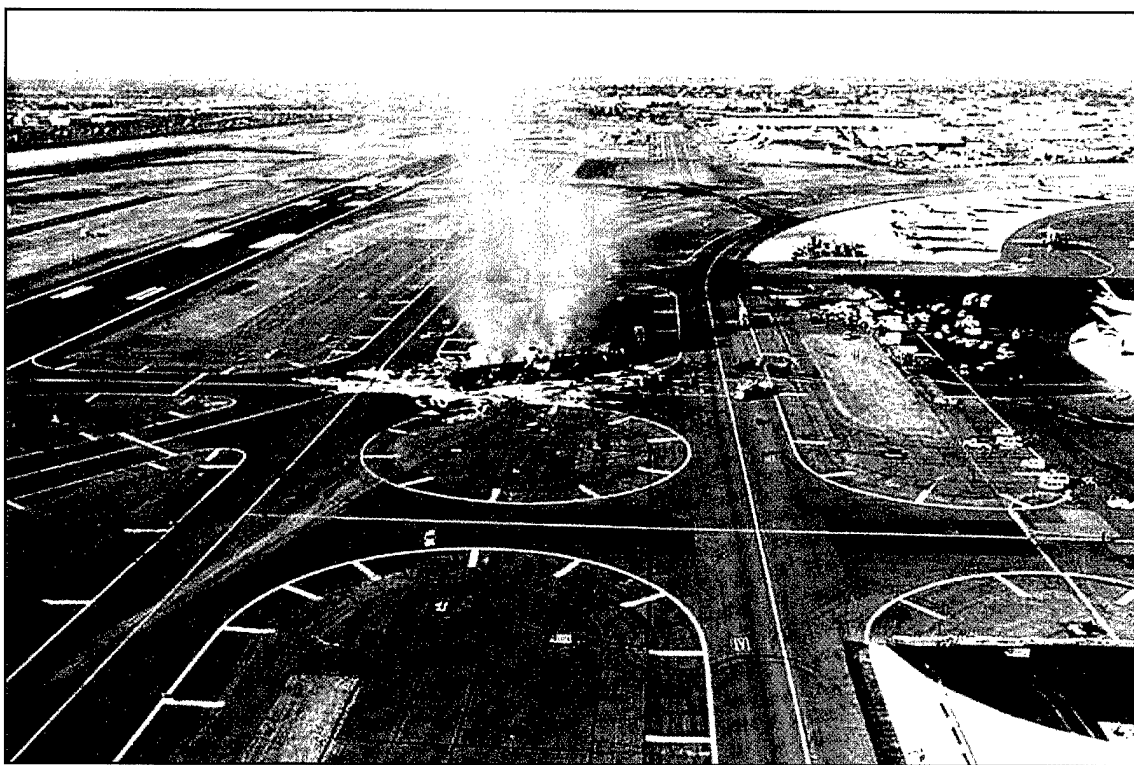
Figure 1. Aerial view of the accident site.

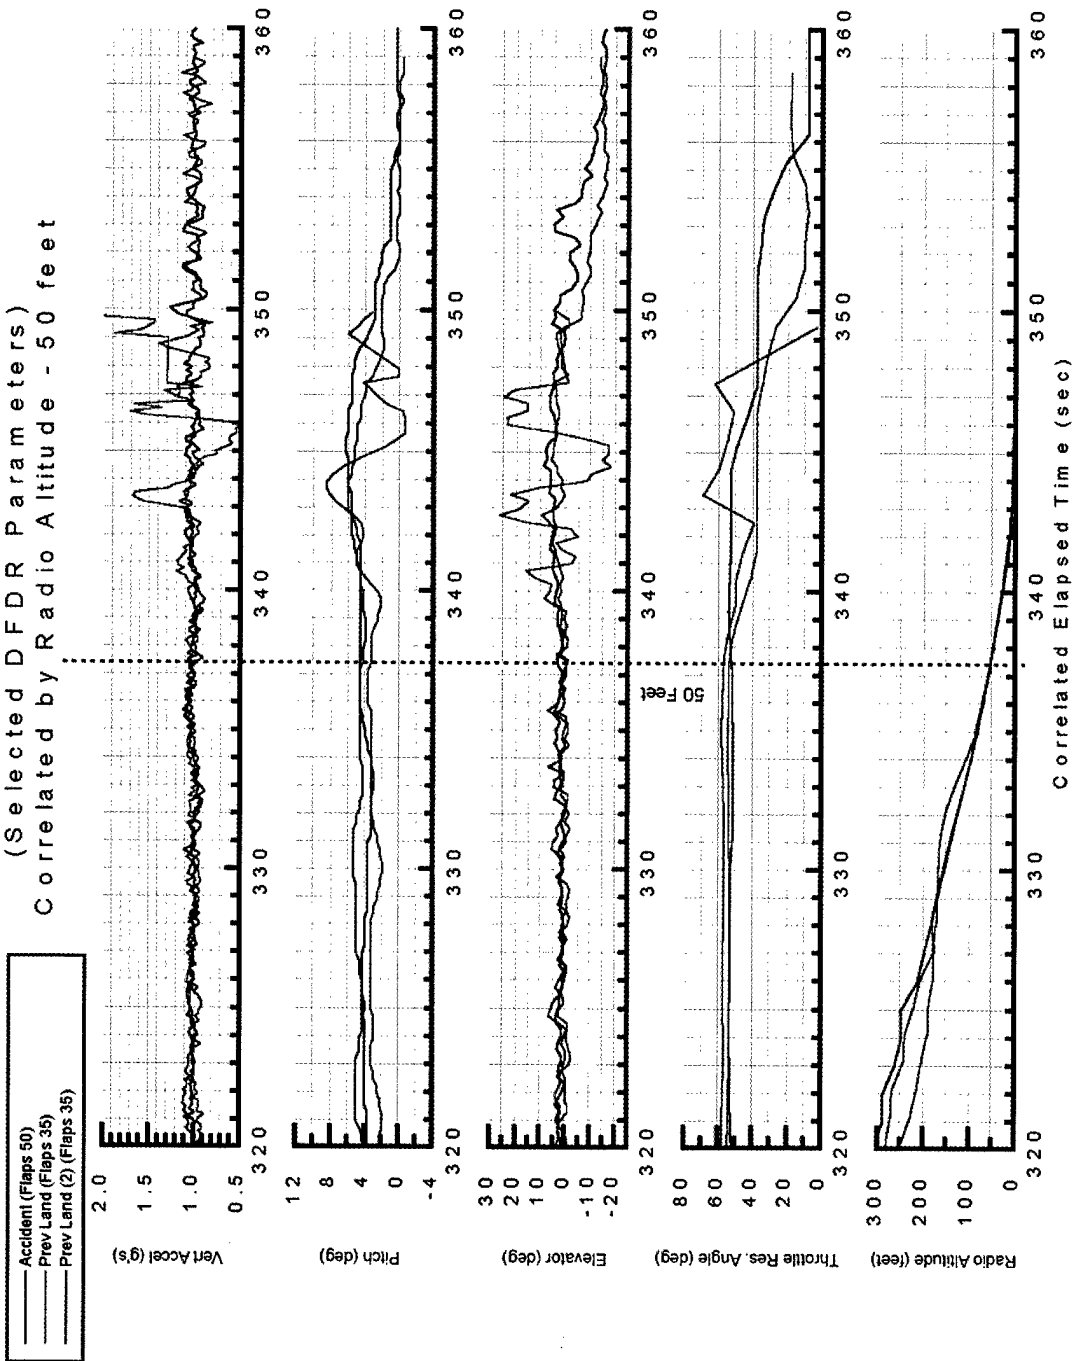
Figure 5. Comparison of selected DFDR parameters for accident landing and previous two landings (correlated by radio altitude - 50 feet).

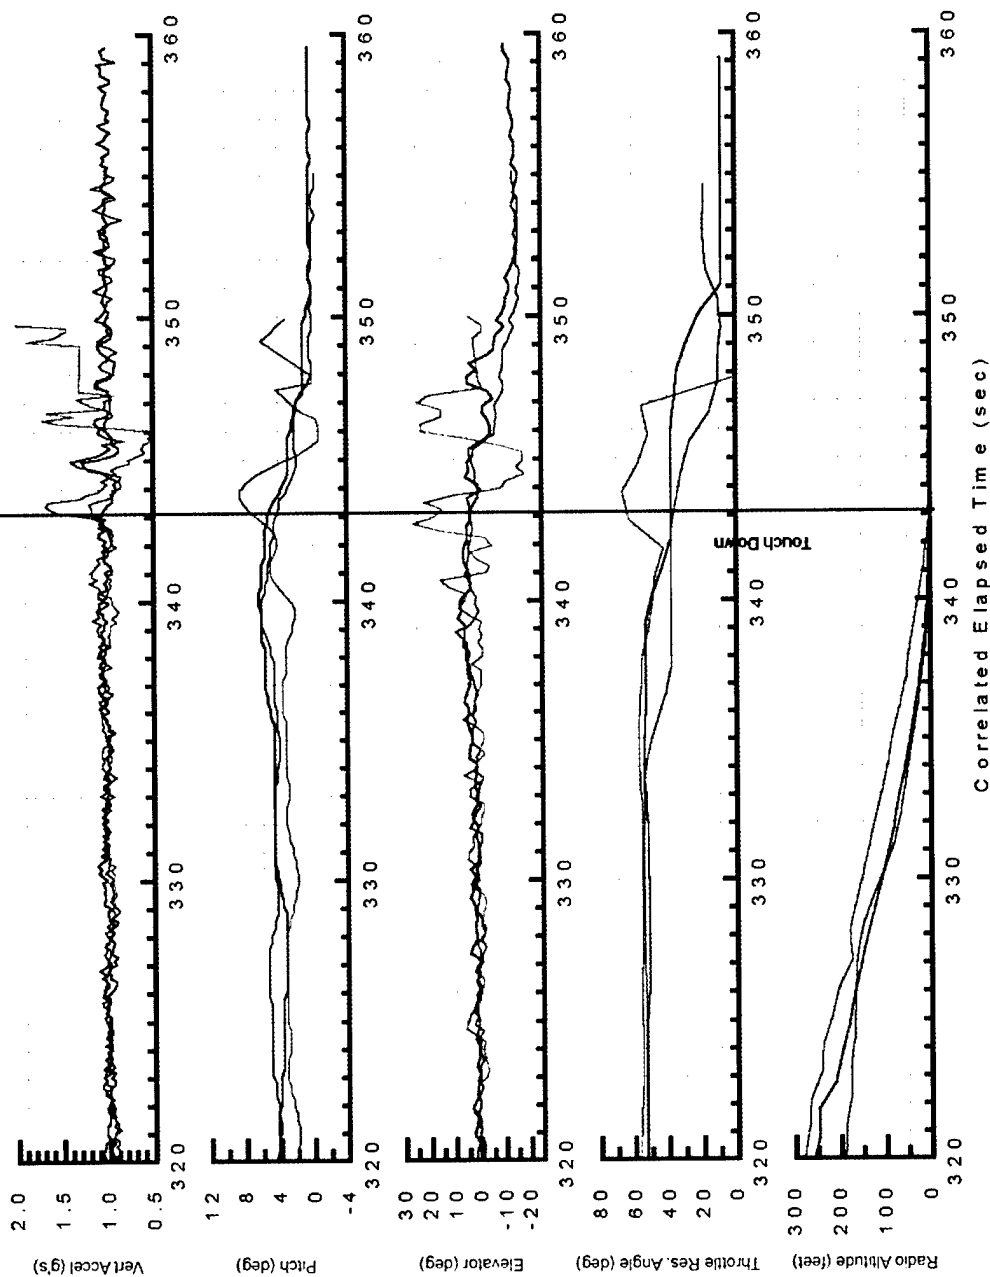
Figure 6. Comparison of selected DFDR parameters for accident landing and previous two landings (correlated by first touchdown).

As the airplane touched down at 0132:18.6, pitch attitude and vertical acceleration were increasing (along with engine speeds). It touched down 1,126 feet beyond the runway displaced threshold with a 7° nose-up pitch attitude. Vertical speed at the time of the first touchdown was about 7.6 feet per second (fps).²³ Vertical acceleration peaked at 1.67 g. About 1/2 second after the first touchdown, the FDR recorded an 18° AND elevator deflection (maximum possible MD-11 AND elevator deflection is 27°) and a TRA decrease.²⁴ At 0132:19, rudder deflection decreased to near zero, and the magnetic heading stabilized at 217.4° (the published magnetic heading for the runway was 219°). Pitch attitude peaked at 8.44° and began decreasing. Thrust continued to increase with N_1 values of about 65 percent. Airspeed began to increase and the airplane became airborne.²⁵

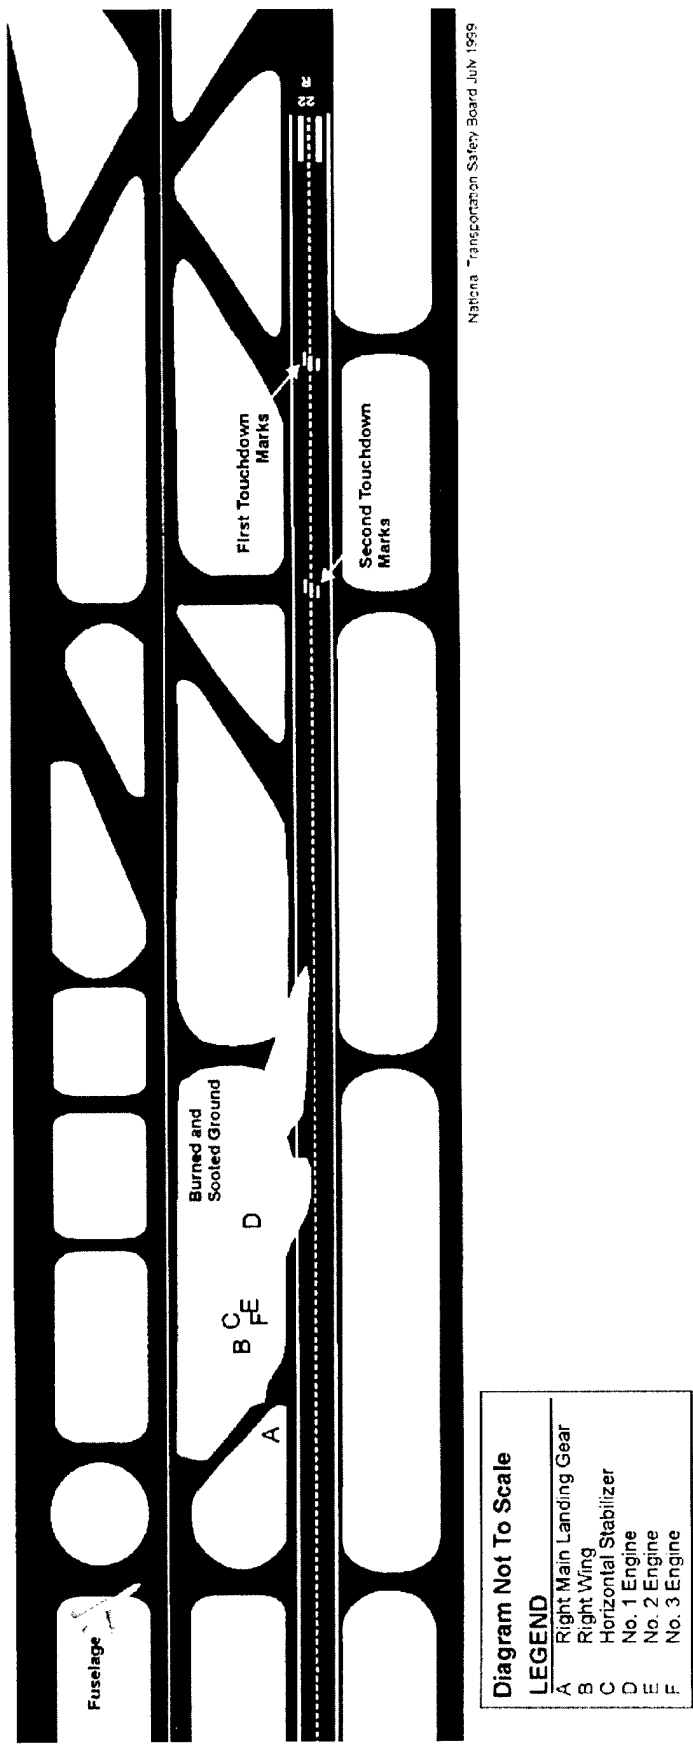
The airplane's wreckage was distributed along a 2,900-foot-long debris path that gradually arced to the right across runway 22R (see figure 7). Pieces of the right inboard trailing edge flap were found at the beginning of the wreckage path, about 2,226 feet from the runway's displaced threshold. The main wreckage, located about 5,126 feet from the runway threshold and 580 feet to the right of the runway centerline, comprised the fuselage, left wing, nose gear, left MLG, center MLG, and horizontal stabilizer. The fuselage came to rest inverted with the nose on a 95° heading. Other airplane components and structure separated from the airplane during the crash sequence and were located along the debris path.

Figure 7. Wreckage distribution diagram.

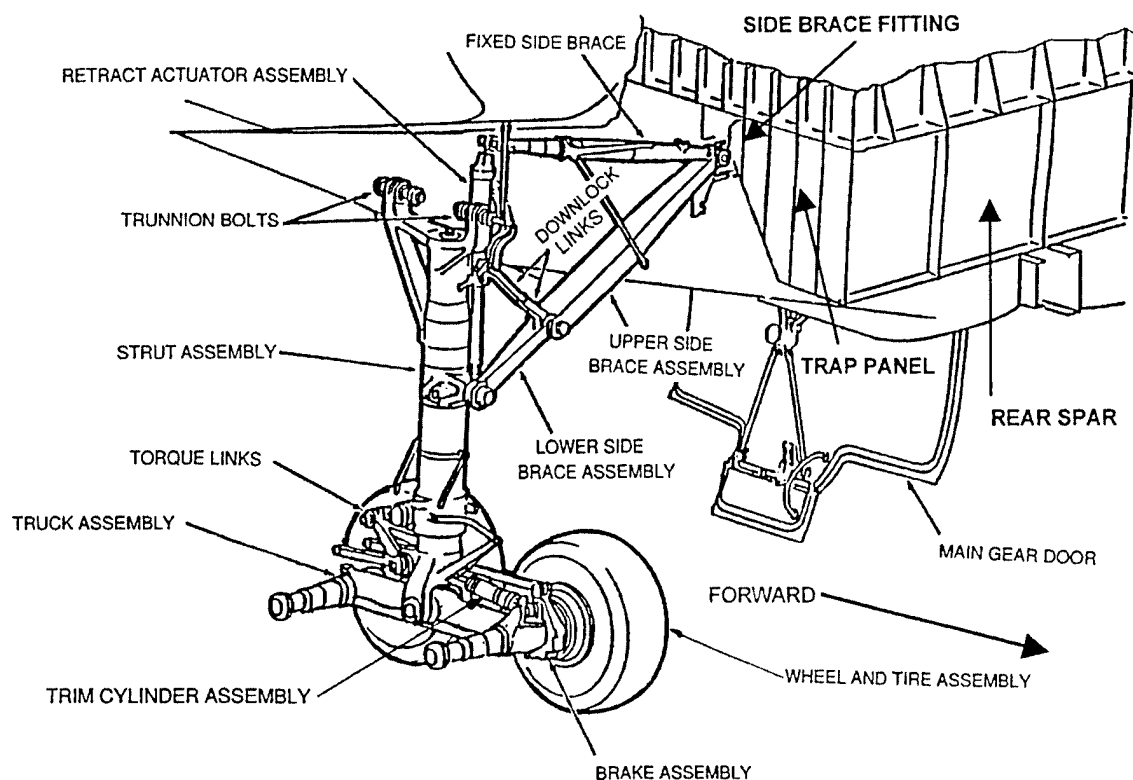
The right MLG was separated from its attach points on the right wing (see figure 8).⁴³ The attach points were broken from the wing, except for the forward lug, which remained attached to the wing with no evidence of failure. The right MLG truck assembly⁴⁴ was found separated into four parts: one part was attached to the aft axle, where the wheels and tires were found intact; a second part was found on the runway; a

Figure 8. Right MLG components.

third part was found attached to the forward axle, where the No. 3 and No. 4 wheels were found intact; and a fourth part was found attached to the strut assembly. The pivot pin was found intact between the truck beam and the oleo piston assembly. The oleo piston and cylinder were found intact, and the piston was fully extended. The torque links were intact and had no structural damage. Parts of a wing-to-gear fitting were found on the aft trunnion⁴⁵ bolt. The forward trunnion bolt, or fuse pin,⁴⁶ failed and had broken into two pieces along the shear plane.⁴⁷ The aft portion of the forward trunnion bolt was found on the runway, and the forward portion was found in the right wing-to-gear-fitting forward trunnion lug.

Scraping damage was found on the forward trunnion lug's forward face. The fixed side brace (to) folding side brace fitting joint was found intact with the side brace, the fixed brace, the side brace fitting (commonly referred to as the "pillow block"), and the pillow block hinge joint pin assembly (see figure 8). The inboard attach bolt was found intact with the pillow block and a part of the trapezoidal panel assembly. The remaining bolt was found detached and in two pieces. One piece was found in the remaining part of

the trapezoidal panel that had broken off from the fuselage and the pillow block assembly. The other bolt piece was found on the runway. The fixed side brace was found fractured about 6 inches from the wing fitting lug and was bent in the aft direction where it failed.

A metallurgical examination of the recovered right MLG components determined that all fracture surface evidence was consistent with overload failure. No evidence of fatigue cracking or corrosion was found. In addition, the examination found no indications of preimpact failures or anomalies. An examination of the right MLG tires found no evidence of pretouchdown failures or malfunctions.

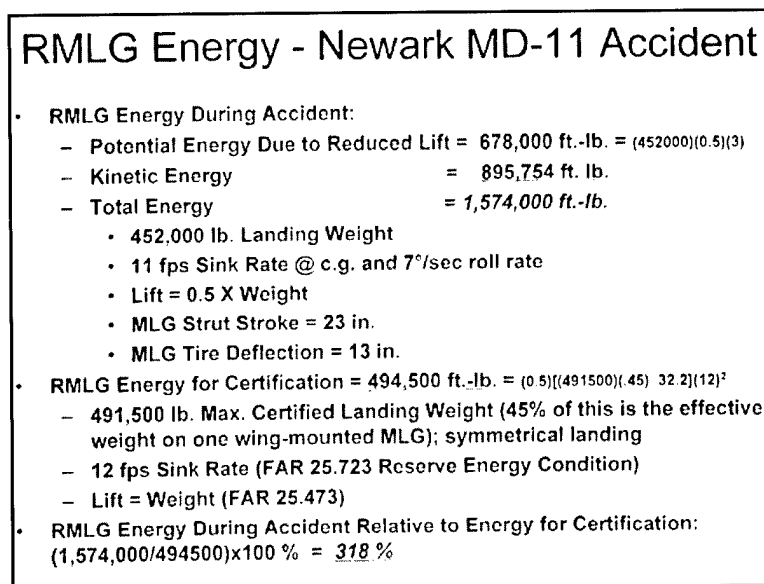
The accident aircraft's recorded vertical acceleration at the start of the second touchdown impact was approximately 0.5 g, that is, wing lift was equal to approximately half the aircraft weight, which imparted huge additional potential energy into the landing gear and attaching structure above and beyond those associated with the 11 fps [c.g.] descent rate and the 7 [degree per second] roll rate [which combined resulted in the 13.5 fps sink rate]. In addition, these energies were imparted primarily into the [right] MLG only, due to the right wing down roll angle...at touchdown. At the accident aircraft's landing weight of 452,000 [pounds]...potential energy of 678,000 ft-lbs was added to the approximately 896,000 ft-lbs. [Right] MLG kinetic energy from the combined aircraft descent and roll rates, for a total energy into the [right] MLG of nearly 1,574,000 ft-lbs. Comparing the loads into the [right] MLG from the accident landing at Newark to the [right] MLG energy absorption requirements for certification shows that the energy developed during the accident landing was over 3 times the reserve energy (ultimate) certification requirements for a single [MLG].

Figure 9. Boeing calculations of right MLG energy in the Newark accident.

The Boeing submission concluded that a “sink rate of approximately 13.5 fps (11 fps at the [c.g.] plus the [right-wing-down] roll rate) at touchdown impact is, by itself, outside the design envelope; a 13.5 fps sink rate landing on a single [MLG] is even further outside the design envelope; [and] a 13.5 fps sink rate landing on a single [MLG] with a net 0.5 g downward acceleration is yet further outside the design envelope.”⁵⁹

In addition, the Boeing submission noted that it was revising the MD-11 maintenance manual to expand hard landing definition and inspection criteria. Boeing
