NAVAL AIR WARFARE CENTER AIRCRAFT DIVISION  
PATUXENT RIVER, MARYLAND

REPORT NO: NAWCADPAX/TR-2000/59

### **BREAKDOWN OF PRESERVATIVE FLUID MIL-PRF-46170 IN AIRCRAFT HYDRAULIC SYSTEMS**

29 March 2001

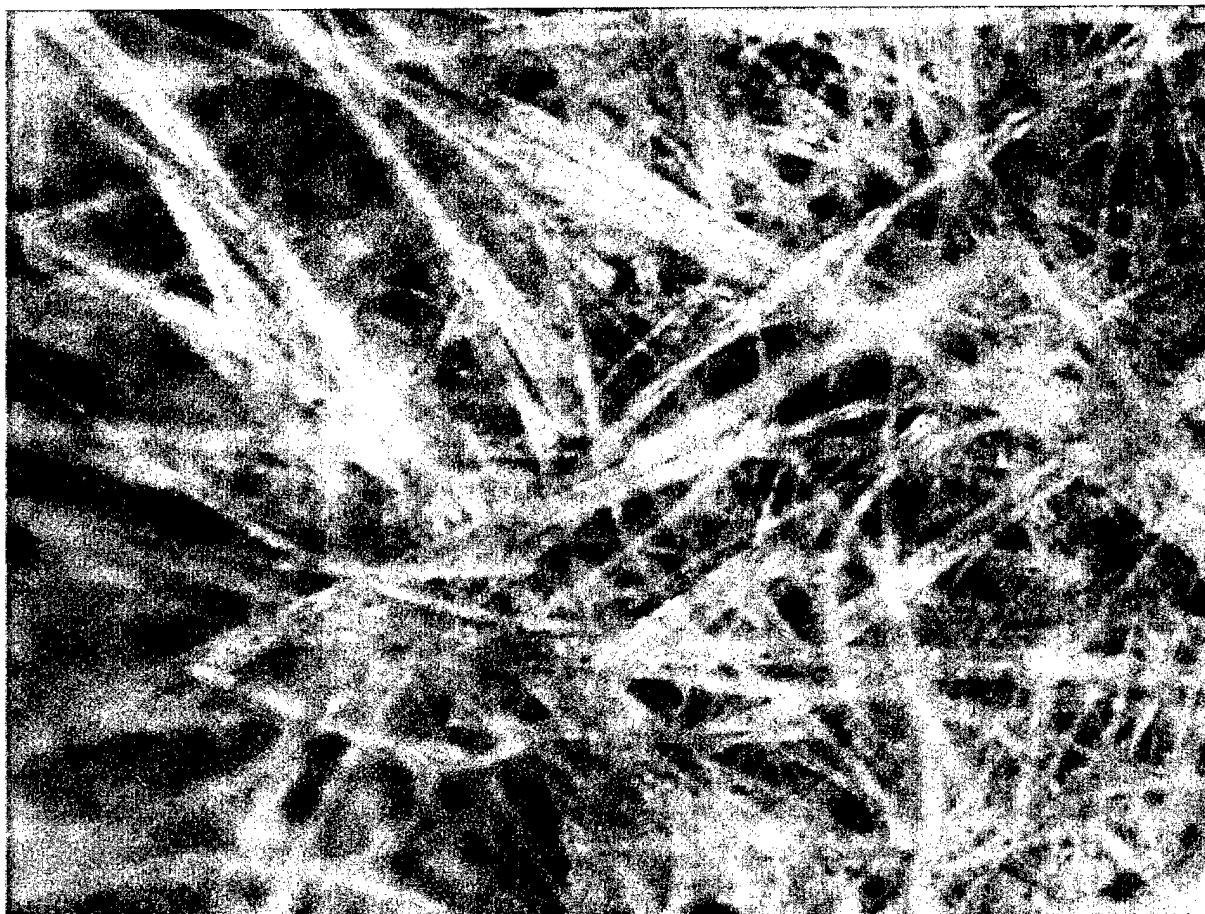
**Figure 1: Test Stand Filter Element After 22 hr**

Return fluid temperature was maintained at 215°F and filter pressure differential was measured at the end of each day of testing. Aircraft representative fluid chemistry caused steady long-term buildup of material in system filter (figure 1). Similar to aircraft filters, test stand filters were plugged with organic material collecting in 22 hr. This relatively long-term continuous buildup was evaluated in phase 2 testing.

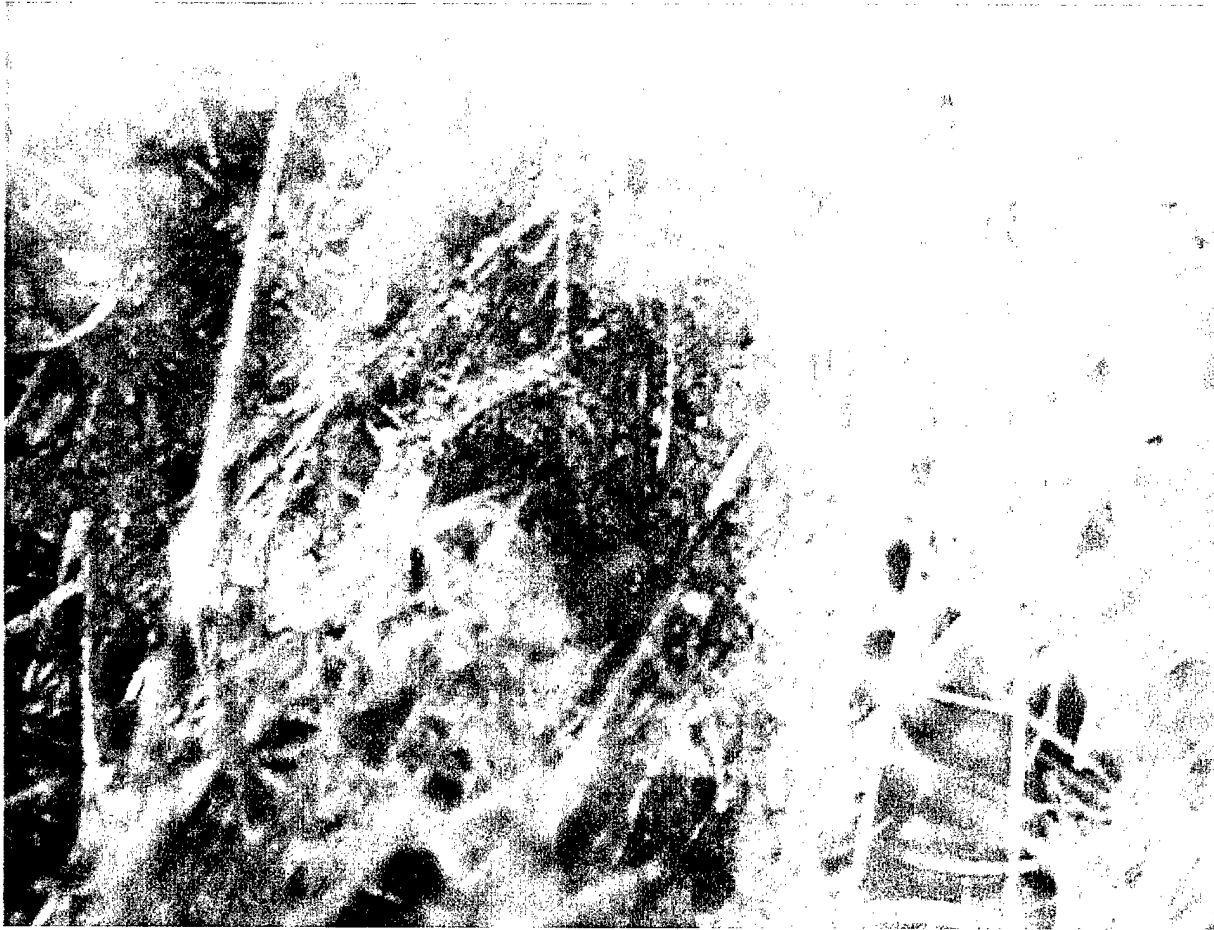
**Figure 4: Test Stand Filter Element (48 hr)**

System baseline testing had progressed to 45 hr with minimal filter loading when an abrupt increase in pressure was observed. Inspection of the system identified a rupture in the heat exchanger that was adding large amounts of water to system fluid.

Inspection of filter media showed that material was present in large chunks against relatively clean media fibers (figure 4). The ruptured heat exchanger allowed water (a polar solvent) to enter the system and release large chunks of material that had formed in the system during previous testing or was an agent causing extremely rapid fluid breakdown under these conditions.

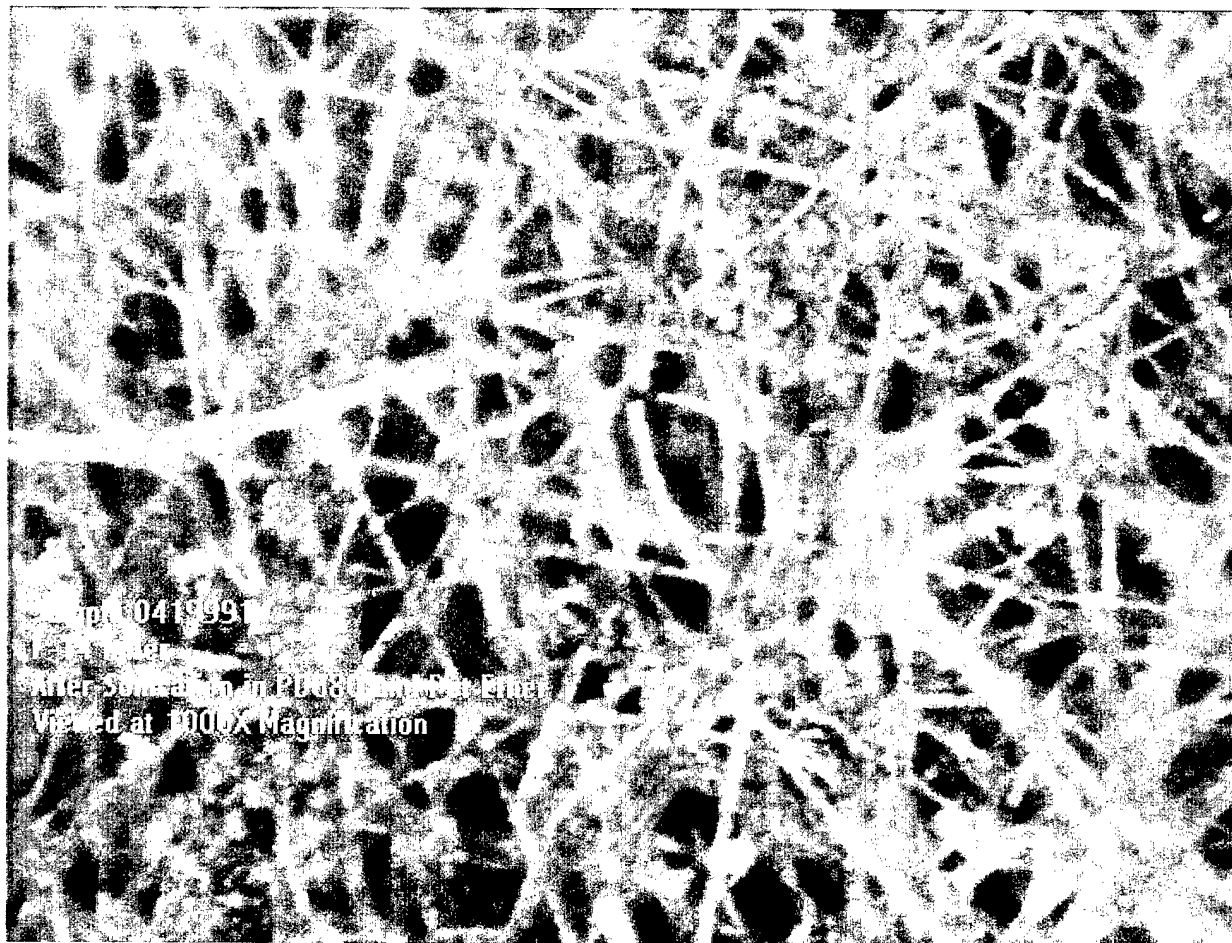
**Figure A-1: F-14 Filter Element After Wash**

Filter elements for F-14 hydraulic systems are replaced at each 300 hr phase inspection. Filters are also changed between phases if filter delta P buttons indicate excessive pressure drop. Filter elements for Navy aircraft trap particles 5 micron and larger in size. Inspection of a prematurely clogged filter element (shown in figure A-1) revealed large amounts of red organic material collecting within the filter media.

The filter element was ultrasonically washed in PD-680 to remove hydraulic fluid and material mechanically trapped within the filter. While many of the larger passages are open, the smaller fluid passages through the media are blocked with an insoluble organic gel, causing a significant reduction in flow area and increased pressure drop. The filter plaque is red in color with a transparent gelatinous appearance. A polar solvent toluene/xylene is required to dissolve the filter plaque.

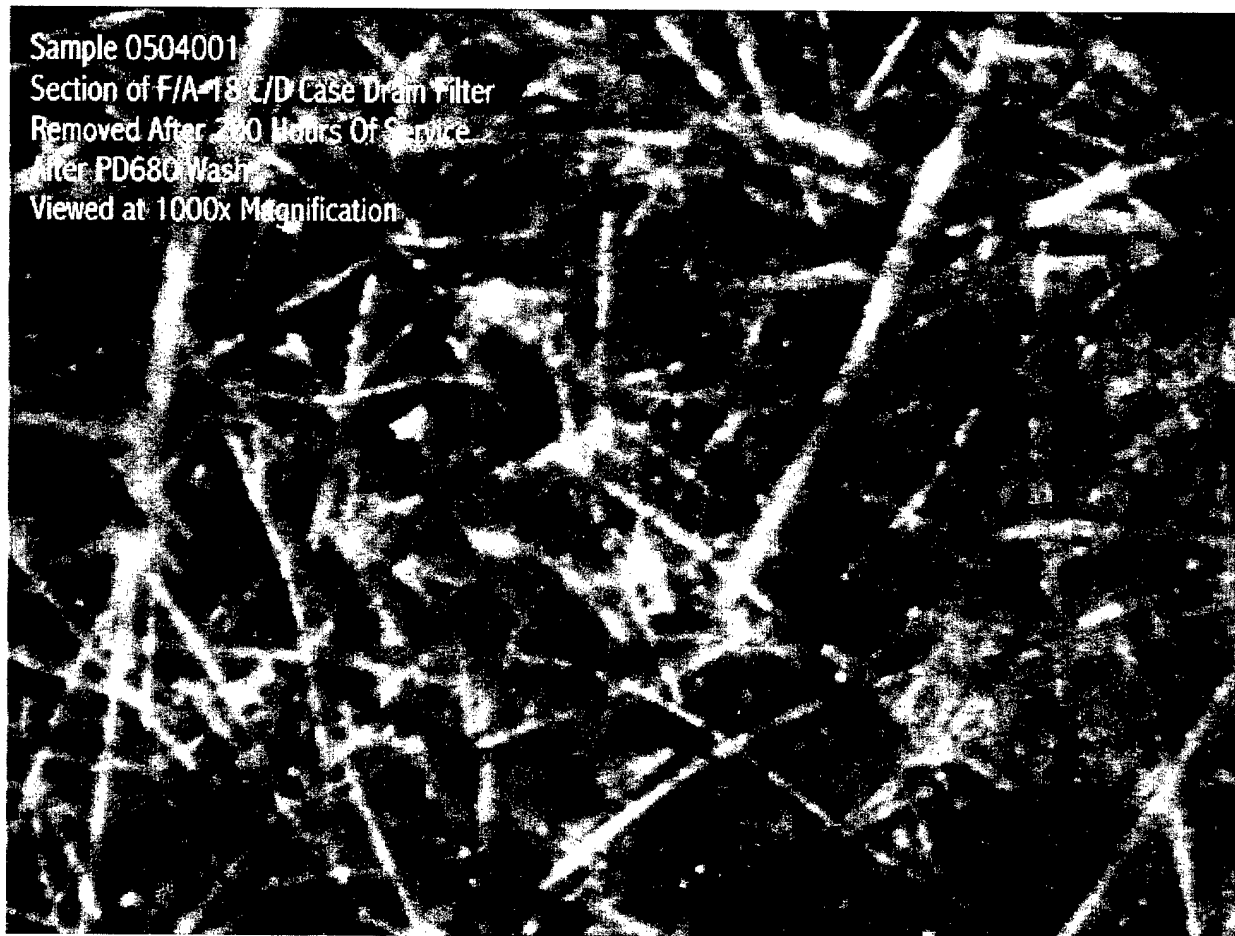
**Figure A-2: F/A-18C/D Filter Removed After 200 hr**

A 200 hr case drain filter was ultrasonically washed with PD-680 to remove any material mechanically lodged in filter fibers. The cleaned filter (figure A-2) shows large amounts of dark organic gel still clogging most of the fluid passages through the media.

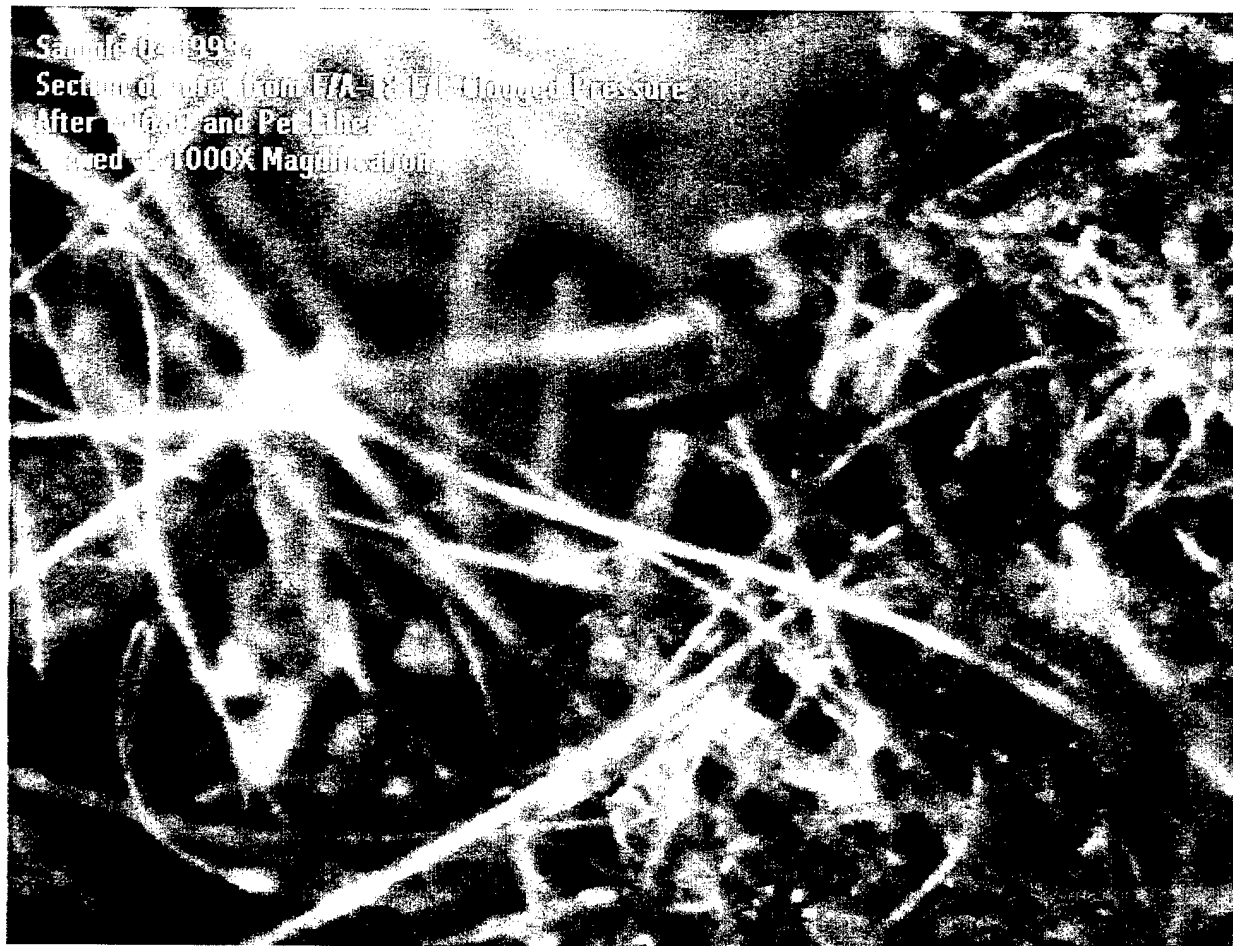
**Figure A-3: F/A-18E/F Clogged Filter After Wash**

Shortly after introduction of the larger pump, filters started to fail at 70 hr. Filters continued to clog at ever increasing rates until some filters were clogged at 20 flight-hours. Problems with filter clogging were worse on HS-1 vice HS-2 due to higher fluid temperatures. The case drain filter element clogging was most severe due to high fluid temperatures and small filter elements.

During this same time period, the leading edge flap HDU motors started to experience premature wearout. Each new motor failed earlier and earlier in service. The wear rate on HS-1 motors was twice that of wear on HS-2 motors. Analysis of clogged filters identified most of the material as an insoluble organic gel (shown in figure A-3). While the HDU motors were wearing out at a rapid rate, the amount of bronze material in the typical clogged filter was minimal.

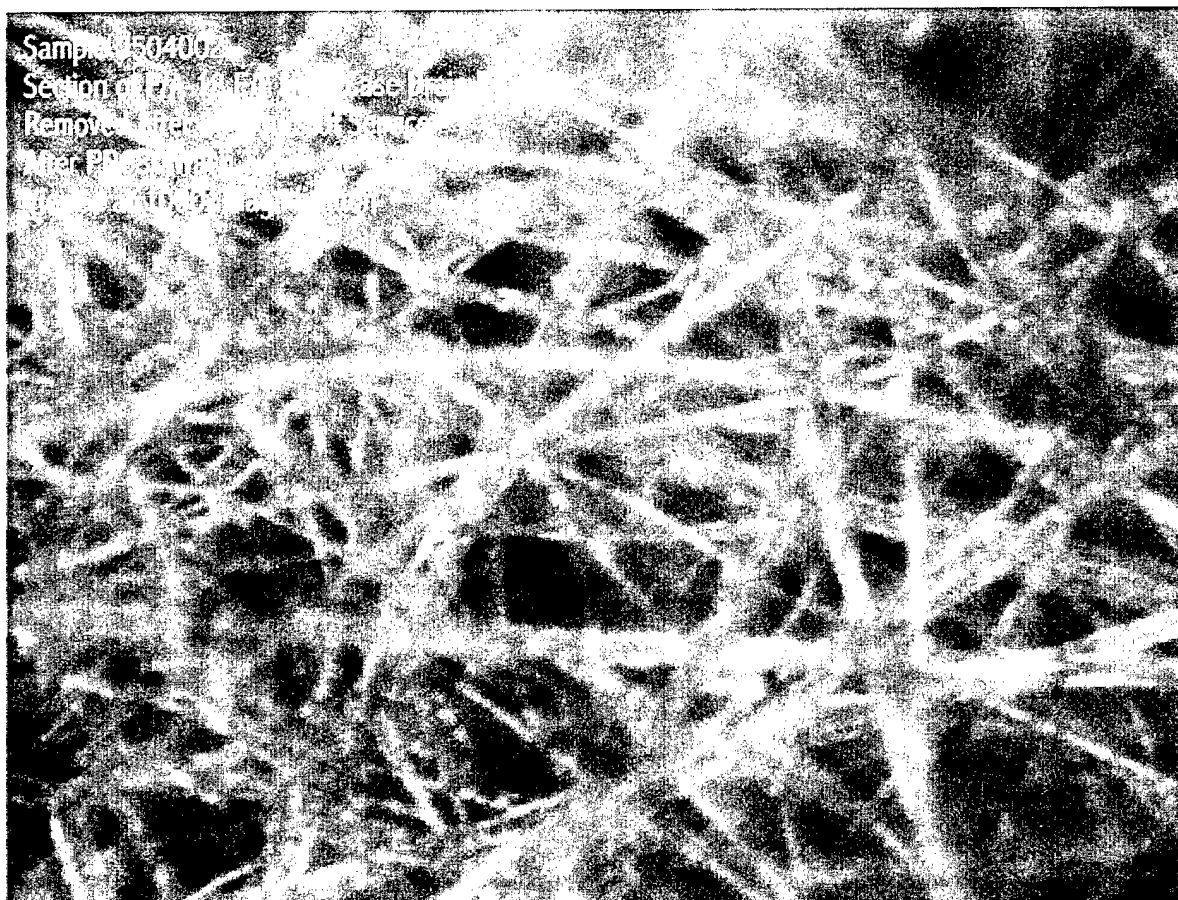
**Figure A-4: F/A-18E/F Case Drain Filter With Improved HDU Motor**

Inspection of filter elements removed after 59 hr of service (figure A-4) show buildup of an insoluble red organic material similar to F-14 system filters. Most fluid passages are open and filter service life has improved dramatically. The plaque buildup rate has been significantly reduced but fluid breakdown is still occurring.

Note: All filter elements inspected prior to the HDU motor redesign had dark green organic material, while current filter elements show buildup of red organic material, similar to material collecting on F-14 hydraulic system filters.

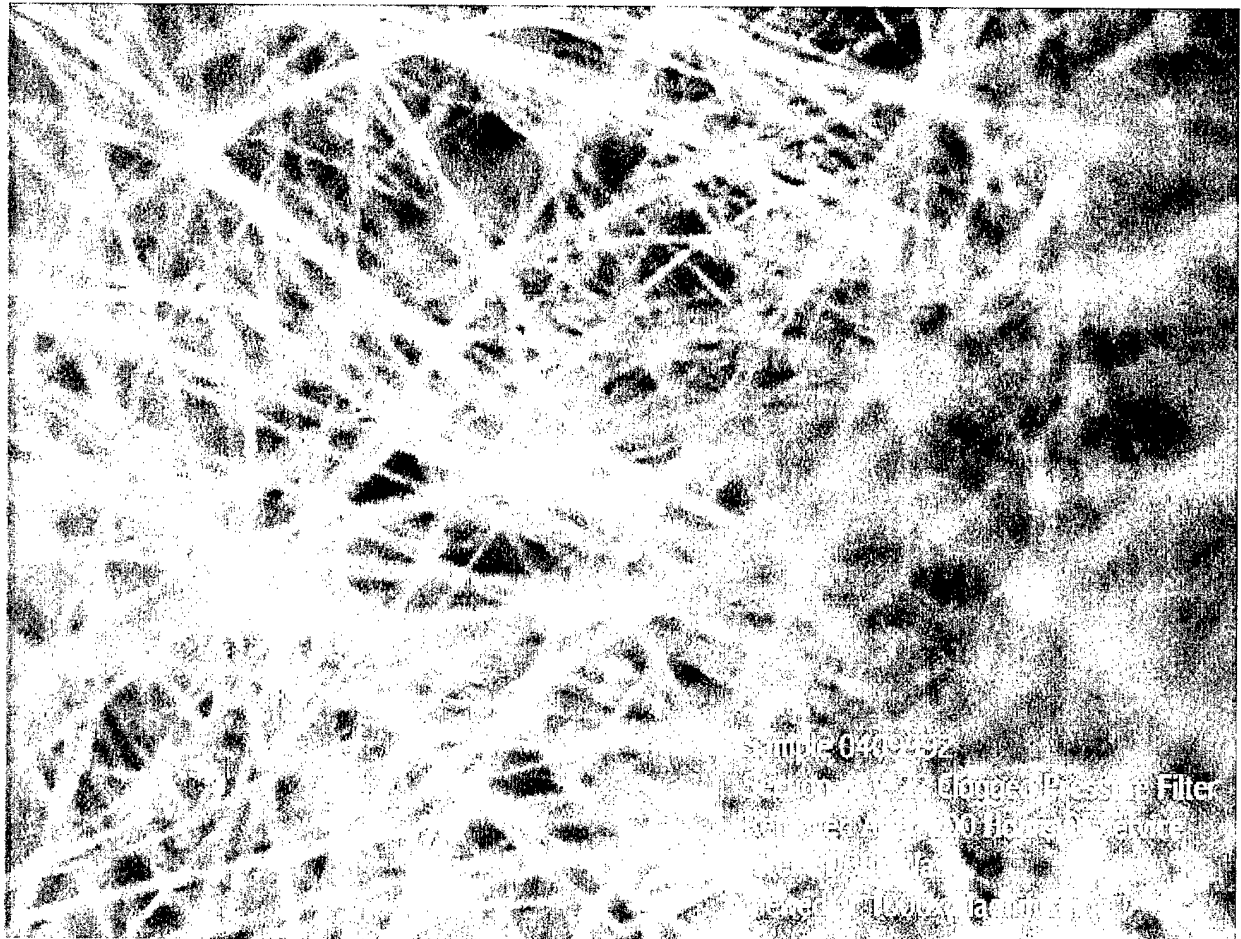
**Figure A-5: V-22 Clogged Filter After Wash**

elements are still in service with well over 400 flight-hours. The filter was checked to verify excessive pressure drop and identify filter debris. Most of the material was wear debris and system contaminants.

Washing the media with PD-680 removed the bulk of the material, resulting in clean light gray fibers (figure A-5). Fibers were straight and uniform with no evidence of filter plaque.
