**(CAVITATION DAMAGE OF MECHANICAL  
PUMP IMPELLERS OPERATING IN  
LIQUID METAL SPACE POWER LOOPS)**

*by R. S. Kulp and J. V. Altieri*

Prepared under Contract No. NAS 3-2541 by  
PRATT & WHITNEY AIRCRAFT DIVISION  
UNITED AIRCRAFT CORPORATION  
Middletown, Conn.

NATIONAL AERONAUTICS AND SPACE ADMINISTRATION

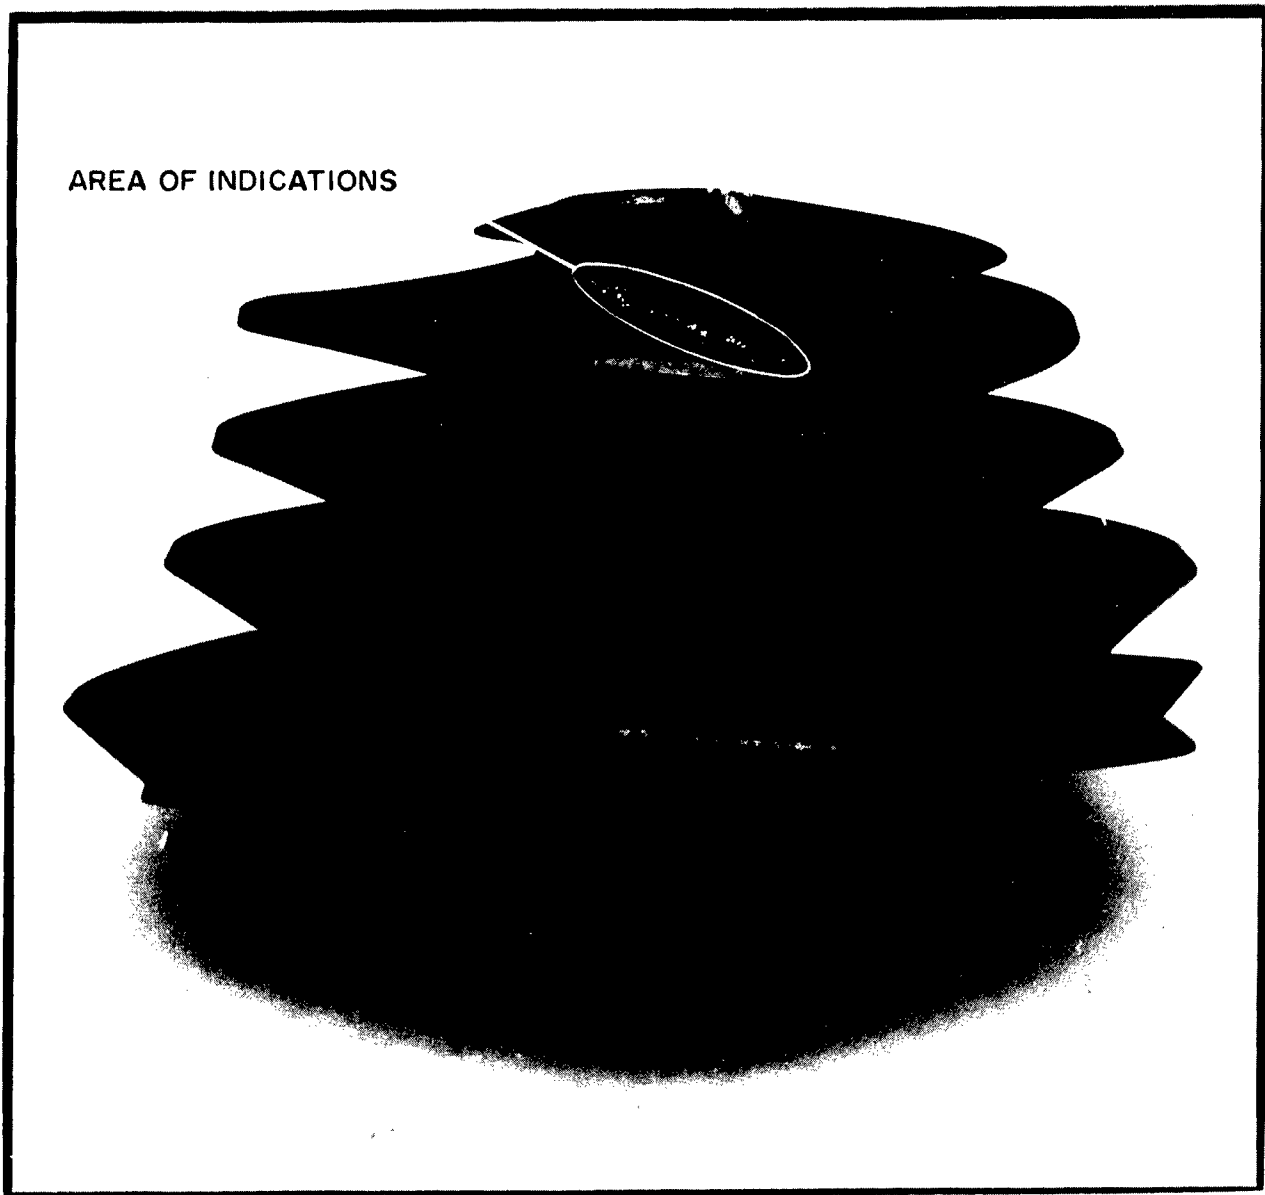
FIG 5

Other internal and external methods of examination and documentation used included radiography, fluorescent inspection, photography, and rubber molds of all vane surfaces. Radiographic and fluorescent inspections revealed no defects of the impeller vanes. An area of surface porosity was revealed by fluorescent inspection, and it was photographed to retain a permanent record. This area was on the impeller hub near the vane root of vane 3 and is shown in Fig. 5. This porosity was produced during the casting process and may be classified as extensive surface roughening.

ZYGLO INDICATIONS ON THE RI-7C3 IMPELLER BEFORE TEST

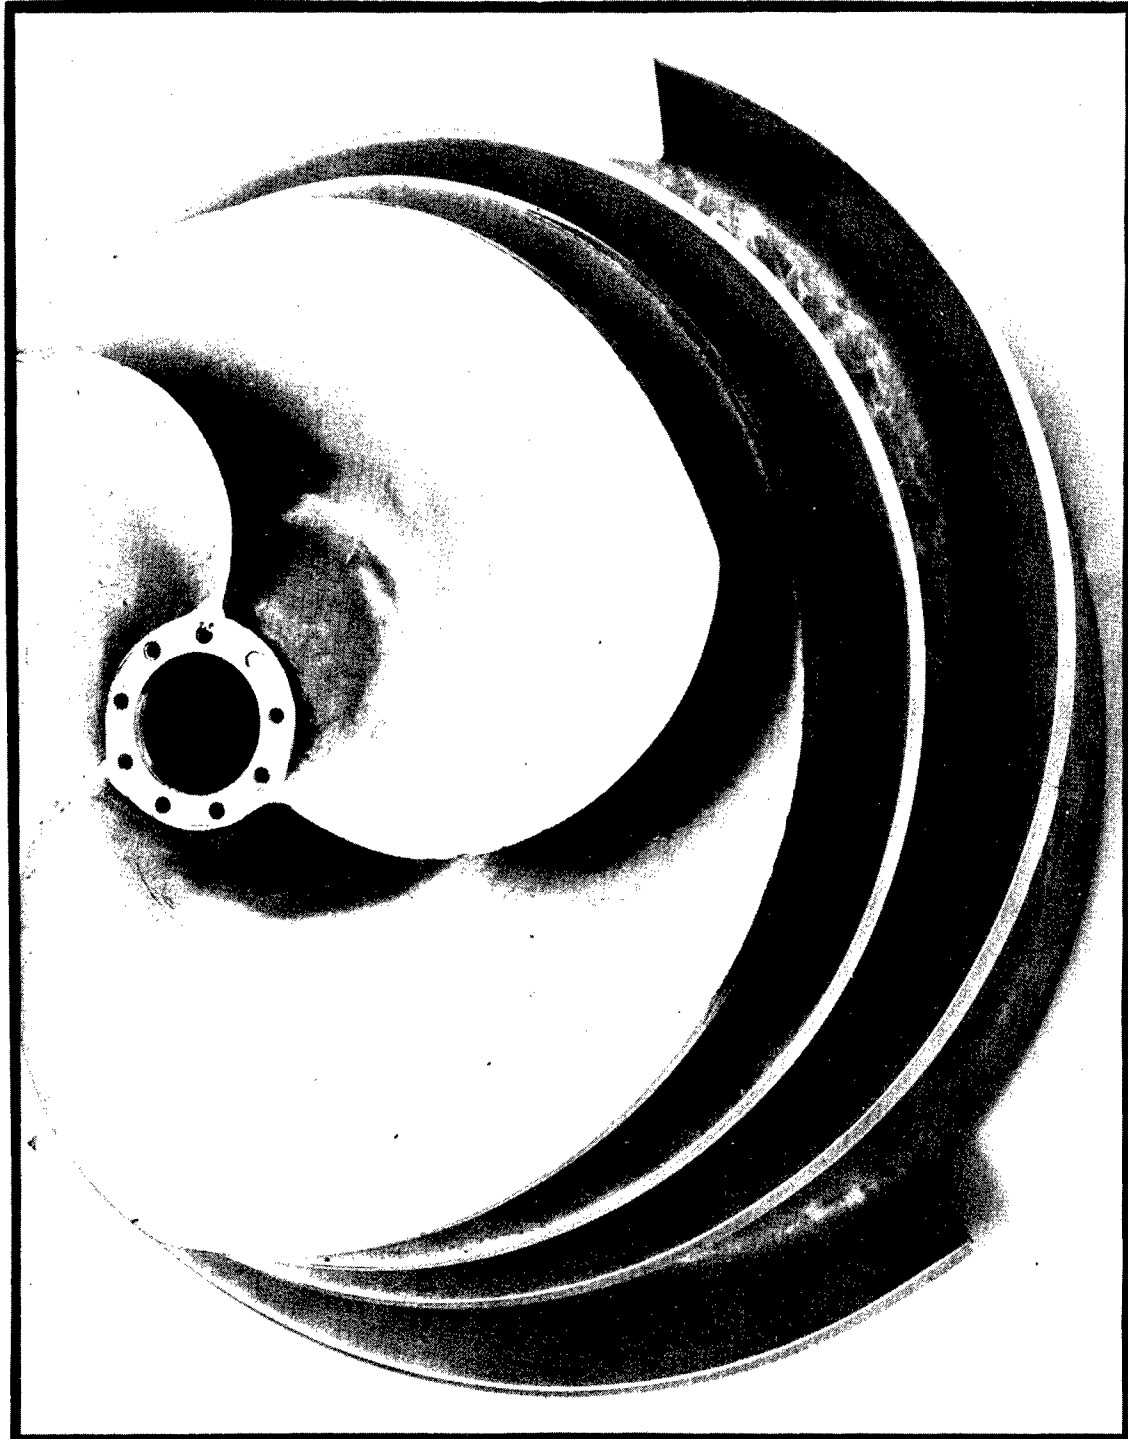
FIG 41

Upon completion of the pump tests and orifice calibrations, the turbopump was removed for disassembly and inspection. Visual inspection of the RI-7C3 impeller revealed scoring marks on the impeller (Fig. 41) and scroll insert (Fig. 42) where the two had contacted during the test. Analysis of the probable cause of rubbing contact led to the conclusion that it was caused by synchronous transients of vibration set up in the pump during tests of the 1.97 inches diameter orifice which cavitared violently. (The accuracy of this analysis is questionable in light of the liquid metal test results described in Section VIII.) The score marks were smoothed off, but not entirely eliminated before reassembly of the turbopump for the liquid metal test.

OVER-ALL VIEW OF LOCALIZED SCORING ON IMPELLER  
AFTER WATER TEST IN TURBOPUMP

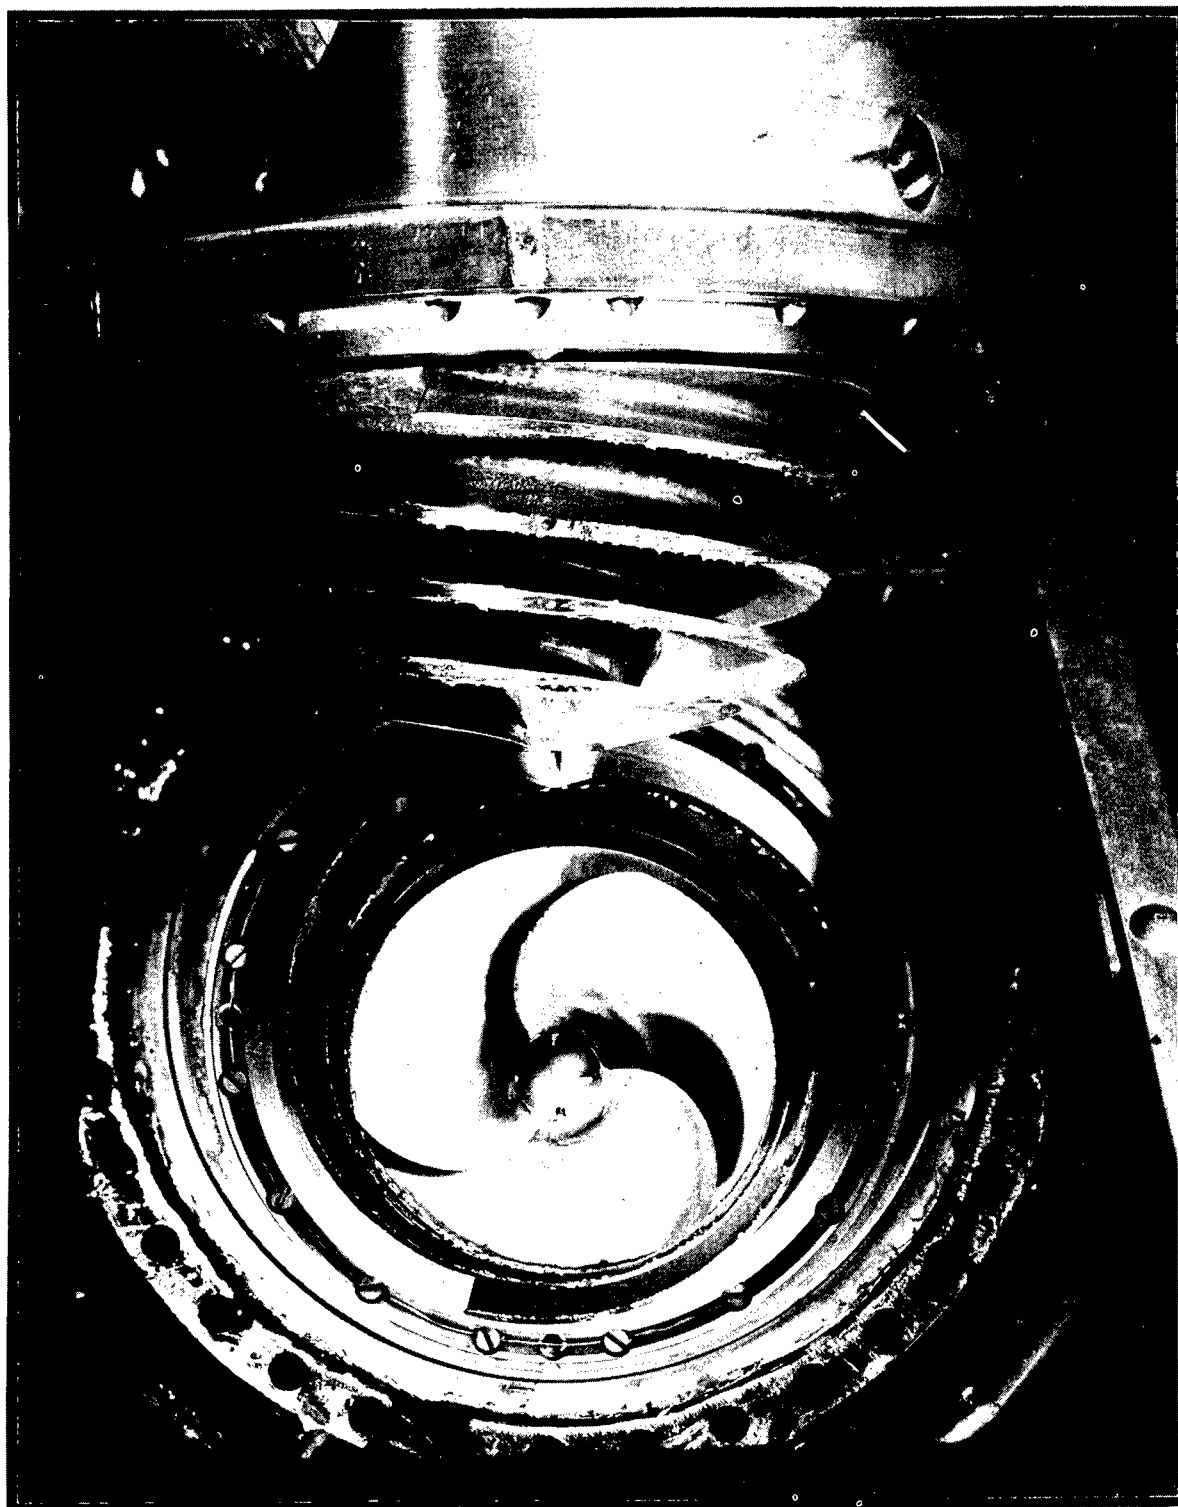
FIG 49

When the turbopump was removed from the test loop, it was immediately apparent that the cause of increased vibration was rubbing contact between the impeller and scroll insert. A photograph of the impeller shortly after removal from the scroll is shown in Fig. 49. Two views of the impeller were obtained in this figure by placing a mirror at an angle under the pump. Several areas of cavitation damage were also noted, one of which can be seen in Fig. 49.

IMPELLER DAMAGE AS SEEN AFTER LIQUID METAL TEST

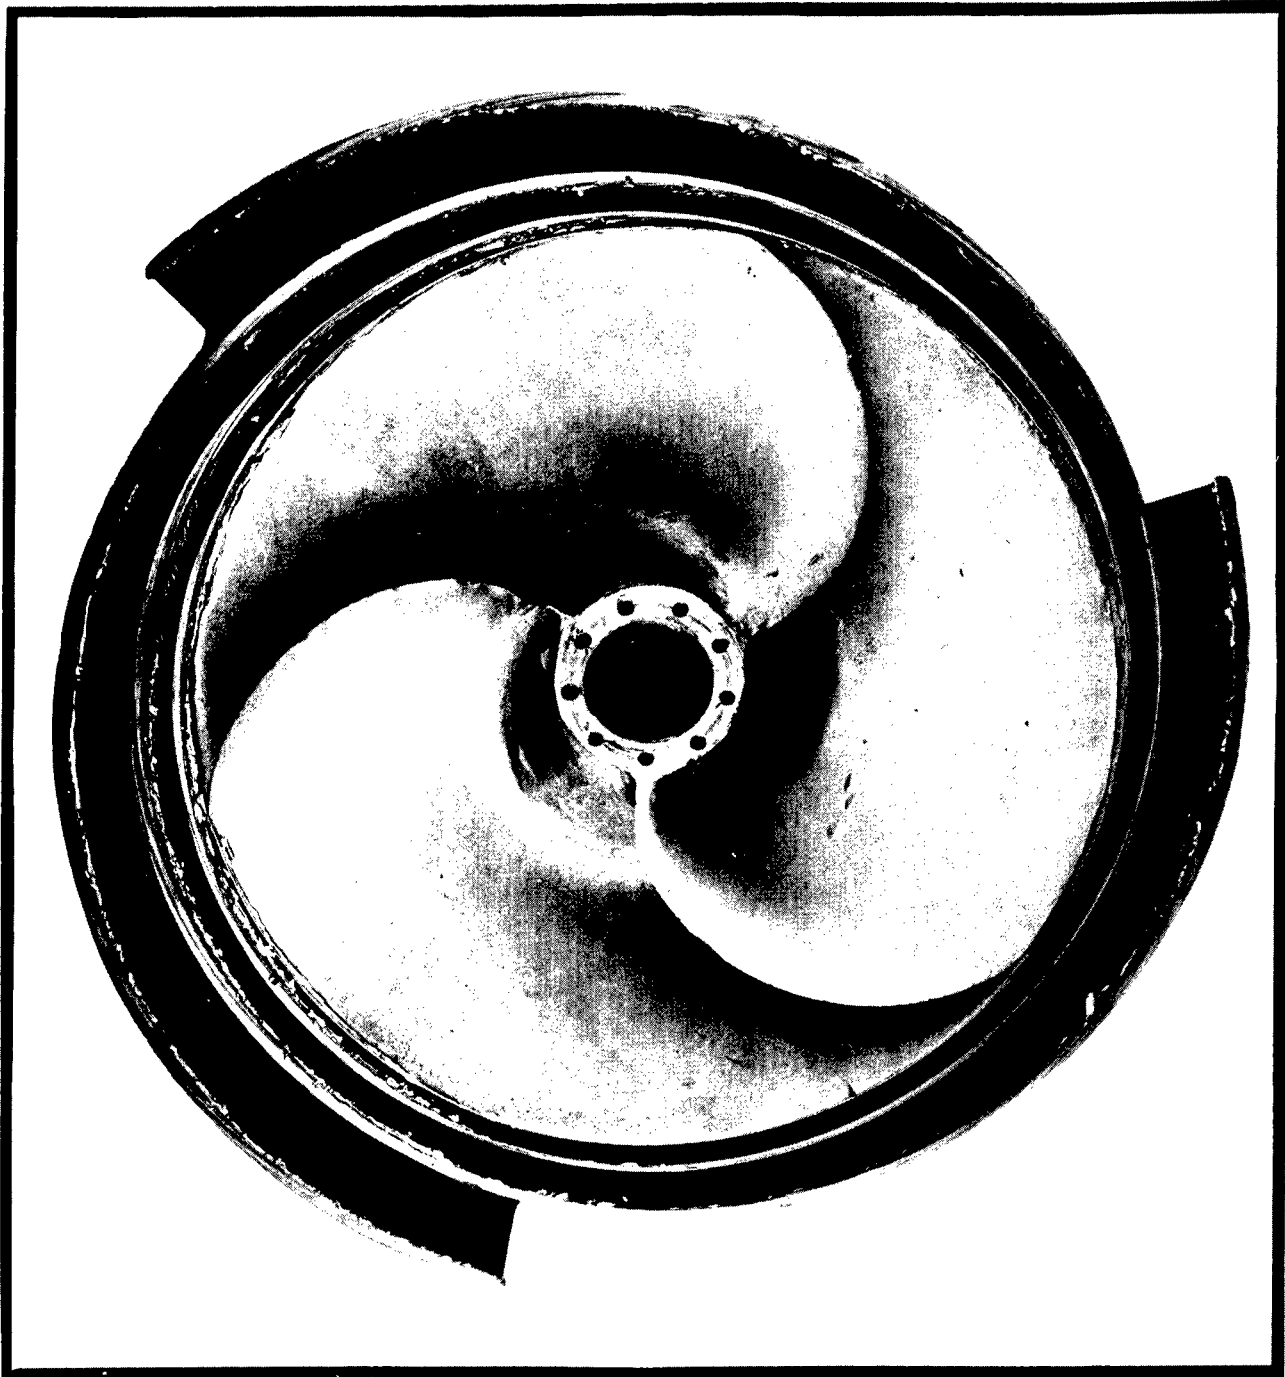
FIG 50

Complete disassembly of the pump revealed additional rubbing damage of the rotating parts. The damage on the impeller is shown more clearly in Fig. 50. It should be noted that the damage is not uniform around the impeller. Very little material was injected into the fluid stream, as evidenced by the apparent flow of metal at the blade tips. Scroll damage from contacting the impeller is shown in Fig. 51. Again, the unsymmetrical pattern of damage should be noted. The cause of the rubbing contact cannot be fully determined from the evidence uncovered, due to the difficulty of separating cause and effect relationships of the damage. However, the unsymmetrical pattern of damage leads to a tentative conclusion that the shaft moved to one side during operation. This is further confirmed by the rubbing damage noted on the dynamic seals shown in Figs. 52 and 53. The cause of this apparent shaft movement has not been satisfactorily determined.

OVER-ALL VIEW OF IMPELLER INLET

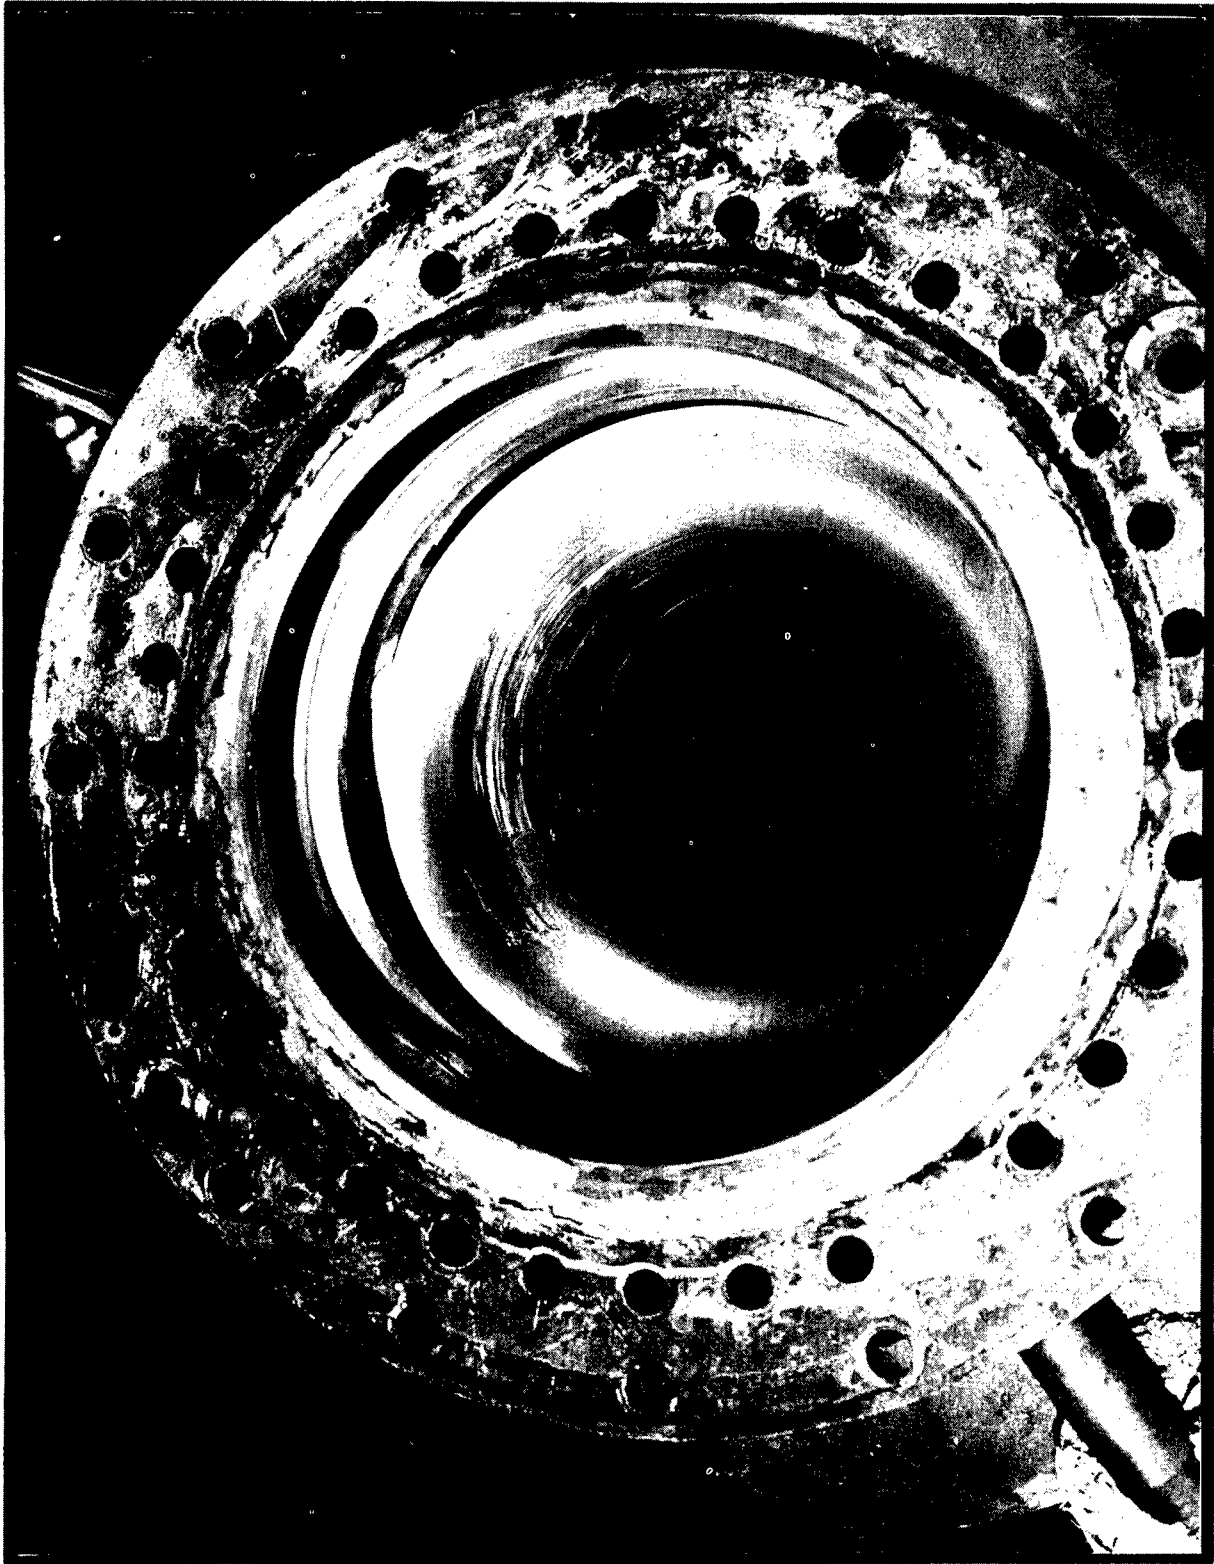
FIG 51

RUB MARKS ON SCROLL ADAPTER

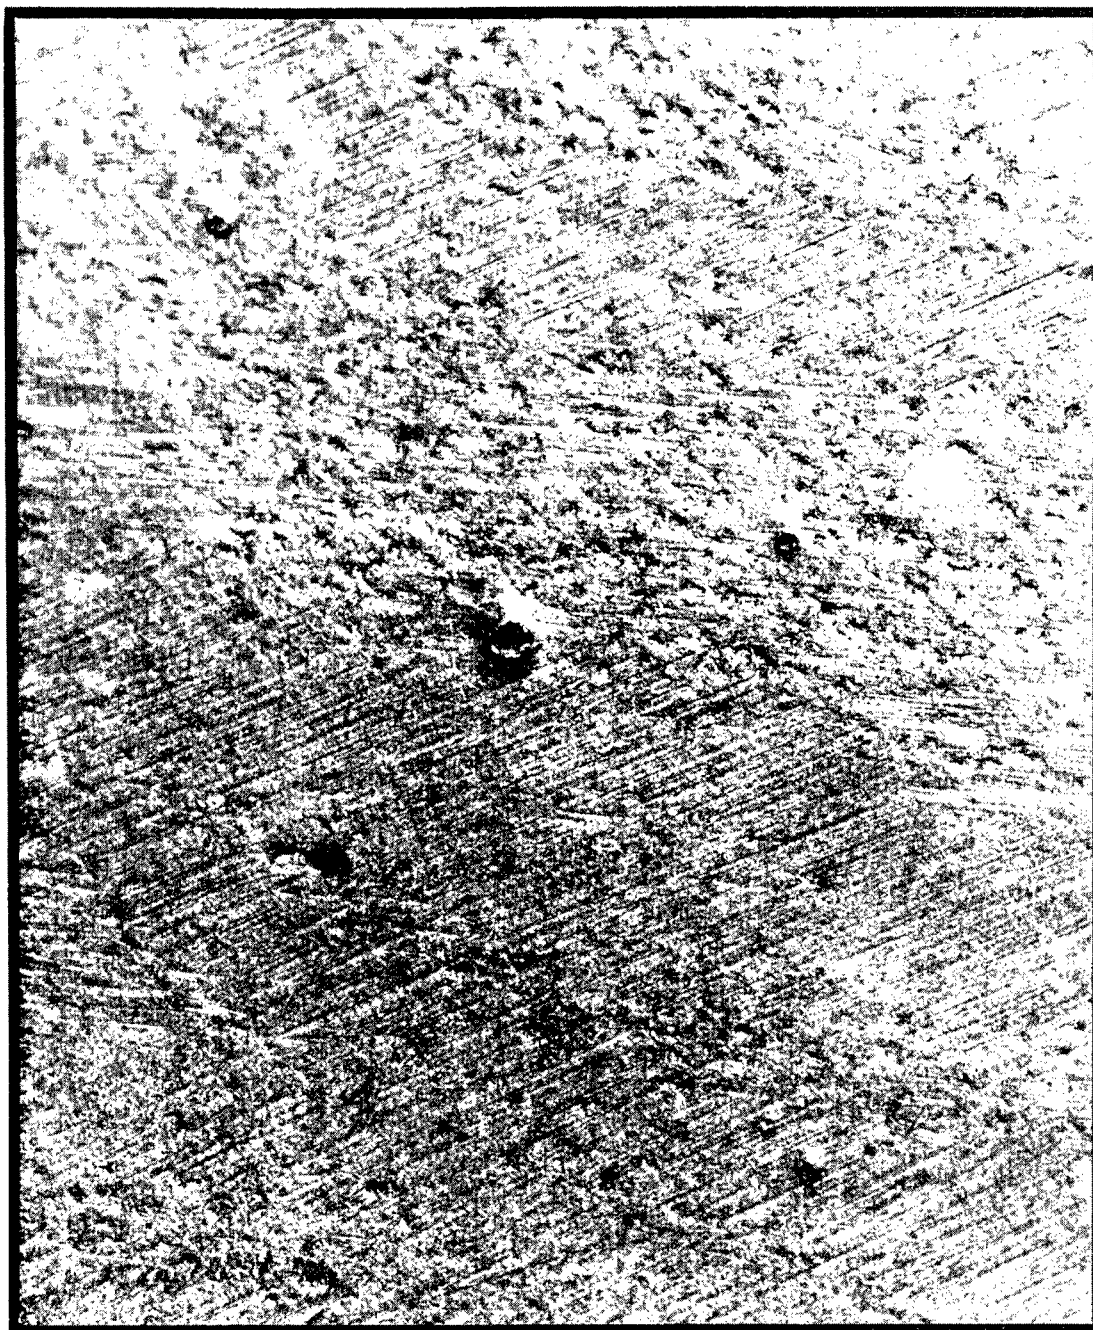
SINGLE EVENT PITTING OF VANE 3 PRESSURE SIDE

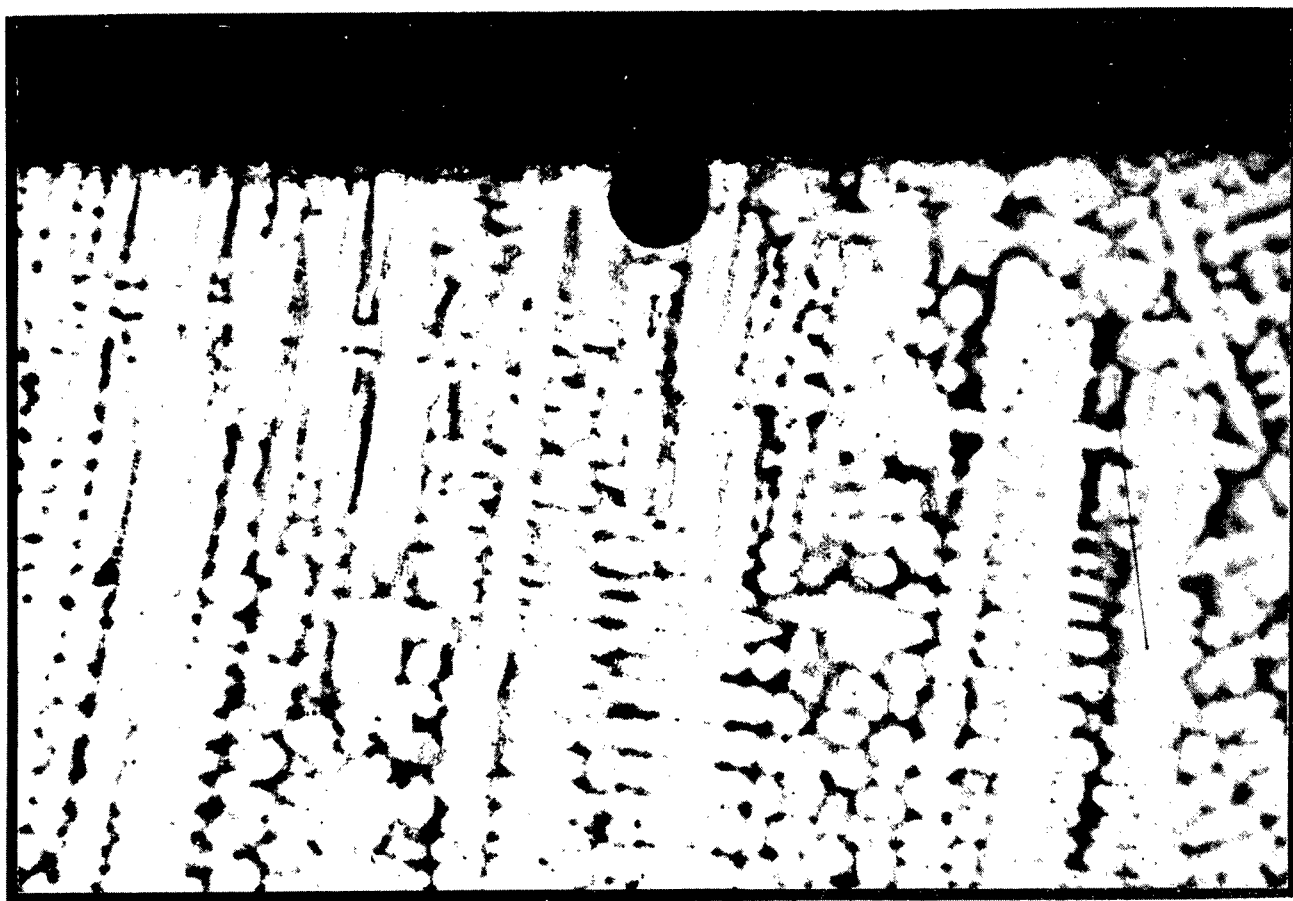
FIG 67

SMALLER PIT OF FIG. 65 IN CROSS SECTION

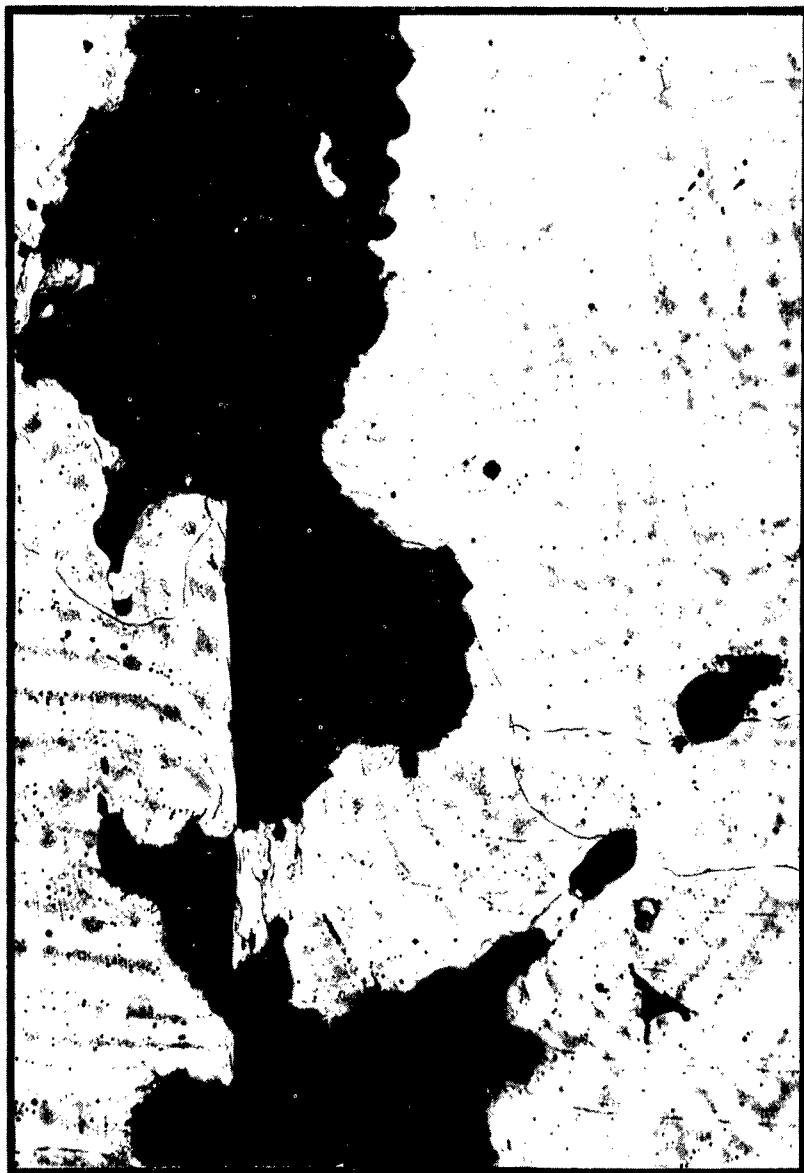
FIG 71

PHOTOMICROGRAPH OF VANE 2 CAVITATION DAMAGE

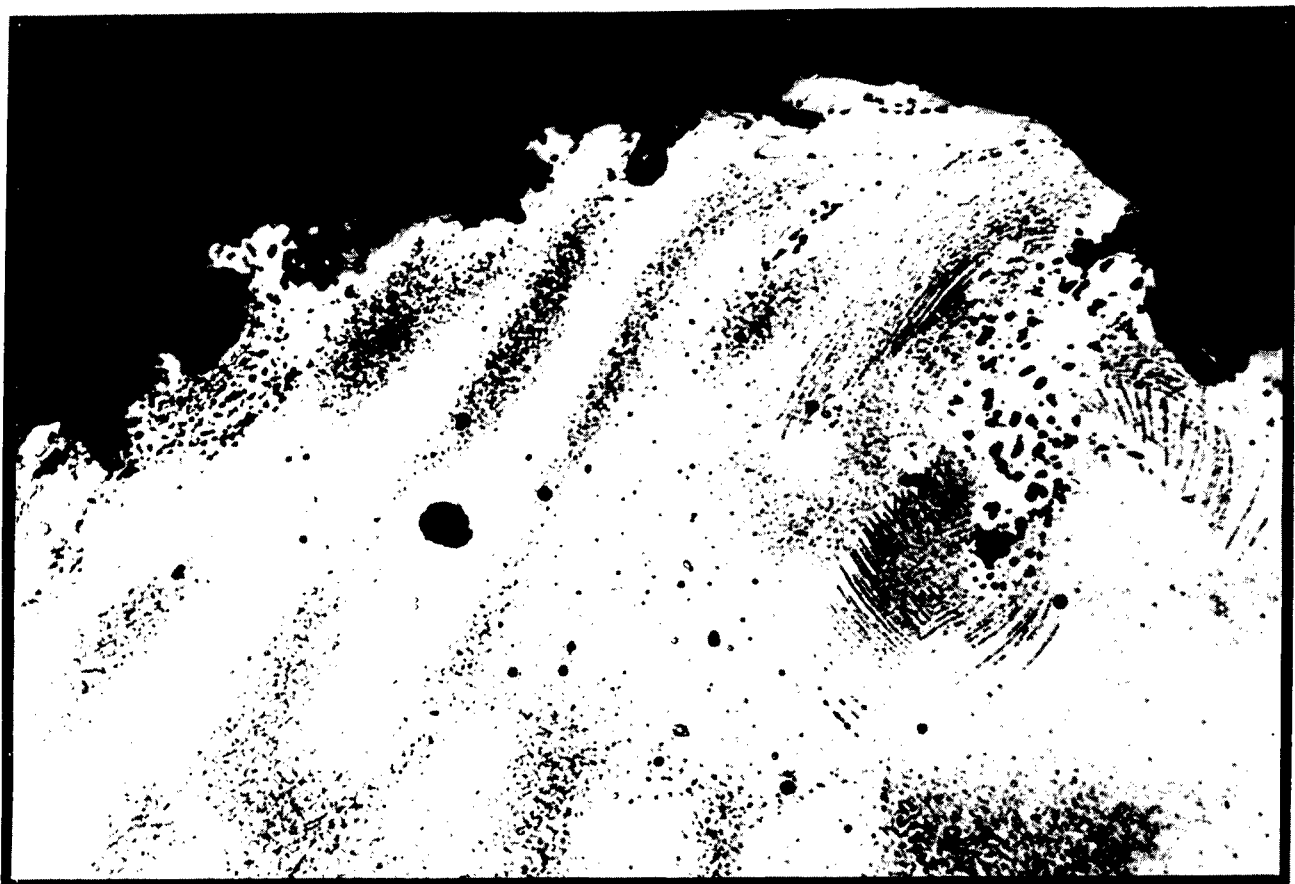
FIG 72

PHOTOMICROGRAPH OF VANE 2 CAVITATION DAMAGE AT  
500X

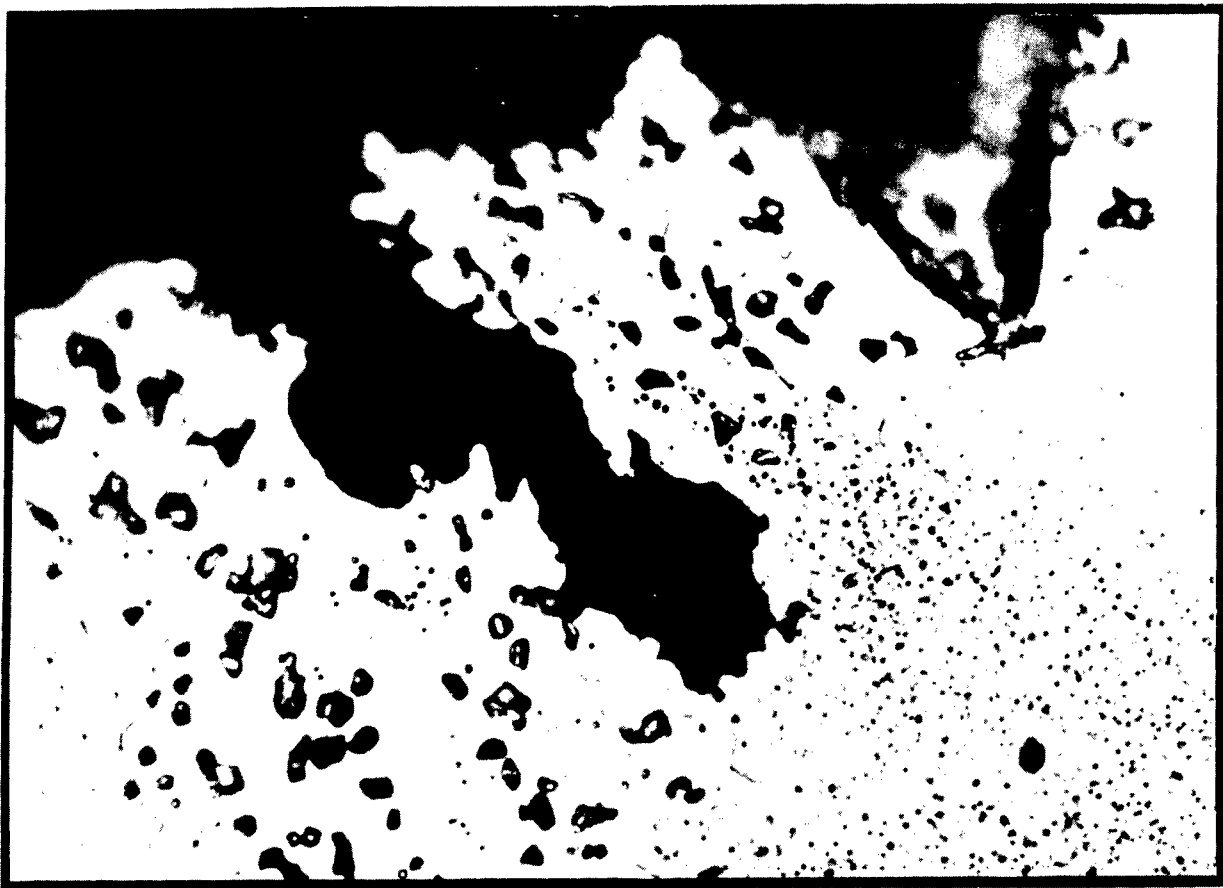
FIG 73

PHOTOMICROGRAPH OF VANE 2 CAVITATION DAMAGE  
AT 2000X

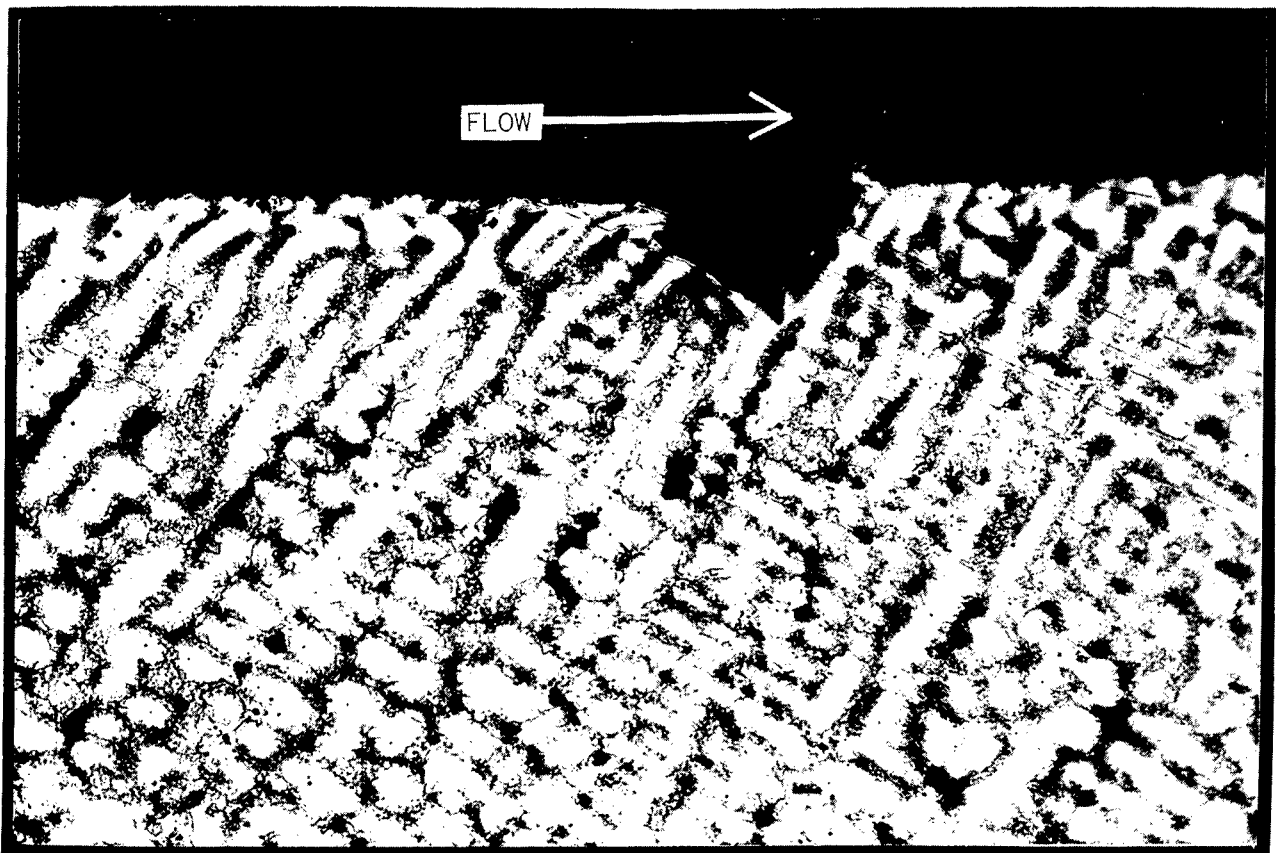
FIG 74

The test showed that the selected test conditions were too severe; they resulted in excessive cavitation damage. Several areas of cavitation damage were found; the most severe damage occurred on the pressure surface near the vane channel exits. The most severely damaged area was measured during metallographic examination to have a depth of penetration of 0.050 inch. Minor damage found on the inlet pressure surfaces was judged to consist of single event pits. The suction surface of one vane at the impeller inlet had cavitation damage induced by two small projections above the blade surface.

PHOTOMICROGRAPH OF PROJECTION CAUSING CAVITATION DAMAGE

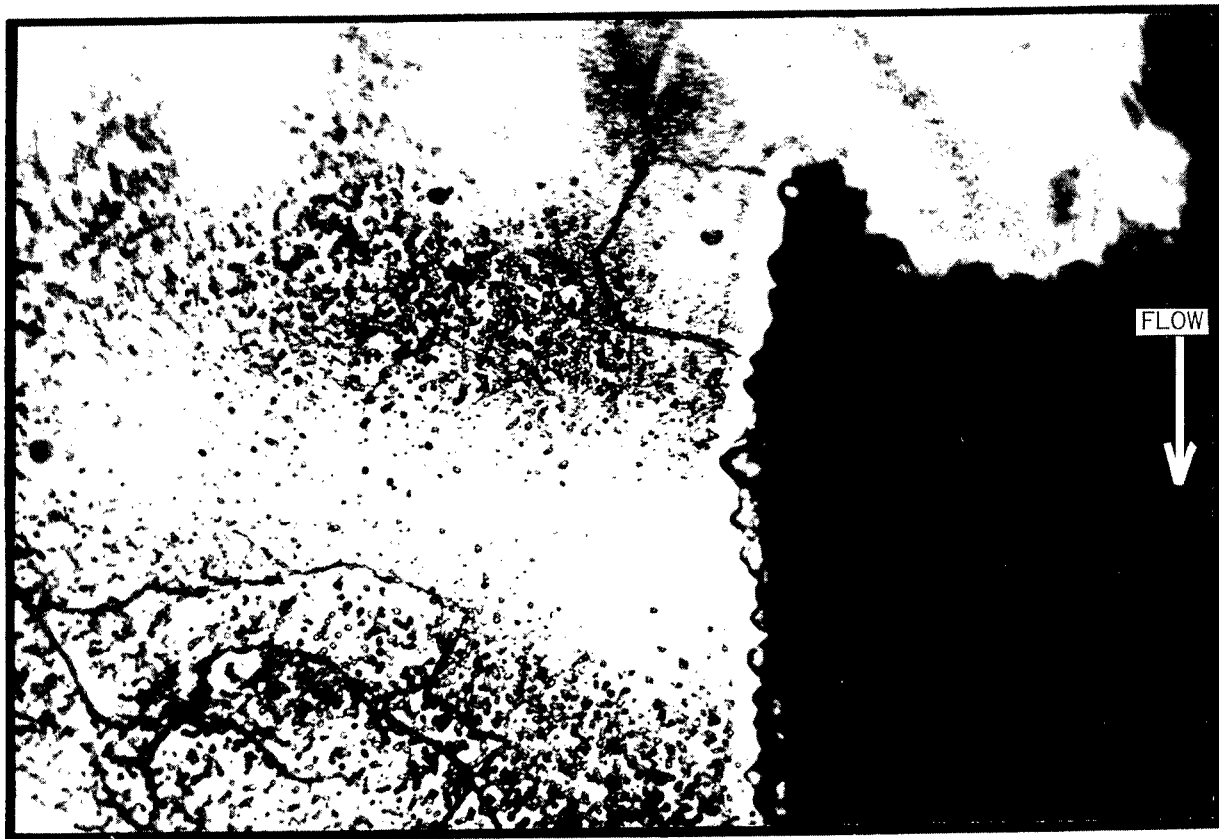
FIG 76

PHOTOMICROGRAPH OF PIT INDUCING CAVITATION DAMAGE  
AT 1500X
