# **Battery Failure on the Electric Propulsion Space Experiment (ESEX)**

**Air Force Research Laboratory (AFMC)  
AFRL/PRSS  
5 Pollux Drive  
Edwards AFB, CA 93524-7048**

**November 2001**

**Special Report**

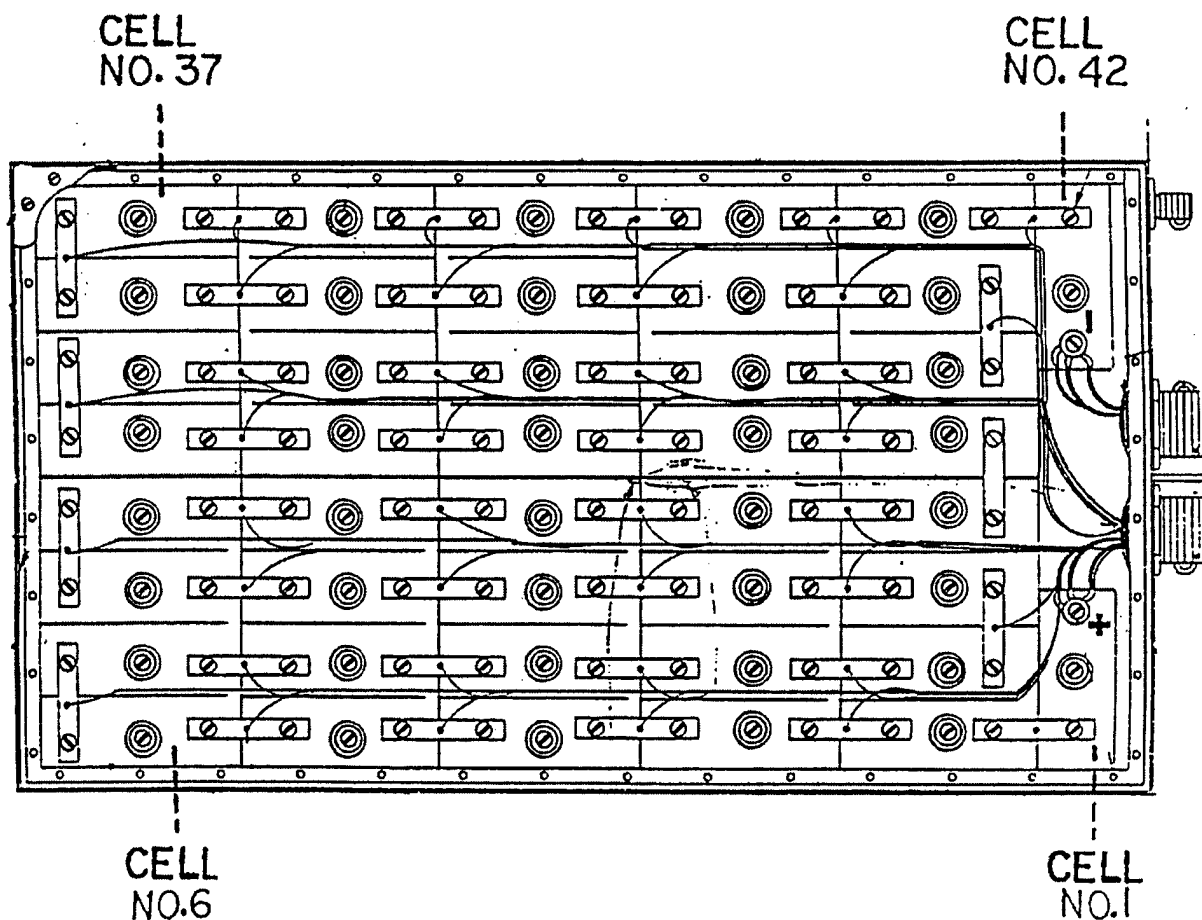
**Figure 2. ESEX Battery Sub-Assembly Drawing Showing the Layout for the 42 Cells**

The ESEX Ag-Zn battery was designed and fabricated by Eagle-Picher Technologies, LLC, and is made up of 126 cells connected in series, divided evenly between three sub-assemblies. As shown in Figure 2, each of the battery sub-assemblies has 42 cells interconnected with a multi-

layer copper strap (128 straps total, each strap had a resistance of 0.047 mΩ), bolted to the cell terminals. The completed sub-assembly then had a layer of potting encapsulate (FR-88 epoxy filled with microscopic glass beads) over the cells, covering the cell interconnects, leaving only the cell vents open to the interior of the battery sub-assembly chassis. Each sub-assembly also has a relief valve (cracking pressure of 3-8 psi) to vent over-pressure through its mounting panel to the outside of the flight unit.

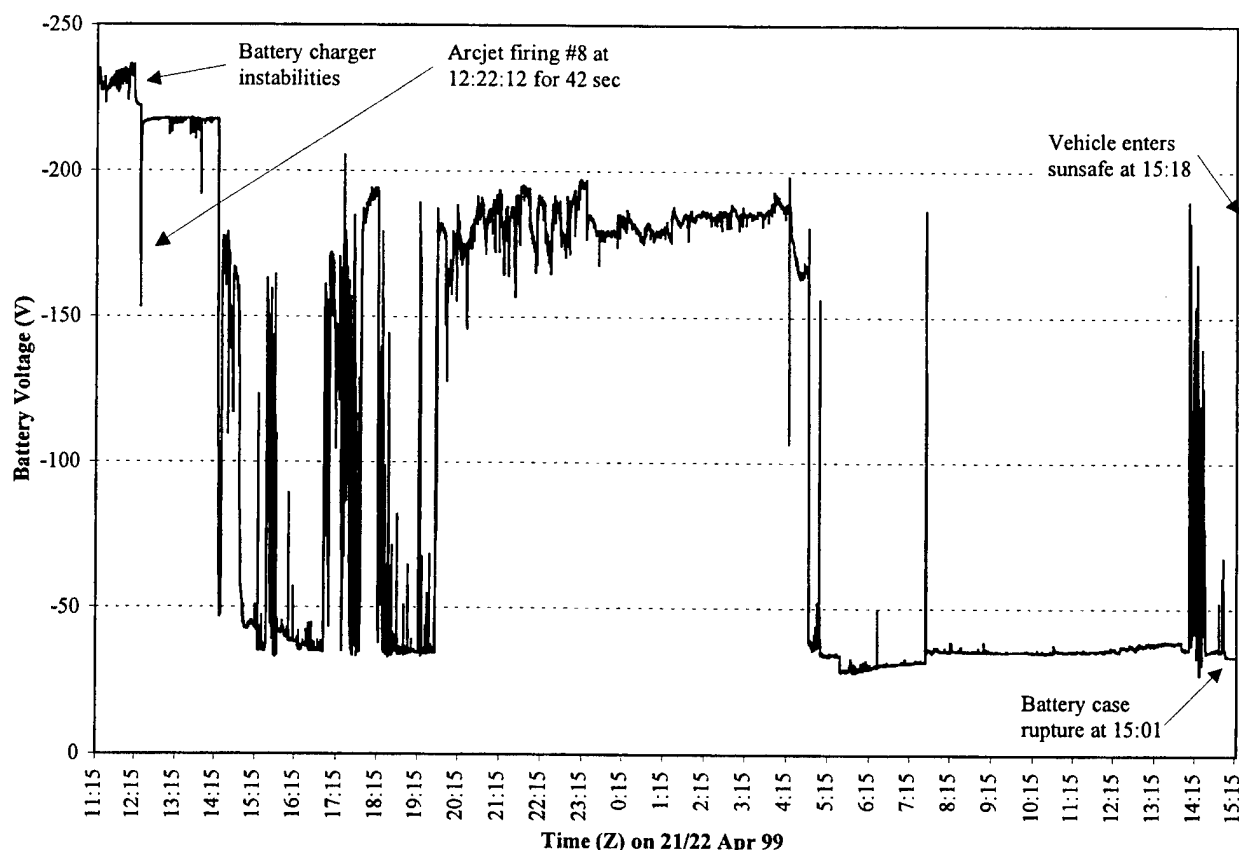
**Figure 5. Battery Voltage Fluctuations Following the Final Arcjet Firing (#8) Ultimately Resulting in the Short Circuit**

Following firing #8, the battery voltage fluctuated erratically between -175 and -200 Vdc with periodic drops as low as -30 Vdc – where it eventually stabilized, as shown in Figure 5. This behavior lasted approximately 24 hours until the battery sub-assembly on panel #1 had a catastrophic failure as a result of a short circuit. As the energy in the cell was discharging internally through the short circuit, there was a dramatic increase in the battery temperature and pressure as hydrogen gas was being generated from electrolyte decomposition. This process continued until there was a breach of the battery case and a release of this super-heated gas internal to the ESEX flight unit on 22 Apr 99 at 1501 Z. This gas release was likely directed at panel #3, since a 40 °F increase in temperature on this panel was observed over the course of a few seconds. This gas was eventually vented into space, causing a dramatic attitude disturbance

on the vehicle just prior to an umbra crossing. The disturbance was violent enough to saturate the ARGOS reaction wheels and cause the vehicle to spin about the yaw axis at 1/8 rpm through the following eclipse period. This spin resulted in the vehicle automatically switching to a safe mode known as "sunsafe" which sheds non-essential power loads and points the solar arrays at the sun to maximize chances of survival. Once ARGOS exited eclipse, the vehicle was recovered through normal recovery procedures, and no long-term impacts have been observed.
