SUMMARY REPORT FOR

NAVAL SURFACE WARFARE CENTER, CARDEROCK DIVISION

LVS MOD DEMO VEHICLE ARMOR PROTECTION KIT INSTALLATION

AUGUST 2001

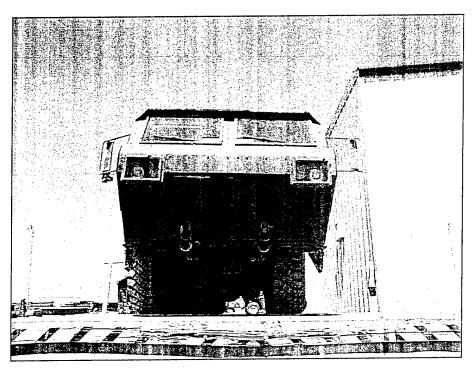
- 1. The black out lights were not connected through the armor kit (Photograph number 20238-001),
- 2. The upper clearance lights were not connected through the armor kit (Photograph number 20238-001),
- 3. Visibility is limited/restricted by the new cab enclosure (Photographs numbered 20238-030 and 031),
- 4. The air flow is restricted to the cab (Photographs numbered 20238-030 and 031),
- 5. The window locks may protrude into the occupant's head/body during an accident (Photograph number 20238-016),
- 6. The door handle (inside cab) is hard to reach next to the seat (Photographs numbered 20238-019 and 020),

- 7. There is no exit point for the occupants during an accident; i.e., the window can not be kicked out (Photographs numbered 20238-001 through 004),
- 8. The dead bolt door locks automatically lock during vehicle operation (Photographs numbered 20238-017 and 018),

PHOTOGRAPH NO. 20238-001 LVS ARMOR PROTECTION KIT FRONT VIEW

It is recommended that these items be addressed should this kit become a LVS option.

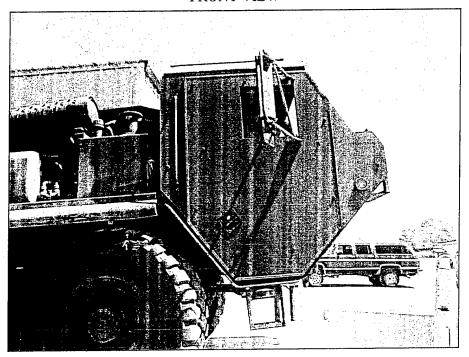
PHOTOGRAPH NO. 20238-002 LVS ARMOR PROTECTION KIT PASSENGER SIDE VIEW

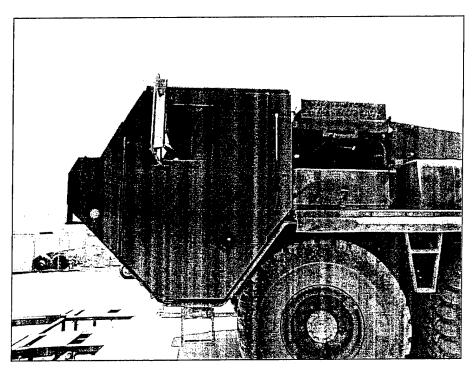
- 12. The underbody plate will act as a mud trap and corrosion issues are probable (Photographs numbered 20238-003 and 029),
- 13. The doors are too heavy for the hinges; occupants get trapped inside the vehicle due to hinges getting off track (Photograph number 20238-010),

PHOTOGRAPH NO. 20238-003 LVS ARMOR PROTECTION KIT DRIVER SIDE VIEW

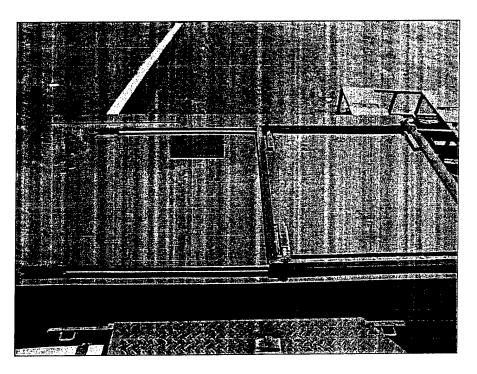
- 9. The bolts in the roof are protruding into the cab area creating a probability of head injury (Photographs numbered 20238-013 and 015),
- 10. The roof hatch is hard to lift and does not seem to slide; no 95th percentile provisions (Photographs numbered 20238-004 and 005),

PHOTOGRAPH NO. 20238-004 LVS ARMOR PROTECTION KIT TOP CENTER VIEW

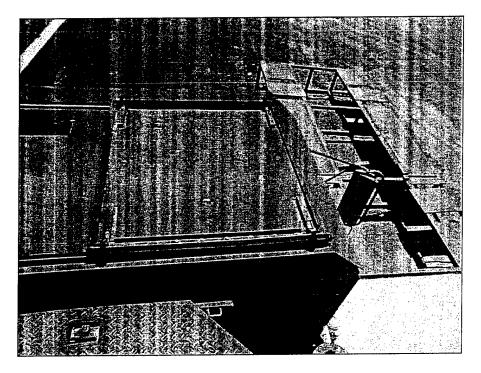
PHOTOGRAPH NO. 20238-005 LVS ARMOR PROTECTION KIT TOP PASSENGER SIDE VIEW

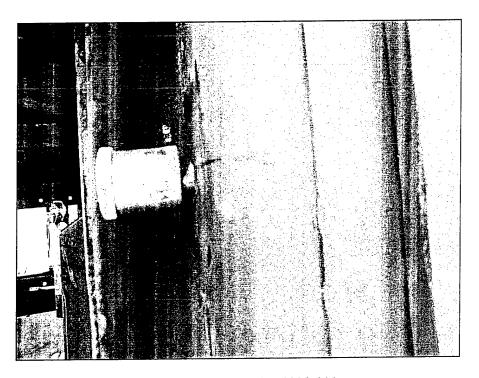
- 16. The driver and passenger side upper door pins are loose (Photograph number 20238-011),
- 17. There is a gap in the armor plate on both sides; only one bolt holds the armor kit on, the other bolt is only through the sheet metal (Photograph number 20238-012),

PHOTOGRAPH NO. 20238-011 LVS ARMOR PROTECTION KIT UPPER DOOR PIN LOOSE – CONTACT MARKS FROM DOOR

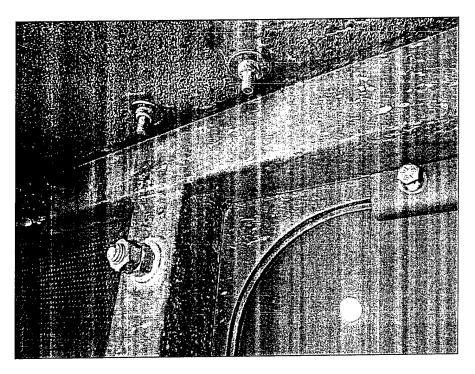
- 11. The entire cab has protruding bolts into the cab space creating a probability of head injuries (Photographs numbered 20238-013, 014, 015, 023, 024, 025 and 027),

PHOTOGRAPH NO. 20238-013 LVS ARMOR PROTECTION KIT PROTRUDING BOLTS – DRIVER'S SIDE ROOF

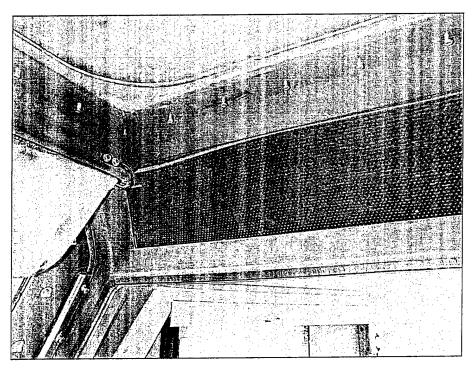
PHOTOGRAPH NO. 20238-015 LVS ARMOR PROTECTION KIT PROTRUDING BOLTS – PASSENGER'S SIDE HATCH

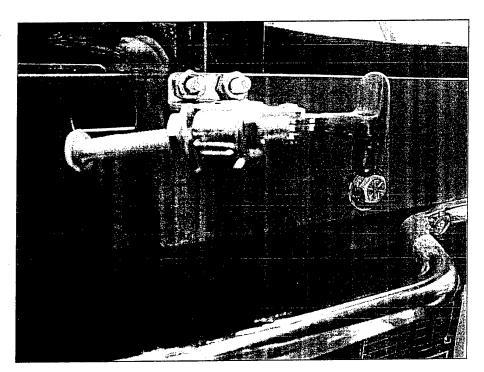
PHOTOGRAPH NO. 20238-016 LVS ARMOR PROTECTION KIT WINDOW LOCKS NOT TIGHT/OPERATIONAL

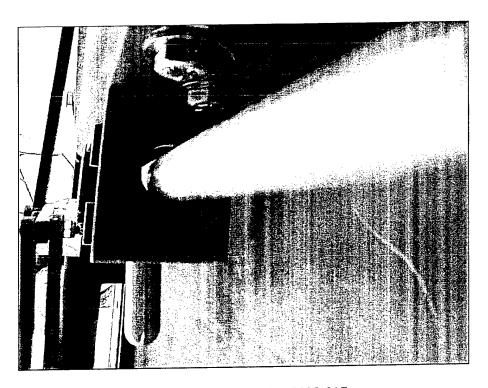
PHOTOGRAPH NO. 20238-017 LVS ARMOR PROTECTION KIT DEAD BOLT DOOR LOCK NOT TIGHT - RATTLES

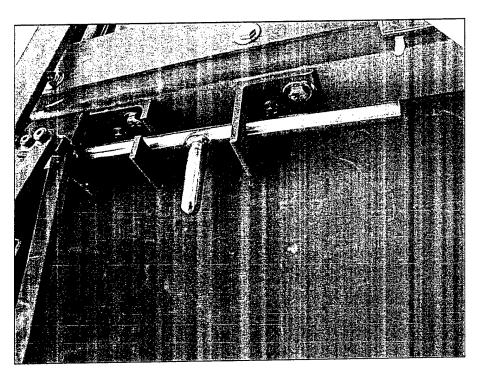
PHOTOGRAPH NO. 20238-018 LVS ARMOR PROTECTION KIT DEAD BOLT DOOR LOCK NOT TIGHT - RATTLES

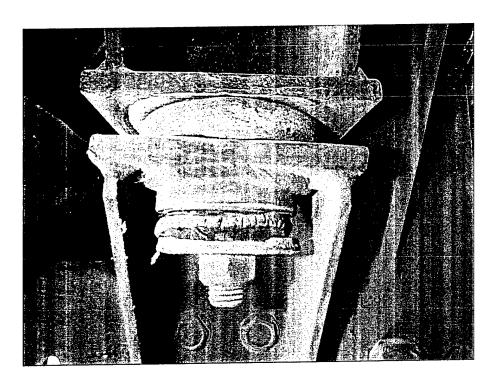
- 19. There is no access to clean the headlights; space will serve as a mud trap (Photograph number 20238-028), and
- 20. The cab mounts are deteriorating due to the additional weight (Photographs numbered 20238-021 and 022).

PHOTOGRAPH NO. 20238-021 LVS ARMOR PROTECTION KIT DRIVER SIDE CAB MOUNTS

- 1. Address the twenty-one items identified should further development be merited.
- 2. Perform accelerated fatigue testing of the vehicle.
- 3. Redesign the cab mounts to consist of a stiffer material.

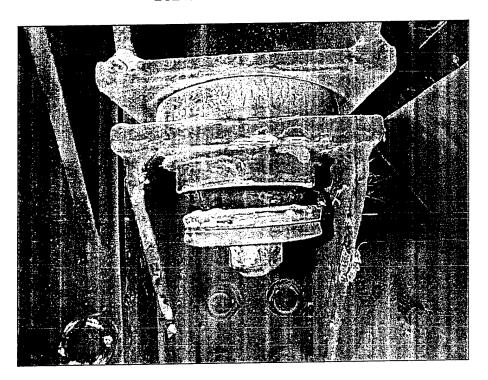
PHOTOGRAPH NO. 20238-022 LVS ARMOR PROTECTION KIT PASSENGER SIDE CAB MOUNTS

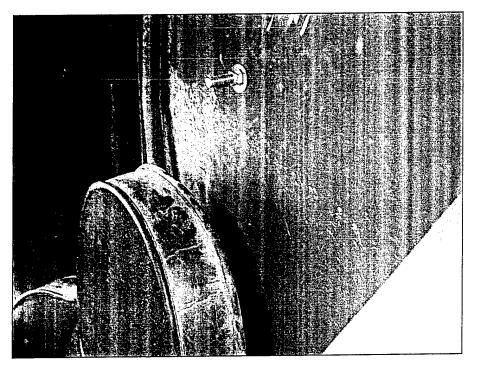
PHOTOGRAPH NO. 20238-023 LVS ARMOR PROTECTION KIT PROTRUDING BOLTS PASSENGER SIDE

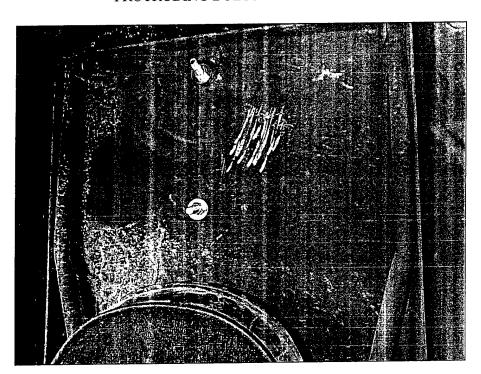
- 14. The armor kit is bolted through the gunner's platform; platform not operational (Photographs numbered 20238-024 and 027),
- 15. The cab structure tube is crushed due to no support for bolts (Photograph number 20238-025),

PHOTOGRAPH NO. 20238-024 LVS ARMOR PROTECTION KIT PROTRUDING BOLTS PASSENGER SIDE

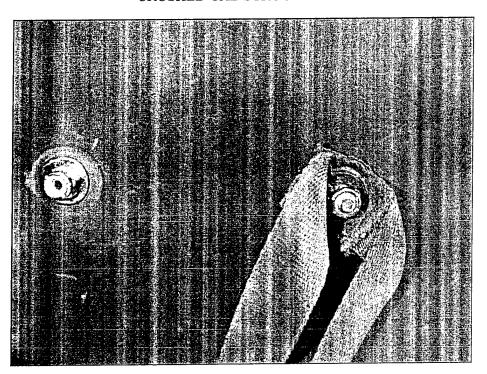
- 18. There is no thread engagement on the nylon bolts inside the cab in the front and gunner's hatch areas (Photograph number 20238-026),

PHOTOGRAPH NO. 20238-026 LVS ARMOR PROTECTION KIT NYLON BOLT NOT ENGAGED

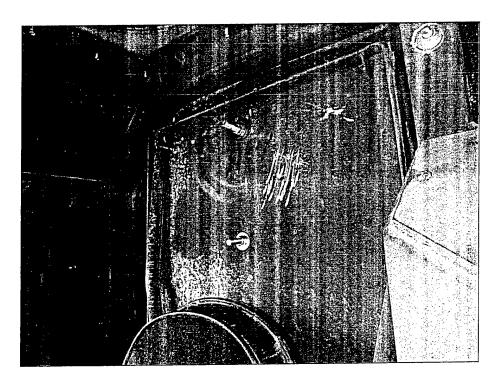
PHOTOGRAPH NO. 20238-027 LVS ARMOR PROTECTION KIT GUNNER'S PLATFORM BOLTED TO ARMOR

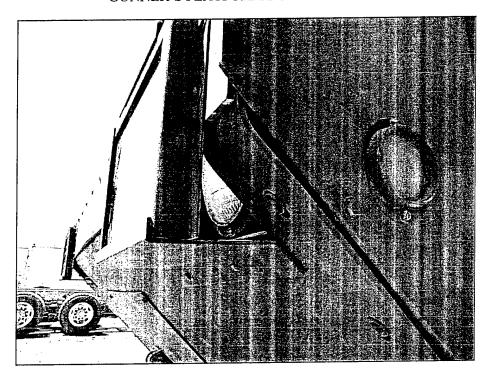
PHOTOGRAPH NO. 20238-028 LVS ARMOR PROTECTION KIT HEADLIGHT ACCESS ELIMINATED/ MUD TRAP AREA
