ERDC/CERL TR-02-26

Condition Assessment of William Beaumont General Hospital Historic Buildings at Fort Bliss, Texas

Thomas R. Napier and Sheila A. McCarthy

September 2002

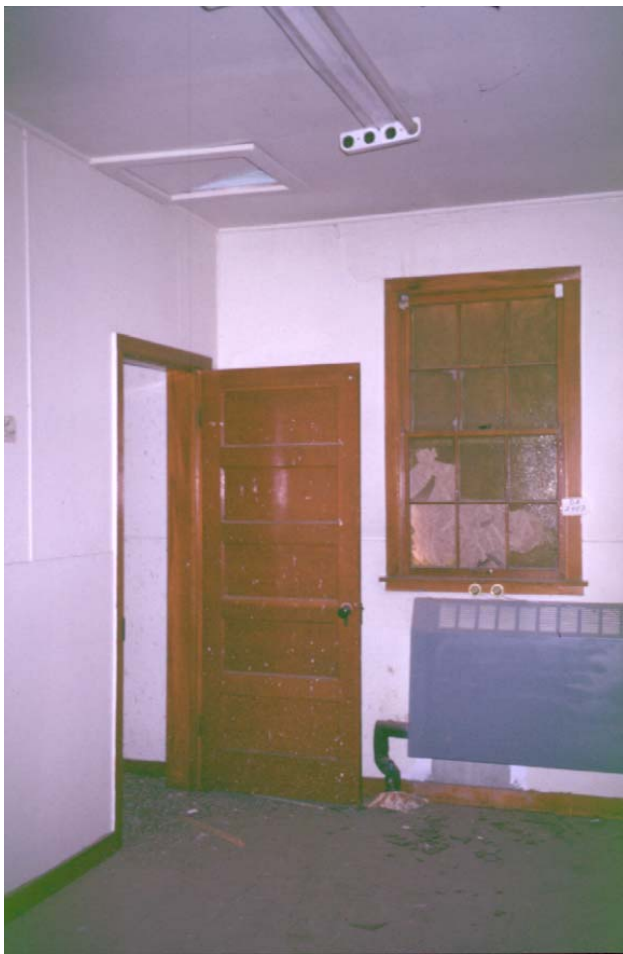
Windows in the foyer areas and sacristy remain in place, although they are boarded on the exterior. They are double hung with six-over-six sashes. In general, they are intact and not seriously deteriorated. Amber colored textured glass appears to be the original glazing material. Many panes have been broken. Some have been replaced with clear glass, and some have not been replaced at all. Serious damage was observed to only two sashes, apparently by vandalism (Drawing 2, E; Photograph 8). It should be possible to repair and refinish these windows. The window below the steeple on the south wall remains unboarded. It is intact, although it will require repair and refinishing.

Photograph 8. Damaged sacristy window sashes.

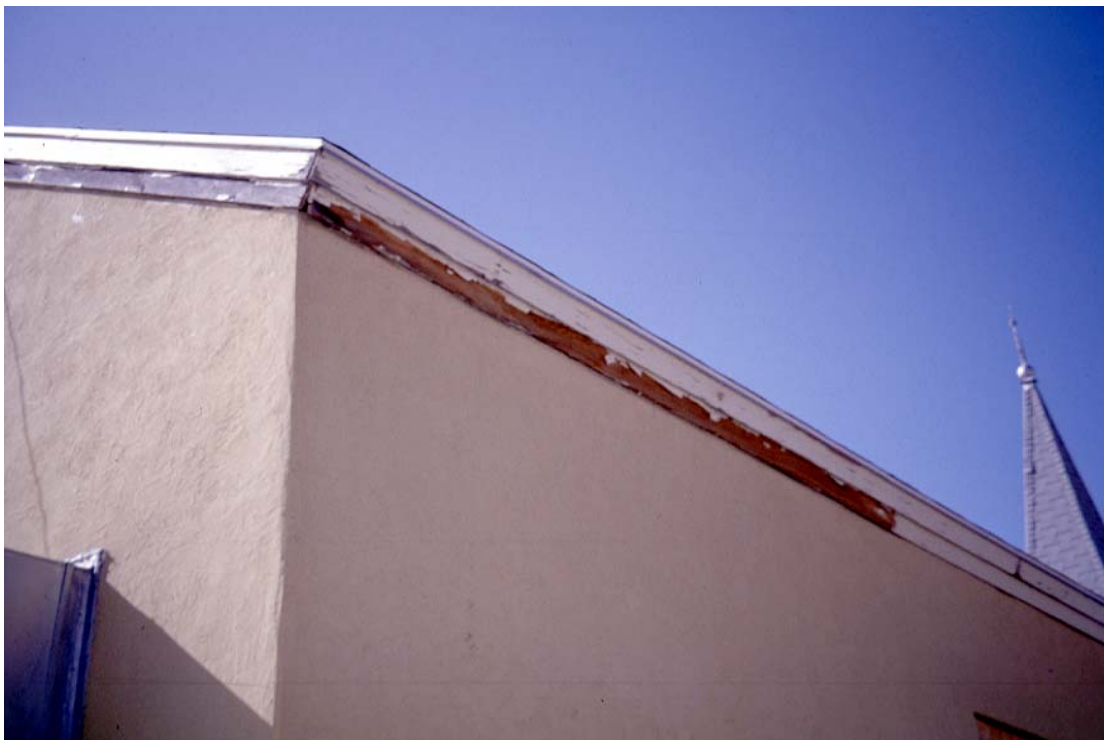
Minor deterioration of the eave trim occurs around the building. For example, paint has failed at the fascia at the north end of the east wall, at the rake trim on the north gable end (Drawing 2, G; Photograph 10), and at the rake trim at the south gable end below the steeple (Drawing 2, H). Scraping, priming, and repainting should be an effective repair.

Photograph 10. Detail of paint failure on chapel trim.

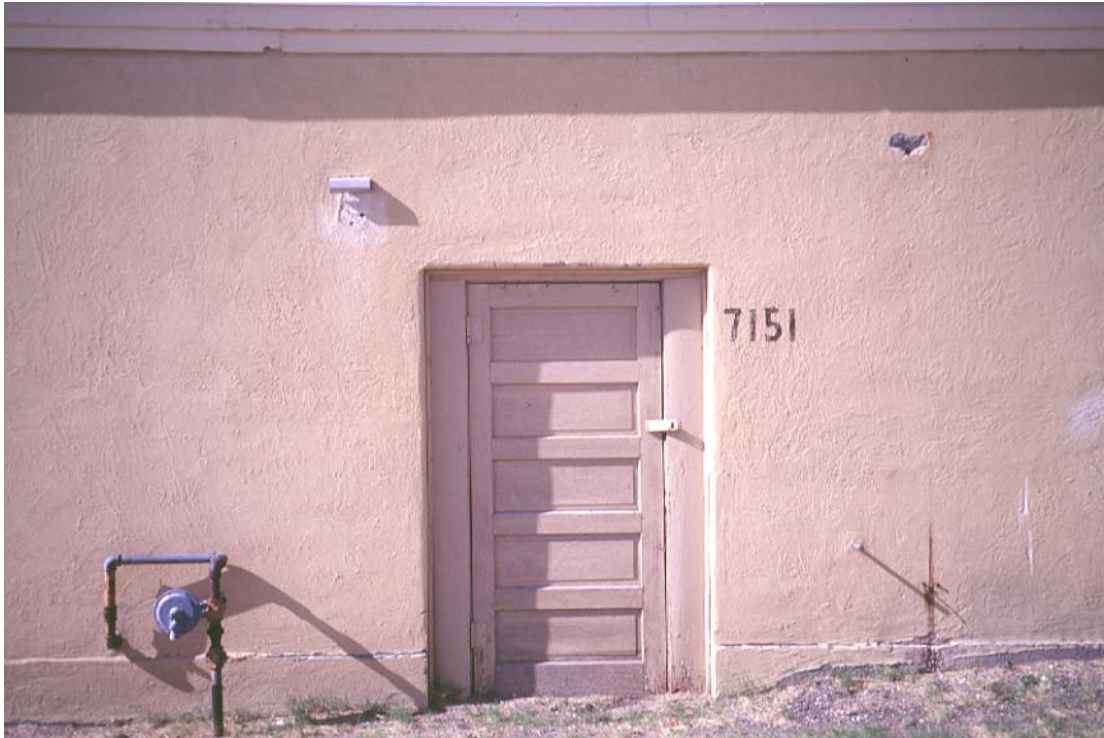
2, S; Photograph 14). No damage from water intrusion was evident in the building's floor or wall finishes near the floor. However the crawl space vents at the building's northwest corner were almost closed by the coarse soil carried by runoff, indicating runoff is entering the crawl space. Regrading to ensure positive drainage away from all sides of the buildings should be included as part of the adaptive use design.

Photograph 14. Chapel site drainage detail.

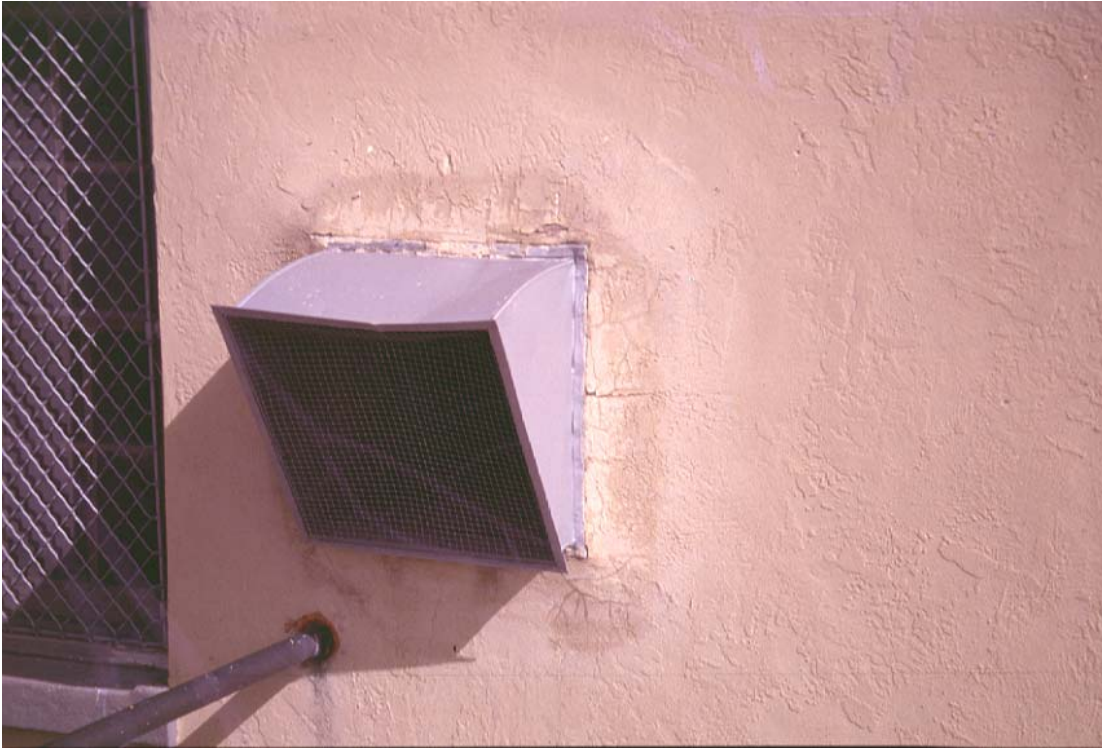
The exterior walls are in generally good condition. Minor cracking occurs around a metal vent hood at the north wall (Drawing 3, E; Photograph 16), around a light fixture over the east exit (Drawing 3, F), at pipe penetrations at the east wall (Drawing 3, G), and around the south exit at the west wall (Drawing 3, H). Louvers and grills on the north wall will require minor repair and refinishing. These repairs should present no problems when refinishing the exterior.

Photograph 16. Minor theater wall cracking around vent hood.

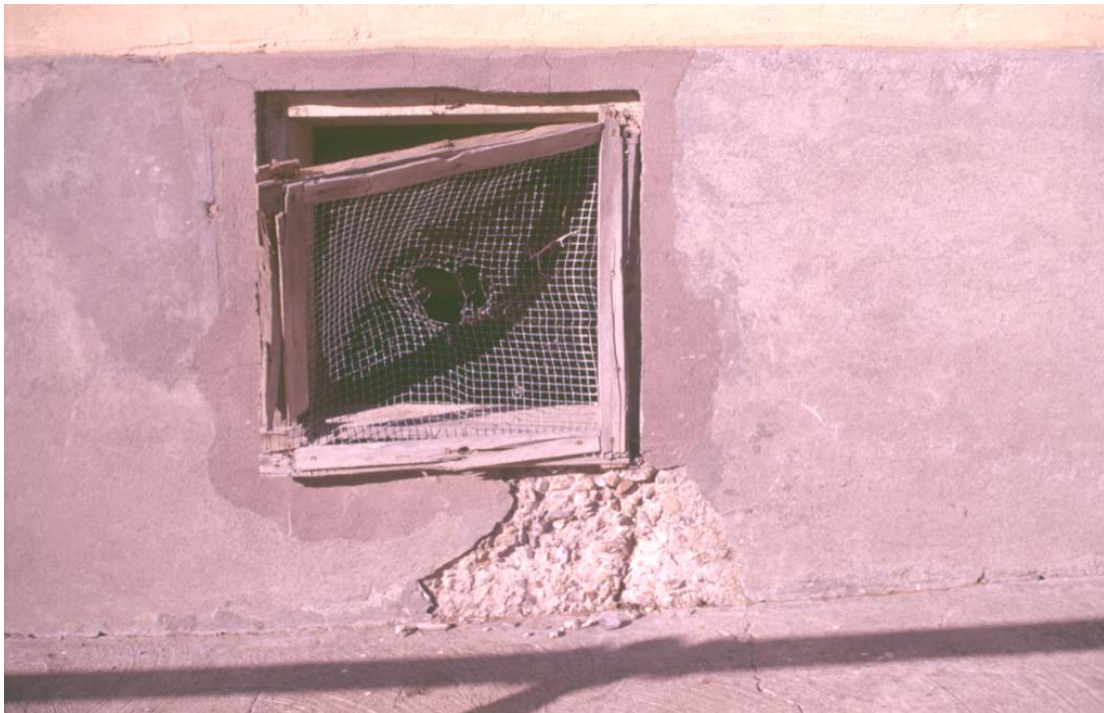
Minor cracking occurs throughout the foundation. A crack appears at the east wall, tracing from the lower corner of a crawl space vent, through the wall, and into the foundation (Drawing 4, A; Photograph 20). However, no differential movement or settlement was evident. This minor cracking should be sealed as part of the exterior refinishing. As the cracking appears to have not progressed for some period of time, repair should remain effective.

Photograph 20. Minor gymnasium foundation cracking.

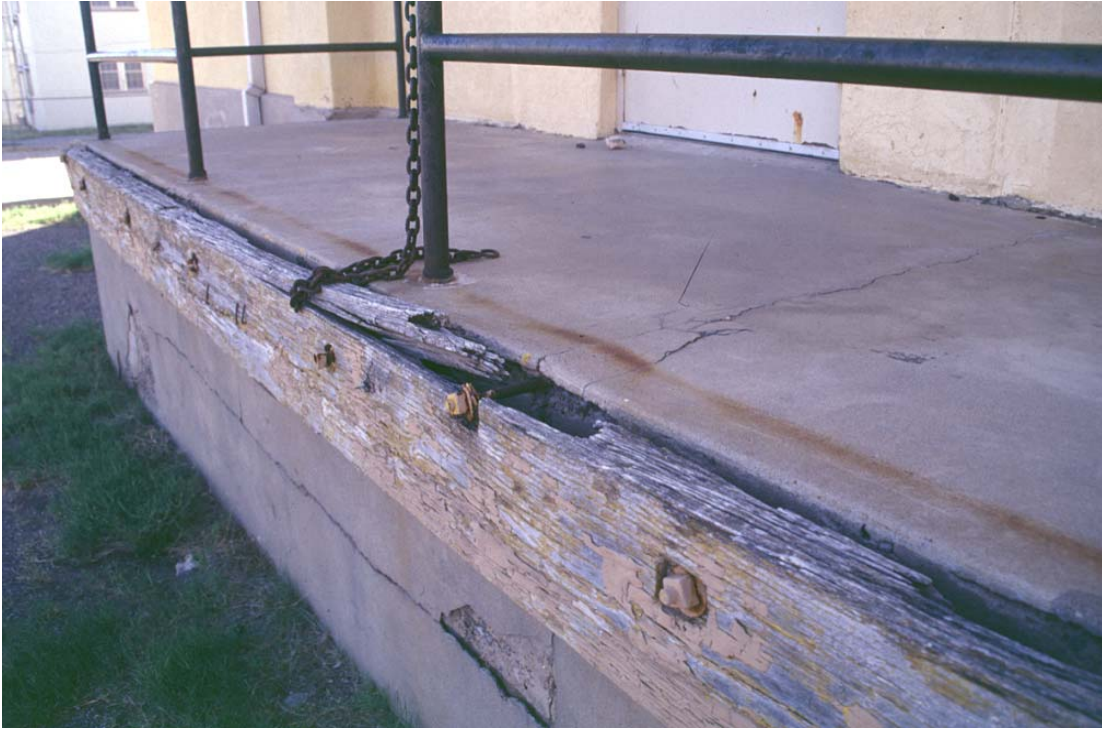
Cracks are present throughout the loading dock (Drawing 4, B). The deck slab is badly cracked, especially at the corners where the pipe railing has rusted and spalled away the concrete (Photograph 22). The slab is also deteriorated around the edges where anchor bolts held wood bumpers. The bumpers themselves are almost totally deteriorated, and the anchor bolts are exposed. Impact from vehicles may also have contributed to cracking and eventual deterioration. Repair of the loading dock may be possible, although replacement may be more feasible.

Photograph 22. Concrete damage on gymnasium loading dock.

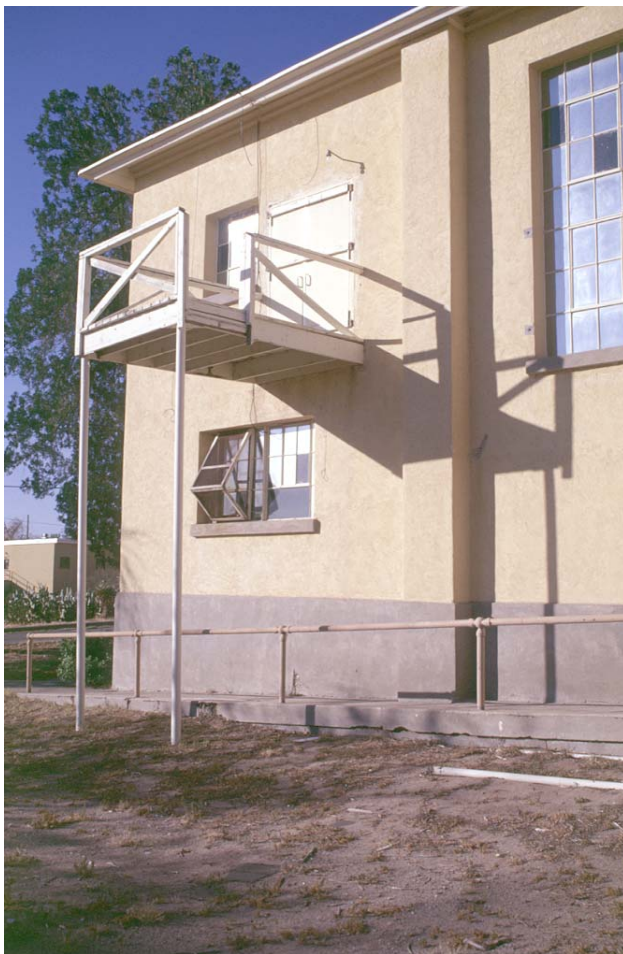
A fire escape stair structure has been added to the south end of the east wall (Drawing 4, F; Photograph 23). The stairs have been removed, but the tower structure remains. It is assumed that this structure will be removed and replaced in a rehabilitation design. The damage to the wall from the structure's anchor bolts will have to be repaired.

Photograph 23. Unused gymnasium fire escape tower.

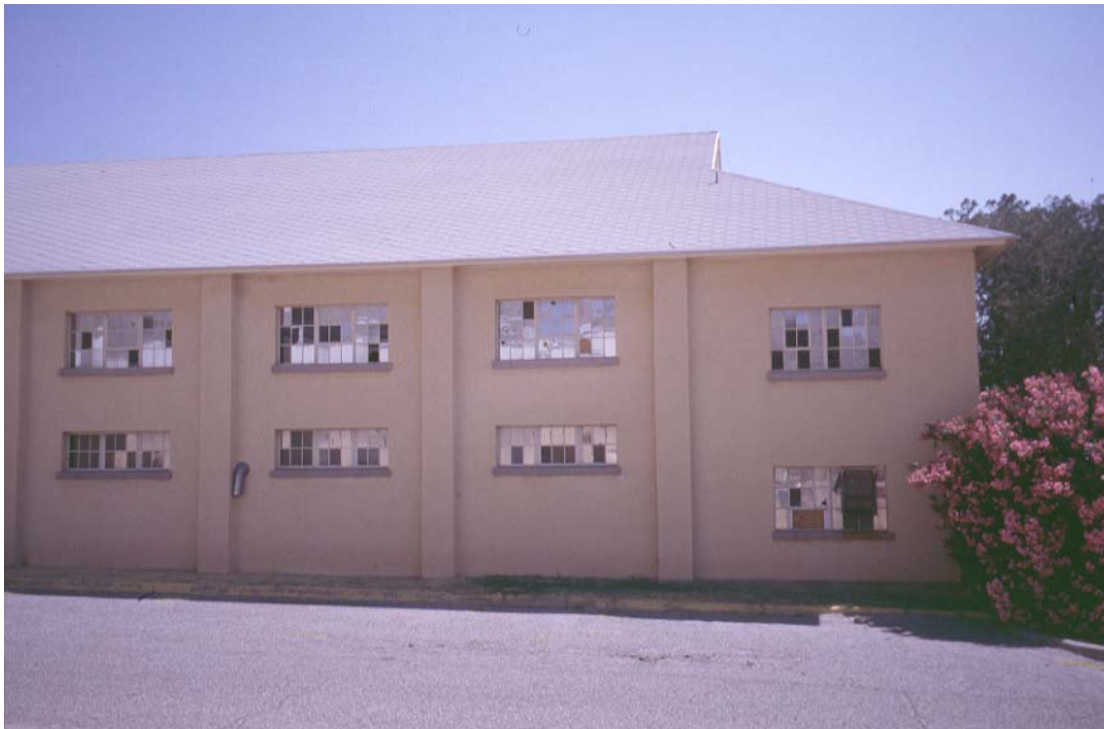
Reflective film has been installed on the glass panes. At present, many of the panes have been replaced without replacing the film (Photograph 25). In a rehabilitation or reuse design, film should be either restored to all glazing, or should be removed altogether.

Photograph 25. Inconsistent use of film on gymnasium windows.

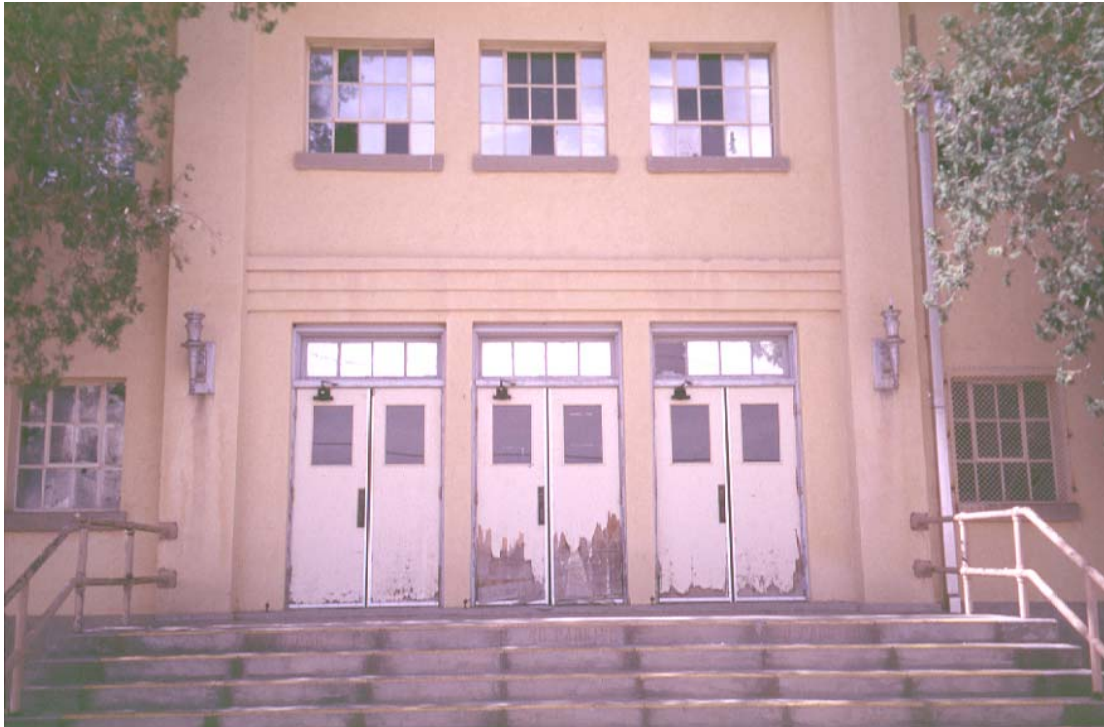
The triple sets of double-leaf doors at the south entry are a significant element of the original south elevation (Drawing 4, I). The doors have been replaced with flush wood doors, which are seriously deteriorated (Photograph 26). These will have to be replaced with a historically appropriate style of door. Two-panel doors are depicted on the original drawings. The transoms above the entry doors are intact, although repair and refinishing will be necessary.

Photograph 26. Deteriorated gymnasium entry doors.

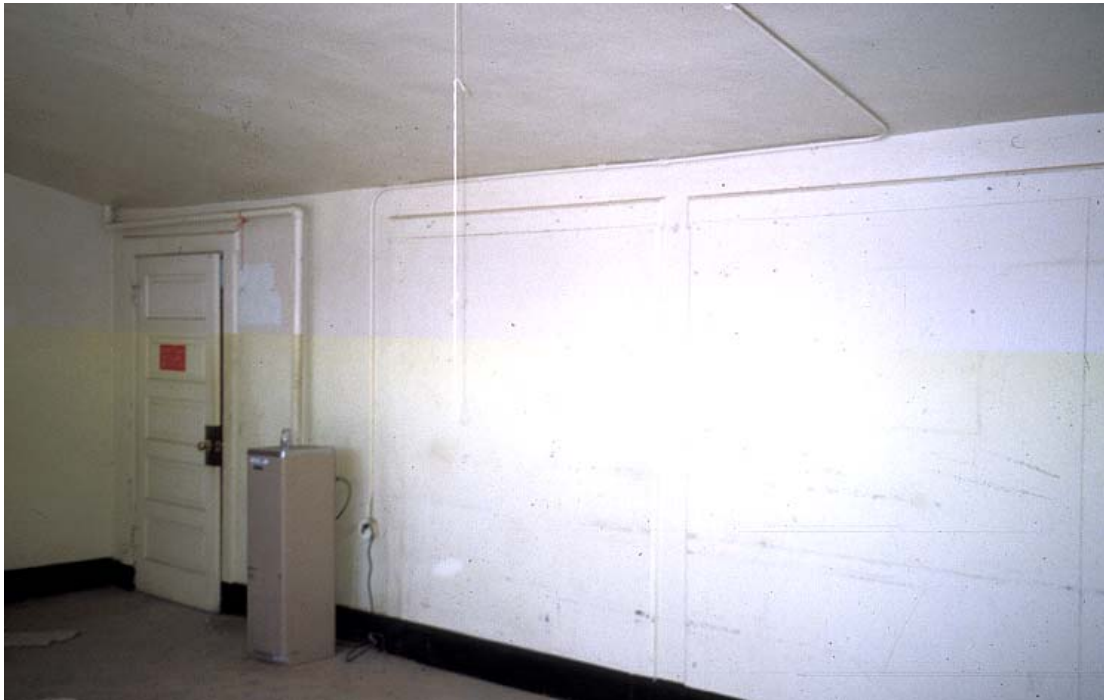
The single door from the lobby to the gym and the north locker room door remain intact. The others have been removed and the openings filled (Drawing 4, P). Padding is installed on the gym walls. The door trim remains, although it has been painted. These portals, especially the former entrance from the lobby, are significant elements in the building's design (Photograph 30). It would be possible to restore these doorways if historically appropriate replacements can be found for the doors. In deciding such a rehabilitation measure, items such as the building's future occupancy, must be considered, especially with regard to the building's function, safety, and circulation.

Photograph 30. Historically incompatible modifications of gymnasium locker room portal.

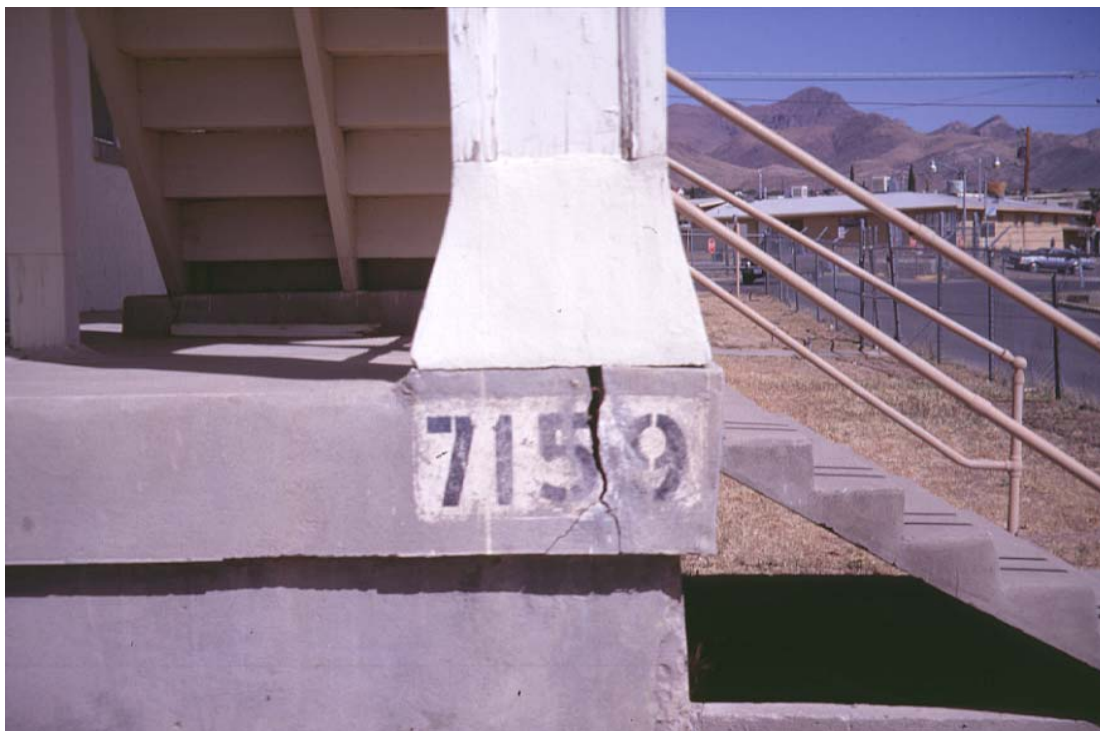
Original drawings depict a framed floor for the porch. The wooden floor has been replaced with concrete slab on all three buildings. The porch columns bear on the concrete slab at the porch's first floor. Significant cracking has occurred in each building at the exterior corners of the floor slab, at the corner columns of the porch (Drawings 5 – 7, C; Photograph 34). As a result, the corner is breaking away from the slab. No such cracking is evident at the other columns.

Photograph 34. Detail of barracks porch slab cracks.

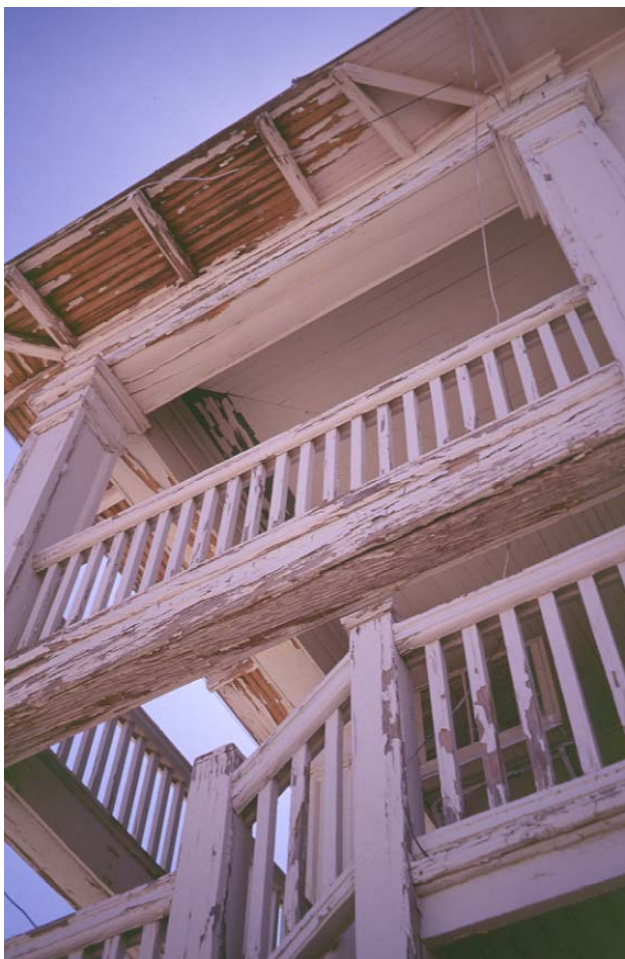
Extensive water damage is evident in the eaves at the north and south ends of all three porches, above the stairwells (Drawings 5 – 7, E; Photograph 38). As part of rehabilitation or reuse design analysis, the roof framing and porch column assemblies in these areas will have to be evaluated for deterioration. See the discussion under "Roofing," page 86. The eaves in the middle sections of each porch, however, are considerably less deteriorated.

Photograph 38. Typical water damage to barracks porch roof.

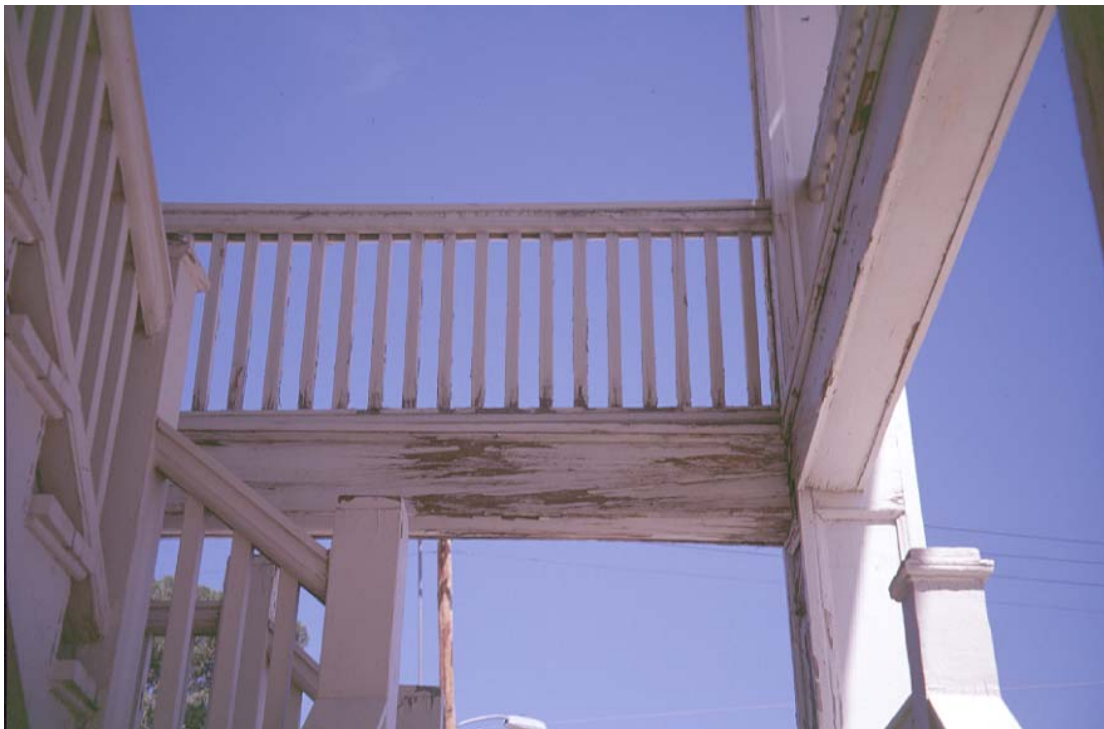
The exterior trim enclosing the porches' structural members is seriously deteriorated, especially at the stairwells at the north and south ends of the building (Drawings 5 – 7, F; Photograph 40). Painting has apparently been neglected for some time. Many, if not most, of the trim boards are severely split and warped. Many baluster pieces are missing. While some of the original trim may be repairable, extensive replacement probably will be necessary. The stucco "base" detail should be replaced to restore the original detail and prevent water accumulation.

Photograph 40. Typical deteriorated exterior trim on barracks.

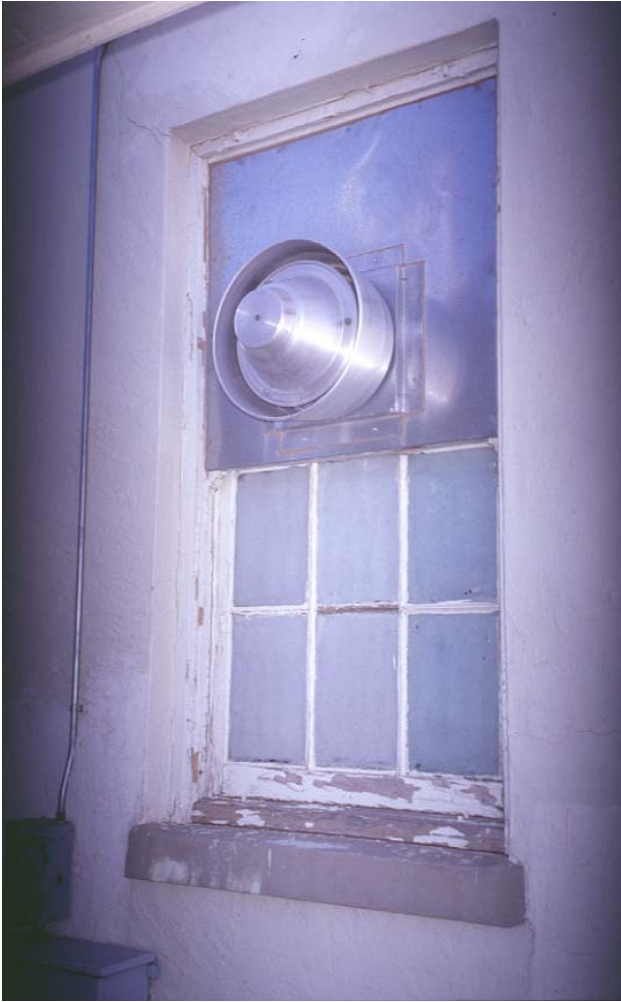
Photograph 43. Non-historic washroom window modification.

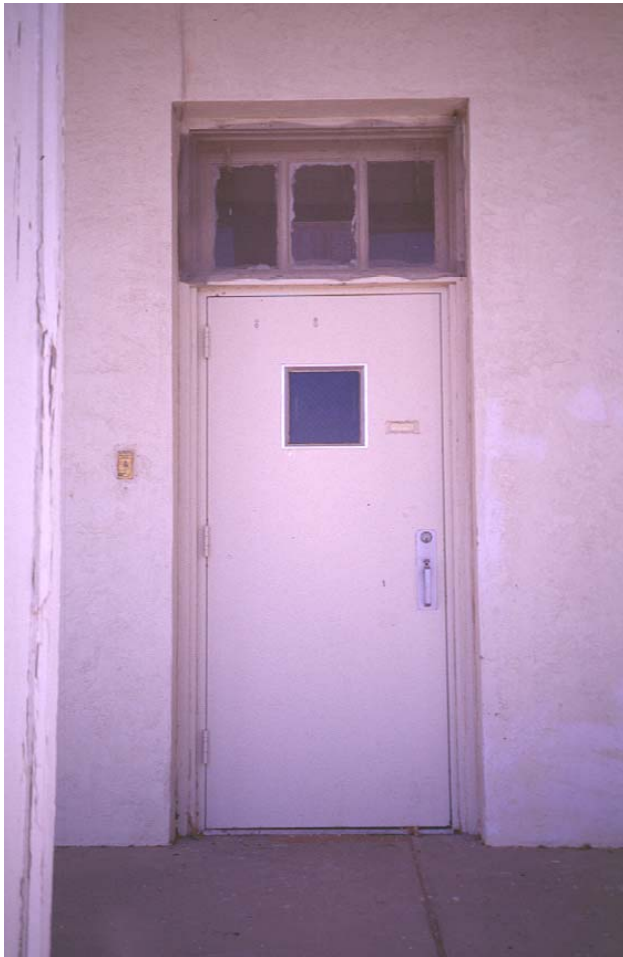
Photograph 44. Non-historic barracks replacement door.

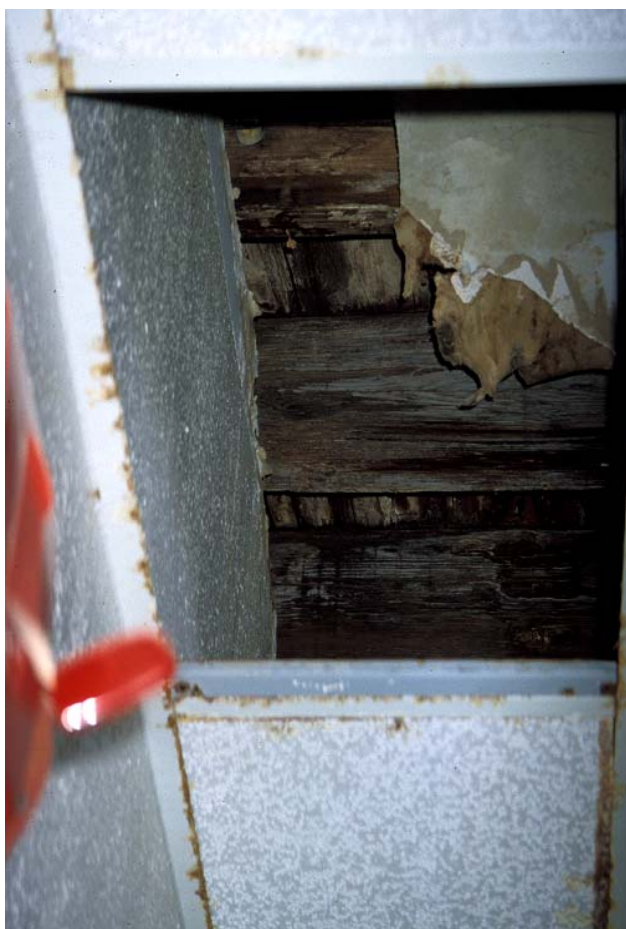
Photograph 45. Typical water-damaged barracks ceiling in first-floor washroom.

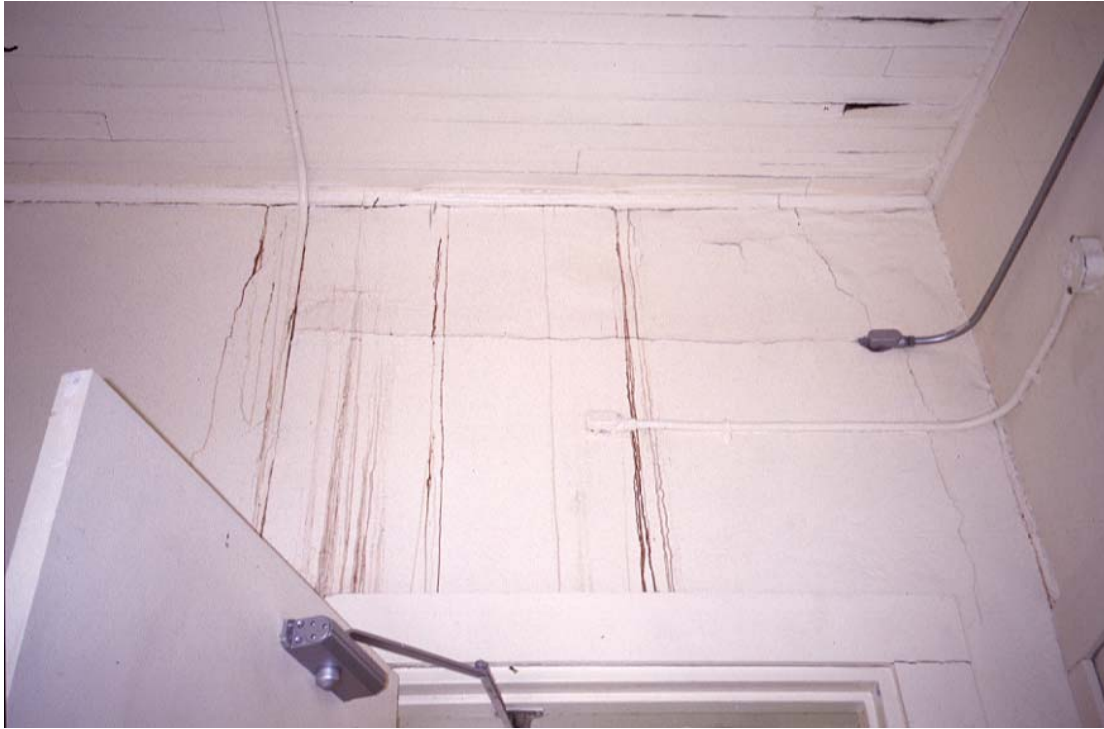
Photograph 48. Signs of roof leakage in porch of Building 7157.

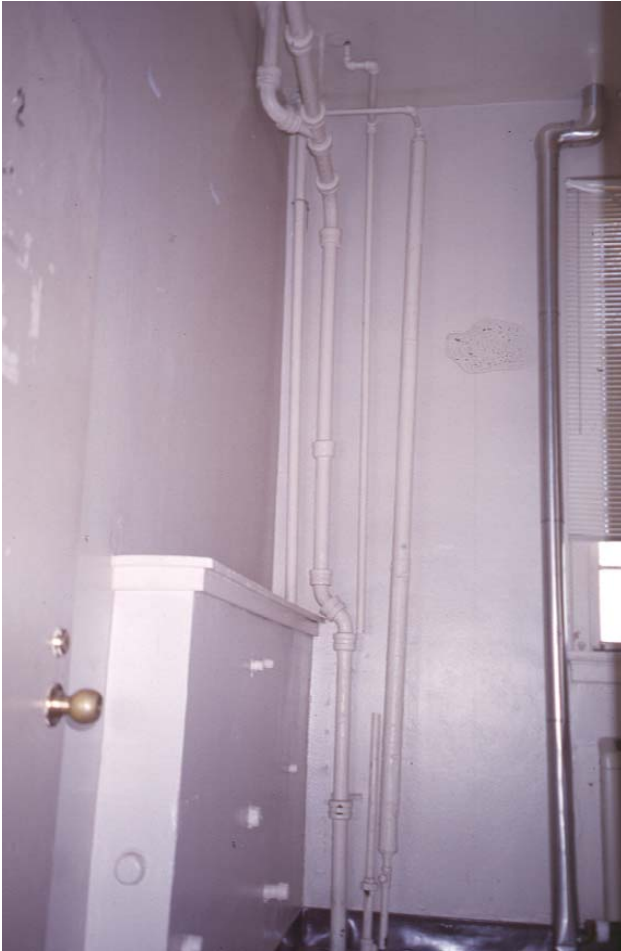
Photograph 49. Non-historic plumbing modifications in Building 7157.

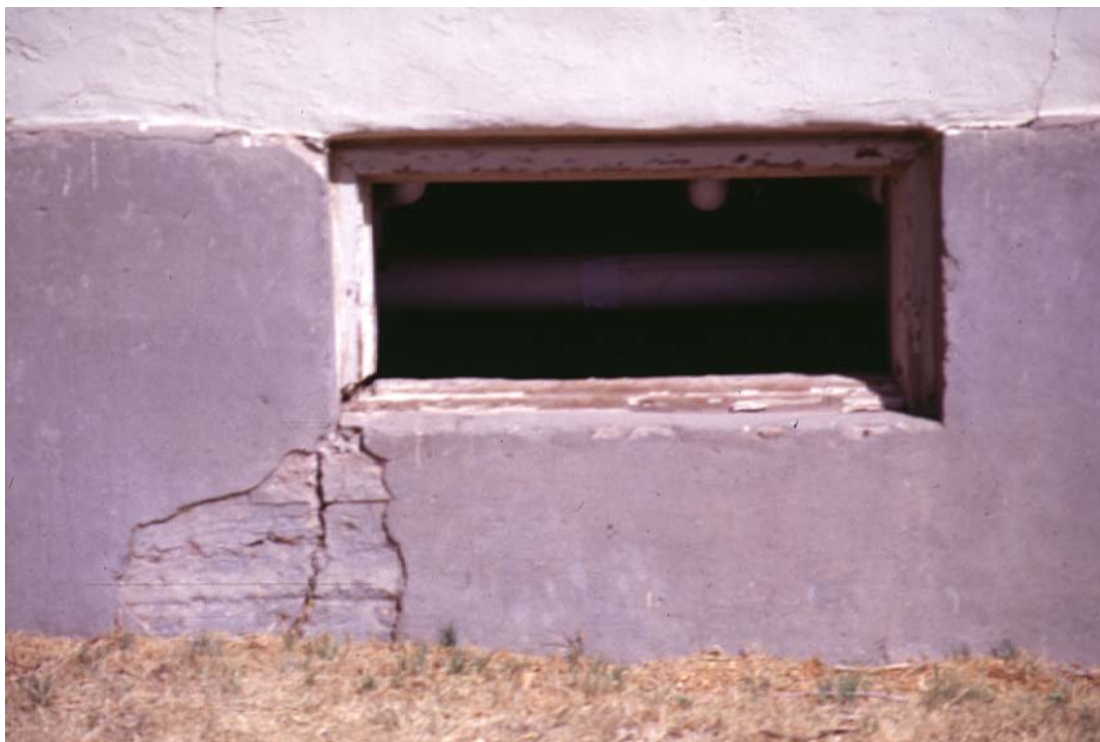
Photograph 54. Building 7159 foundation crack.

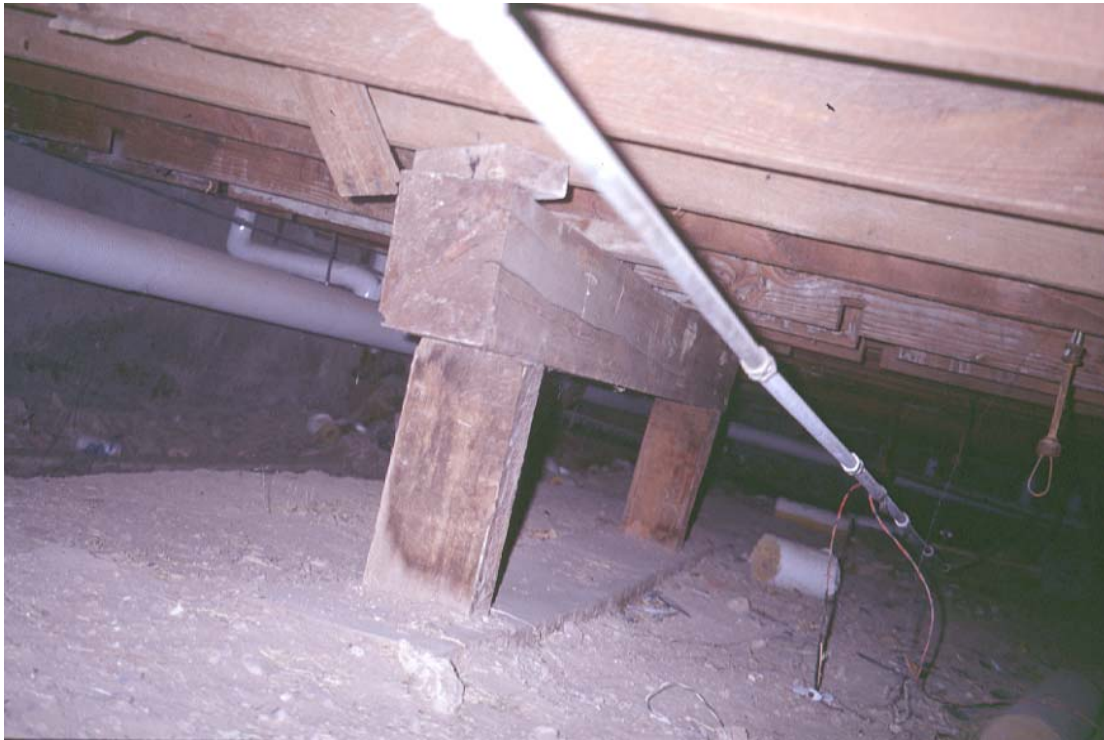
Photograph 56. Makeshift repair of floor framing under Building 7159.

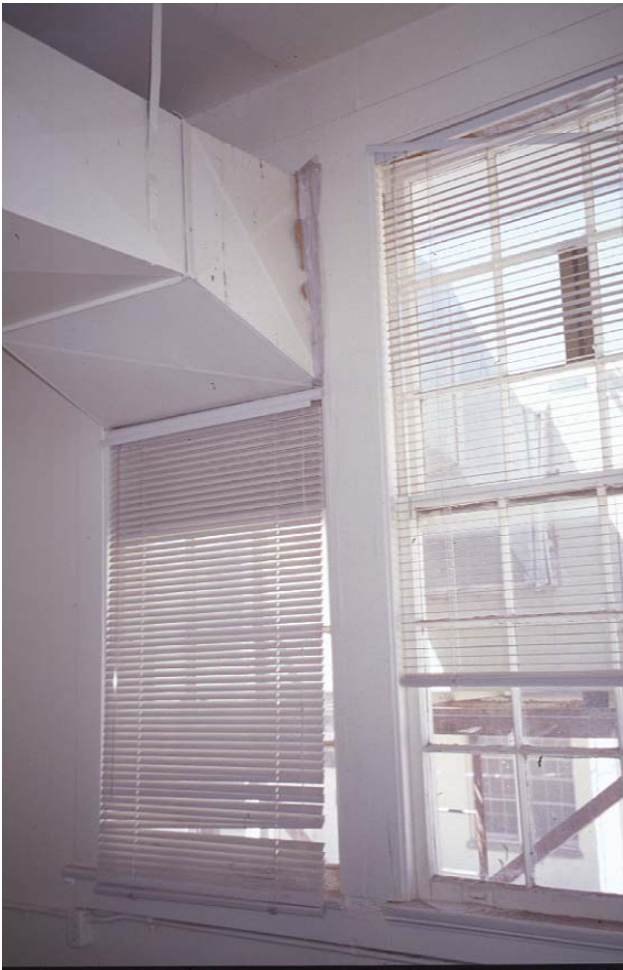
Photograph 59. Non-historic modification of window sashes in Building 7159.

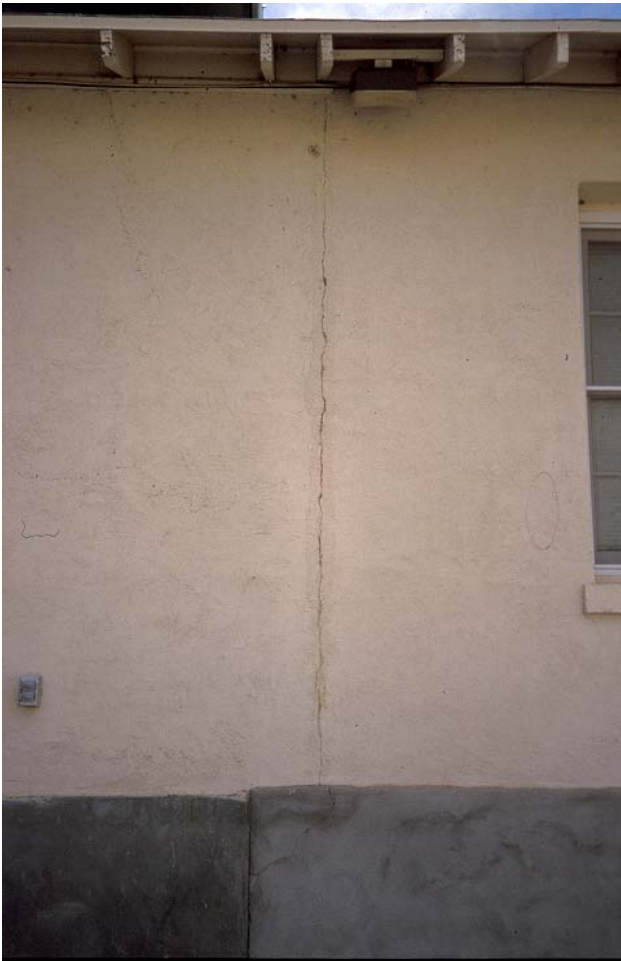
Photograph 61. BOQ foundation and wall crack.

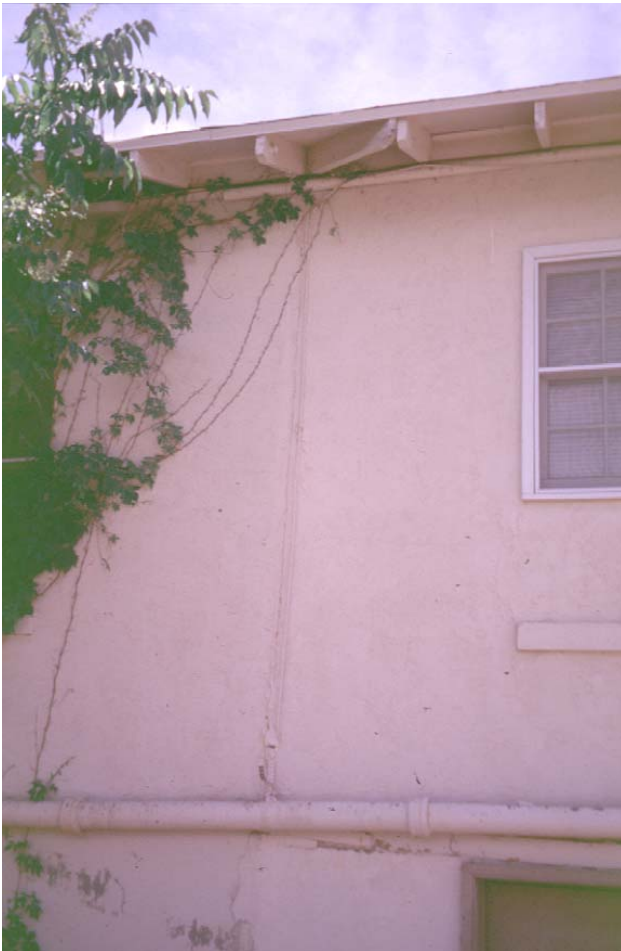
Photograph 62. Minor BOQ wall crack.

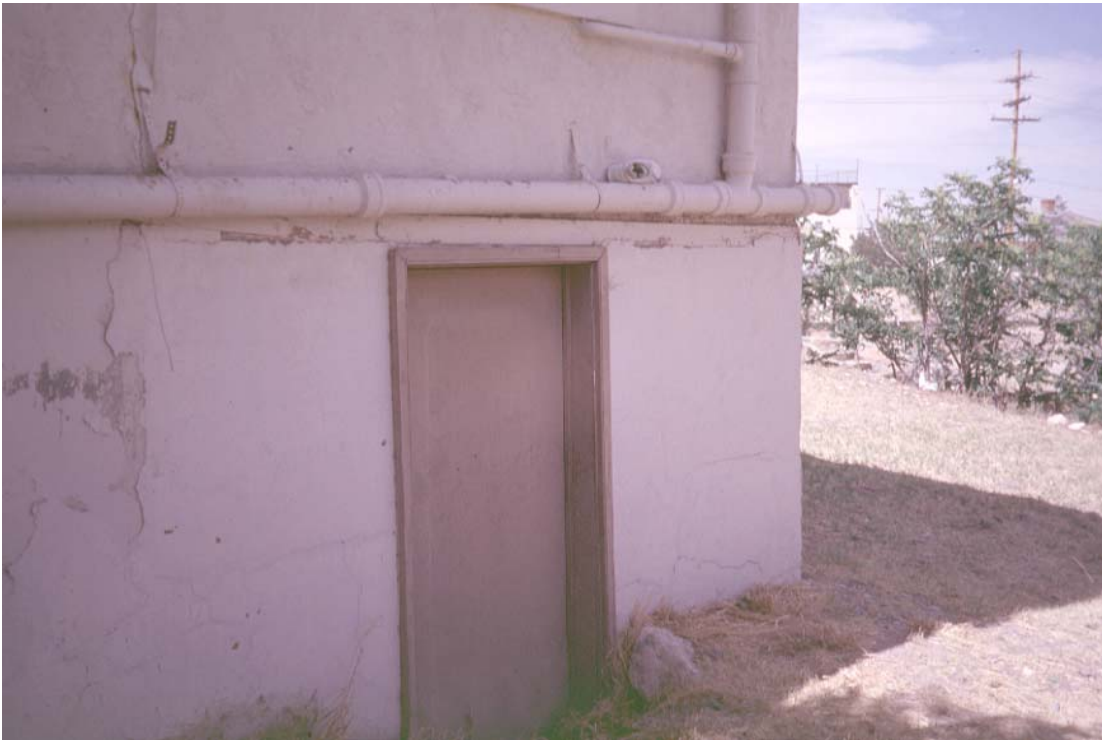
Photograph 64. Deteriorated BOQ basement door.

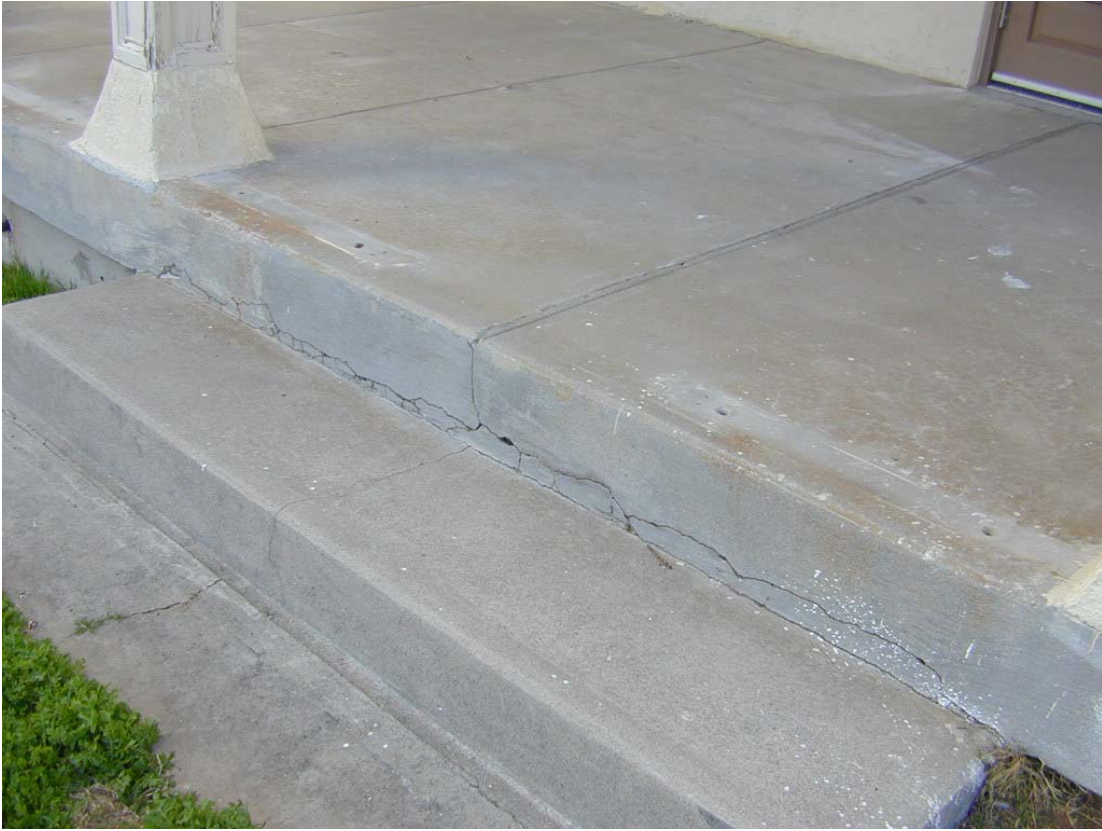
Photograph 72. Crack in north porch slab of Conference Center.

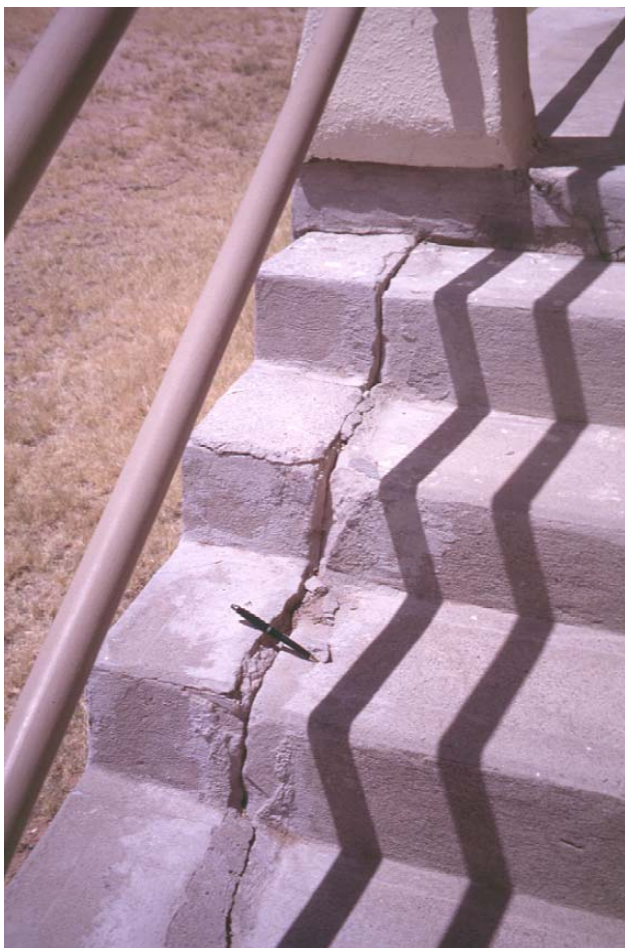
Photograph 74. Badly cracked Conference Center stairs.

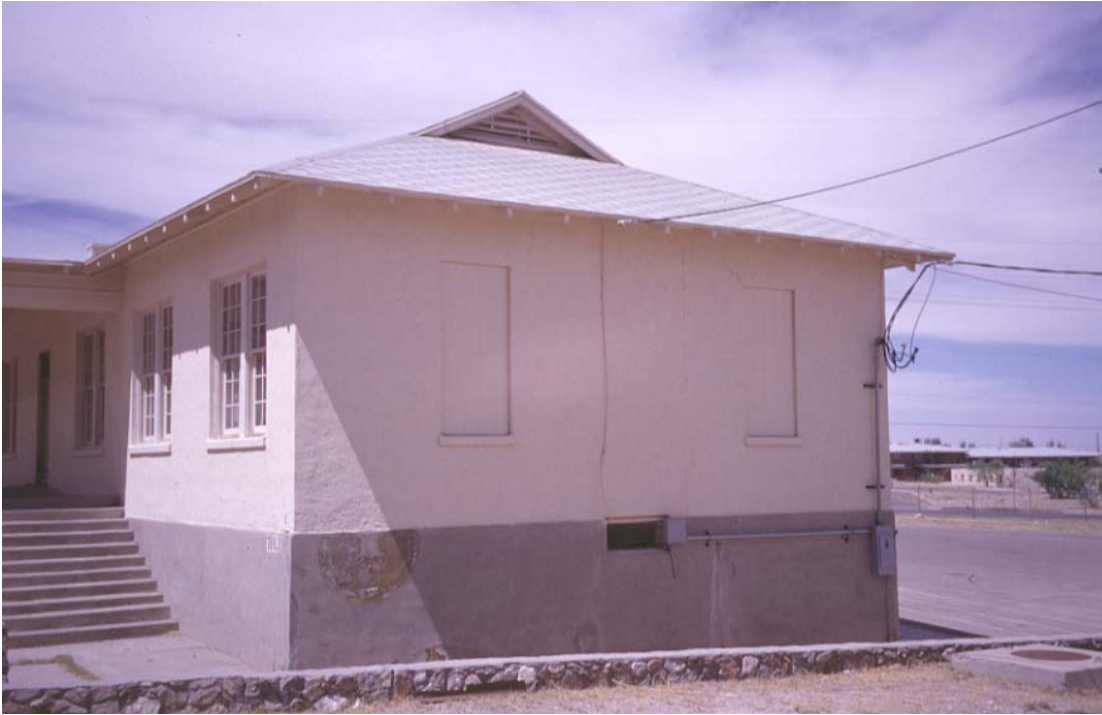
Photograph 80. Boarded windows in the south wall of Conference Center.
