# **Failure Analysis of a Cracked UH-1 Tailboom Former, P/N 205-030-807-97**

**ARL-TR-3828**

**June 2006**

**Scott Grendahl  
U.S. Army Research Laboratory  
Weapons and Materials Research Directorate  
Aberdeen Proving Ground, MD 21005**

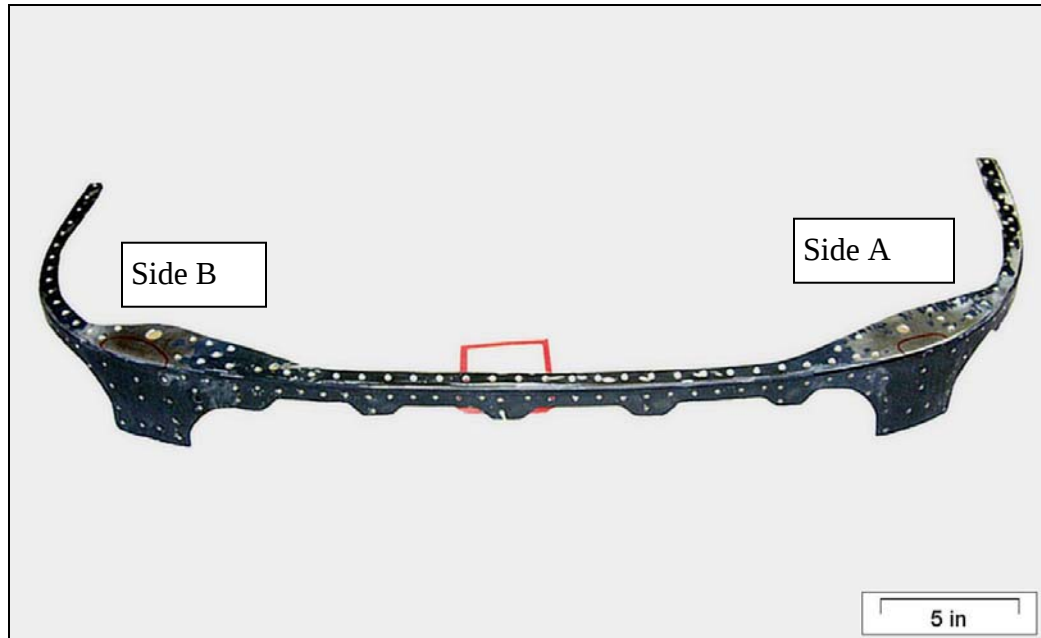
The U.S. Army Aviation and Missile Command sent the U.S. Army Research Laboratory Weapons and Material Research Directorate a UH-1 tailboom former (P/N 201030-807-97) from the U.S. Army Kwajalein Atoll facility (USAKA) in the Marshall Islands for investigation. The component was being investigated due to the presence of cracks observed near bolt hole locations on the part. This component was quality deficiency report exhibit number M24H90327. The material utilized to manufacture the former was specified to be clad 2024-T4 aluminum alloy sheet IAW QQ-A-362. QQ-A-362 is a very old cancelled specification. No copies of that specification could be recovered. It was superseded by QQ-A-250/5B, which was subsequently cancelled, and superseded by the current specification for clad 2024-T4 aluminum sheet, SAE-AMS-QQ-A-250-5. The part was characterized through nondestructive inspection, chemical analysis, optical microscopy, scanning electron microscopy, and mechanical testing. Figure 1 depicts the as-received tailboom former from USAKA.

Figure 1. As-received component UH-1 tailboom former.

- The UH-1 tailboom former exhibited cracking near both of the bolt hole locations. The crack on side A (figure 1) was a through-thickness crack propagating entirely through the 0.050-in thickness of the component. The overall crack length was 1.25 in. The crack on side B was similar, and its overall crack length was 1.3 in.

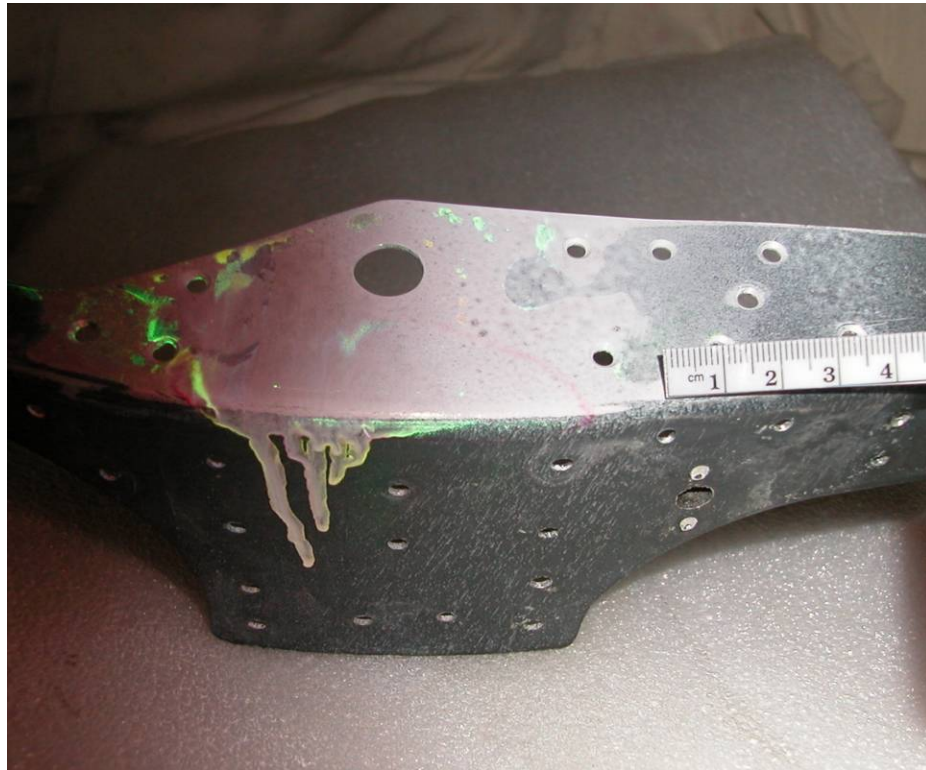
An extremely faint 3.50-cm indication was noted on side B of the as-received image in figure 1. The crack can be observed at a higher magnification in figure 3. The ECI revealed that the depth ranged from 0.020 to 0.040 in and the maximum width was 0.005 in. The eddy current measurements were approximate, as the proximity to the edge made the inspection difficult. No penetrant bleed through was noted on the inside face of the former (paint was not removed from inside concave surface).

Figure 3. Fluorescent indication of the crack on side B.

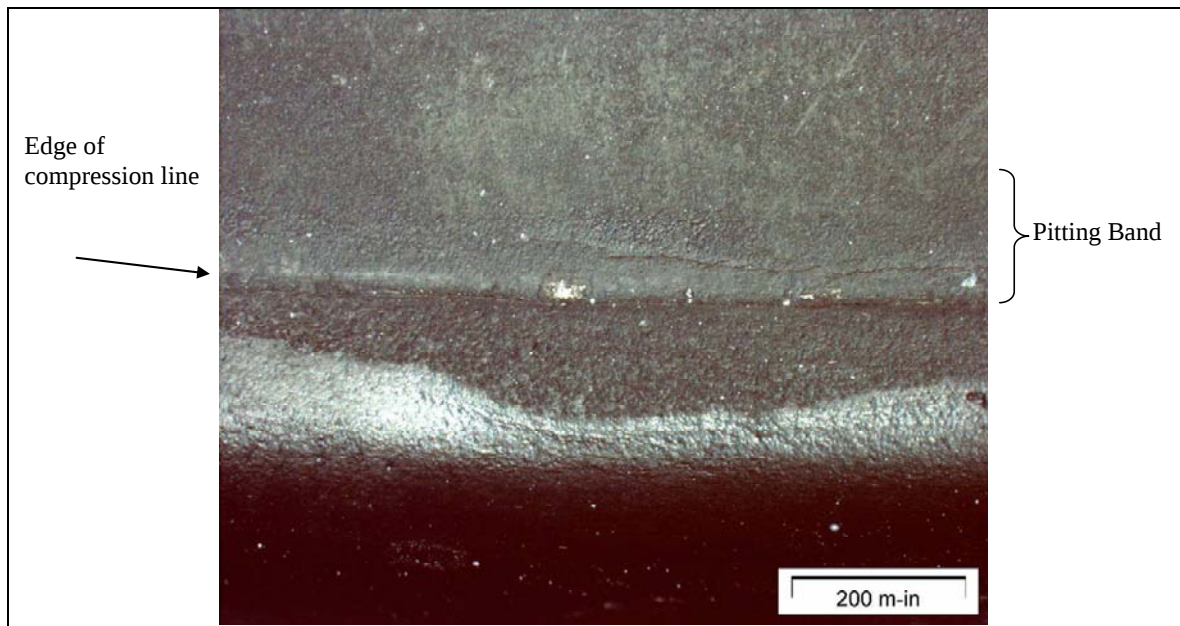
The tailboom former failed by a fatigue mechanism initiated at corrosion pits. These pits likely developed over time either from damage induced during overhaul or within the natural crevice formed by the tailboom former and its mating component in the assembly. Pits were observed both with paint covering them and inactive, and recently active and corroding. It is likely that some of the pitting corrosion was missed during overhaul and paint was reapplied over them.

Figure 26. Corrosion pitting band near edge of crevice compression line.

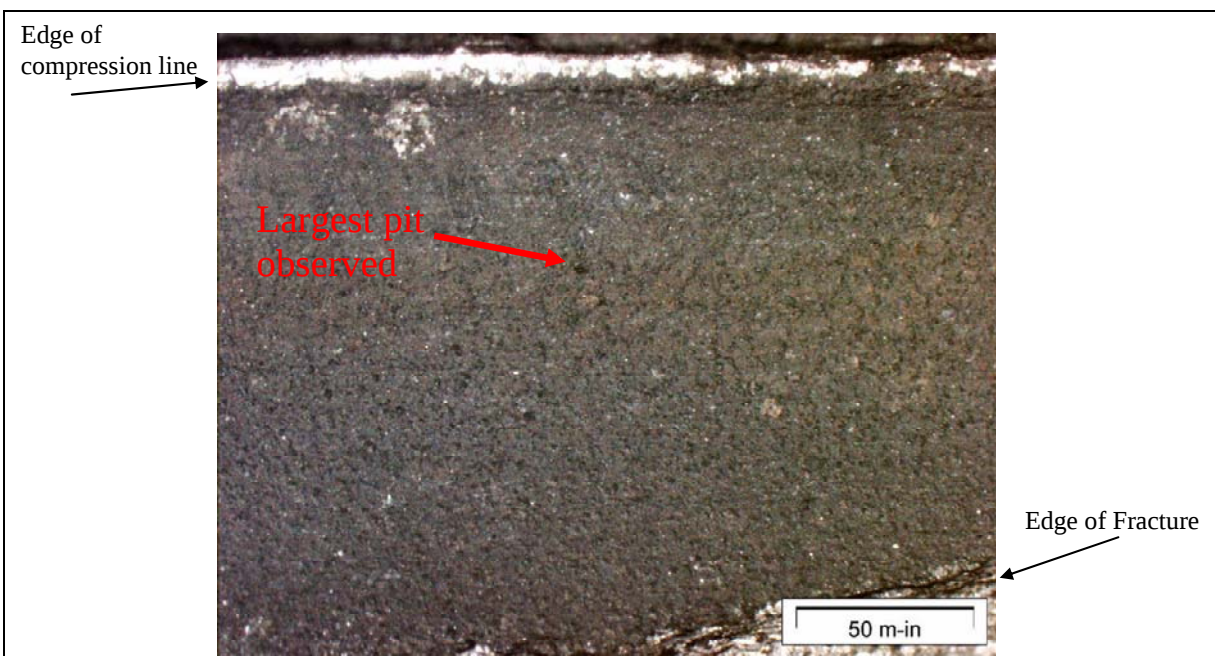
Figure 27. Pits adjacent to the edge of the fracture.
