Electrospark Deposition for the Repair of Army Main Battle Tank Components

ARL-TR-3849

July 2006

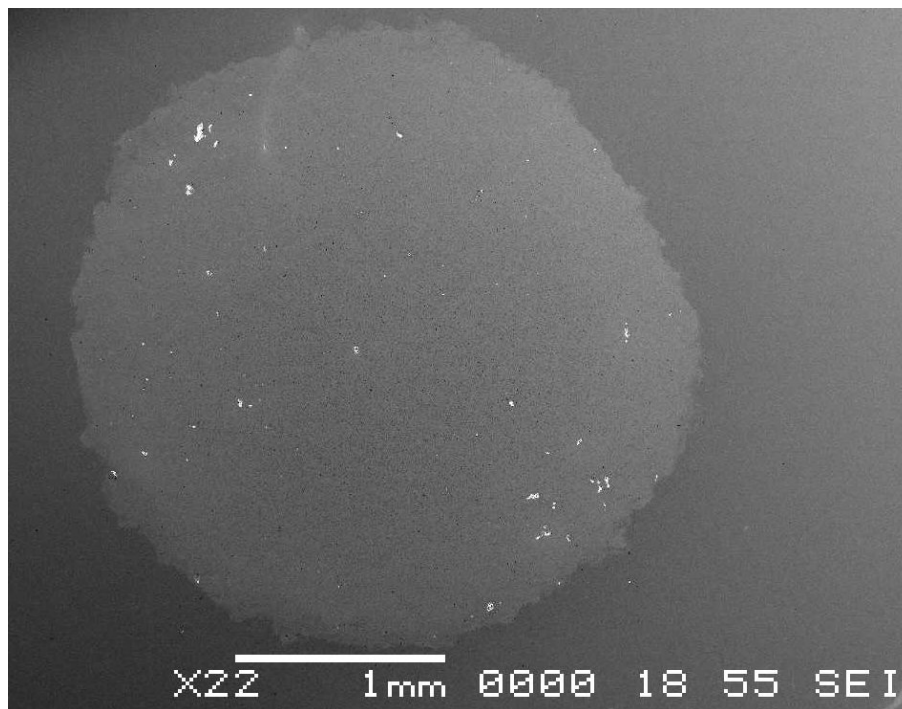
Figure 12. SEM micrograph of the surface of condition 4 after ESD repair (magnified 22 \times).

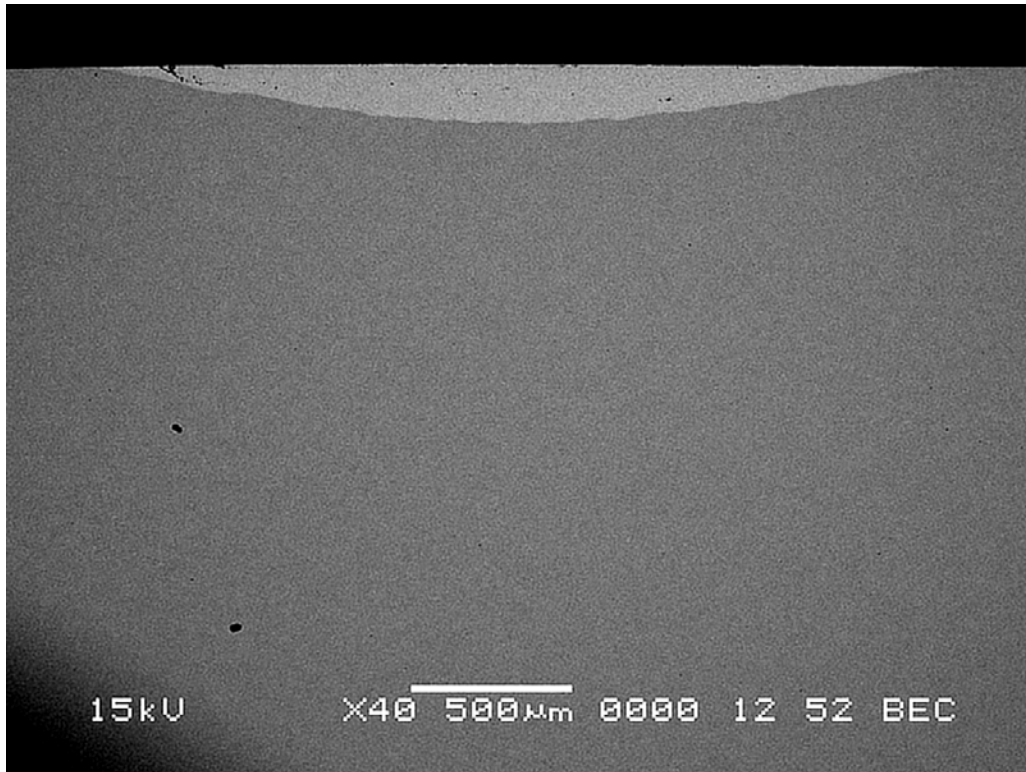
Figure 13. SEM micrograph of a section through condition 4 after ESD repair (magnified 40×).

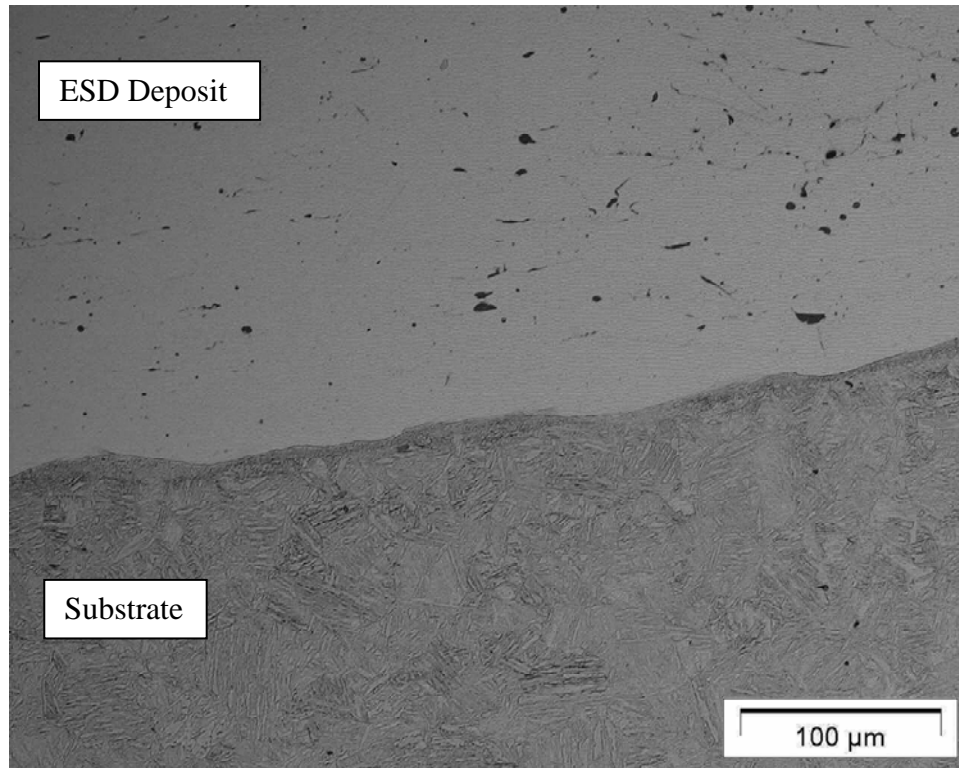
Figure 15. Photomicrograph showing interface between deposit and substrate. Substrate was AISI 9310 steel etched with 2% nital (magnified 200 \times).

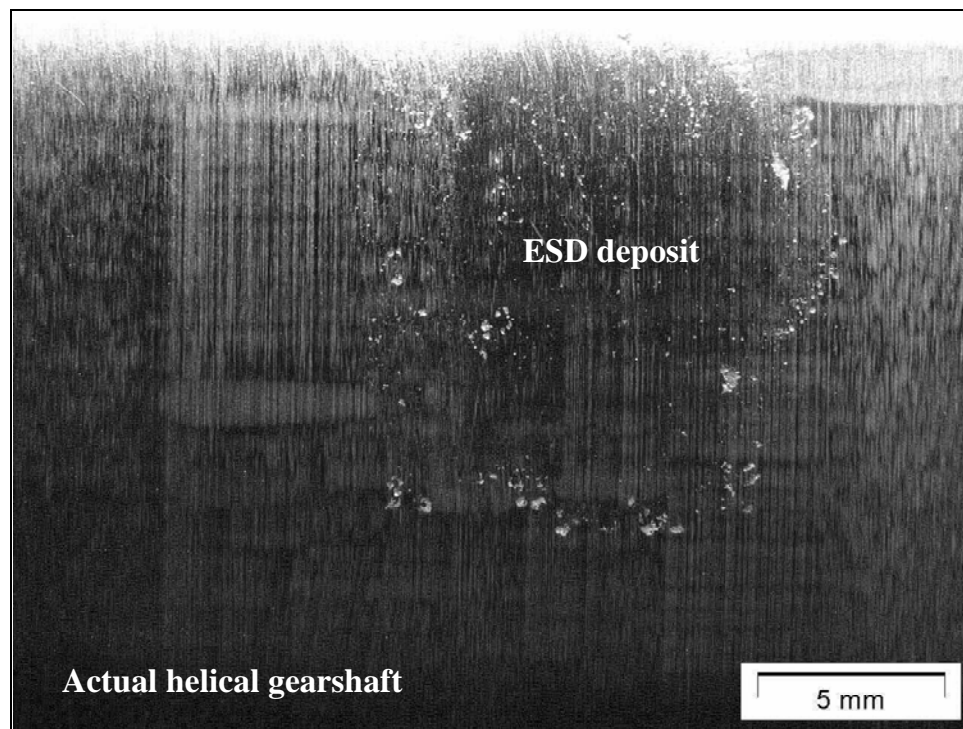
Figure 16. Porosity around the ESD deposit (“halo effect”) of a chrome-plated sample (magnified 5 \times).

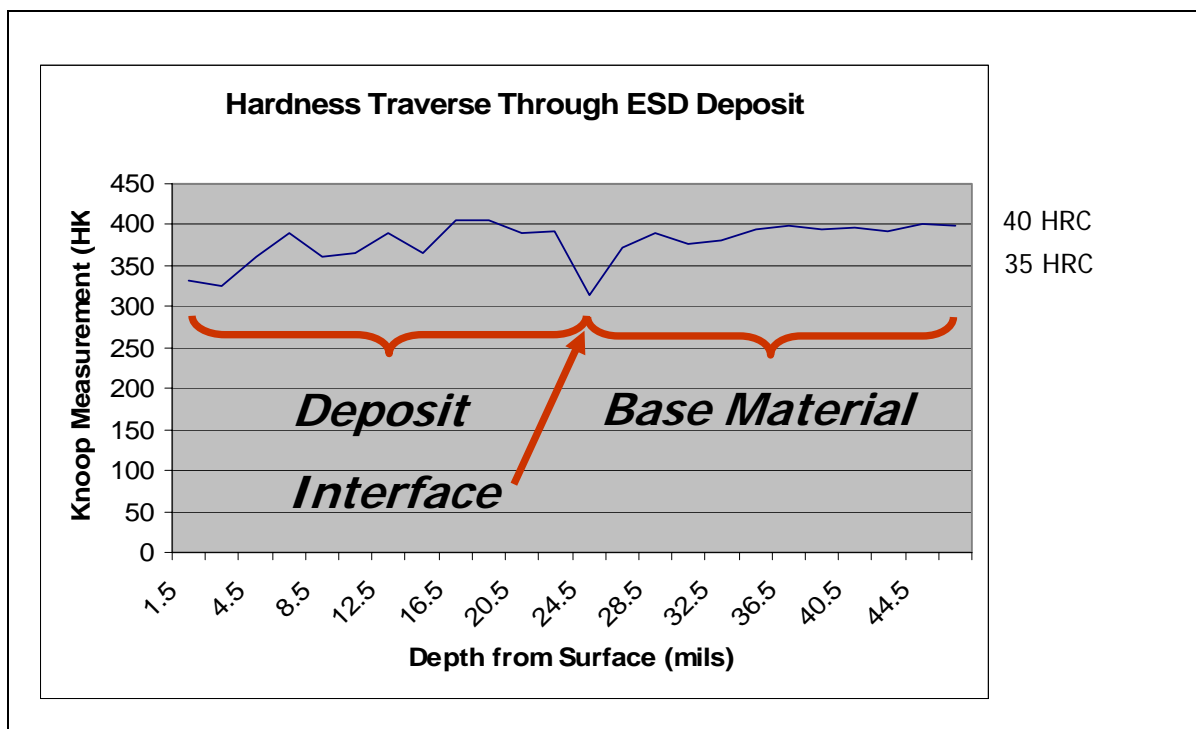
Figure 20. Plot of hardness through ESD into the base metal, showing similar hardness values.

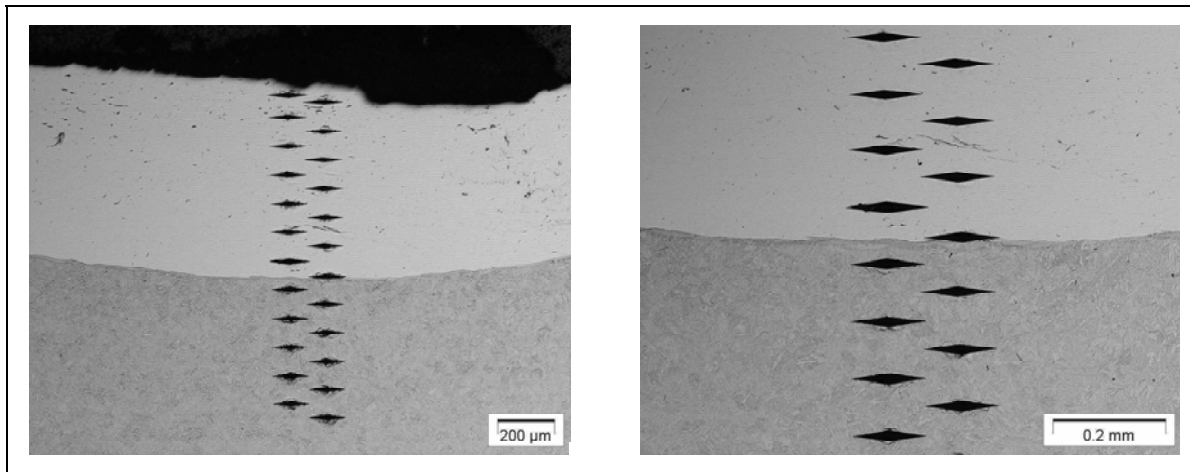
Figure 21. Micrographs of Knoop microhardness indents through the ESD into the base metal. Base metal etched with 2% nital (magnified 50× [left] and 100× [right]).

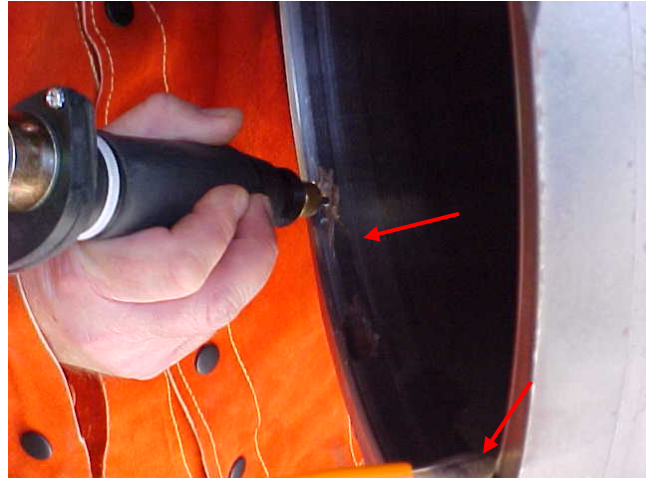
REPAIR PROCESS

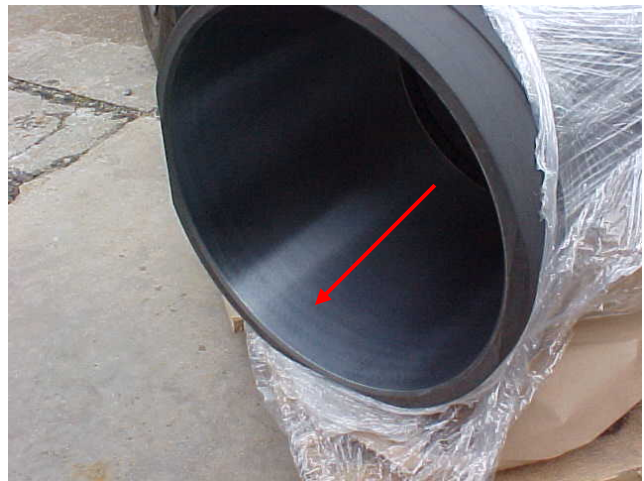
AFTER ESD REPAIR, CHROME PLATING, AND FINISH GRINDING

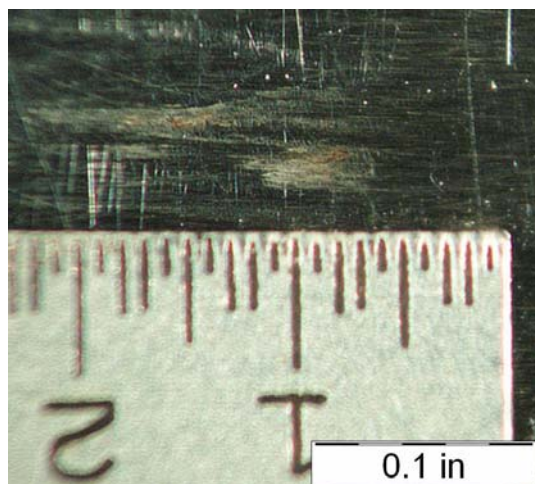
CORROSION PIT FOR ESD REPAIR

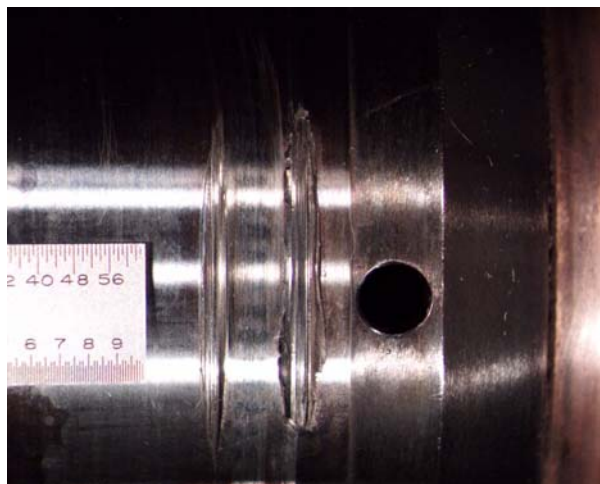
WEAR MARK FOR ESD REPAIR

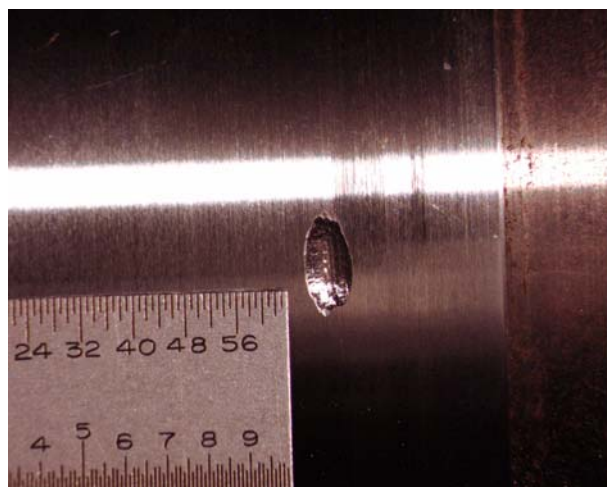
CORROSION PIT PREPARED FOR ESD

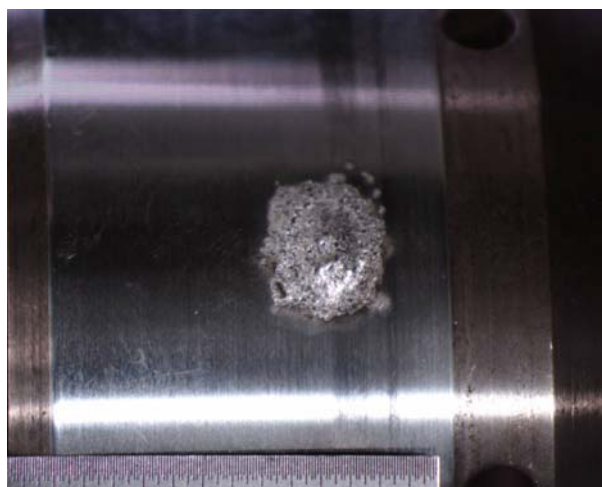
CORROSION PIT FILLED IN BY ESD
