ERDC TR-07-10

## **Geologic Setting of Mosul Dam and Its Engineering Implications**

September 2007

Final report

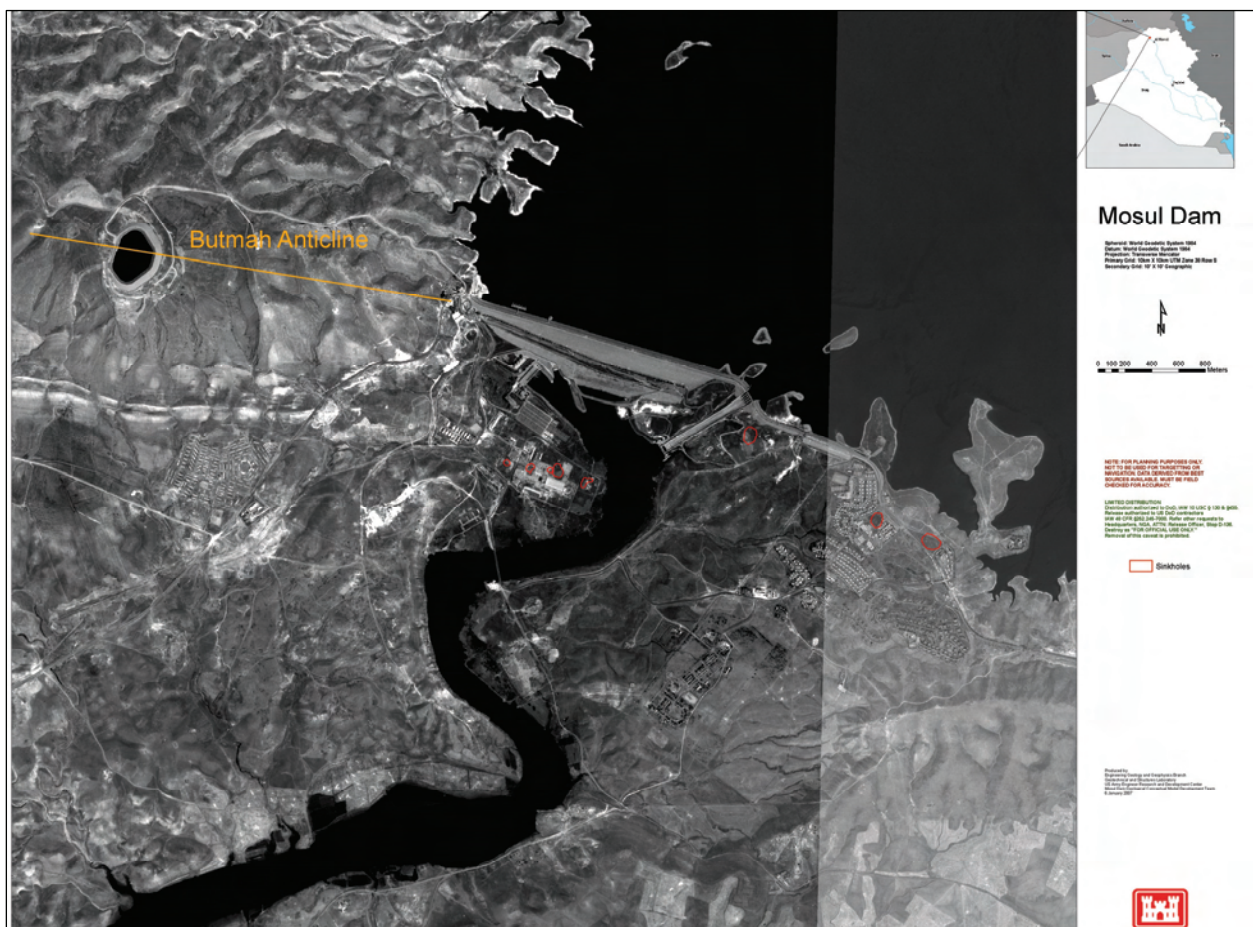
A hyperspectral image of the dam and its immediate vicinity shows a number of sinkholes that are visible downstream of the dam and on the east abutment (Figure 4). Sinkholes, caves, and cracks appeared in and around the dam foundation during construction and reservoir impoundment (in 1984). Several horizons of foundation materials are micro-fractured and highly permeable, and are undergoing dissolution. These conditions require the current and continuous grouting program that was initiated during construction in an effort to minimize further dissolution and karst development. Major functional integrity issues and concerns with the dam have always been associated with the nature of the foundation materials and with manifestations of continued dissolution such as sinkholes, seepage, and cracks in the embankment.

Figure 4. Hyperspectral image of the vicinity of Mosul Dam showing locations of sinkholes (red dots; compiled by S. Broadfoot using GIS).

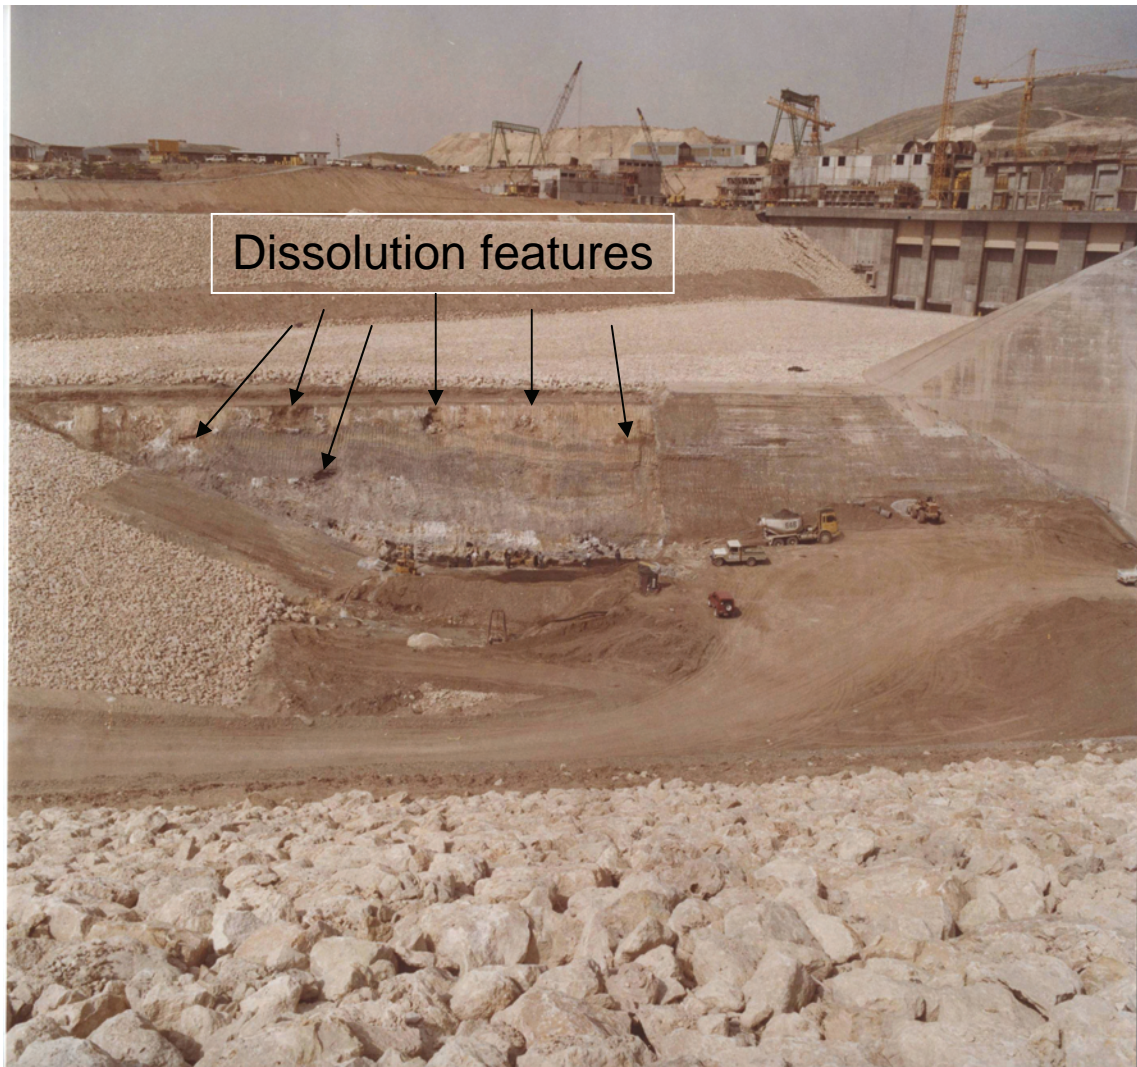
centuries to millennia before construction of the dam. This long-term dissolution is evidenced by the dissolution features visible in photos taken during construction (Ayoub 2006, photographs shown at the Sep 2006 workshop in Vicksburg, MS) (see Figure 7).

Figure 7. Photo taken during construction of Mosul Dam (1982-1983) showing caves, breccia, and collapsed bedding exposed during excavation, attributed to prehistoric and historic dissolution of gypsum prior to dam construction. (Photo provided by A. T. Ayoub.)

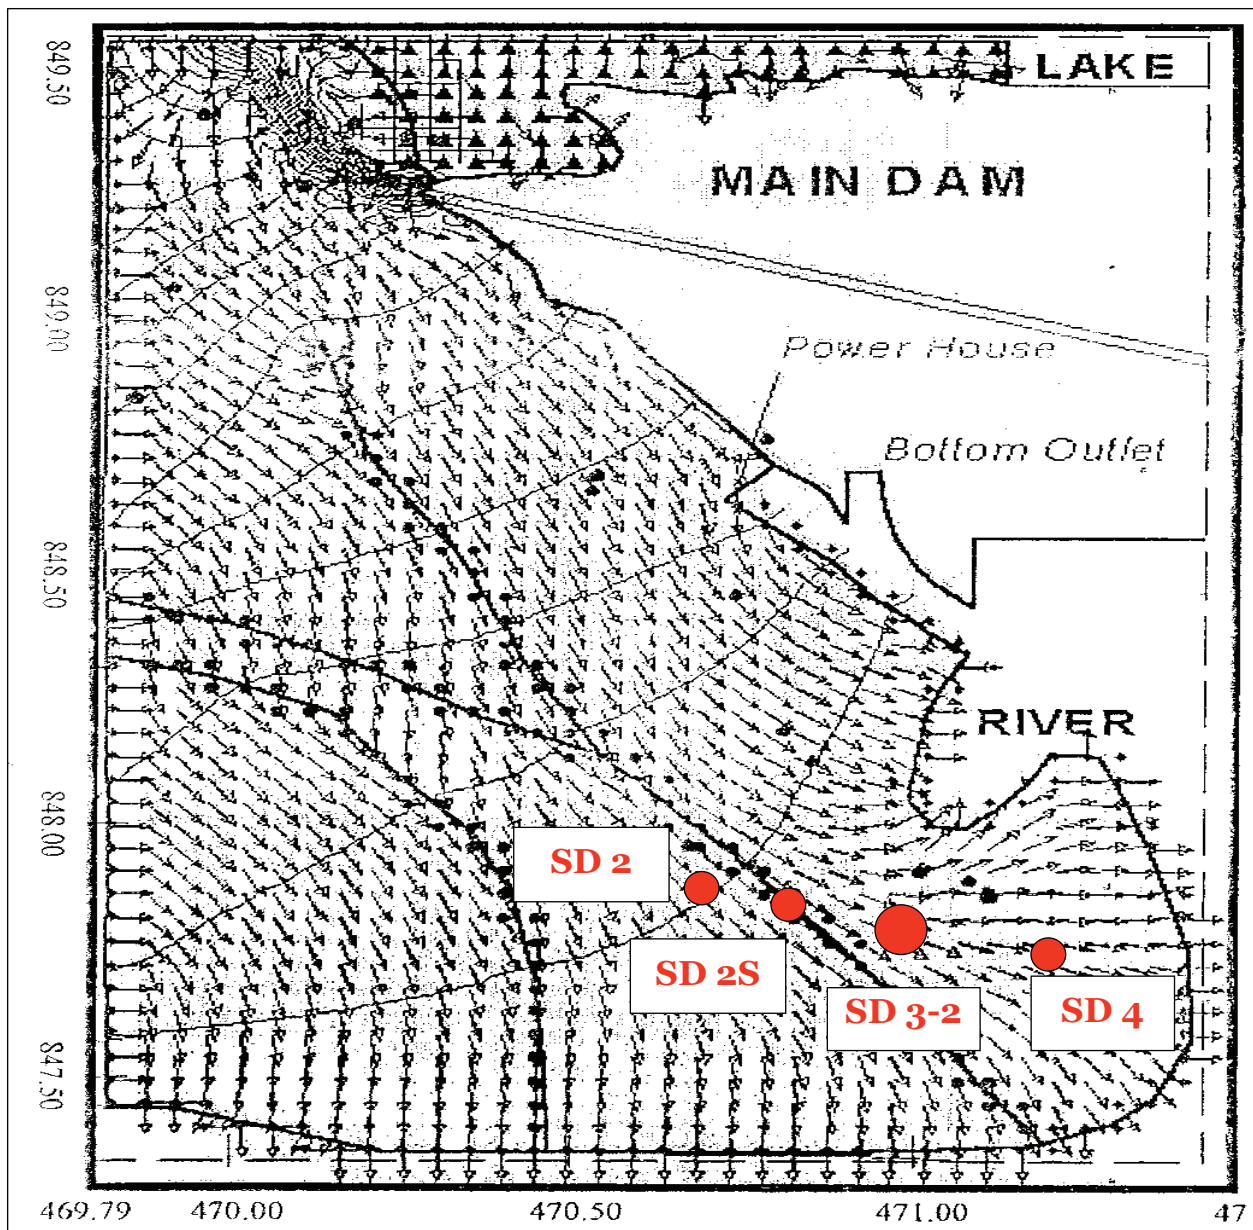
Four sinkholes (SD2, SD2S, SD3, and SD4) formed between 1992 and 1998 approximately 800 m downstream in the maintenance area of the dam (west abutment; LOD Final Report). The development of the sinkholes began with the appearance of concentric tension cracks followed

by settlement. The sinkholes appeared in a linear arrangement, approximately parallel to the dam axis. Sinkhole SD4 was excavated and observed for a year. The water level in this sinkhole did not fluctuate with changes in the reservoir level, but was sensitive to changes in the tailwater level. Fluctuating groundwater levels can lead to sinkhole development. Where an existing void or cavern has formed, the soil above has been alternately saturated and drained, resulting in reduction in pore pressure and eventual collapse.

Figure 9. Drainage net provided by Mosul Dam staff indicates flow toward sinkholes in downstream maintenance area (sinkholes in red; modified by M. L. Pearson and J. R. Kelley).

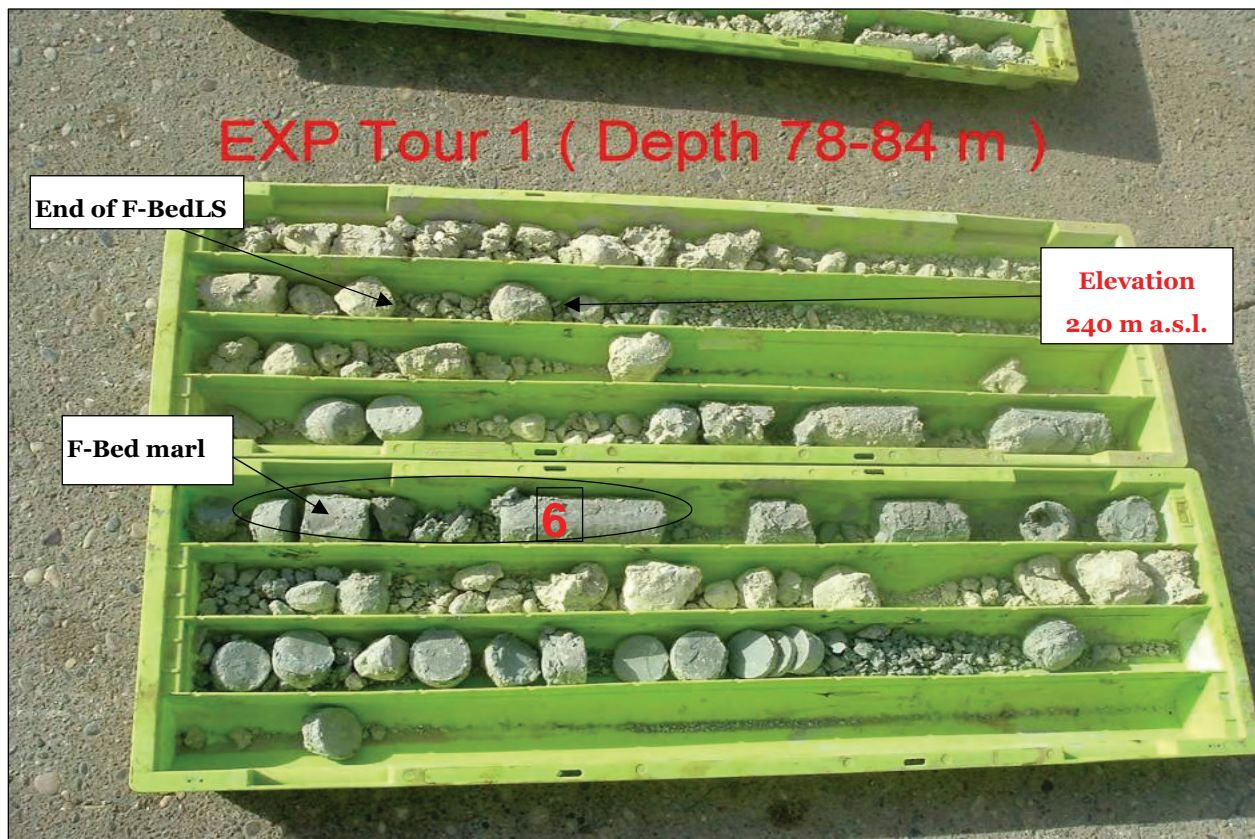
Figure 10. Core recovered from near sinkhole in residential area in 2006. Very small pieces of core and missing segments indicate RQD at or near zero, very poor rock quality.

that was considered competent to support the spillway and saddle dam during construction has deteriorated and may no longer be competent.

The appearance of a previously unknown sinkhole near the spillway crest in 2005 also shows this very active dissolution and degradation of rock quality in the east abutment. The potential for failure of the east (left) abutment has increased since construction.

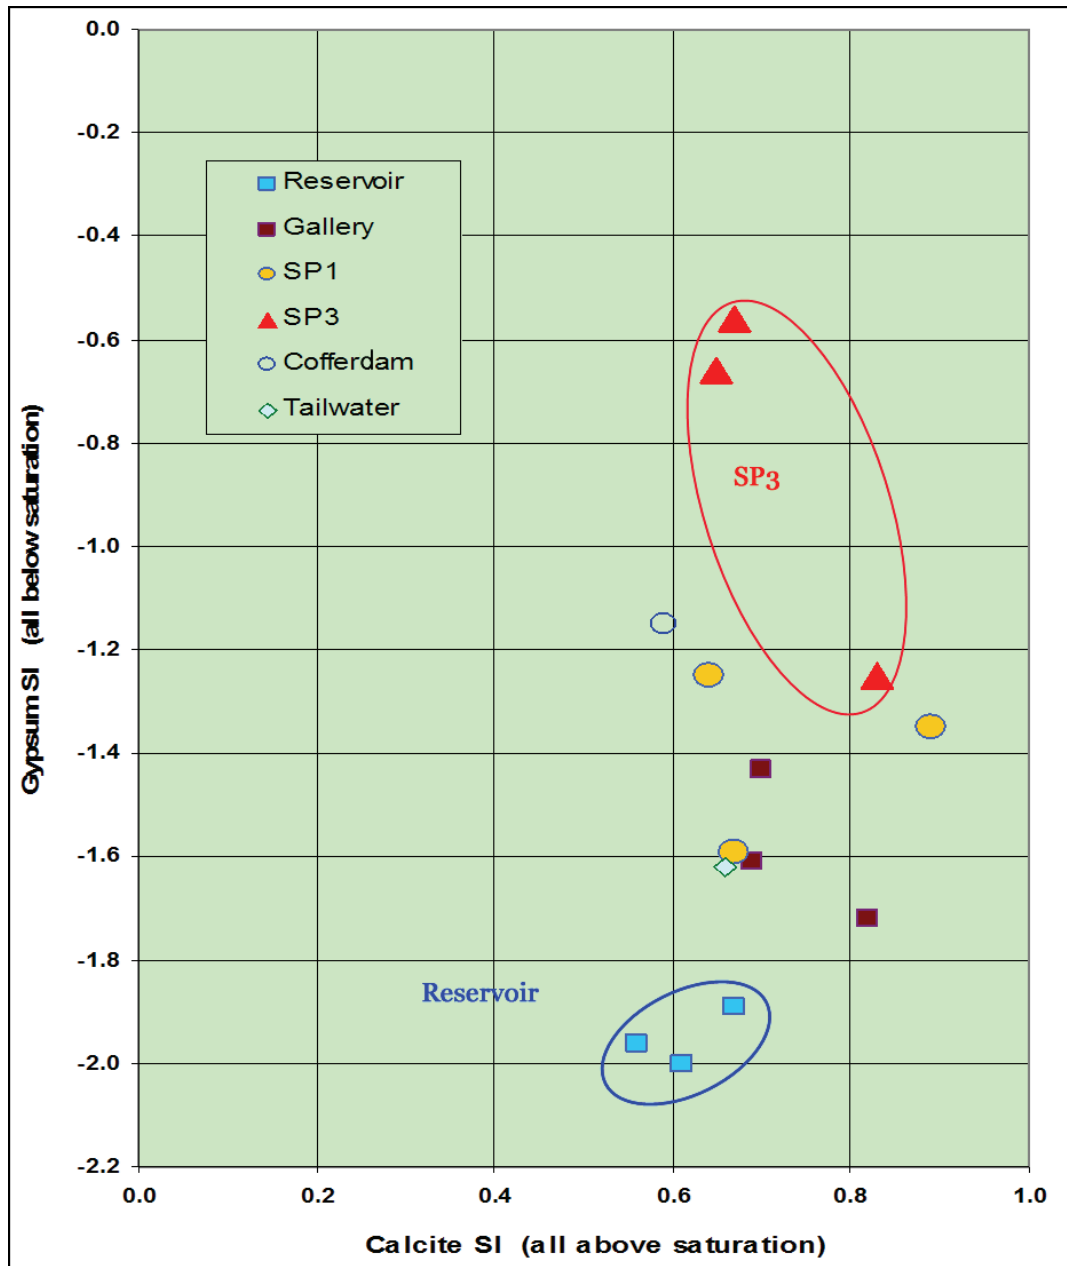
Data for groundwater chemistry available for the ERDC study show that the water is undersaturated with respect to gypsum, although some interesting trends are evident (Table 3 and Figure 12). The analyses that most closely approach equilibrium are in samples associated with the east abutment. That is, less-negative values for saturation of SP3 water with gypsum (red oval in Figure 12) correspond to the removal of gypsum from the abutment and the increase in dissolved gypsum in seep water relative to reservoir water.

Figure 12. Chemical compositions of reservoir water and seep waters as represented by their saturation indexes for calcite (abscissa) versus gypsum (ordinate). Less-negative values for saturation of SP3 water (red oval) with gypsum correspond to the removal of gypsum from the abutment and increase in dissolved gypsum in seep water relative to reservoir water.

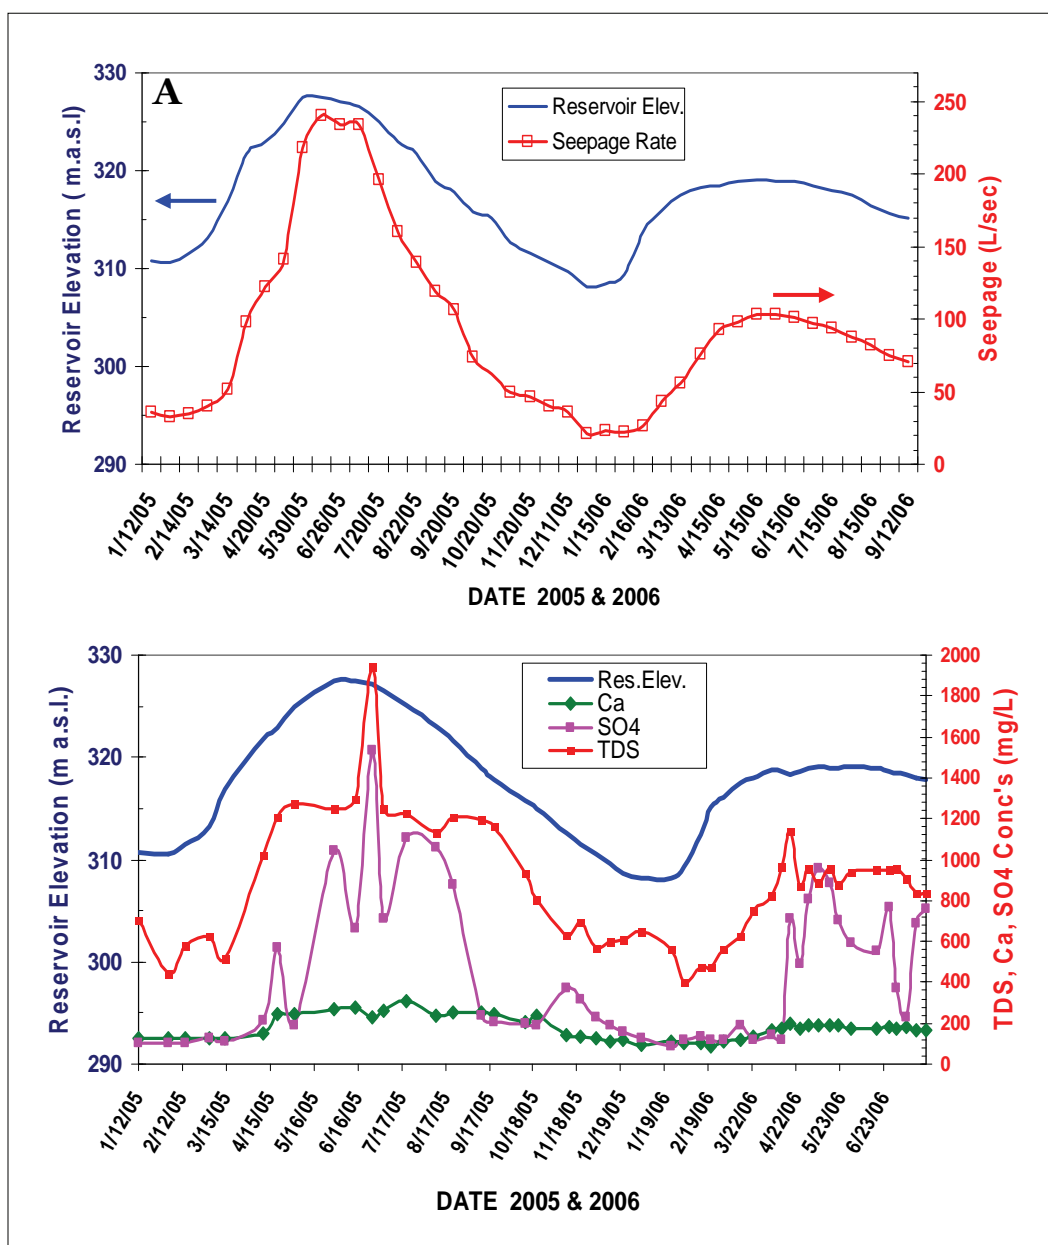
The increase in dissolved solids concentrations in both SP3 and SP1 may be attributed to the inundation of stratigraphically higher, gypsiferous strata. The higher concentrations of sulfate and TDS in the SP3 effluent reflect the greater continued presence of gypsum in the east abutment. The lower solute concentrations in the SP1 effluent may reflect the reduced presence of gypsum in the drained media, as well as a shorter residence time in the subsurface. A more detailed spatial analysis of the dissolution rates as a function of flow and other variables is necessary to distinguish among several possible causes for the observed trends in dissolution.

Figure 13. For Seepage Point Number 3 (SP3, east of spillway), trends in seepage rates (upper plot, red line, right scale) and solute concentrations (lower plot, right scale) are strongly correlated to very similar trends in reservoir elevation (blue lines, left scales). Data are for an 18-month period in 2005-2006.

Based on data for SP3 in 2005, the average bulk dissolution of gypsum is  $5.8 \text{ m}^3 \cdot \text{day}^{-1}$ . Dissolution associated with SP1 for the same period is only  $0.17 \text{ m}^3 \cdot \text{day}^{-1}$ . These rates are much lower in the first half of 2006 (limit of available data), presumably in response to holding the pool elevation at or below 318 m. The amounts indicated for recent dissolution are far smaller than estimates of the initial dissolution rates of a total of 13,000 tons of minerals dissolved during the period from February to August 1986

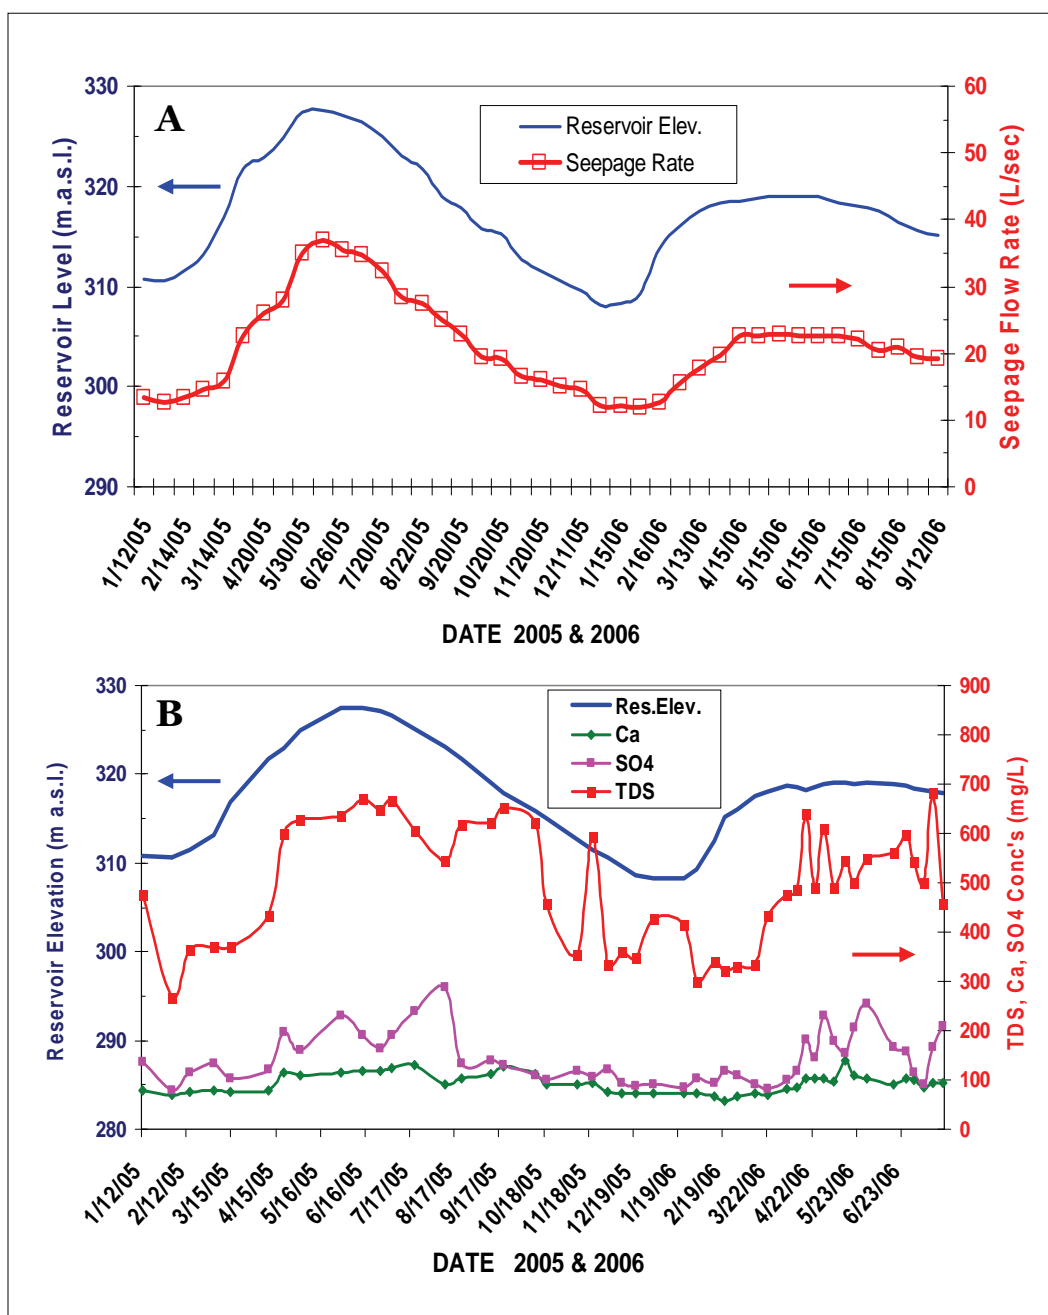
Figure 14. Data from Seepage Point Number 1 (SP1, west of spillway) showing trends in both seepage rates (upper plot, red line, right scale) and solute concentrations (lower plot, right scale) during an 18-month period in 2005-2006. Trends correlate strongly with trends in reservoir elevation (blue lines, left scales).
