Technical Findings, Lessons Learned, and Recommendations Resulting from the Helios Prototype Vehicle Mishap

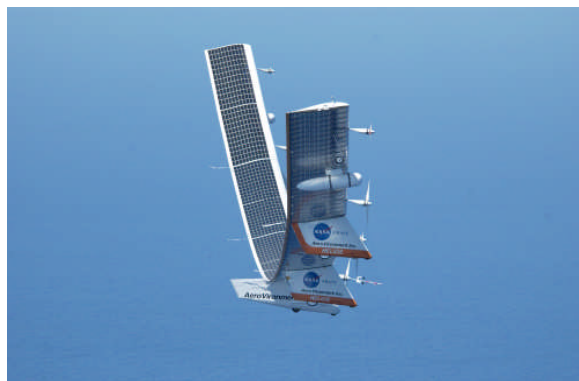
At 10:19am, the Stationary Pilot (SP), located in a trailer near the runway, noted that instrumentation and the aircraft were behaving as though it was in turbulence (noted later as the 1st encounter with turbulence). At 10:22am and again at 10:24am the aircraft again encounter some turbulence. The aircraft's wing dihedral became larger than normal and mild pitch oscillations occurred; the wing dihedral during both events returned to normal without any pilot inputs, and the oscillation damped out. These events both occurred during the time when the Stationary and Mobil crews were focused on the handoff procedure. Neither crew was aware of the high wing dihedral or the pitch oscillations. At 10:35am, at approximately 2,800 feet altitude, the aircraft began experiencing airspeed excursions of around ± 2 ft/sec. The persistent high wing dihedral (Figure 5) and the subsequent loss of pitch control, the aircraft became very unstable in a highly divergent pitch mode in which the airspeed excursions from the nominal flight speed about doubled every cycle of the oscillation. During the final nose down dive (approaching 90°) the aircraft exceeded the maximum allowable speed by over a factor of two. The resulting high dynamic pressures caused progressive failure of the wing leading edge secondary structure on the outer wing panels. Soon thereafter, the solar cells and skin on the upper surface of the wing began to rip off. These failures destroyed the aircraft's ability to generate lift and sustain flight; as a result, the aircraft fell into the ocean (Figure 6). The aircraft impacted the ocean within the confines of the PMRF test range and was destroyed.

Figure 5: HP03-2 with high wing dihedral

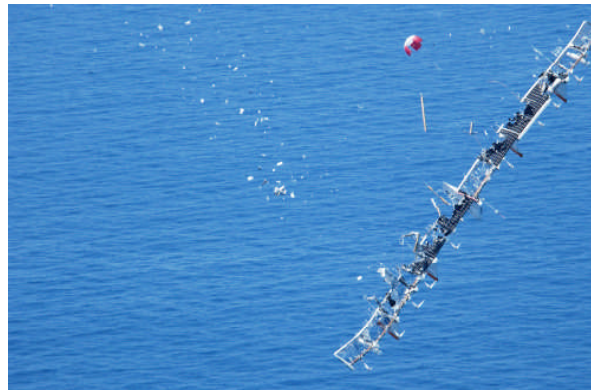
Figure 6: HP03-2 falling towards the Pacific Ocean

The aircraft impacted the ocean in mile-deep water 10 miles off the coast of Kauai. The vehicle structure including the main load carrying composite wing spars were severely damaged. The elapsed time from the first effort to diagnose and correct the high wing dihedral condition to the point at which the airplane began to break up in the air was 91 seconds. Figure 7 provides time histories of the aircraft's pitch rate and airspeed, and the wing dihedral for the 30-minute flight.

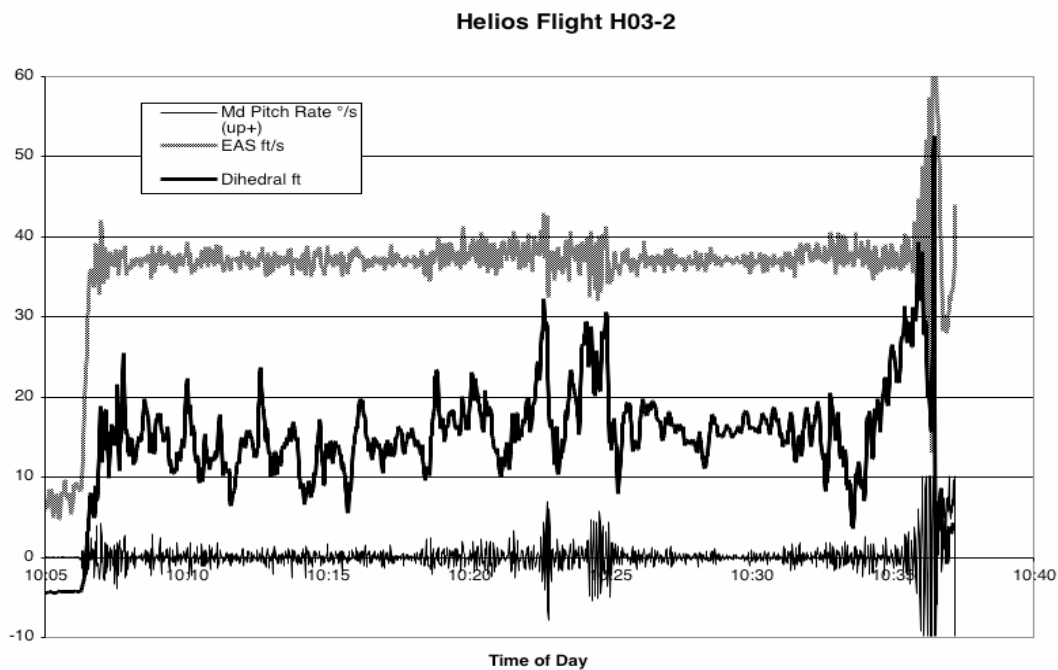
Figure 7: Wing dihedral, pitch rate, and airspeed history during mishap

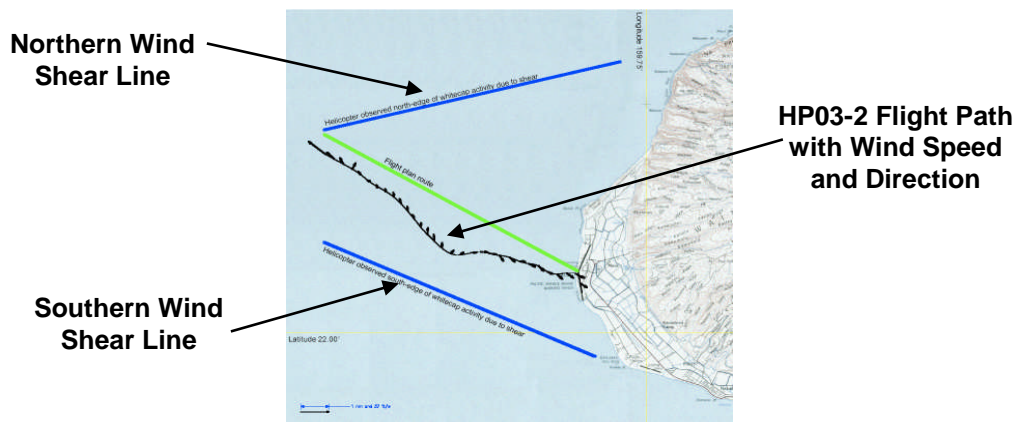
In earlier years the strategy on climb-out for the Helios vehicles was to avoid the shear lines until the airplane achieved sufficient altitude to get above the most significant turbulence. Aircraft measurements and flow simulations in the area of the mishap indicated that this altitude is about 4000 to 5000 feet. Because HP03-2 flew at a somewhat higher equivalent airspeed than previous solar-powered configurations without an increased rate of climb, the slope of the climb-out trajectory was lower than previous flights. This meant a longer flight trajectory over which the airplane was exposed to the greater turbulence at lower levels, and at the same time, trying to avoid the north and south shear lines (Figure 8). Regardless of these concerns, the weather conditions on July 26, 2003 were within the bounds required for performing flights from the PMRF.

Figure 8: Helicopter observed turbulence shear line

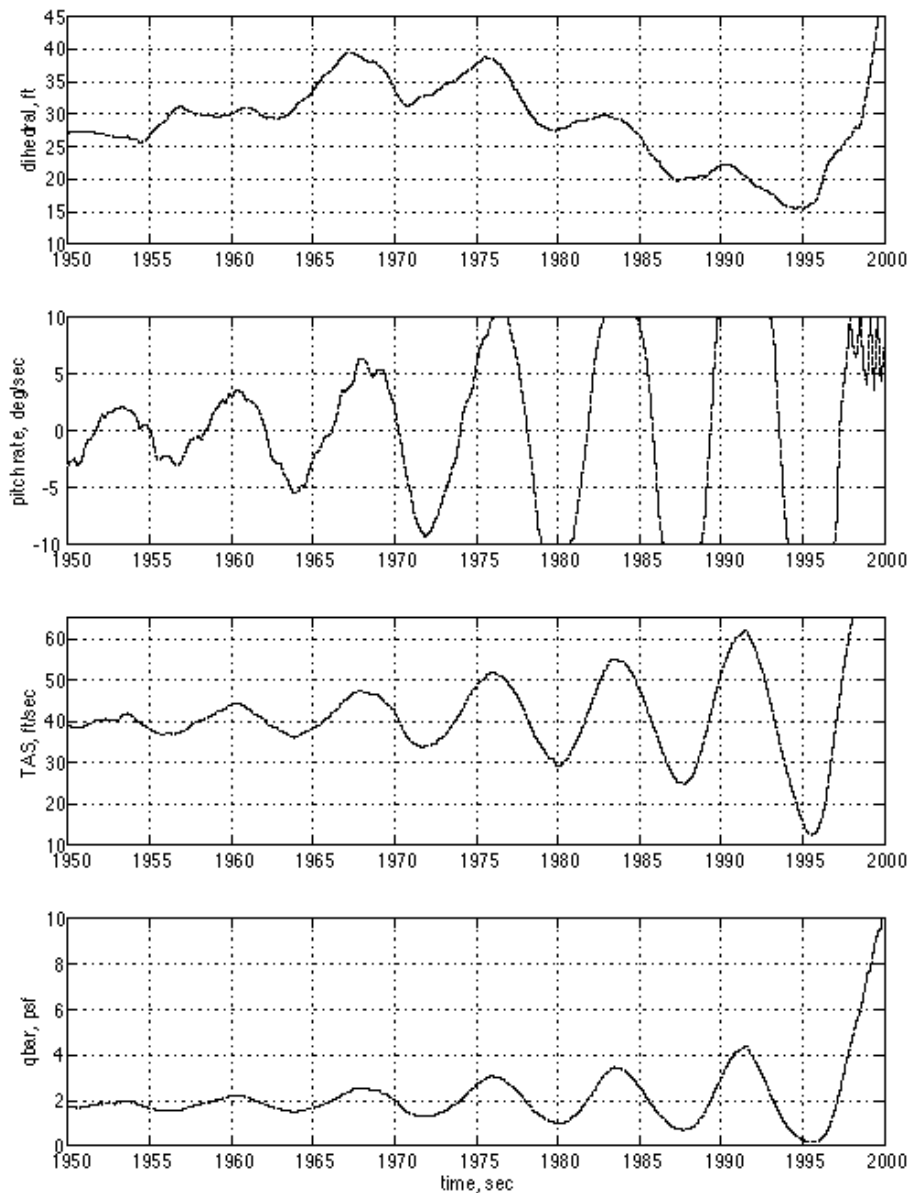
The 1st encounter with turbulence did not cause high wing dihedral. The next two encounters occurred in the space of three minutes. The aircraft developed high dihedral deflections of about 30 feet, began to oscillate in pitch, and then recovered on its own without pilot interaction. Since this type of pitch oscillation was a known flight dynamic characteristic of the Helios class of vehicles that had been predicted, observed, and controlled several times in prior flights with predecessor configurations, the MP and SP pilots and flight crews did not interpret the airspeed variations associated with the events as serious periodic oscillations, but rather as typical responses due to turbulence. On the 4th encounter with turbulence (Figure 9), the dihedral increased to an even higher magnitude of about 40 feet, and the pitch oscillation diverged rapidly.

Figure 9: Dihedral, pitch, vehicle airspeed, and dynamic pressure for mishap event

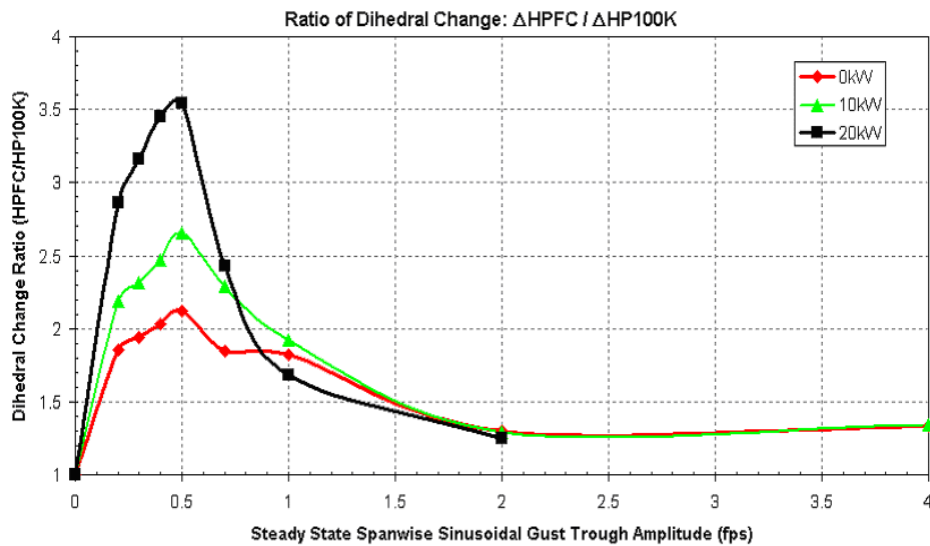
Turbulence Effects: In terms of the environmental effects, turbulence was determined to have initiated the high wing dihedral, however it was also determined the turbulence was not necessary to maintain it. Post mishap analysis revealed that spanwise lift redistribution (from the center of the aircraft to the outboard wing panels) was very sensitive to small amplitude gusts (Figure 10). It had been the experience of the Helios type aircraft that its dihedral varied as local airflow varied along the wingspan. Figure 11 provides a comparison of the wing spanwise lift distribution for the HP01 and HP03-2 aircraft configurations with a superimposed 0.5 ft/sec gust. For this study, it was assumed that the aircraft encountered a gust exhibiting a 0.5 ft/sec downward flow at the centerline and 0.5 ft/sec upward flow at the wing tips. Although the probability of the aircraft encountering such a gust is very low, the intent of the analysis was to show the sensitivity of the aircraft to gusts, even small gusts. The HP03-2 configuration has noticeably more lift outboard and less lift inboard. The increased lift outboard would be expected to lead to considerably increased dihedral. It is important to remember that the modeled sensitivity to local variations in sectional airflow is primarily a consequence of the aircraft's reactions to increasing dihedral, trailing edge up elevator, and wing tip leading edge twisting up, not the first-order effects of airflow change. The airflow variation is only the transitory force. It was determined that elevator response and the change in wing twist contributed to the wing's slow return to nominal dihedral conditions. In the absence of a gust that flattens the wing (for example, a momentary gust having relative downward air motion on the tips and upward near the airplane centerline), these aerodynamic effects slowed the return to nominal dihedral.

Figure 10: HP03-2 increased sensitivity to small gusts

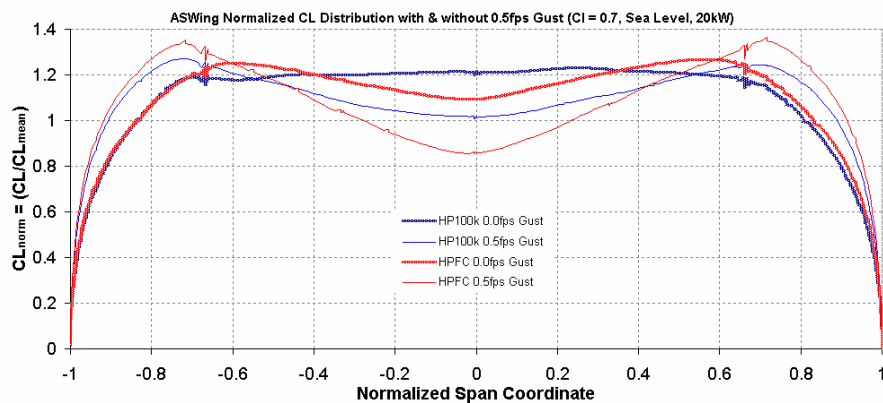
Figure 11: Variation of spanwise lift distribution with gust velocity

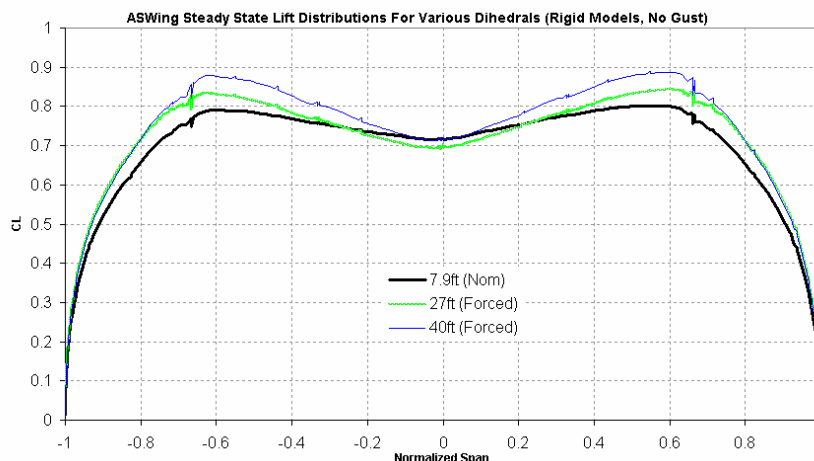
The quantification of the primary effects of dihedral on elevator position and twist is best illustrated by analyzing the spanwise lift distribution. For a given airspeed and motor power setting, the predicted spanwise distribution of lift is provided in Figure 12. The spanwise redistribution of lift from the center of the aircraft to more outboard panels is the primary cause of the unexpectedly slow return to lower dihedral after any perturbation.

Figure 12: Spanwise lift distribution for various wing dihedrals
