ERDC/CERL SR-08-14

Pythian Powerhouse and Laundry

Historic Building Survey

August 2008

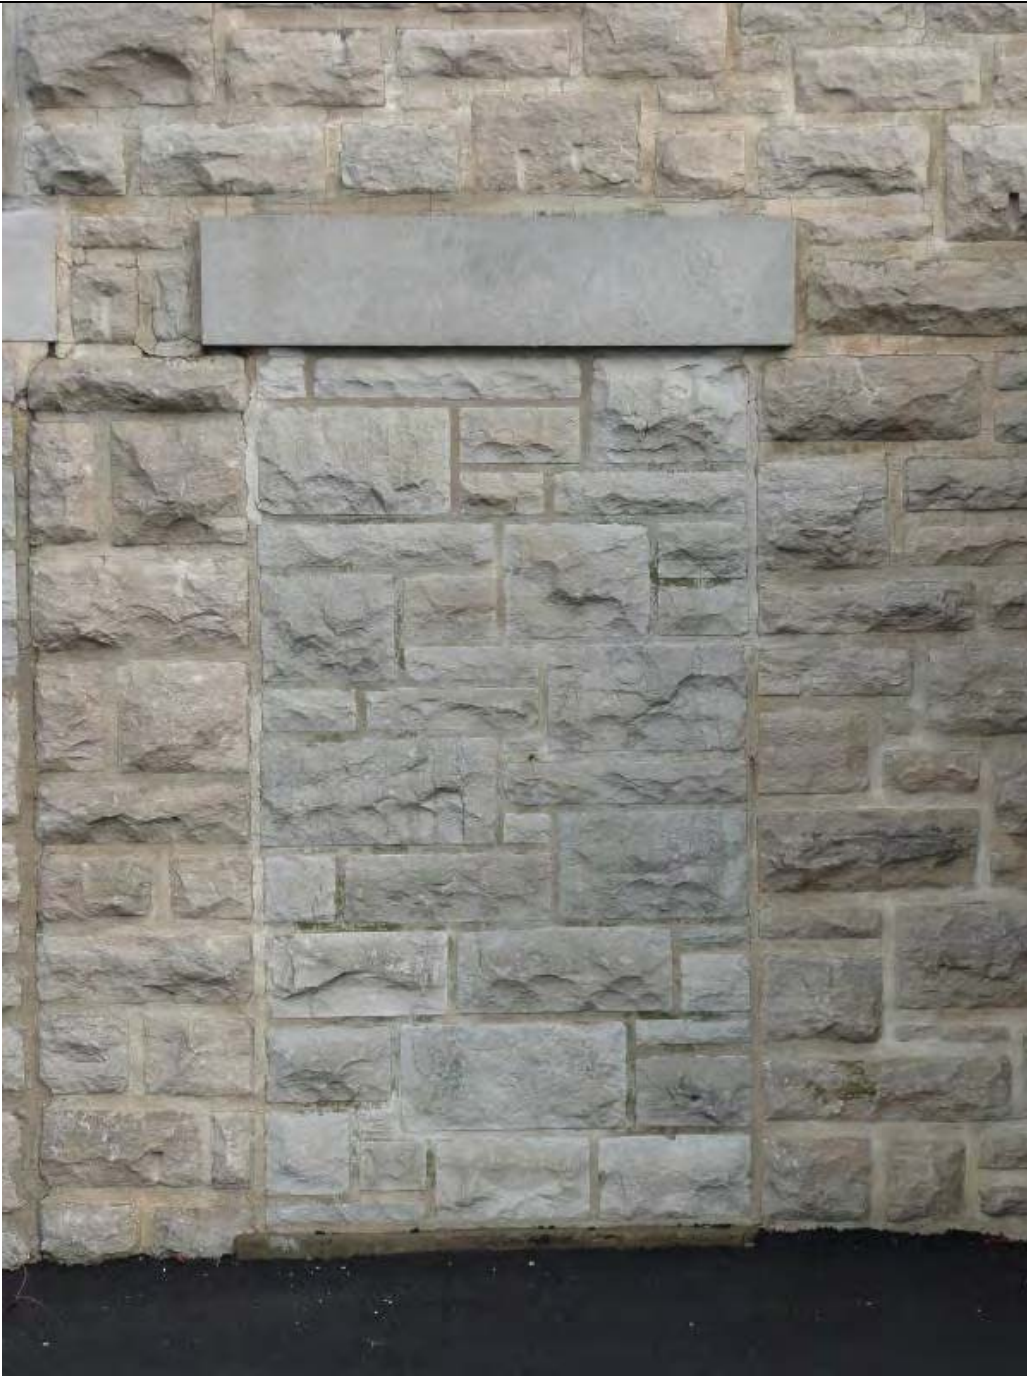
Photo 4 – view of modified filled window opening on south elevation

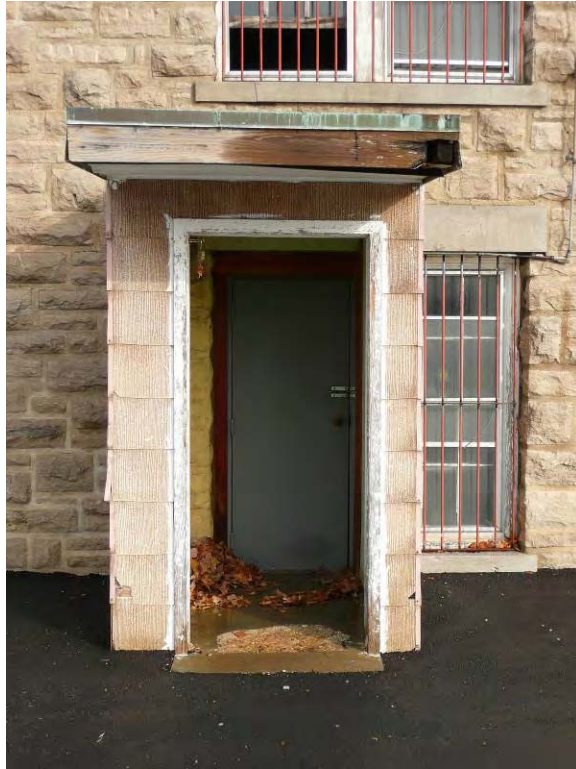
Photo 6 – close-up of window modification near vestibule addition on south elevation

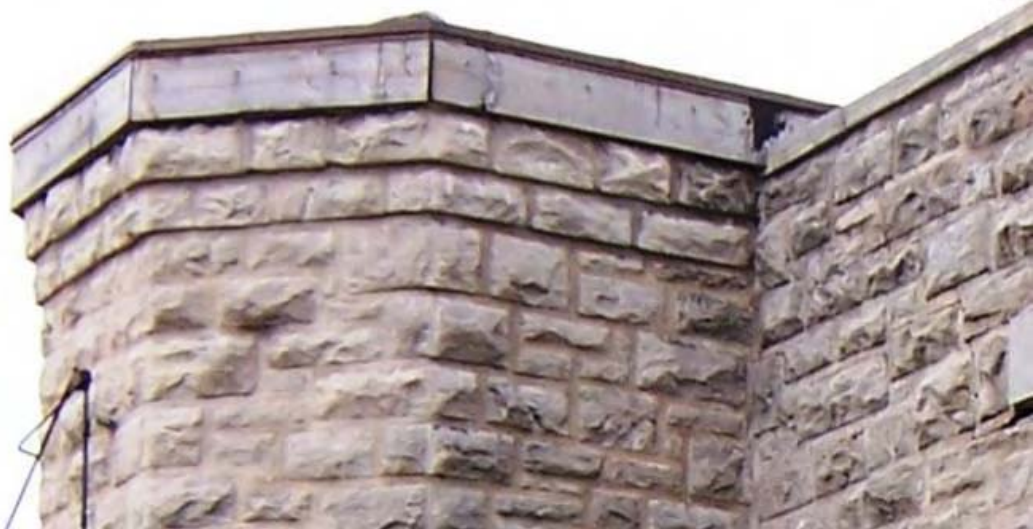
The east elevation (Photo 9) is where the original chimney stack was located. A majority of the stack is intact; however, the top portion of the stack that extended above the two-story roof height has been removed and has been capped off (Photo 10). The chimney is located in the center of the elevation and is five-sided. There are two sets of paired wood double-hung windows on the first floor; one on each side of the chimney. One single six-over-six wood double-hung window is to the right of the chim-

Photo 10 – close-up of chimney stack modification

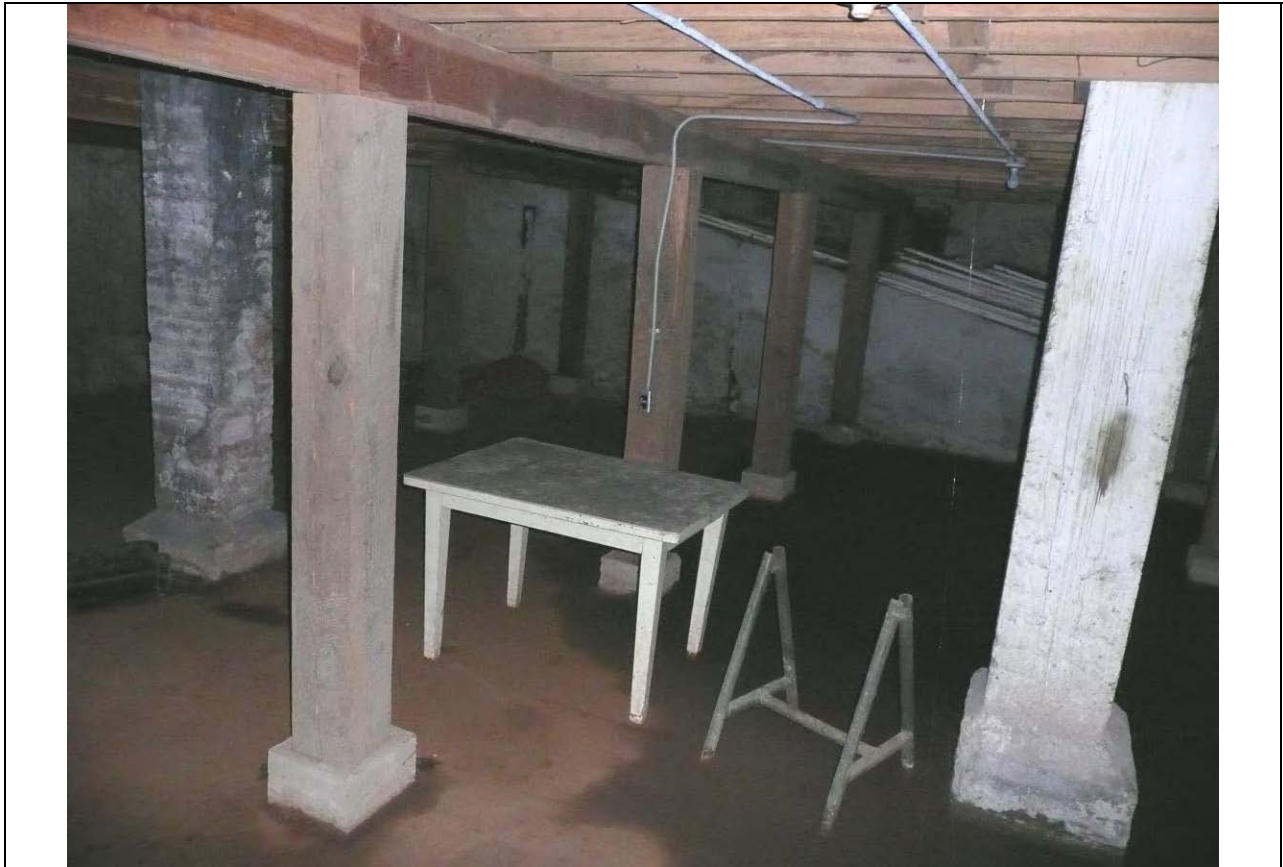
4. Structural System, Framing: The building has a simple structural system. The exterior walls are approximately 1'-10" thick cut limestone. Two concrete columns are located in the two-story space that extends from the lower level (basement) up through the second floor. These 1'-0" by 1'-0" columns are set within a concrete pier. Each column base measures 1'-6" by 1'-6". The columns are located 24'-0" from the east wall and 12'-2" and 24'-10" from the south wall (Photo 14). Newer 0'-8" by 0'-8" wood columns are spread throughout the basement to support the wood floor addition above. These columns are set within concrete foundations (Photo 15).

Photo 15 – view of added wood columns used to support first floor

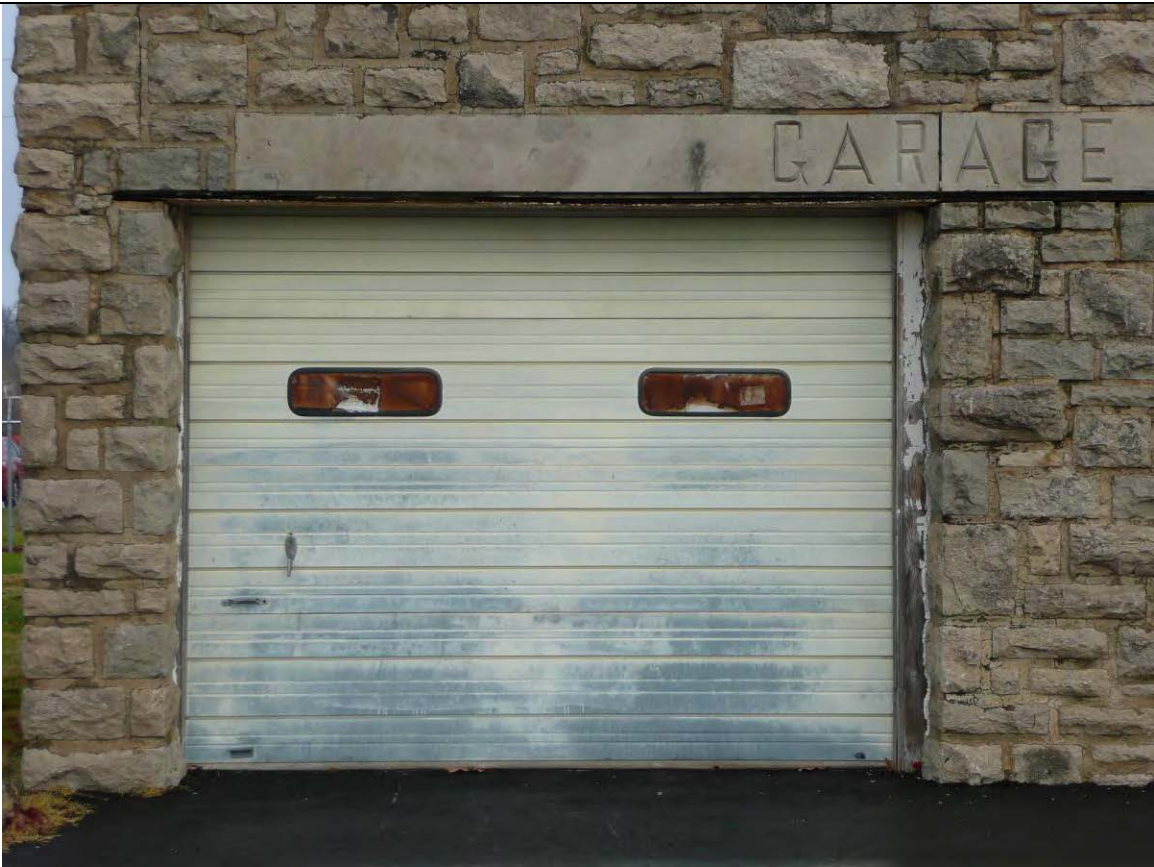
Photo 17 – replacement metal garage door on south elevation

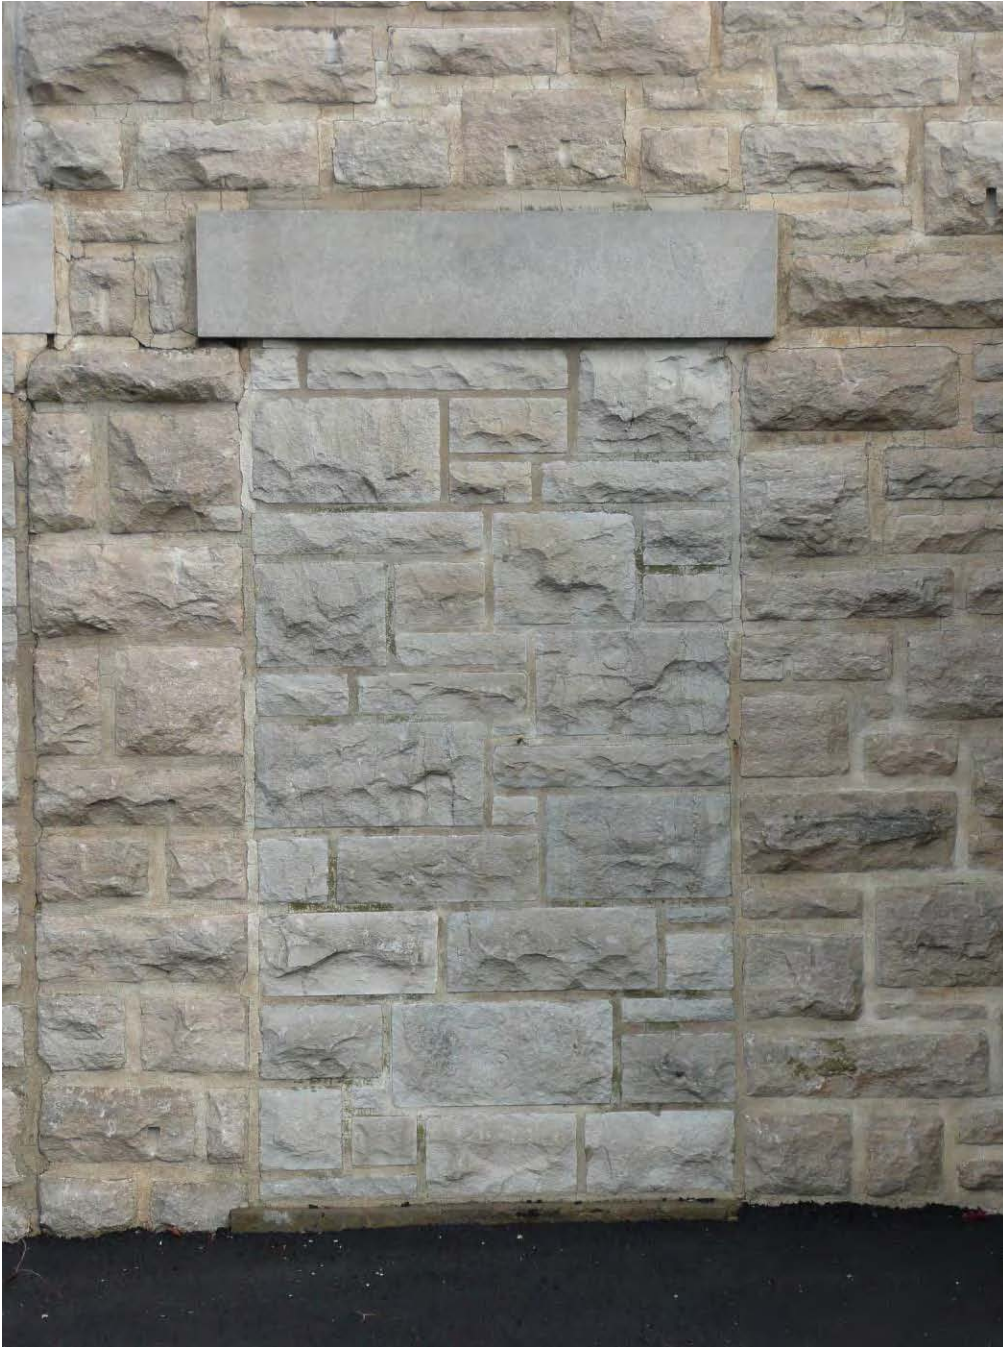
Photo 25 – Type 7 window or door

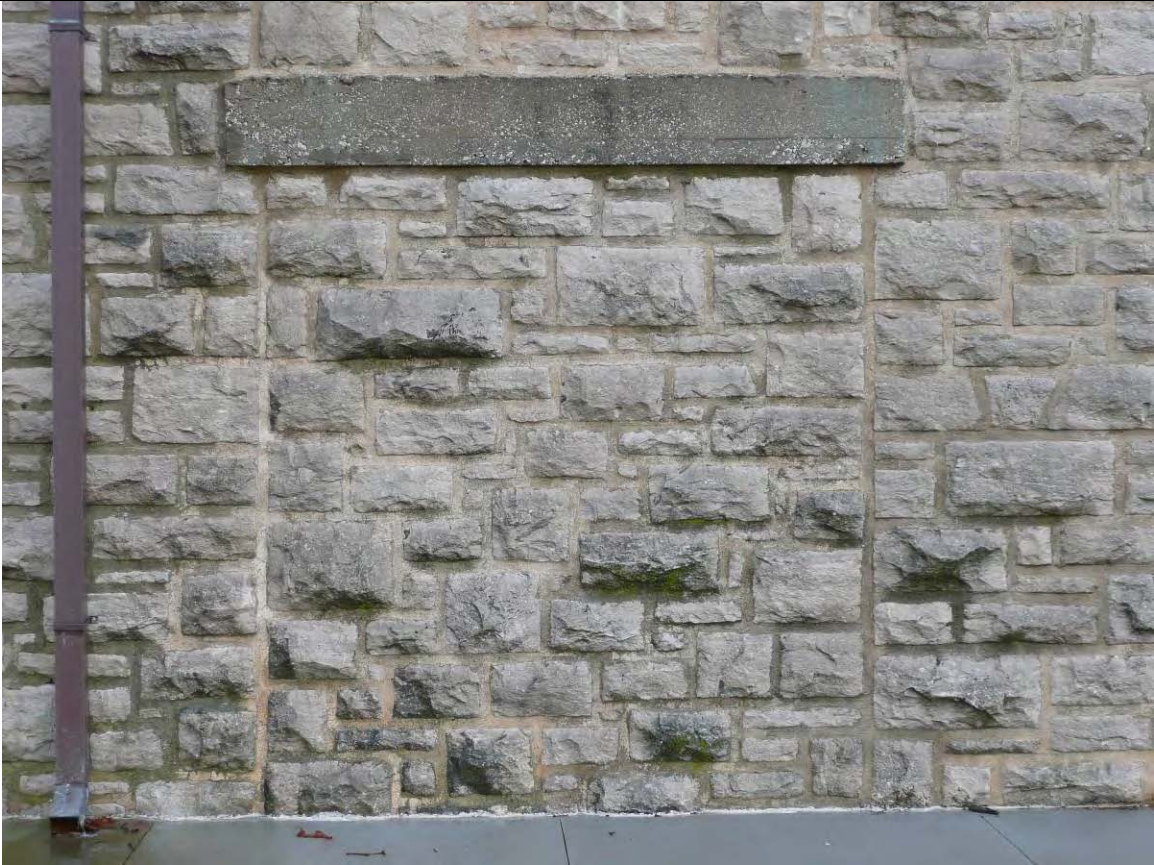
Photo 26 – Type 8 window

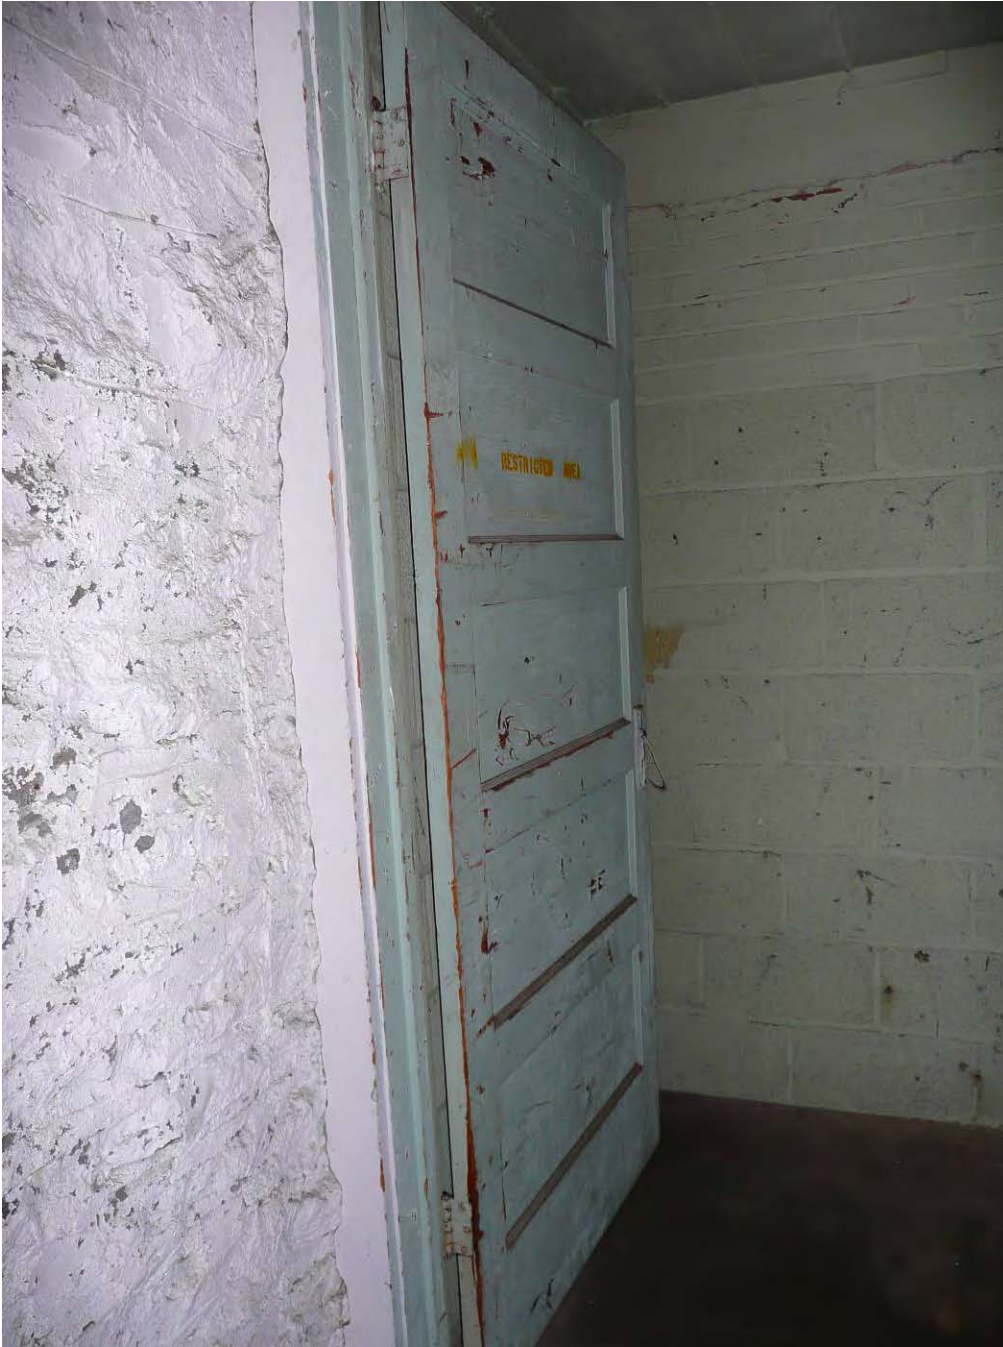
Photo 40 – view of five-panel wood interior door and door opening filled with concrete masonry units
