# HADITHA DAM PERIMETER SECURITY HADITHA, IRAQ

## SUSTAINMENT ASSESSMENT

**SIGIR PA-09-192**  
**APRIL 13, 2010**

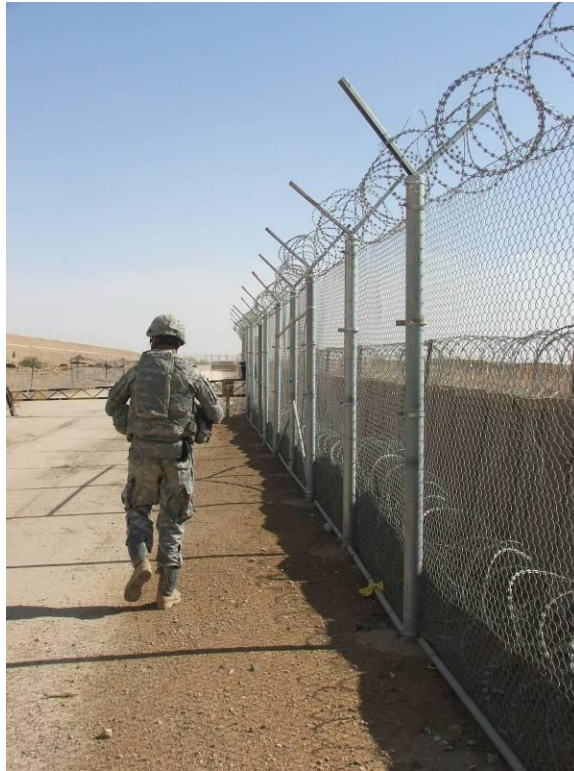
**Site Photo 2. Typical fence section**

Some sections of the perimeter fence did not conform to the Uniform Facilities Guidelines Section 3231 or the USACE standard drawings for the security fence. Strands of barbed wire were not placed on the “V” shaped brackets along the top of the fence to contain the concertina wire coil. The contractor used concertina wire coil that is a single coil approximately 18 inches in diameter, instead of the contract-required interlaced double coils of 24 and 30 inch diameter.

The fence brace rails were different dimensions than shown on the contractor’s drawings. The brace rails were attached to the pull post approximately 36 inches above the post base, instead of 58 inches as shown on the contractor’s drawings. The difference will affect the ability of the brace panel to resist tension from the chain link fabric.

Also, SIGIR noted that many of the brace rails were misaligned. This may not be critical to the function of the brace panels, but is indicative of poor workmanship.

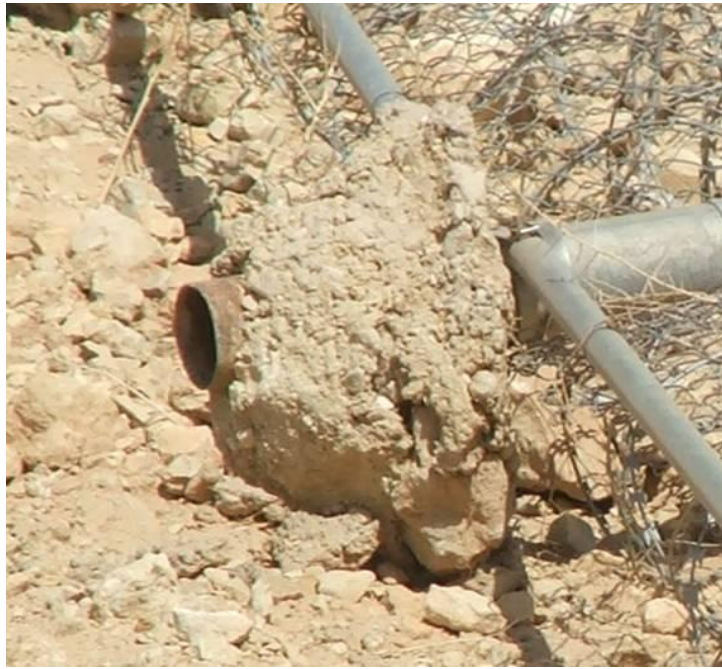
**Site Photo 6. Concrete anchorage at failed fence post**

The concrete anchorage for the fence posts was approximately 8 to 12 inches deep (Site Photo 6), which was inconsistent with the contractor's design drawings that showed a 45 inch depth for a typical line post. The configuration of the concrete anchorage was not consistent with the contractor's design plans and tapered from approximately 16 inches in diameter at the top to 8 inches in diameter at the base of the post, instead of the required uniform diameter of 16 inches. In addition, the anchorage did not cover the end of the post as shown in the design drawings, which will allow for increased corrosion of the post.

After the inspection, it was determined that the fallen fence line poles were in the ground less than 0.5 meters. The Al Asad Resident Office stated that the contractor will replace and set the poles in concrete to the proper depth. In addition, approximately 10% of the remaining fence poles will be reset.

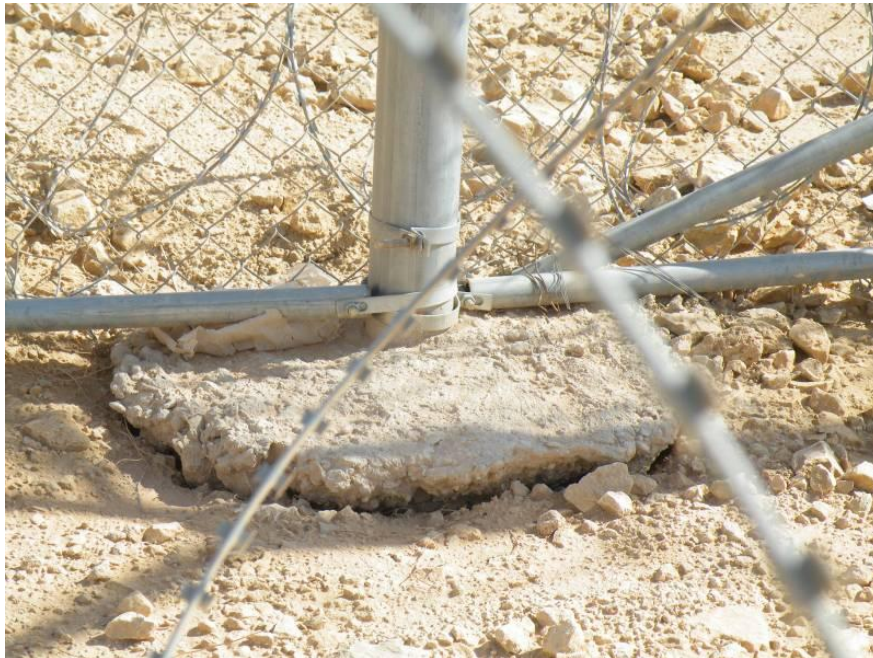
**Site Photo 7. Concrete anchorage**

SIGIR examined the post foundations for several posts that were still in the ground. A gap existed between the concrete anchorage and the surrounding soil, indicating movement of some posts (Site Photo 7).

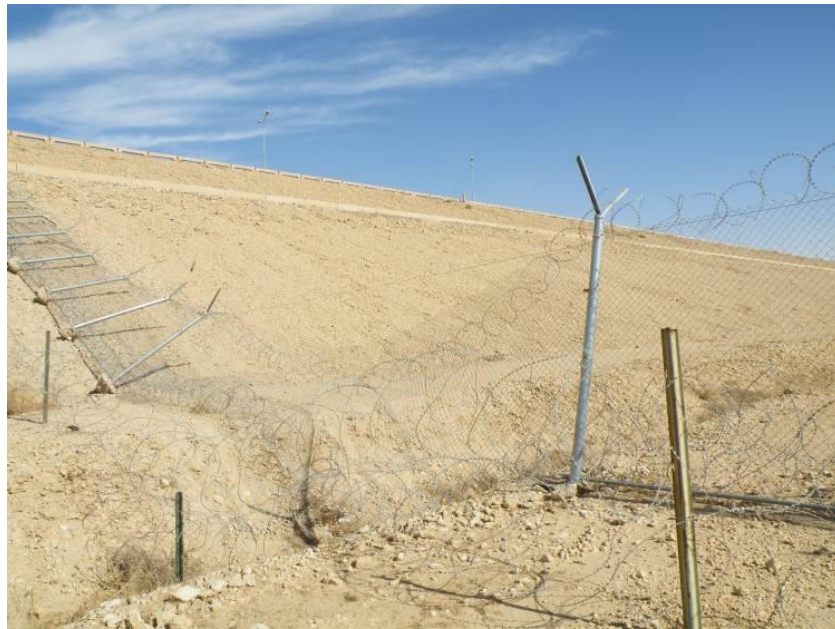
**Site Photo 8. Poorly constructed swale crossing**

While inspecting the collapsed section of the fence, SIGIR noted a poorly constructed swale<sup>7</sup> crossing (Site Photo 8). To bridge an existing swale perpendicular to the fence line, the contractor extended the spacing between posts and extended the chain link fence

across the swale. This left a gap several feet high and several feet wide beneath the chain link fence. The concertina wire placed at the base of the fence did conform to the contour of the channel and provides a less effective barrier to prevent entry to the facility.

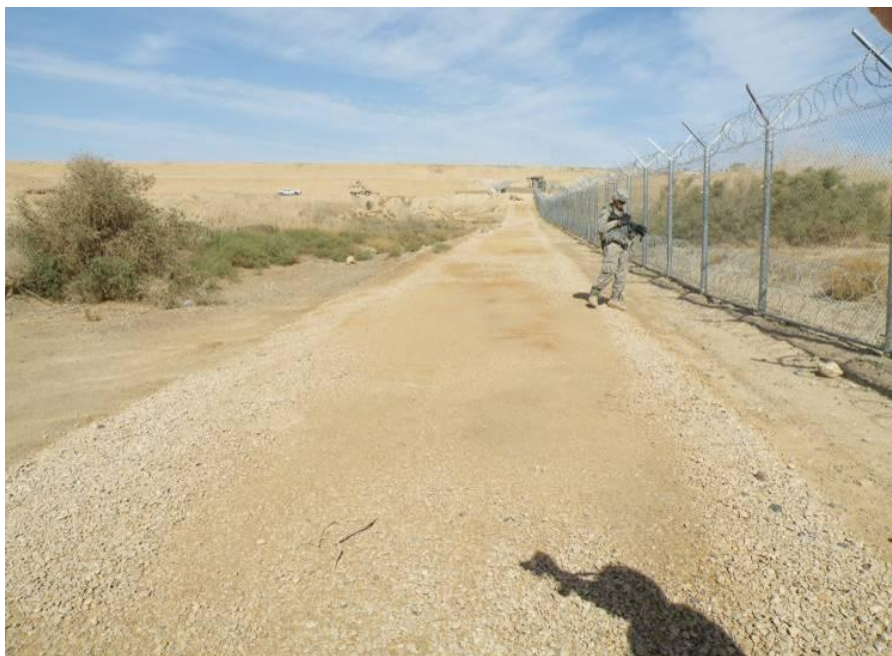
**Site Photo 9. Perimeter drive**

SIGIR inspected approximately 300 meters of the perimeter access road which was approximately 4 meters wide and surfaced with a coarse aggregate. The alignment of the road generally followed the perimeter fence and was straight with good visibility (Site Photo 9).

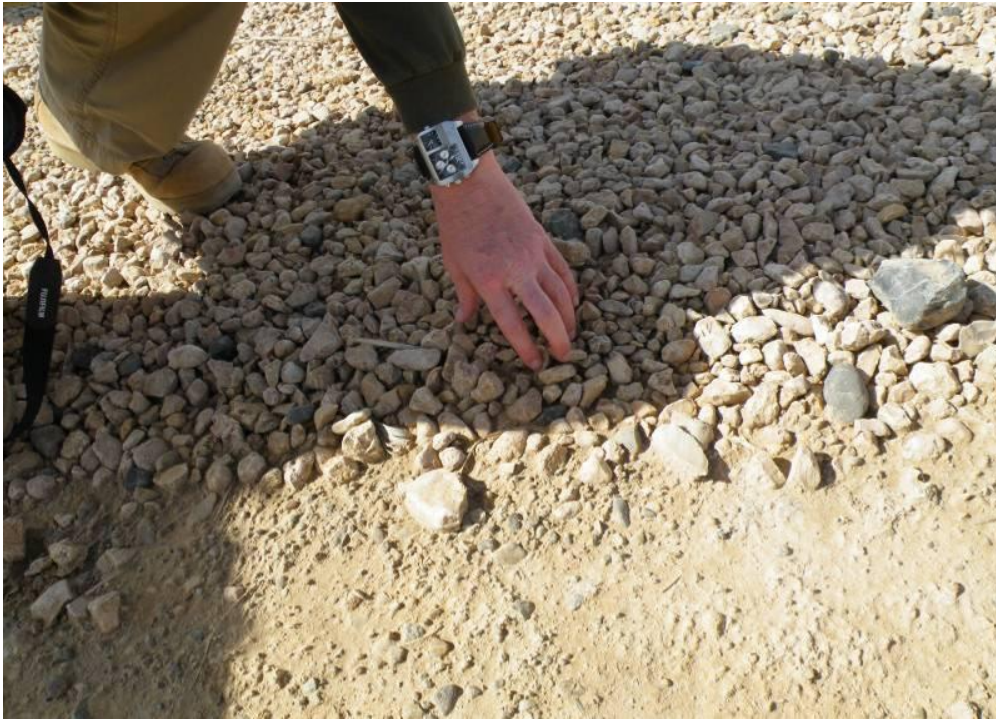
**Site Photo 10. Roadway surface**

The contractor's design drawings show a 6-inch layer of compacted, coarse aggregate for surfacing. SIGIR verified the presence of a 4-6 inch layer of coarse aggregate on the roadway surface (Site Photo 10).

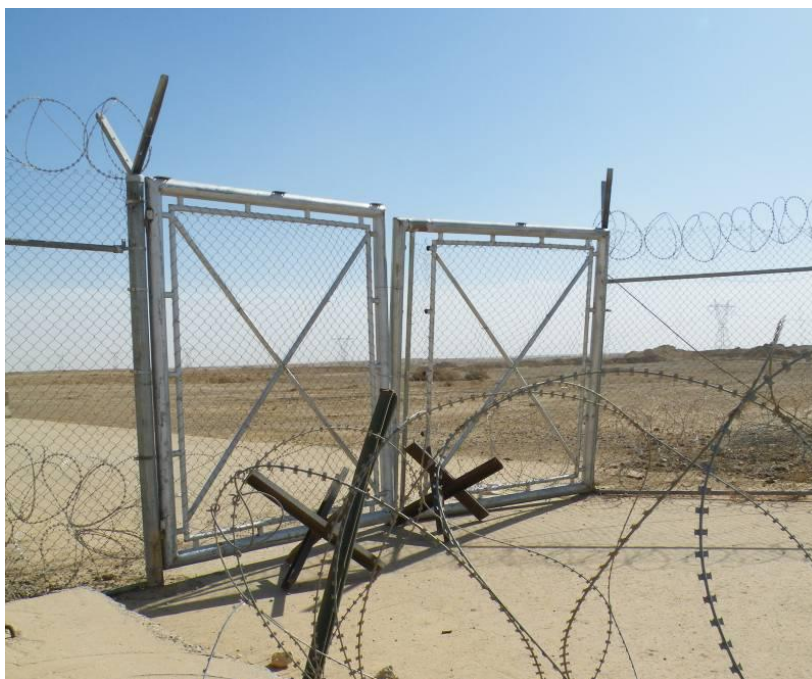
**Site Photo 11. Entry gate**

SIGIR noted that the quality of construction of the entry gate was poor. The swing panels of the gate were misaligned and the swing posts were not plumb (Site Photo 11).

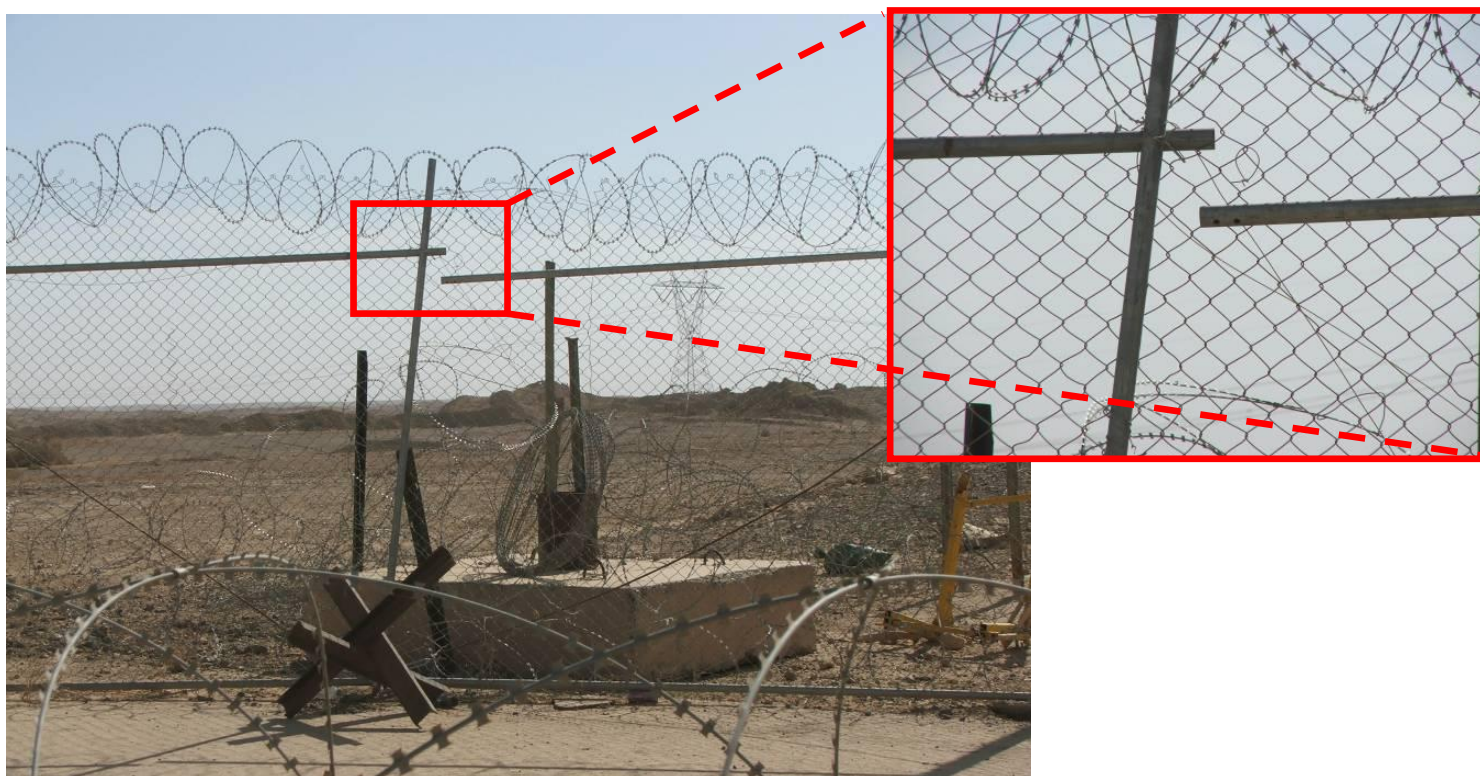
**Site Photo 12. Broken fence near entry gate**

The section of fence adjacent to the gate was broken and was inadequately repaired (Site Photo 12). According to Iraqi Army representatives, the fence fell apart. Iraqi Army representatives attempted to repair the fence with materials on hand.
