**ASC-TR-2010-5002**

# **THREATS TO AIRCRAFT STRUCTURAL SAFETY, INCLUDING A COMPENDIUM OF SELECTED STRUCTURAL ACCIDENTS / INCIDENTS**

**Engineering Directorate (ASC/EN)  
Aeronautical Systems Center**

**MARCH 2010  
Final Report**

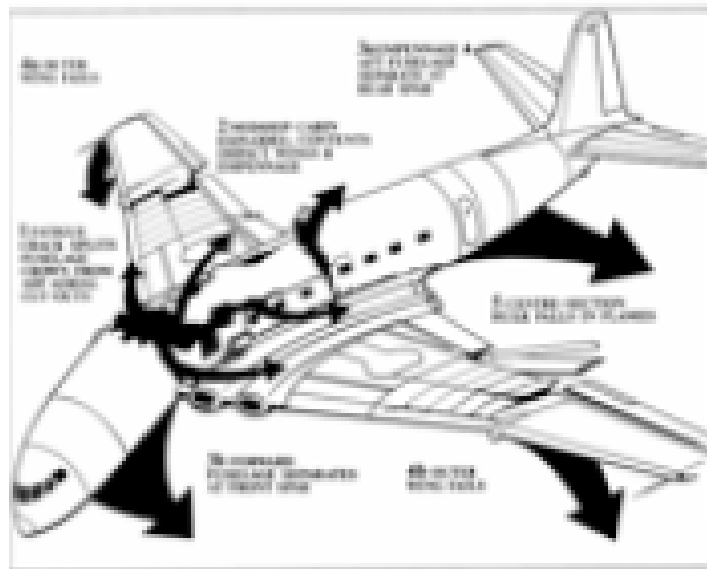
According to Swift [A3], the origin was believed to be at the end fastener hole at a frame cut-out adjacent to the ADF window. Swift has provided a detailed analysis, which describes the loss in residual strength with crack progression and the reason for the lack of crack arrest and fail-safe capability [A3-A5].

**Figure A3: Uncontained Running Cracks Led to Aircraft Breakup. Poor Detail Design of Cutouts Led to Running Cracks in the Highly Stressed Low Toughness Skin**

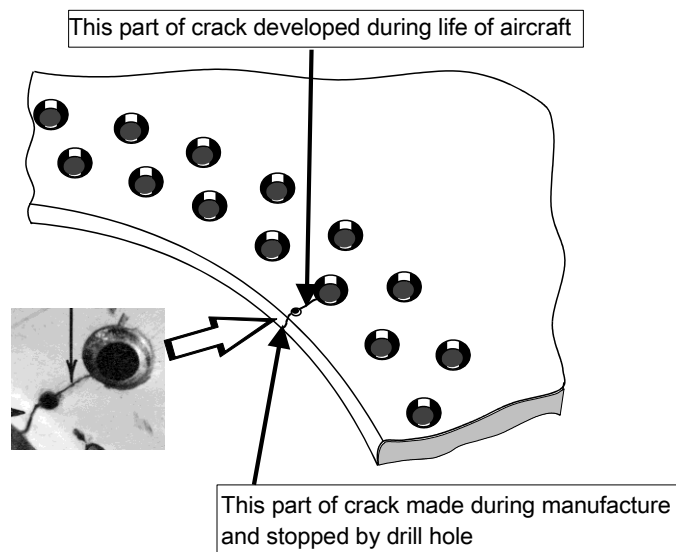
-VI-3. Crack and Drill Hole in Reinforcing Plate at Starboard Rear Corner of Front ADF Aerial Window Comet G-ALYP

During the reconstruction of G-ALYP, a pre-existing manufacturing crack or tear was found at the edge of the ADF window cut-out (See Figure A4). This crack had been stop-drilled, which was the accepted repair practice at that time. Several other locations in this aircraft had similar kinds of manufactured cracks or tears that had also been stop-drilled in the factory [A4].

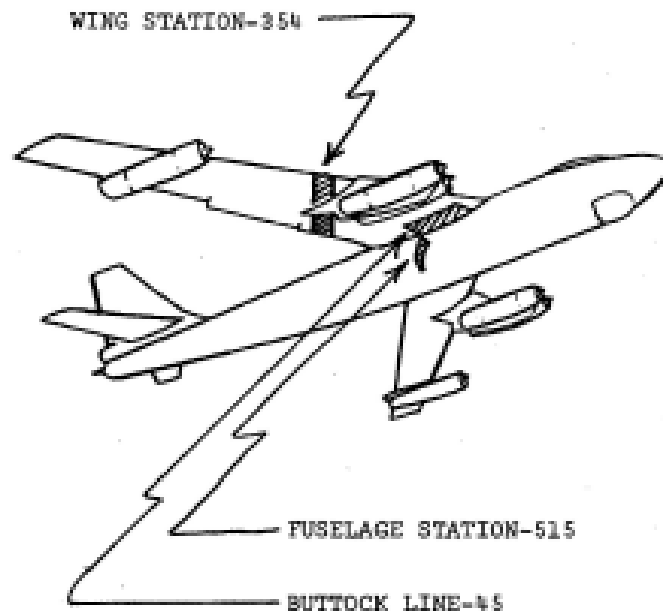
A structural crisis was reached within the USAF Strategic Air Command on 13 March 1958, when two aircraft broke up in midair in separate incidents. Near Homestead Air Force Base, Florida, a B-47B disintegrated at 15,000 feet, three minutes after takeoff. Its center wing section failed due to fatigue cracking at buttock line 45. The aircraft had a total of 2,077 hours at the time of the accident. See Figure A11 for the critical locations on the B-47.

**Figure A11: Sketch Illustrating Critical Locations of the B-47 Aircraft**

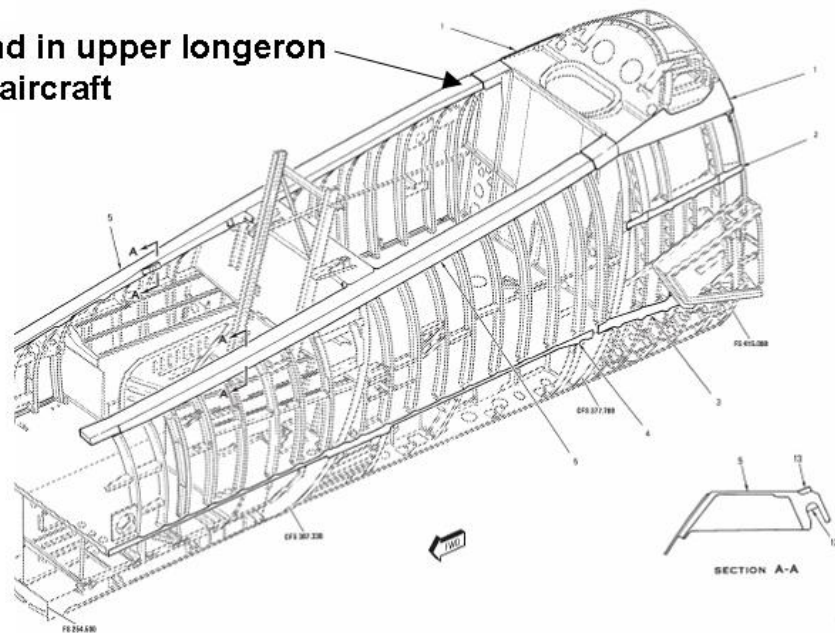
Figure 356. Main Structure Longerons (Sheet 1 of 4)

**Crack found in upper longeron  
of mishap aircraft**

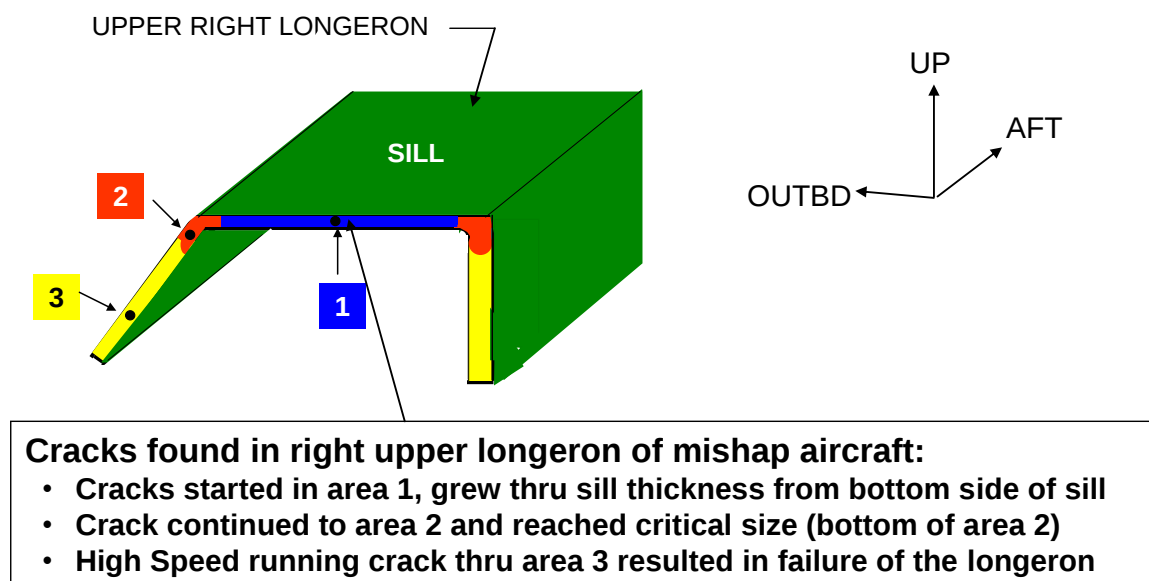
Based on the AIB report [A24], it appears that the fatigue cracking and failure are due to high stresses that were the result of poor workmanship and quality control (i.e., inadequate receiving inspection of fracture critical parts that were improperly manufactured and inspected by a subcontractor). This failure demonstrates the vulnerability of single load path (i.e., non fail-safe) structures to manufacturing discrepancies and emphasizes the importance of developing and enforcing rigid fracture control procedures (including factory inspections to ensure conformation to blueprint and in-service damage tolerance based inspections) on those parts where fail-safe designs are not practical.

**Figure A24: Cracking Events Occurring in the F-15C Forward Fuselage Upper Longeron at FS377**

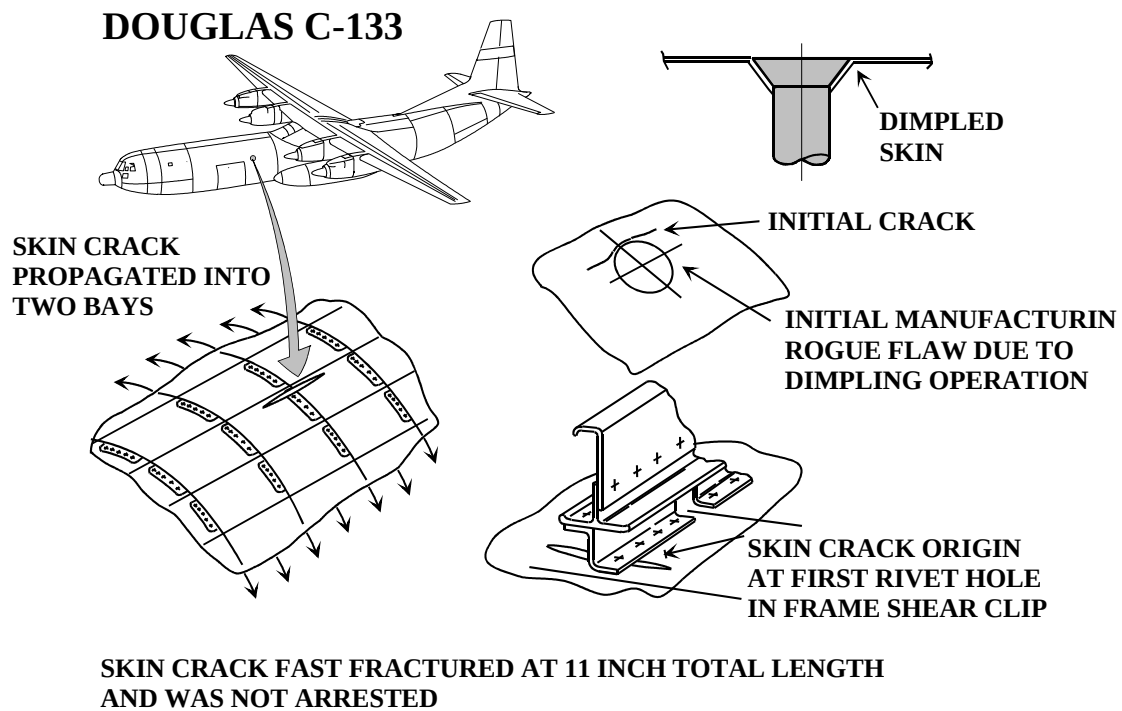
The fasteners were countersunk into dimpled skin. The crack that propagated to failure grew from a manufacturing flaw caused by the dimpling operation. A C-133 was successfully full-scale fatigue tested to 38,000 simulated flight hours. The high time airplane at the time of the accident had accumulated 16,000 flight hours. A Douglas Aircraft team designed a crack arresting system, so as to achieve fail-safety in the remaining C-133 fleet. A sketch of the initial manufacturing flaw and subsequent fatigue crack is shown in Figure B8.

**Figure B8: Details of the Cracking that Led to Failure of C-133 Transport Aircraft**

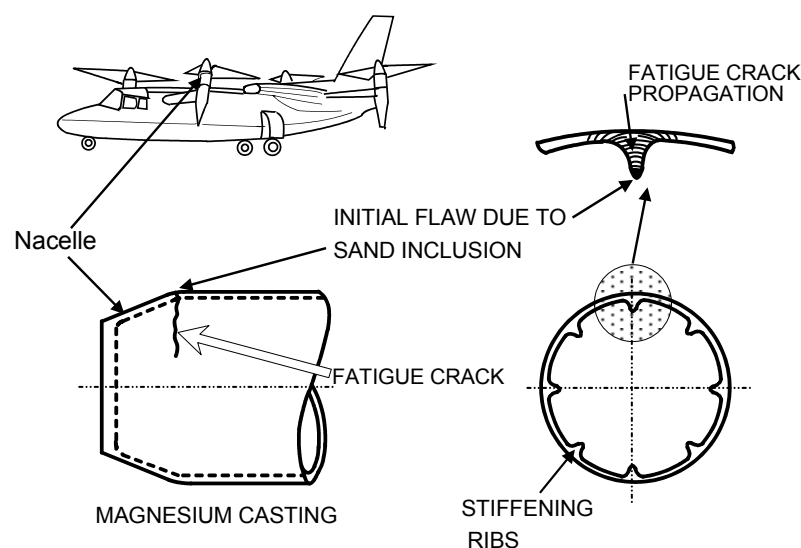
The Curtis Wright X-19 VTOL Experimental Aircraft, a tri-service research project, crashed during a flight test at the FAA Test Center in Atlantic City New Jersey in mid 1965. The aircraft crashed after a propeller nacelle magnesium casting failure. The cause of the crash was a manufacturing defect in the magnesium sand casting used in the propeller nacelle. This material flaw was a sand inclusion at the tip of one of the stiffening ribs in the most highly loaded location of the nacelle structure. Some of the details of this flaw are illustrated in Figure B10 [B5, B7].

**Figure B10: Sketch of Flaw Details Associated with X-19 Aircraft Accident**

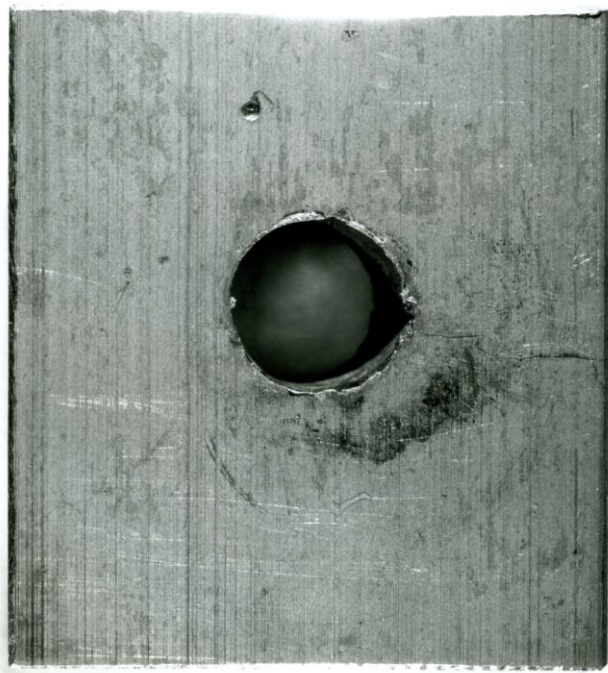
**Figure C3: Photo of Damaged Hole and Cracked Spar Cap**

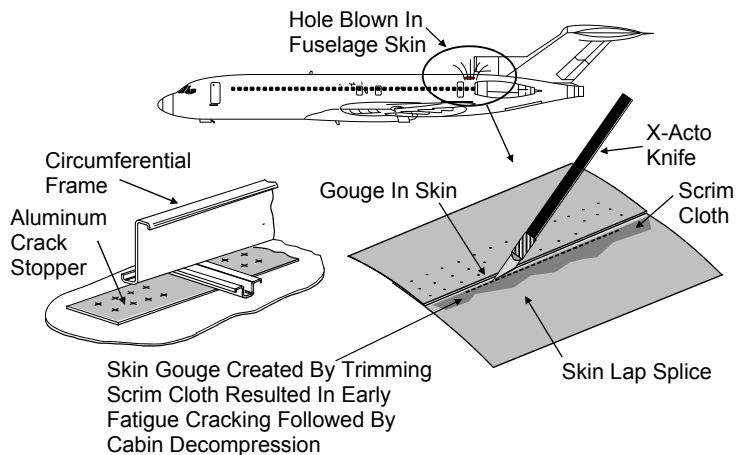
The second example concerns an Eastern Airlines 727 that suffered sudden cabin decompression caused by fatigue cracking induced by the X-Acto knife maintenance induced damage as shown in Figure C5. The rivets in the lap splice had been removed to clean out corrosion in the splice. Cold cure adhesive tape had been replaced and the excess tape trimmed off with an X-ACTO knife. The knife created a sharp gouge in the skin that became sites for the nucleation of fatigue cracks. Separate fatigue cracks linked together to form a long crack which eventually fast fractured and caused decompression. Fortunately, the fast fracture was successfully arrested by the aluminum crack stoppers located at the circumferential frames as shown in the sketch. The very large damage ‘crack arrest fail-safe’ capability designed into this fuselage saved this aircraft [C2, C3].

**Figure C5: Maintenance Action that Led to Skin Failure by Fatigue**

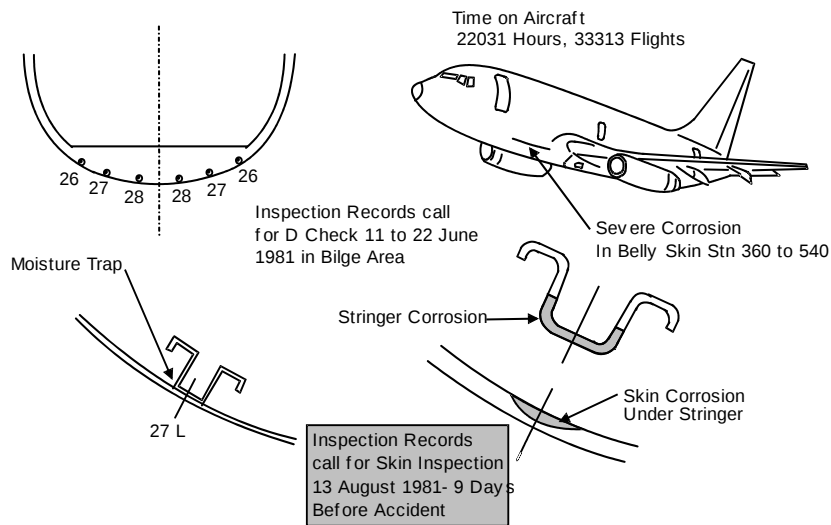
**Figure D4: Sketches Illustrating the Locations and Causes of Corrosion on B737 Aircraft**

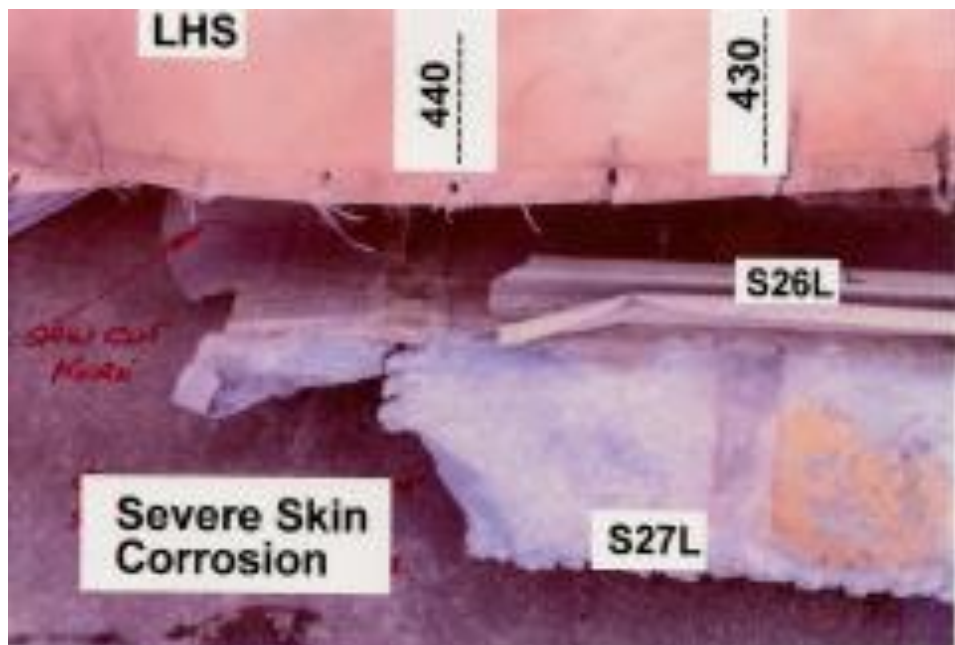
**Figure D5: Photo of Skin Corrosion in Lower Lobe of B737 Aircraft**

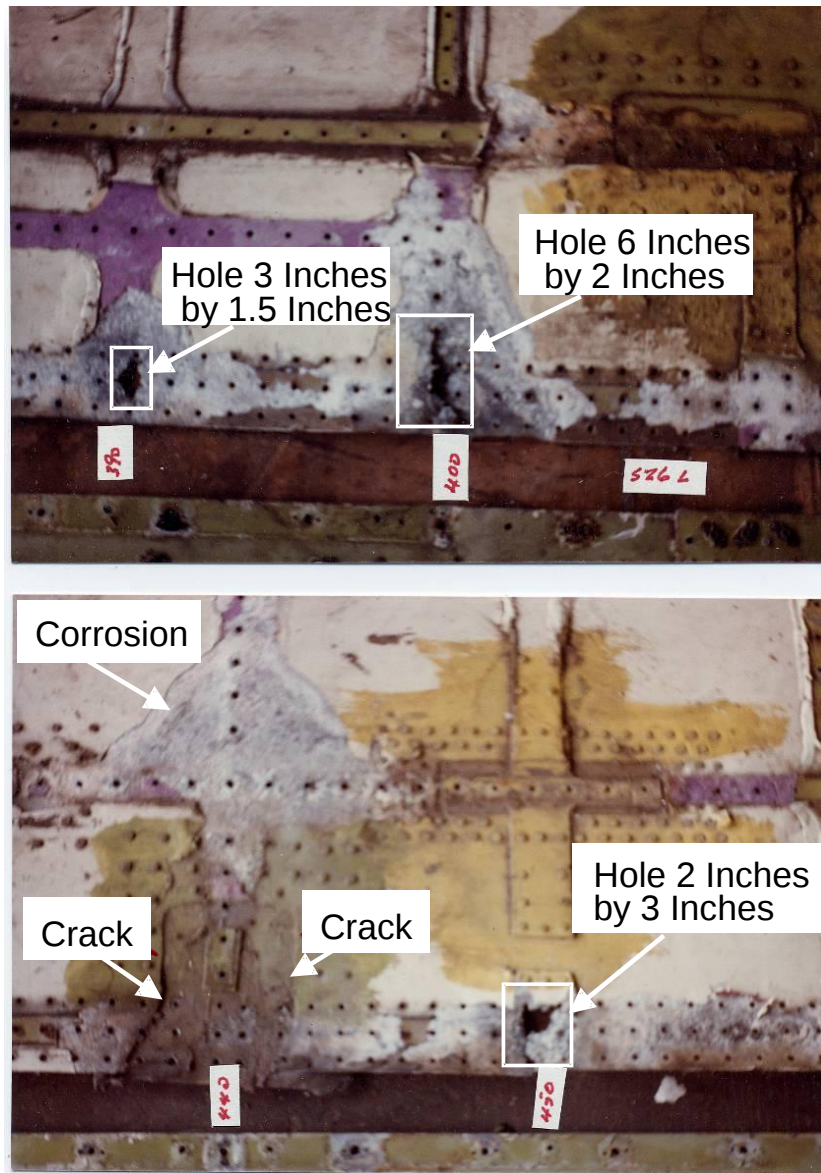
**Figure D7: Photos Illustrating Severe Corrosion of FEAT B737 Aircraft**

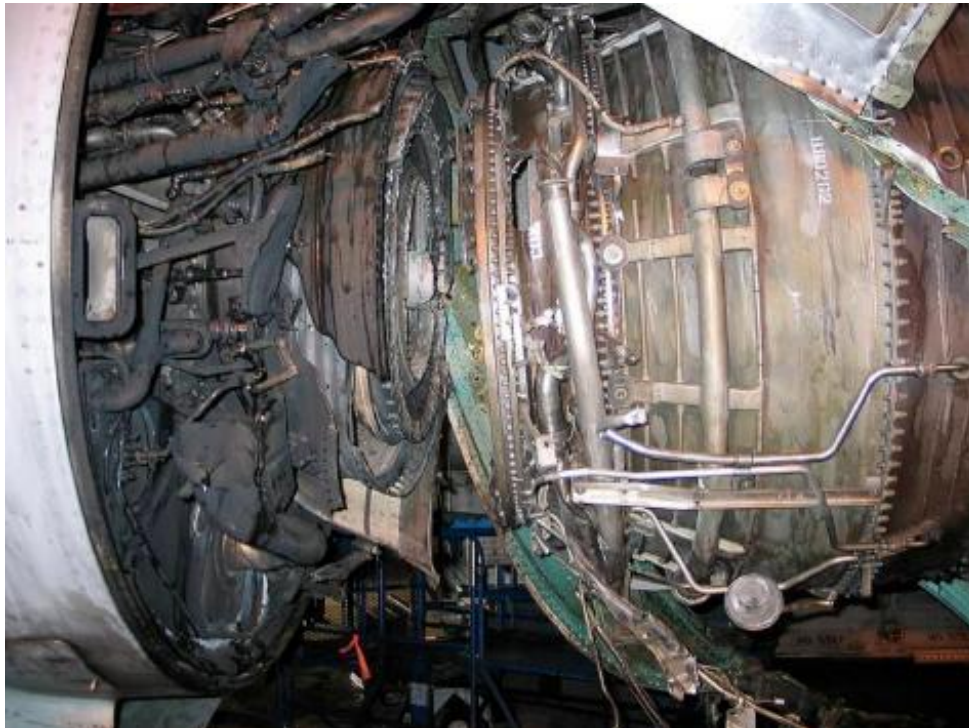
**Figure F15: Photo of Damage Associated with Uncontained Rotor Failure in a GE CF6 Engine**

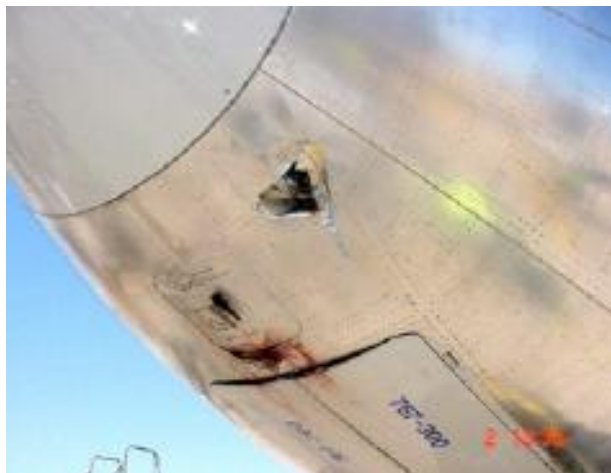
**Figure G4: Photo of Bird Strike Damage to Underside of Fuselage of B767 Aircraft**

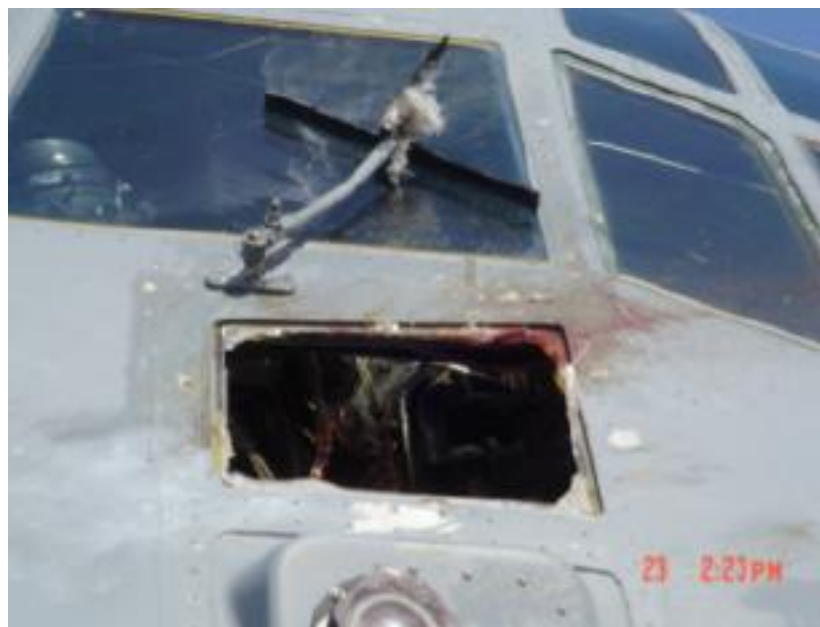
**Figure G7.: Photo of Bird Strike Damage to Outside of the C-130 Aircraft**

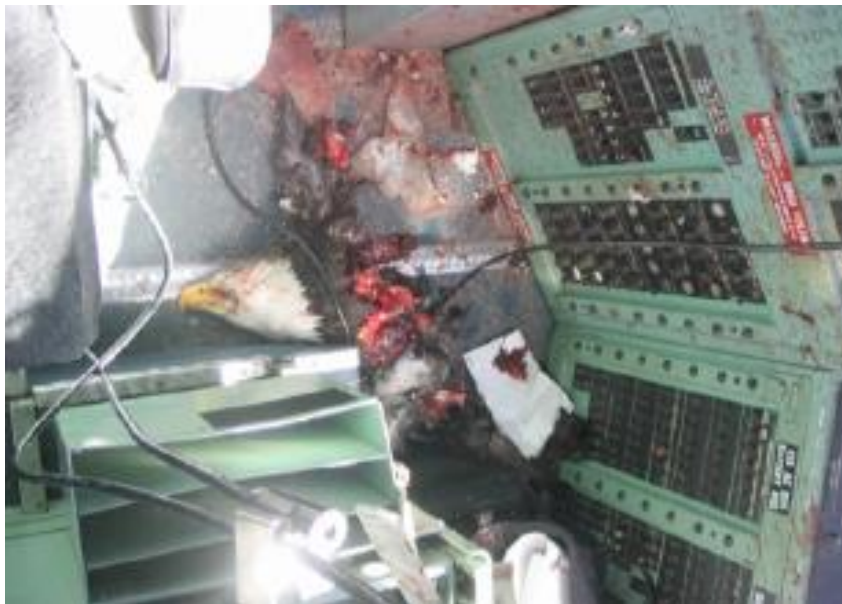
**Figure G9: Photo of Bird Strike Damage to Interior of the C-130 Aircraft**

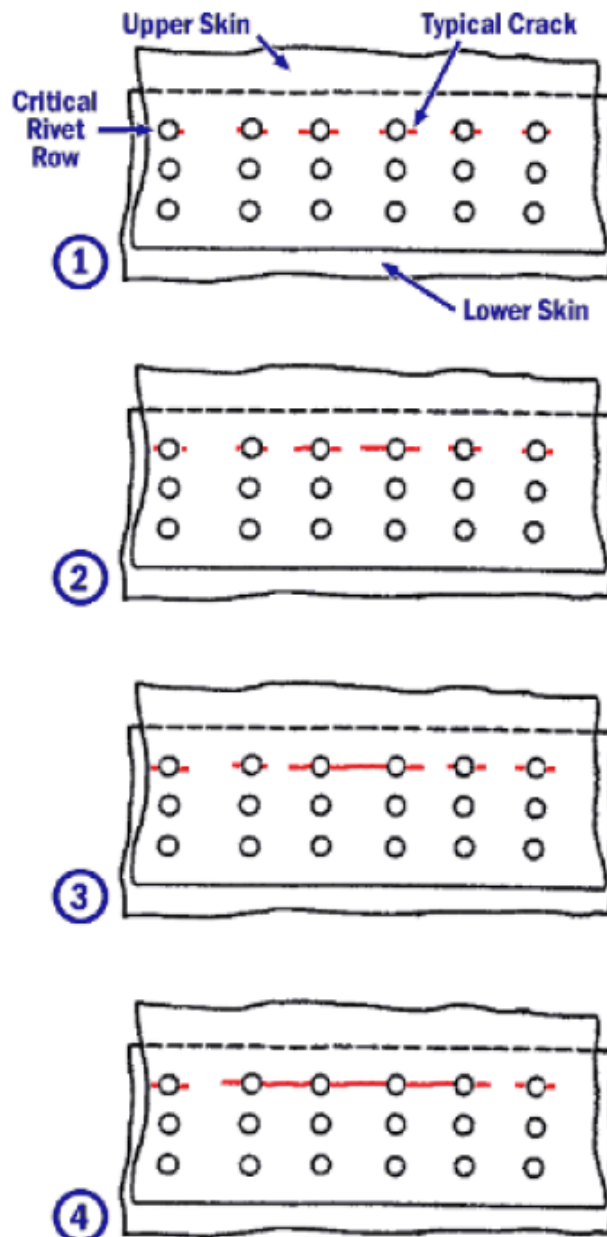
**Figure J7: Sketches Illustrating the Development of Small Fatigue Cracks in the Skin**

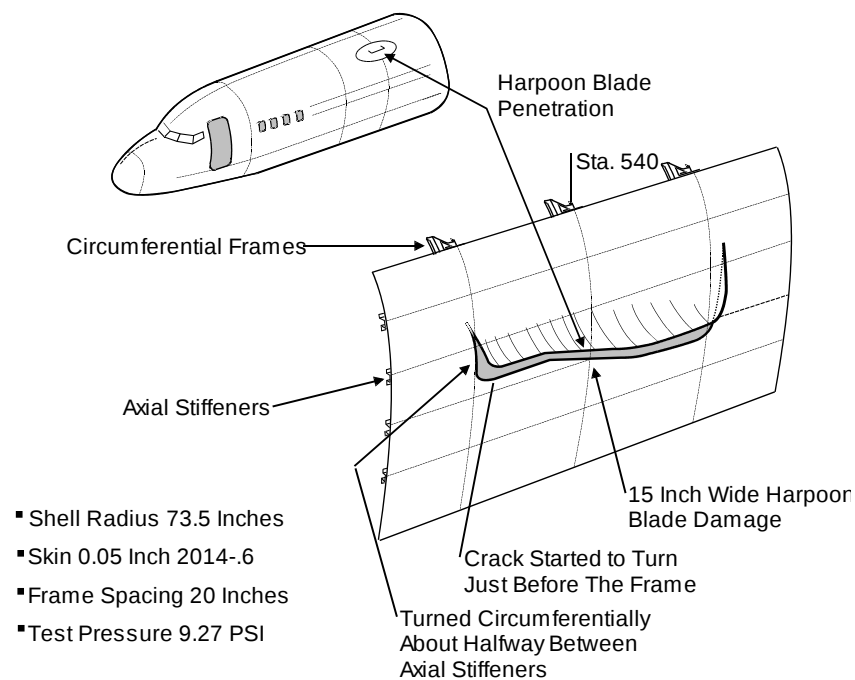
**Figure K6: Details of DC-8 Arrested Fuselage Crack**
