**REPORT ON THE  
PETERBOROUGH EXPLOSION**

**BLAST DAMAGE AND INJURIES**

**R. MERRIFIELD**

**Health and Safety Executive  
H M Explosives Inspectorate**

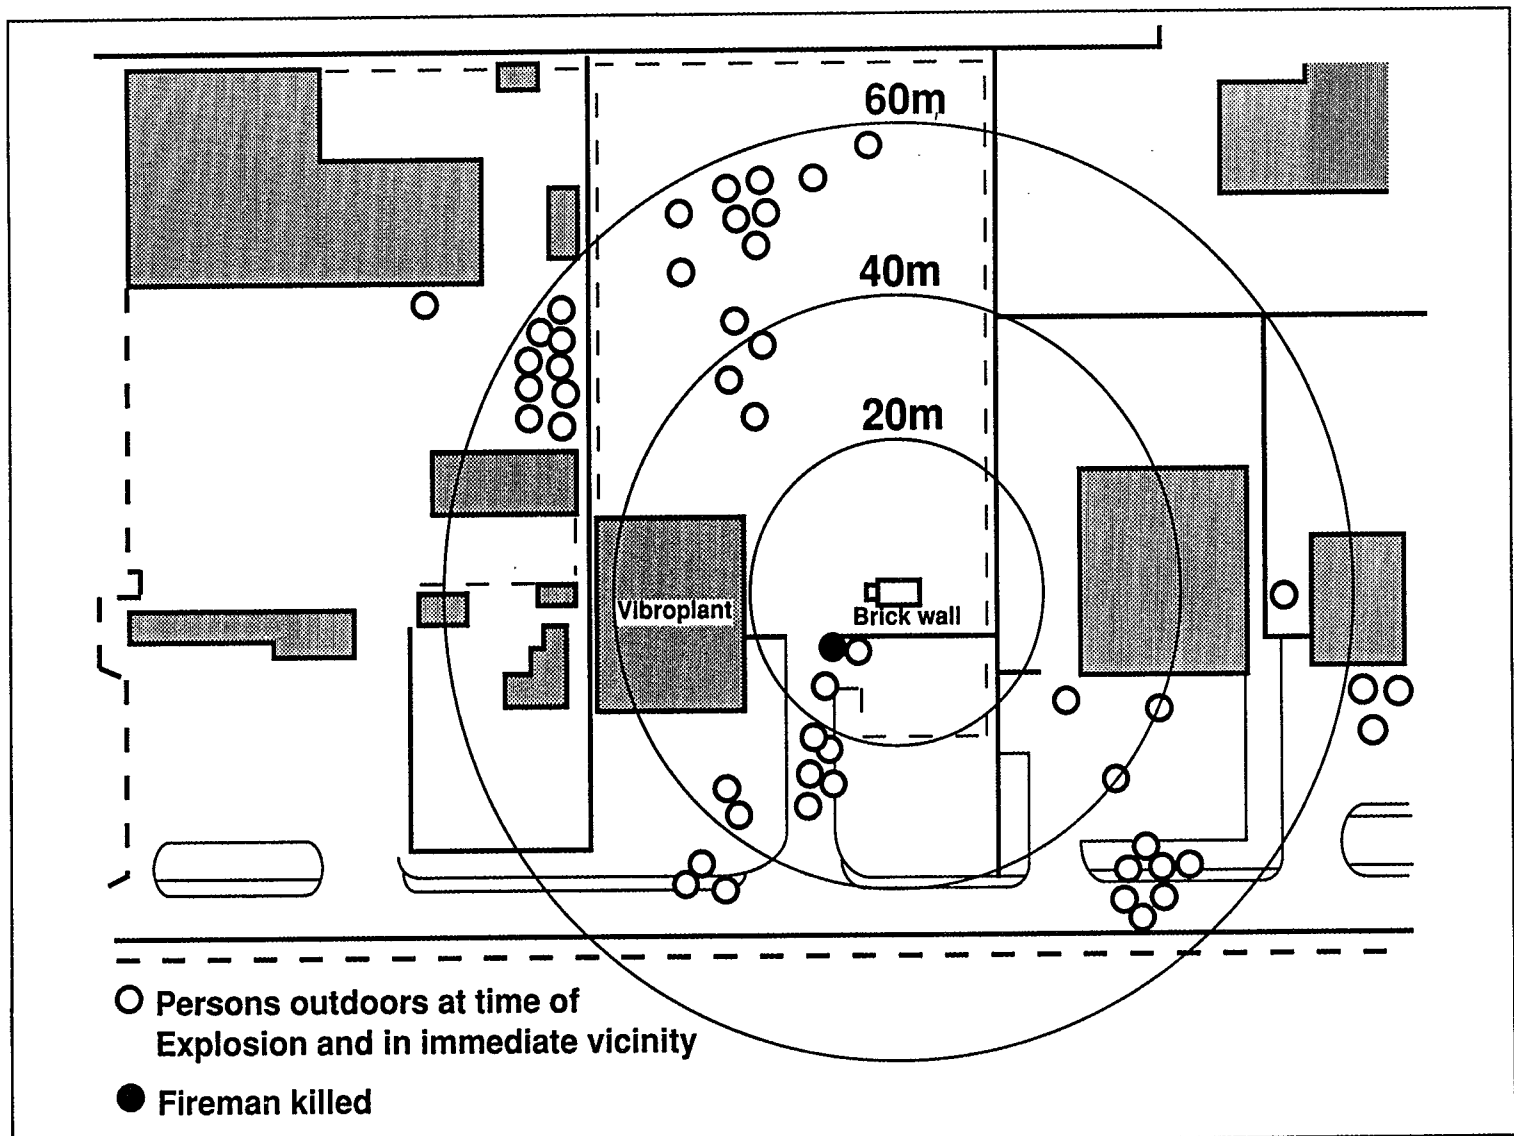
Fig 8

- 31 The fireman killed in the incident was approximately 15 or so metres away from the centre of the explosion and was killed by a fragment (see Figure 8). One of the badly injured persons (burned) was a fireman who had been standing close to the fatality. The other badly injured person was outdoors approx. 40 metres away, and was hit by a fragment. The injury 'contours' are summarised in Table 4.

- 34 In the 12 minute period between the onset of fire and the final explosion, numbers of people congregated both outdoors in close proximity to the van, and against windows which overlooked the Vibroplant yard (see Figure 8). This had the effects of causing persons outdoors to be blown off their feet, sustain hearing damage, and for some to be injured by fragments. Persons indoors sustained serious cuts from flying glass, translational injuries, and injuries from falling

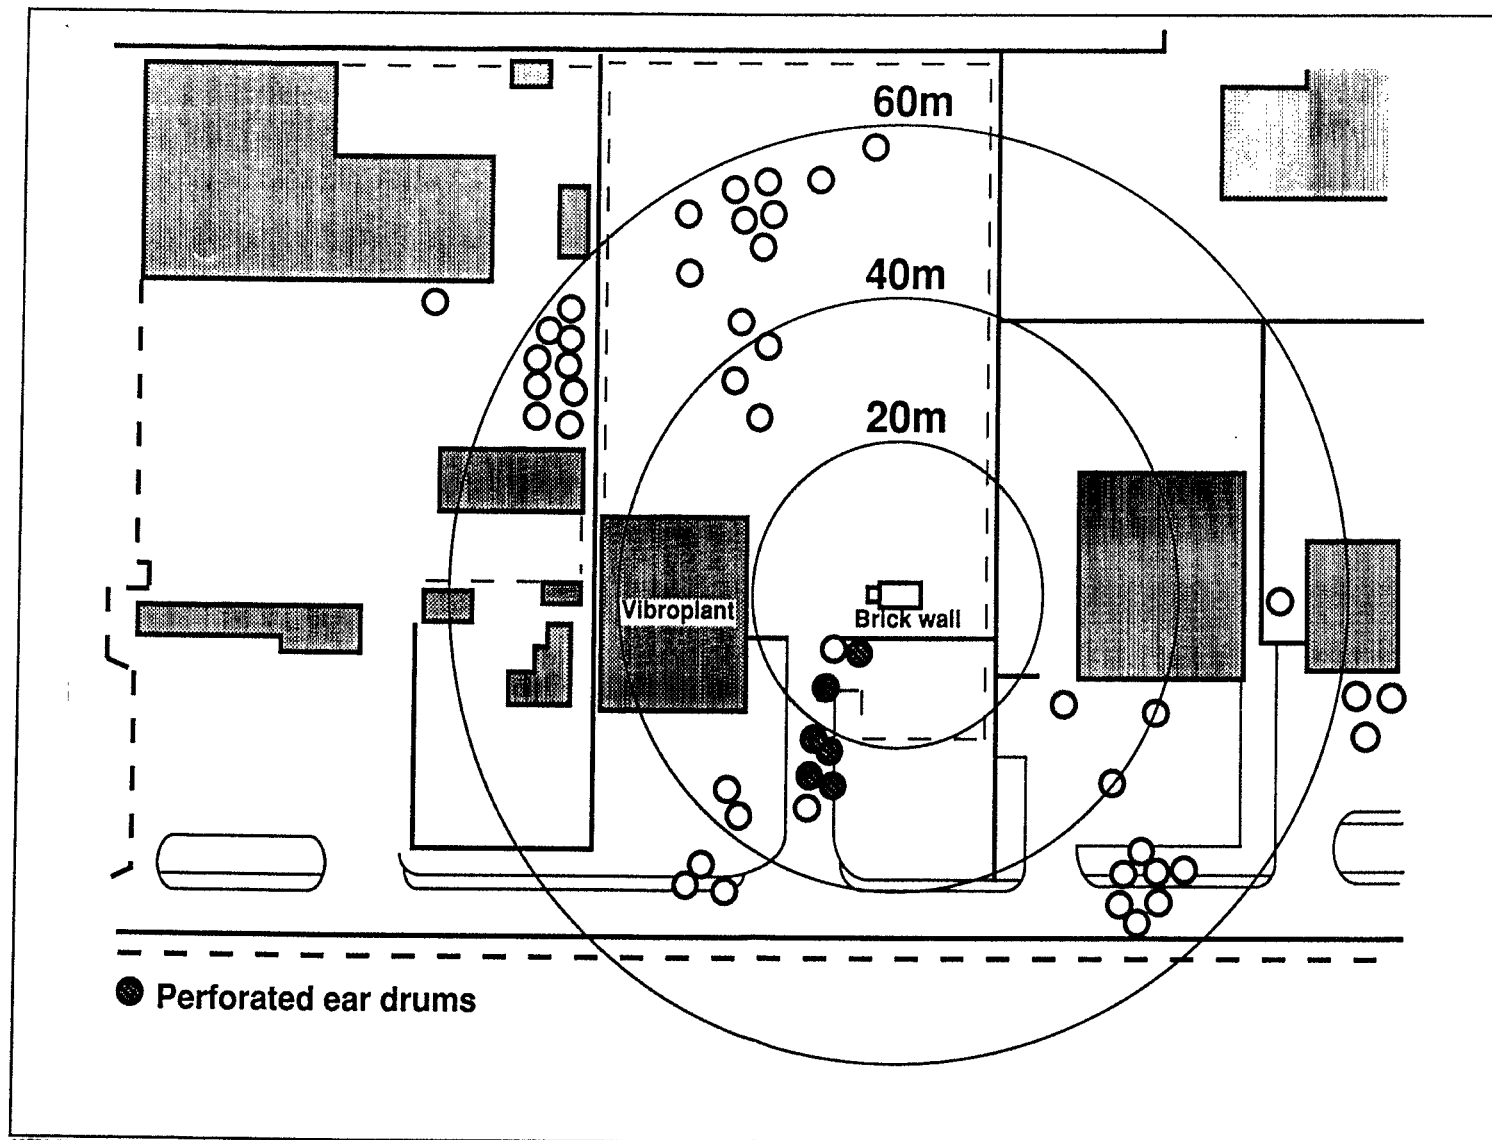
- 32 Persons outdoors and close to the explosion sustained perforated eardrums (see Figure 9), cuts and bruises from flying debris, and were thrown to the ground (see Figure 10). Persons indoors sustained the greatest numbers of injuries from flying glass. Other injuries indoors were due to collapsed ceilings.

Fig 9 Injuries sustained to persons outdoors
