In-bore Detonation of Non-standard Ammunition,
Testing a Russian T-55 Tank

Steven J. Reeves and Ralph Scutti

In-bore Detonation of Non-standard Ammunition

Testing a Russian T-55 Tank

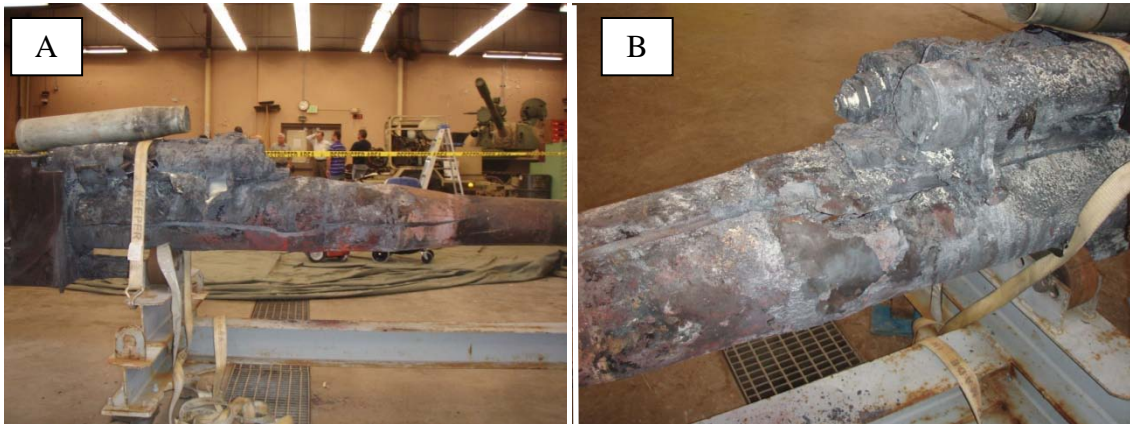
The fractured 100-mm cannon (figure 1) was sent to US Army Research, Development and Engineering Command, Armament Research, Development and Engineering Center, Benet Laboratories for a failure analysis.

Figure 1 Failed 100-mm gun tube after incident, 65” and 60” long cracks in images A and B respectively

The final report titled; Evaluation of Failed 100-mm T55 Soviet Tank Cannon, August 2009 concluded ‘Through Benet Laboratories failure analysis and interior ballistics simulations the gun tube could safely fire the BK5M HEAT round. The accident was caused by the BK5M HEAT round detonating in the tube. A reason for the premature detonation is unknown and part of an ongoing investigation. The projectile was at or near maximum acceleration when the event took place.’ The report also stated in the summary; ‘Failure mode of the tube is fast fracture due to an overpressure situation, Projectile travelled approximately 16 inches prior to the event, Tube material had adequate strength to support firing of the HEAT round under normal conditions, The chamber pressure at the time of the accident was 3000 Bars, The residues examined from the bore surface were determined to be rust, brass and elements found in the primer, and The projectile was fired and began to move’.

5) The failure analysis performed by Benet Laboratory concluded that the projectile moved approximately 16 inches down the tube before detonating. Additionally Benet concluded that the gun tube did not fail due to fatigue or wear but rather due to an event (force) that it was not designed to contain.

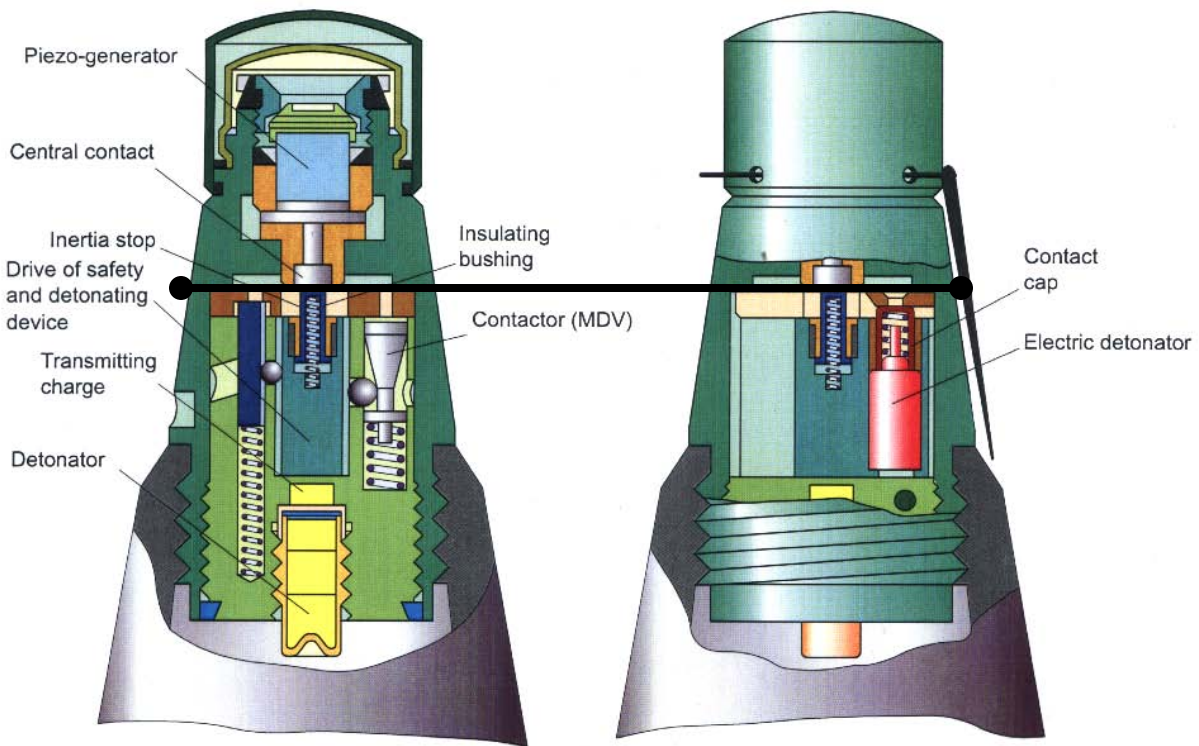
Figure 3 Fuse, GPV-2 for the Russian BK-5M 100-mm HEAT projectile (shown as received).
Modification, all internal components below black line were removed

Since the high explosive could not be removed to totally inert the round the GPV-2 fuse was modified in an attempt to make the projectile less likely to detonate prematurely. The safe and arming mechanism was removed from the GPV-2 fuse, leaving only the piezo-generator and central contact in the fuse. All energetic materials were removed from the GPV-2 fuse. All of the components under the black line (fig 3), the safe and arming mechanism, were removed. The group that performed the modification had documentation indicating that all fuses were modified and all material removed from the fuses was destroyed.

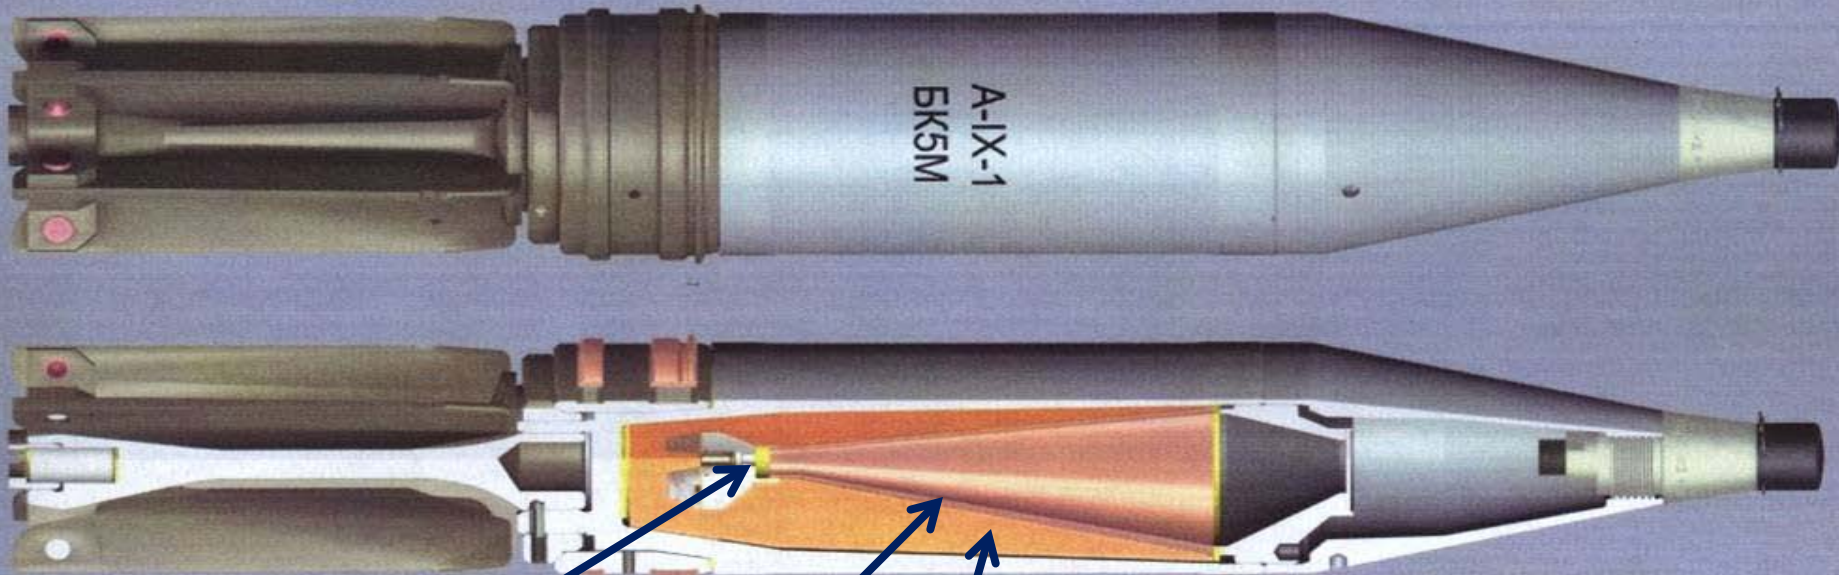
100mm HEAT BK5M Warhead

K-1-T detonator Cap

Copper Lining

RDX

638mm/25.11" Long, 12.2kg/26.90 lbs

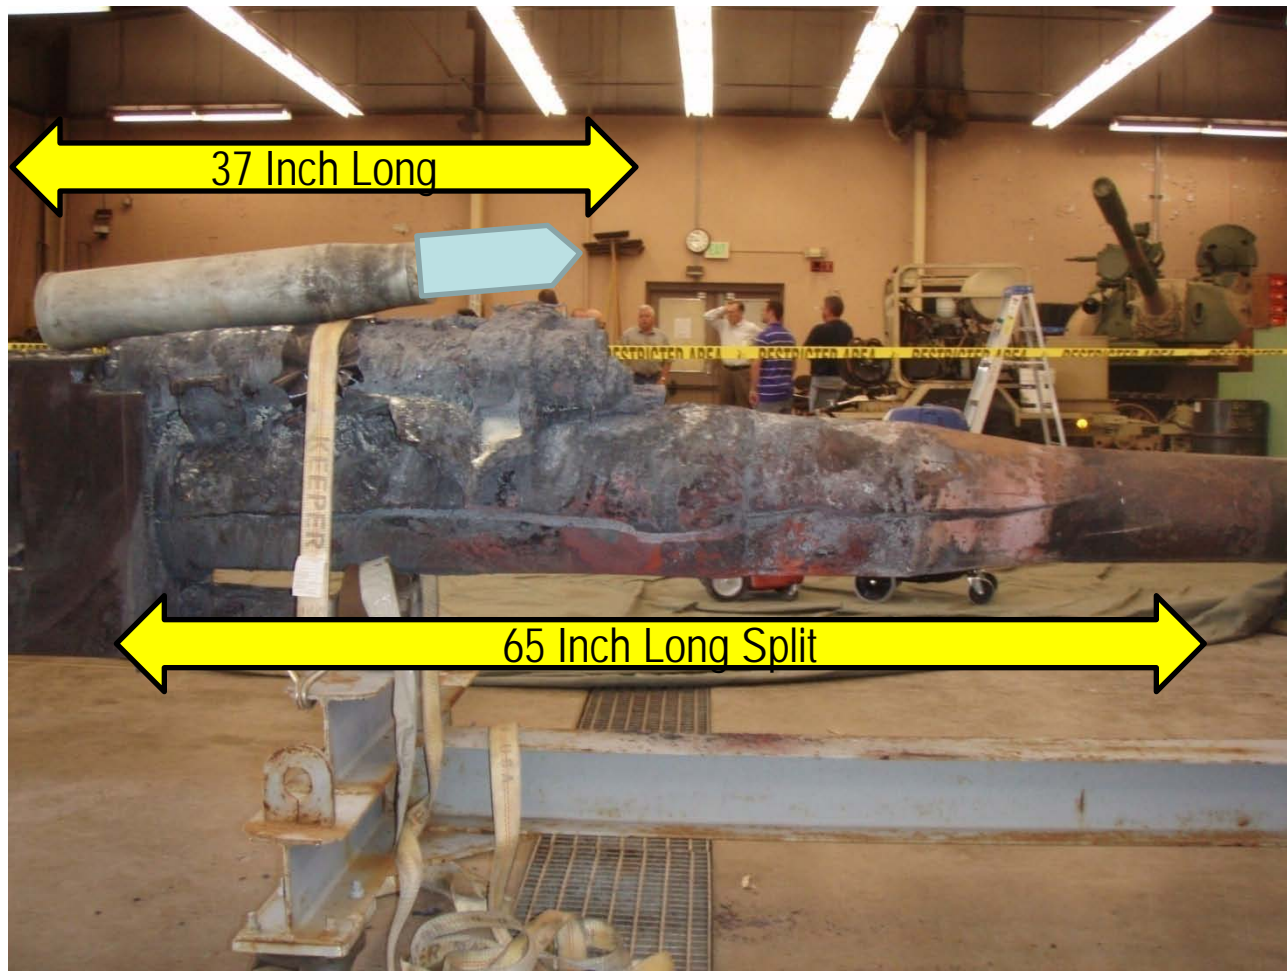
Post Incident

- Gun tube manufactured ~ 1974
- No inspection records prior to 1995
- Benet Labs post incident failure analysis
 - Gun Tube could safely fire HEAT round
 - Projectile detonated in gun tube
 - Projectile traveled ~ 16 inches prior to event
 - Projectile was near maximum acceleration at event
