THI QAR VILLAGE ROADS  
SEGMENT 3  
GOVERNORATE OF  
THI QAR, IRAQ

**SIGIR-PA-06-059**  
**OCTOBER 26, 2006**

SUBJECT: Report on Project Assessment of Thi-Qar Village Roads Segment 3 Project,  
Thi-Qar, Iraq (Report Number SIGIR-PA-06-059)

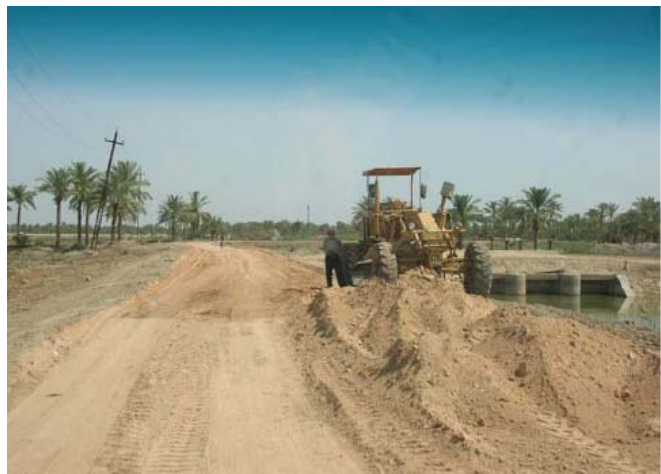
**Site Photo 2. Fill material being leveled. (Photo provided by USACE)**

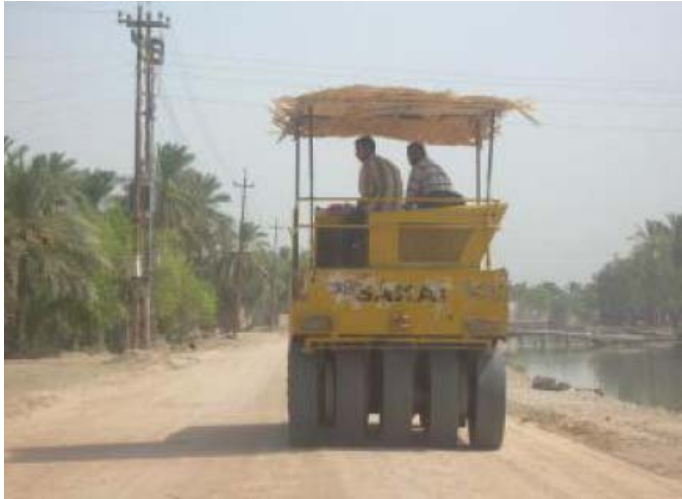
**Site Photo 4. Rolling operations to compact sub-base.  
(Photo provided by USACE)**

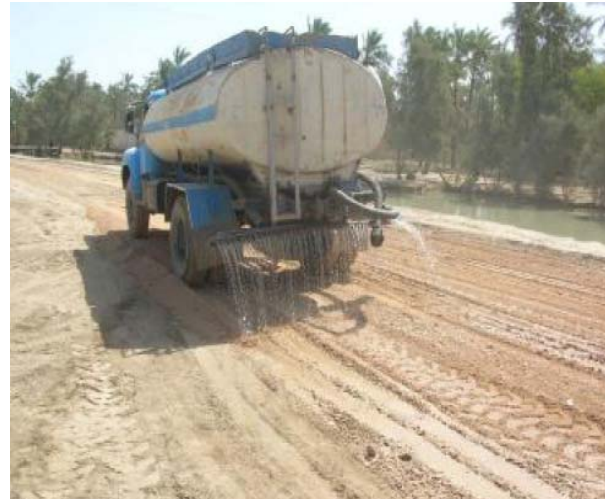
**Site Photo 5. Watering the sub-base.  
(Photo provided by USACE)**

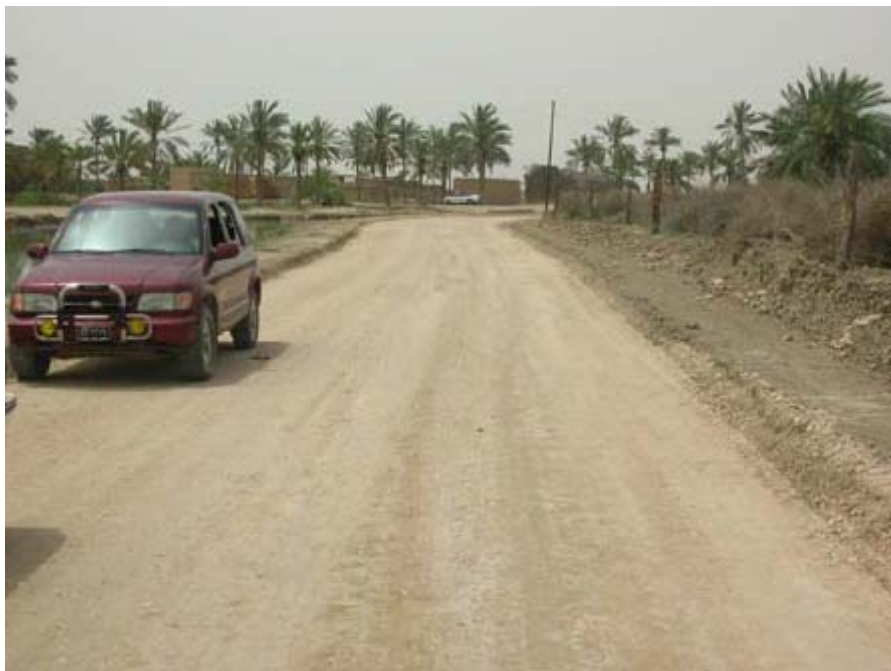
**Site Photo 6. Compacted sub-base. (Photo provided by USACE)**

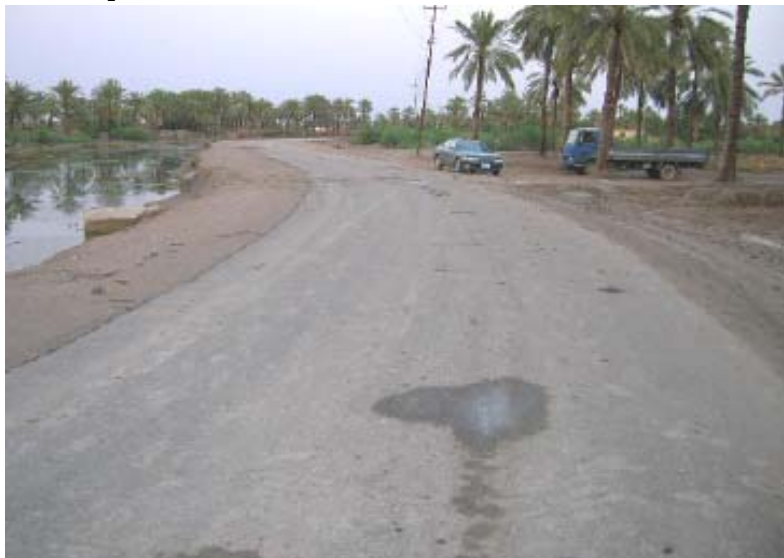
**Site Photo 9. Curved section of Thi Qar Village road in April 2006. (Photo provided by USACE)**
